**Former Clifton Caravan Sales  
Morpeth, Northumberland**

**Phase 2 Geoenvironmental Appraisal**

30 April 2021

20004-01

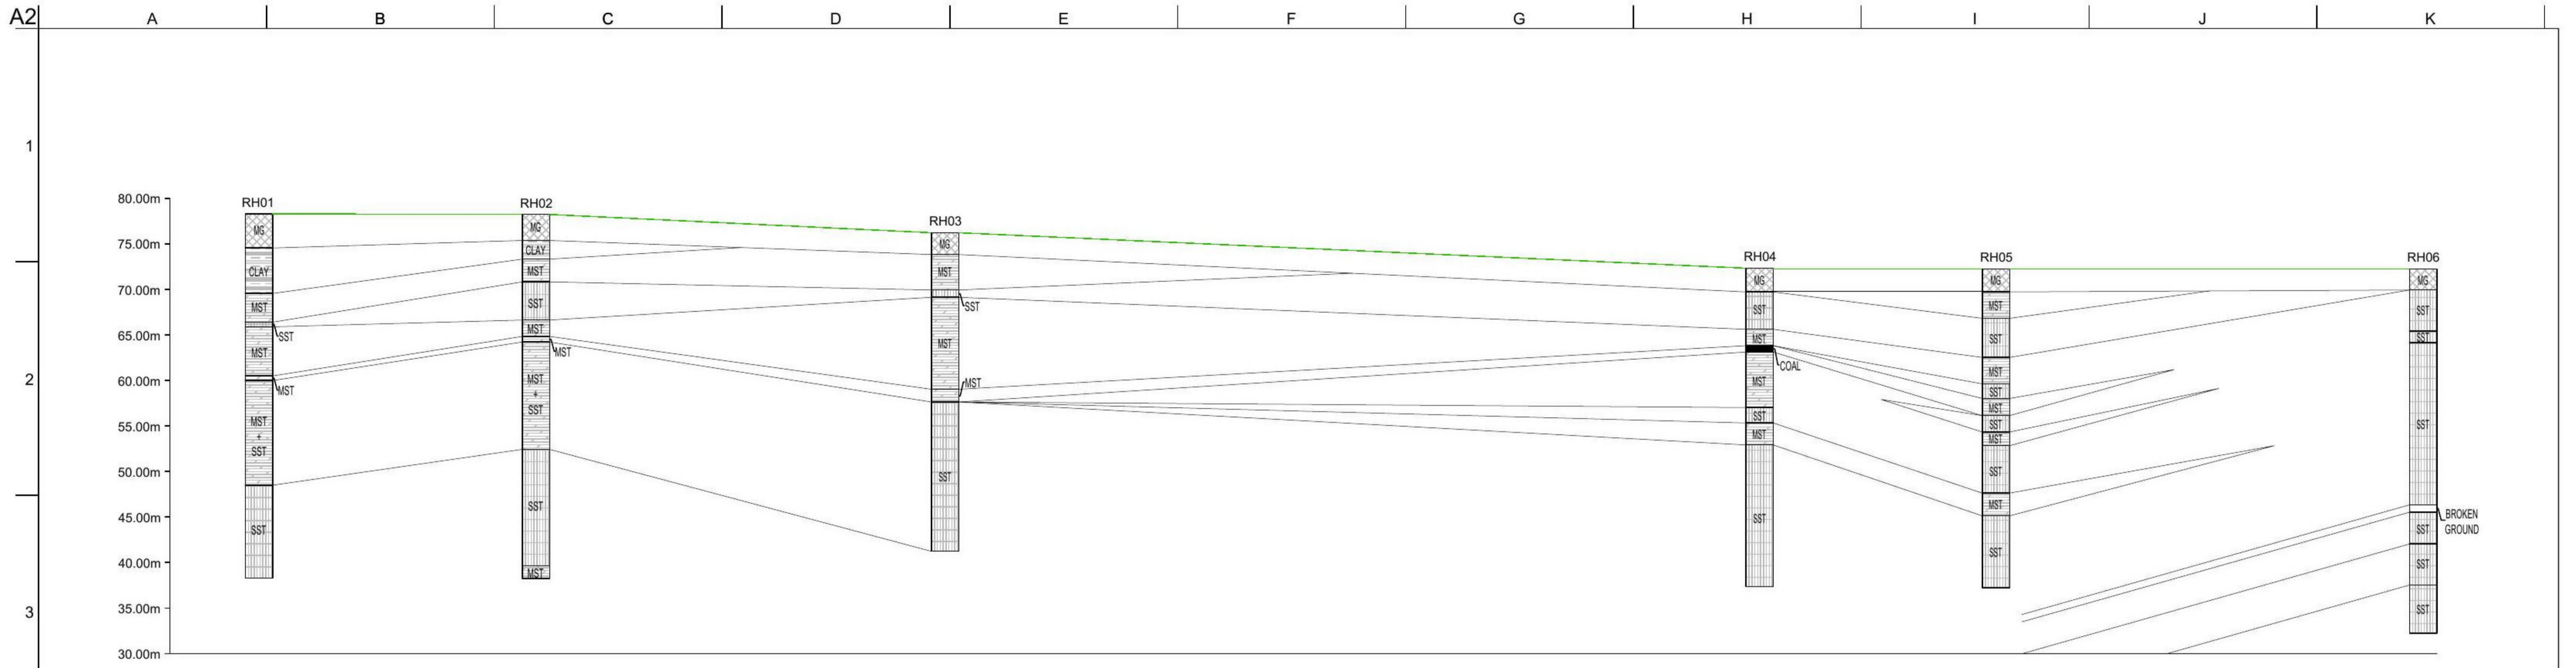
**GEOLOGICAL CROSS SECTION**  
SCALE 1:500

- ROTARY BOREHOLE
- MG MADE GROUND
- SST SANDSTONE
- MST MUDSTONE

Exploratory Hole	Bedrock Depth (m bgl)	Depth to Coal Seam / Workings (Thickness (m))	Rock Cover Above Solid Coal Seam (rock cover ratio*)	Notes
RH01	8.75m	17.8m (0.5m)	9.05m (16.1: 1)	Carbonaceous Mudstone
RH02	4.90m	13.4m (0.6m)	8.5m (14.1: 1)	Carbonaceous Mudstone
RH03	2.4m	17.2m (1.4m)	14.8m (10.5: 1)	Carbonaceous Mudstone
RH04	2.6m	8.5m (0.7m)	5.9m (8.4: 1)	Intact Coal (Three Quarter Coal?)
RH05		-	-	-
RH06	2.3m	25.9m (0.8m)	23.6m (29.5: 1)	Broken Ground/ Bed separation (Brockwell Coal (Thickness 0.6m))
