Bat Survey of Wainsford Bungalow Little Bardfield

**John Dobson B.Sc
Essex Mammal Surveys**

August 2022

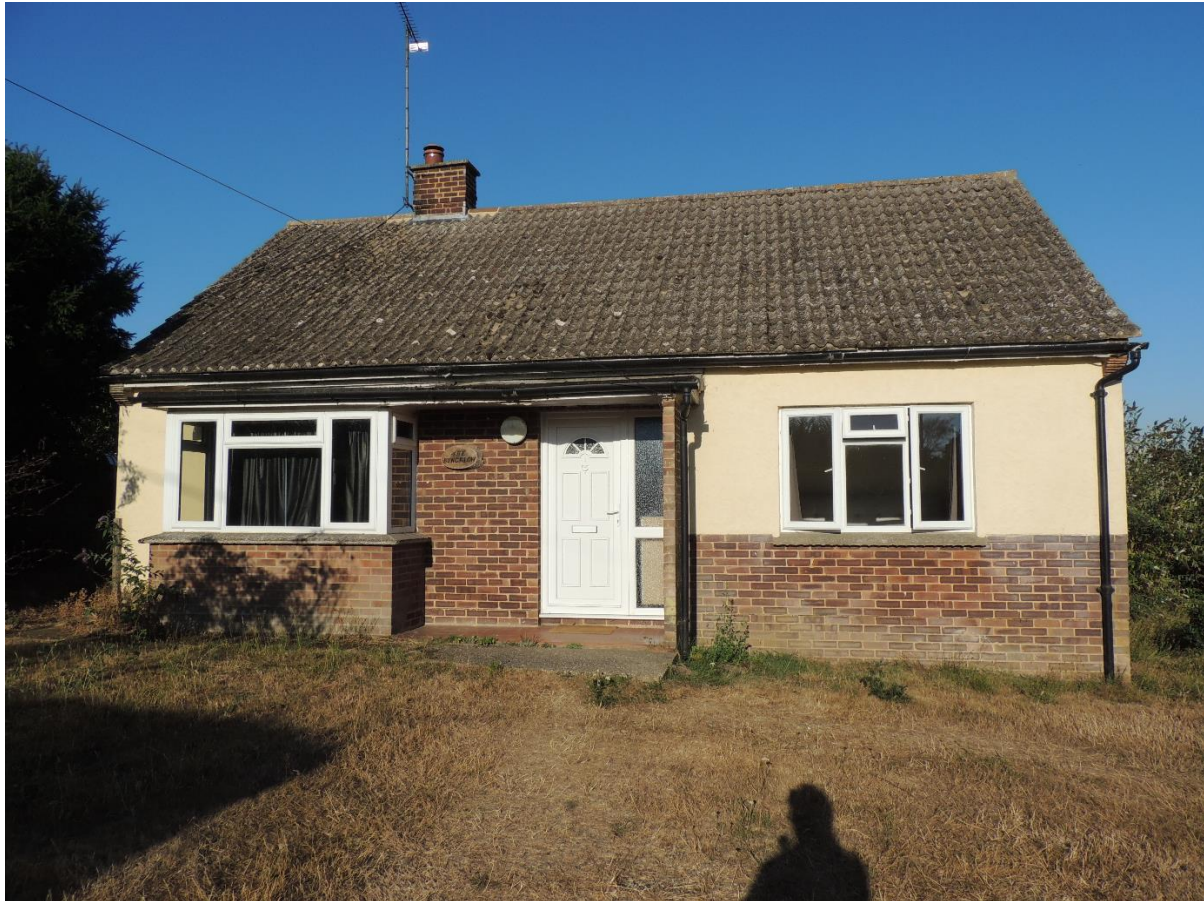
Photo 1: Front (eastern) elevation. Note tight seal to roof tiles

the gable walls. There was also a tight seal to the roof tiles and no evidence such as droppings or staining was found on the pale walls where the presence of bats would have been readily apparent.

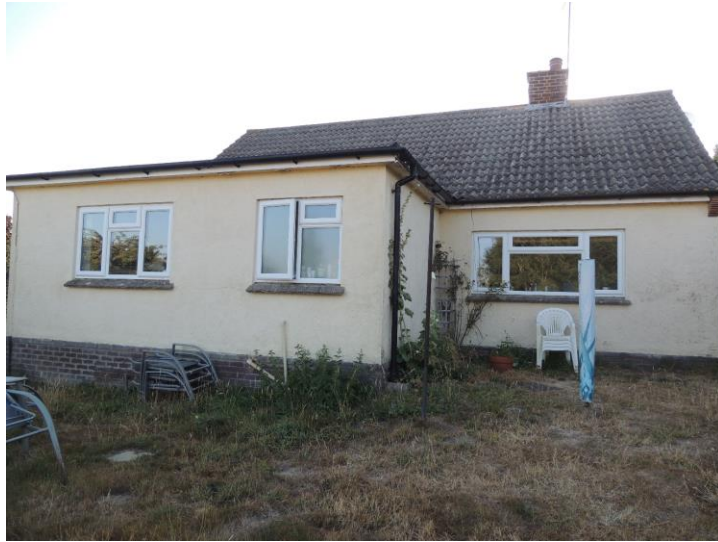
Photo 3: Western elevation. There was a tight seal to the flat-roofed extension

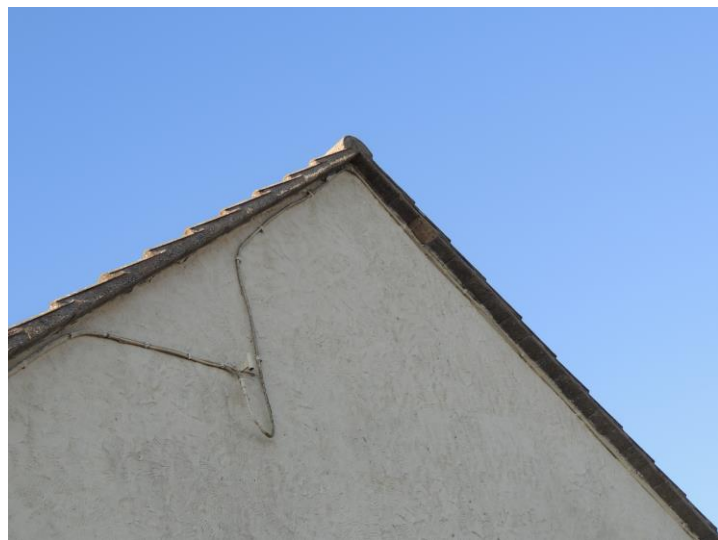
The survey building is a detached residential bungalow with a tile and felted roof and pale, rendered walls. The building is aligned N-S. The survey found that the roof void was accessed via a ladder in the centre of the property and found that one end of the loft had a cluttered construction, with a wooden tower to support the water tank. There was a covering of cobwebs on some of the roof beams, notably at the top of the gable walls, conditions that are usually a deterrent to colonisation by bats. No evidence of their presence was found on the floor of the loft or along the internal eaves of the building. Externally, there was a tight seal along the eaves and gables, where the overlapping roof tiles were cemented to the top of

Photo 5: Note tight seal to gable wall

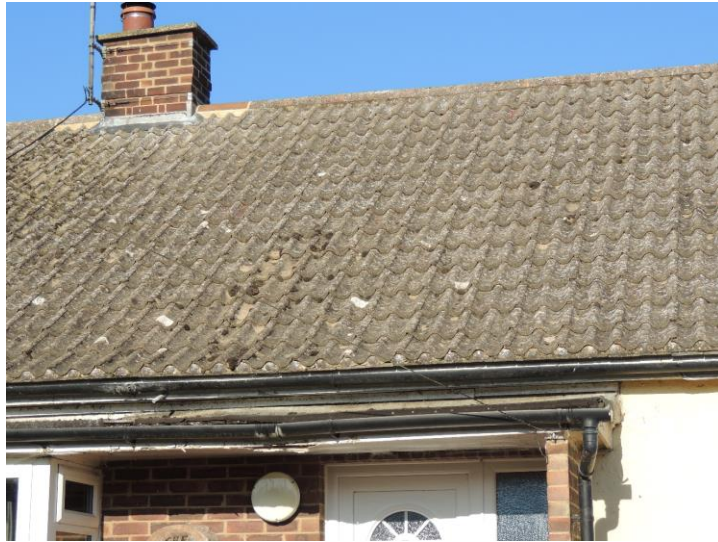
Photo 6: Note tight seal to roof tiles

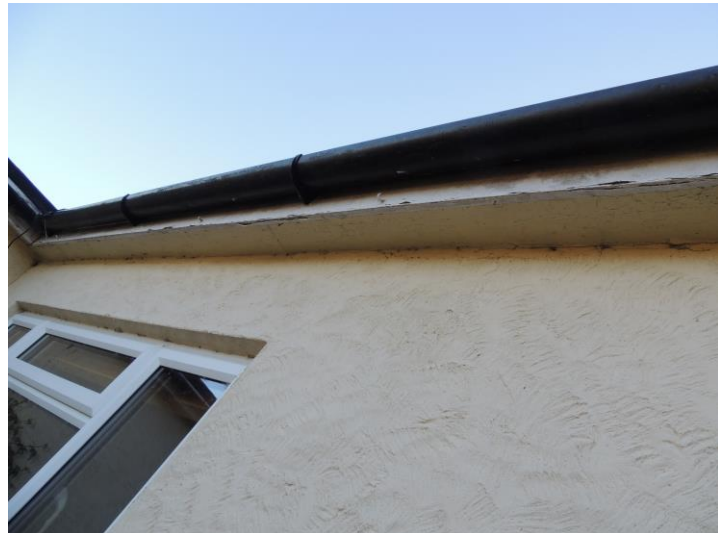
Photo 7: Typical section of eaves showing tight seal

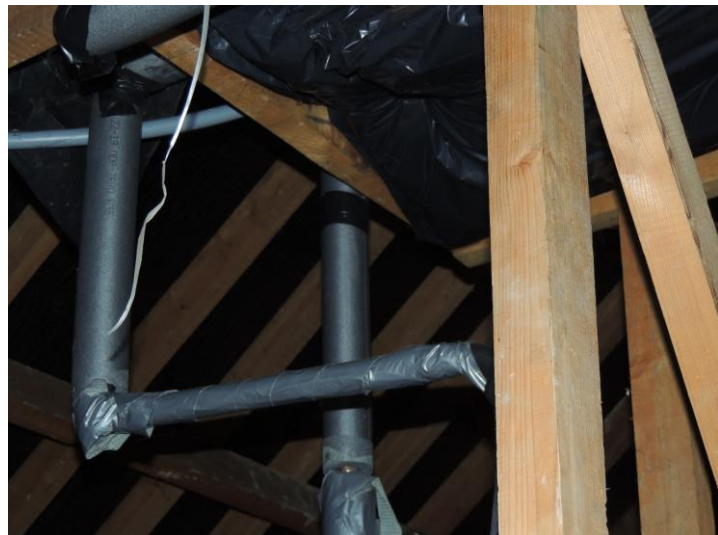
The survey building is a detached residential bungalow with a tile and felted roof and pale, rendered walls. The building is aligned N-S. The survey found that the roof void was accessed via a ladder in the centre of the property and found that one end of the loft had a cluttered construction, with a wooden tower to support the water tank. There was a covering of cobwebs on some of the roof beams, notably at the top of the gable walls, conditions that are usually a deterrent to colonisation by bats. No evidence of their presence was found on the floor of the loft or along the internal eaves of the building. Externally, there was a tight seal along the eaves and gables, where the overlapping roof tiles were cemented to the top of the gable walls. There was also a tight seal to the roof tiles and no evidence such as droppings or staining was found on the pale walls where the presence of bats would have been readily apparent.

Photo 8: A complex tower supporting the water tank clutters one end of the loft

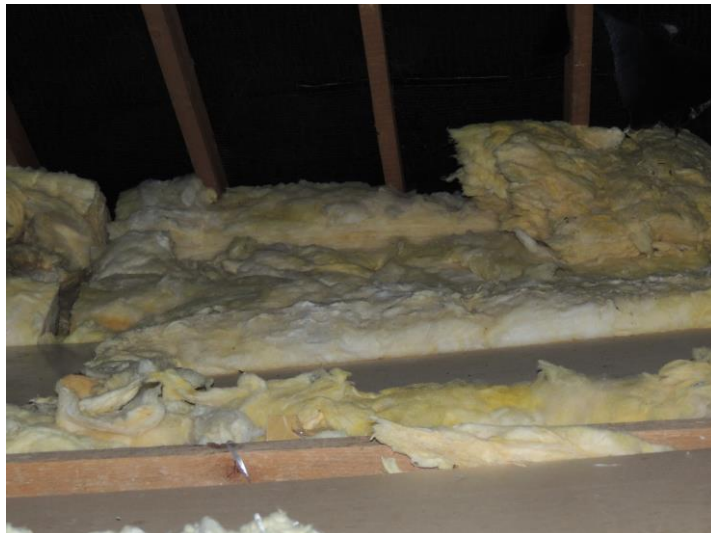
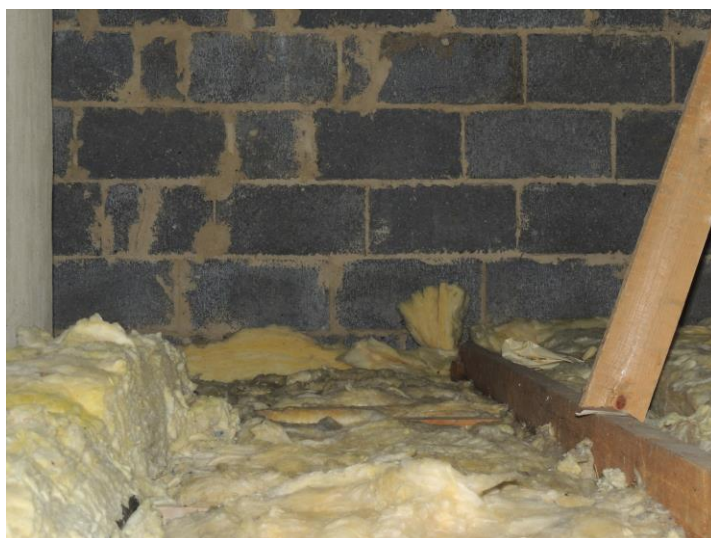
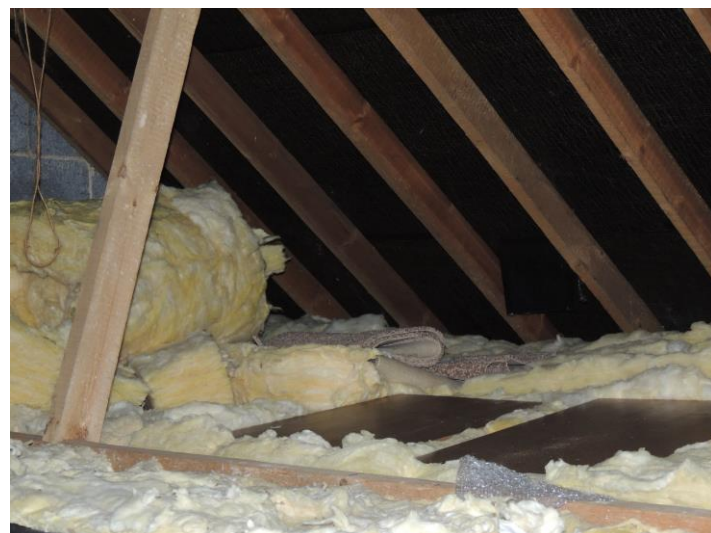
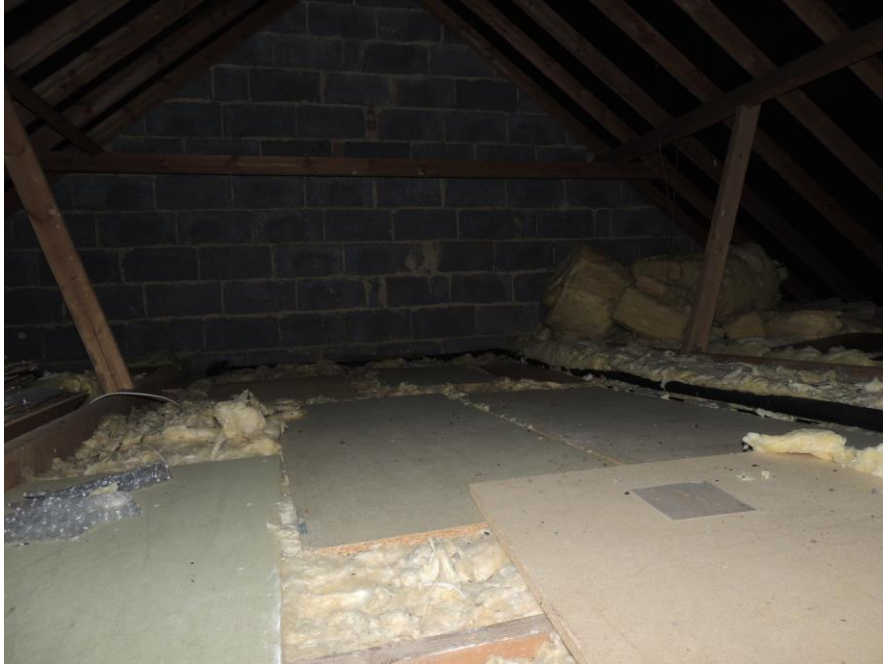
Photo 9: Note lack of evidence of bats on floor of loft

Photo 10: Note lack of evidence of bats on floor of loft

Photo 11: Note lack of evidence of bats on floor of loft

Photo 12: Note lack of evidence of bats on floor of loft

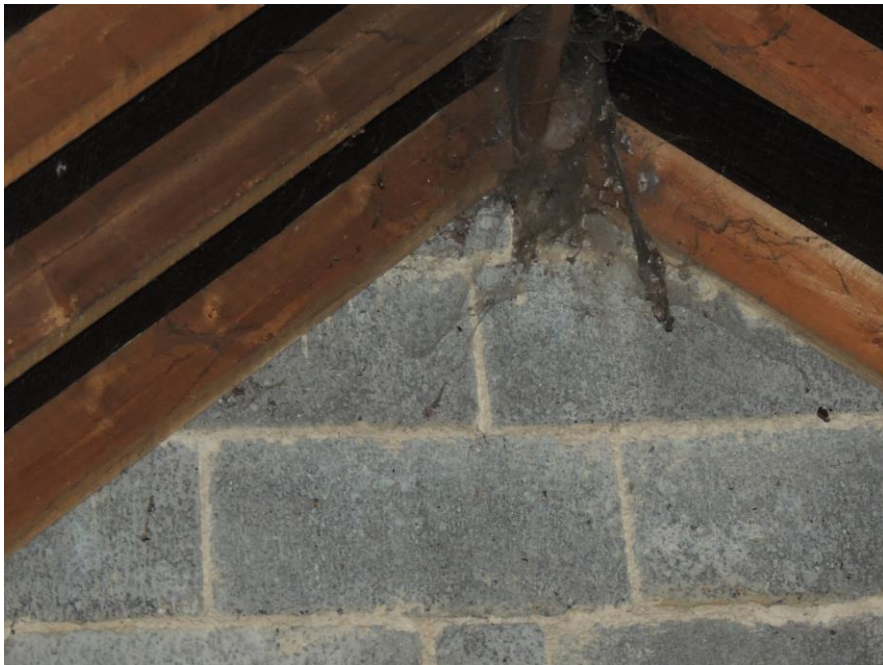
Photo 13: Note cobwebs at apex of gable wall

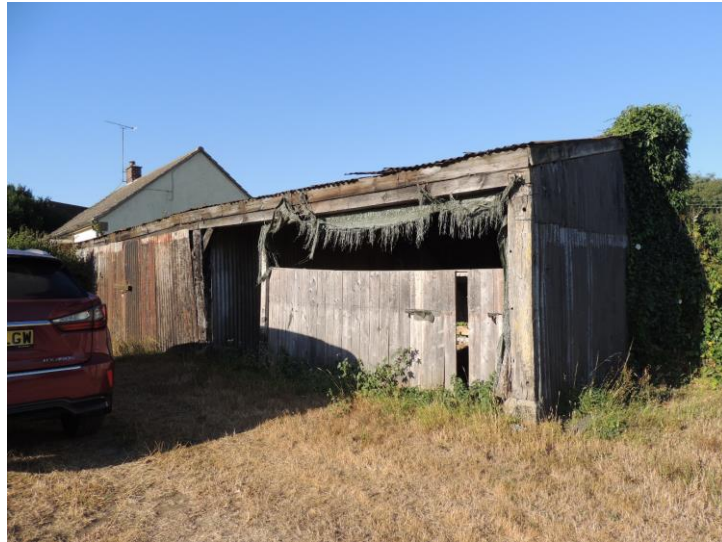
A large shed to the east of the bungalow had walls and roof of corrugated tin. The western side of the building had collapsed since the earlier survey, with the remaining part of the structure appearing to be in poor condition. The interior received daylight illumination via a missing door, conditions in which bats seek out dark areas or cavities in which to roost. The lack of such features meant that this structure was unsuitable as a roosting place for bats.

Photo 13: Eastern and northern elevations of shed

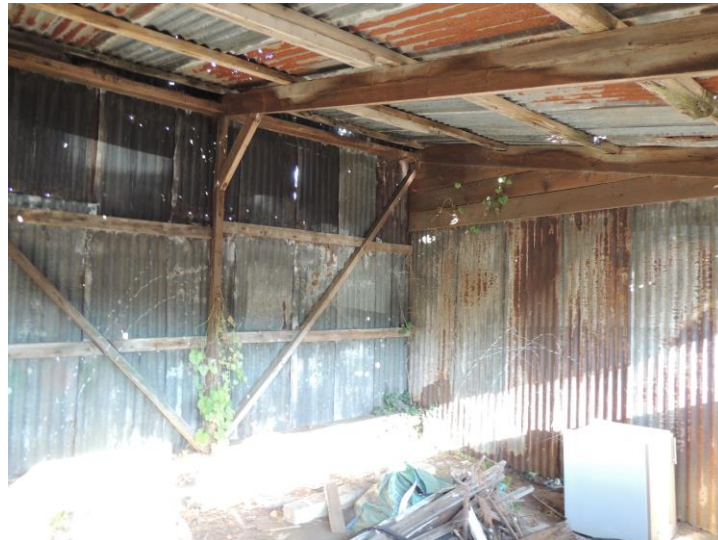
Photo 14: The interior had no features that might be occupied by bats

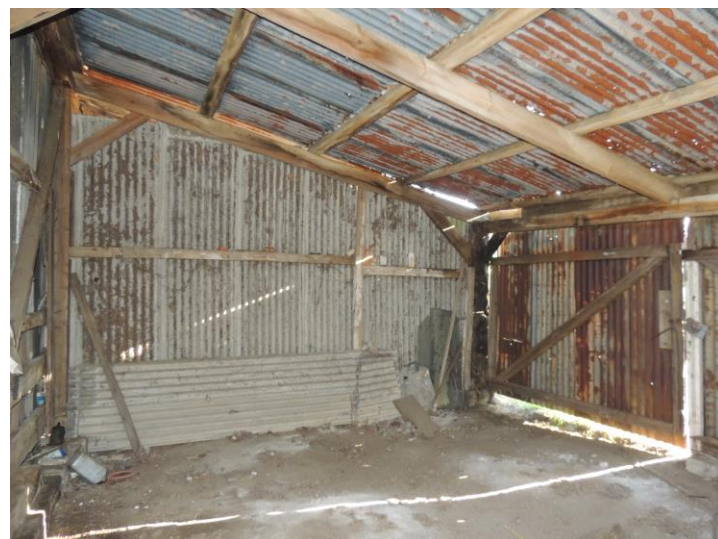
Photo 15: The interior of the shed had no features that might be occupied by bats

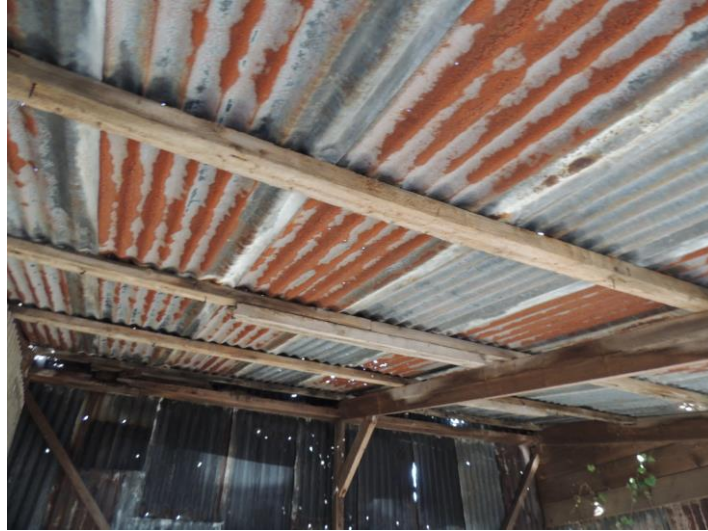
Photo 16: The roof of the shed had no features that might be occupied by bats

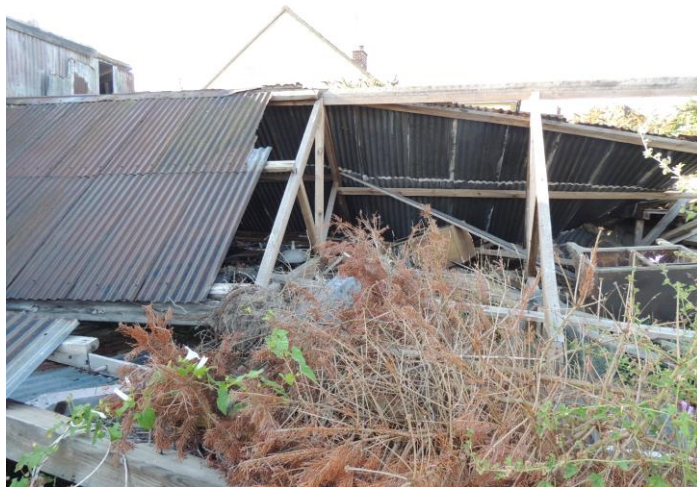
A large shed to the east of the bungalow had walls and roof of corrugated tin. The western side of the building had collapsed since the earlier survey, with the remaining part of the structure appearing to be in poor condition. The interior received daylight illumination via a missing door, conditions in which bats seek out dark areas or cavities in which to roost. The lack of such features meant that this structure was unsuitable as a roosting place for bats.

Photo 17: Part of the building had collapsed since the earlier survey

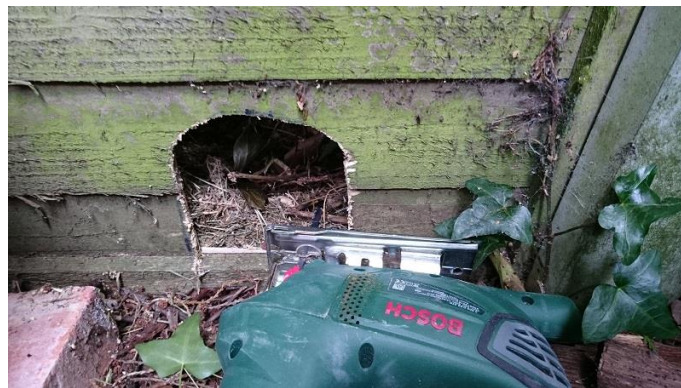
Photo 19: Hedgehog pathway at base of fence

1: It is recommended that the existing gaps along the site boundaries are retained to allow hedgehogs and common toads to forage across the site as, potentially, at present. However if boundary fences are to be introduced, see below:

A gap 13cm by 13cm is sufficient for any hedgehog to pass through. This will be too small for nearly all pets.
