RETFORD ROAD, SOUTH LEVERTON DRAINAGE STATEMENT

This document has been produced in conjunction with the proposed planning approved residential scheme (21/00775/FUL) at Priory Farm, Retford Road, South Leverton. The information produced is to support the discharge of Planning Condition 20.

**Proposed Residential Development,
Priory Farm, Retford Road,
South Leverton, Notts.**

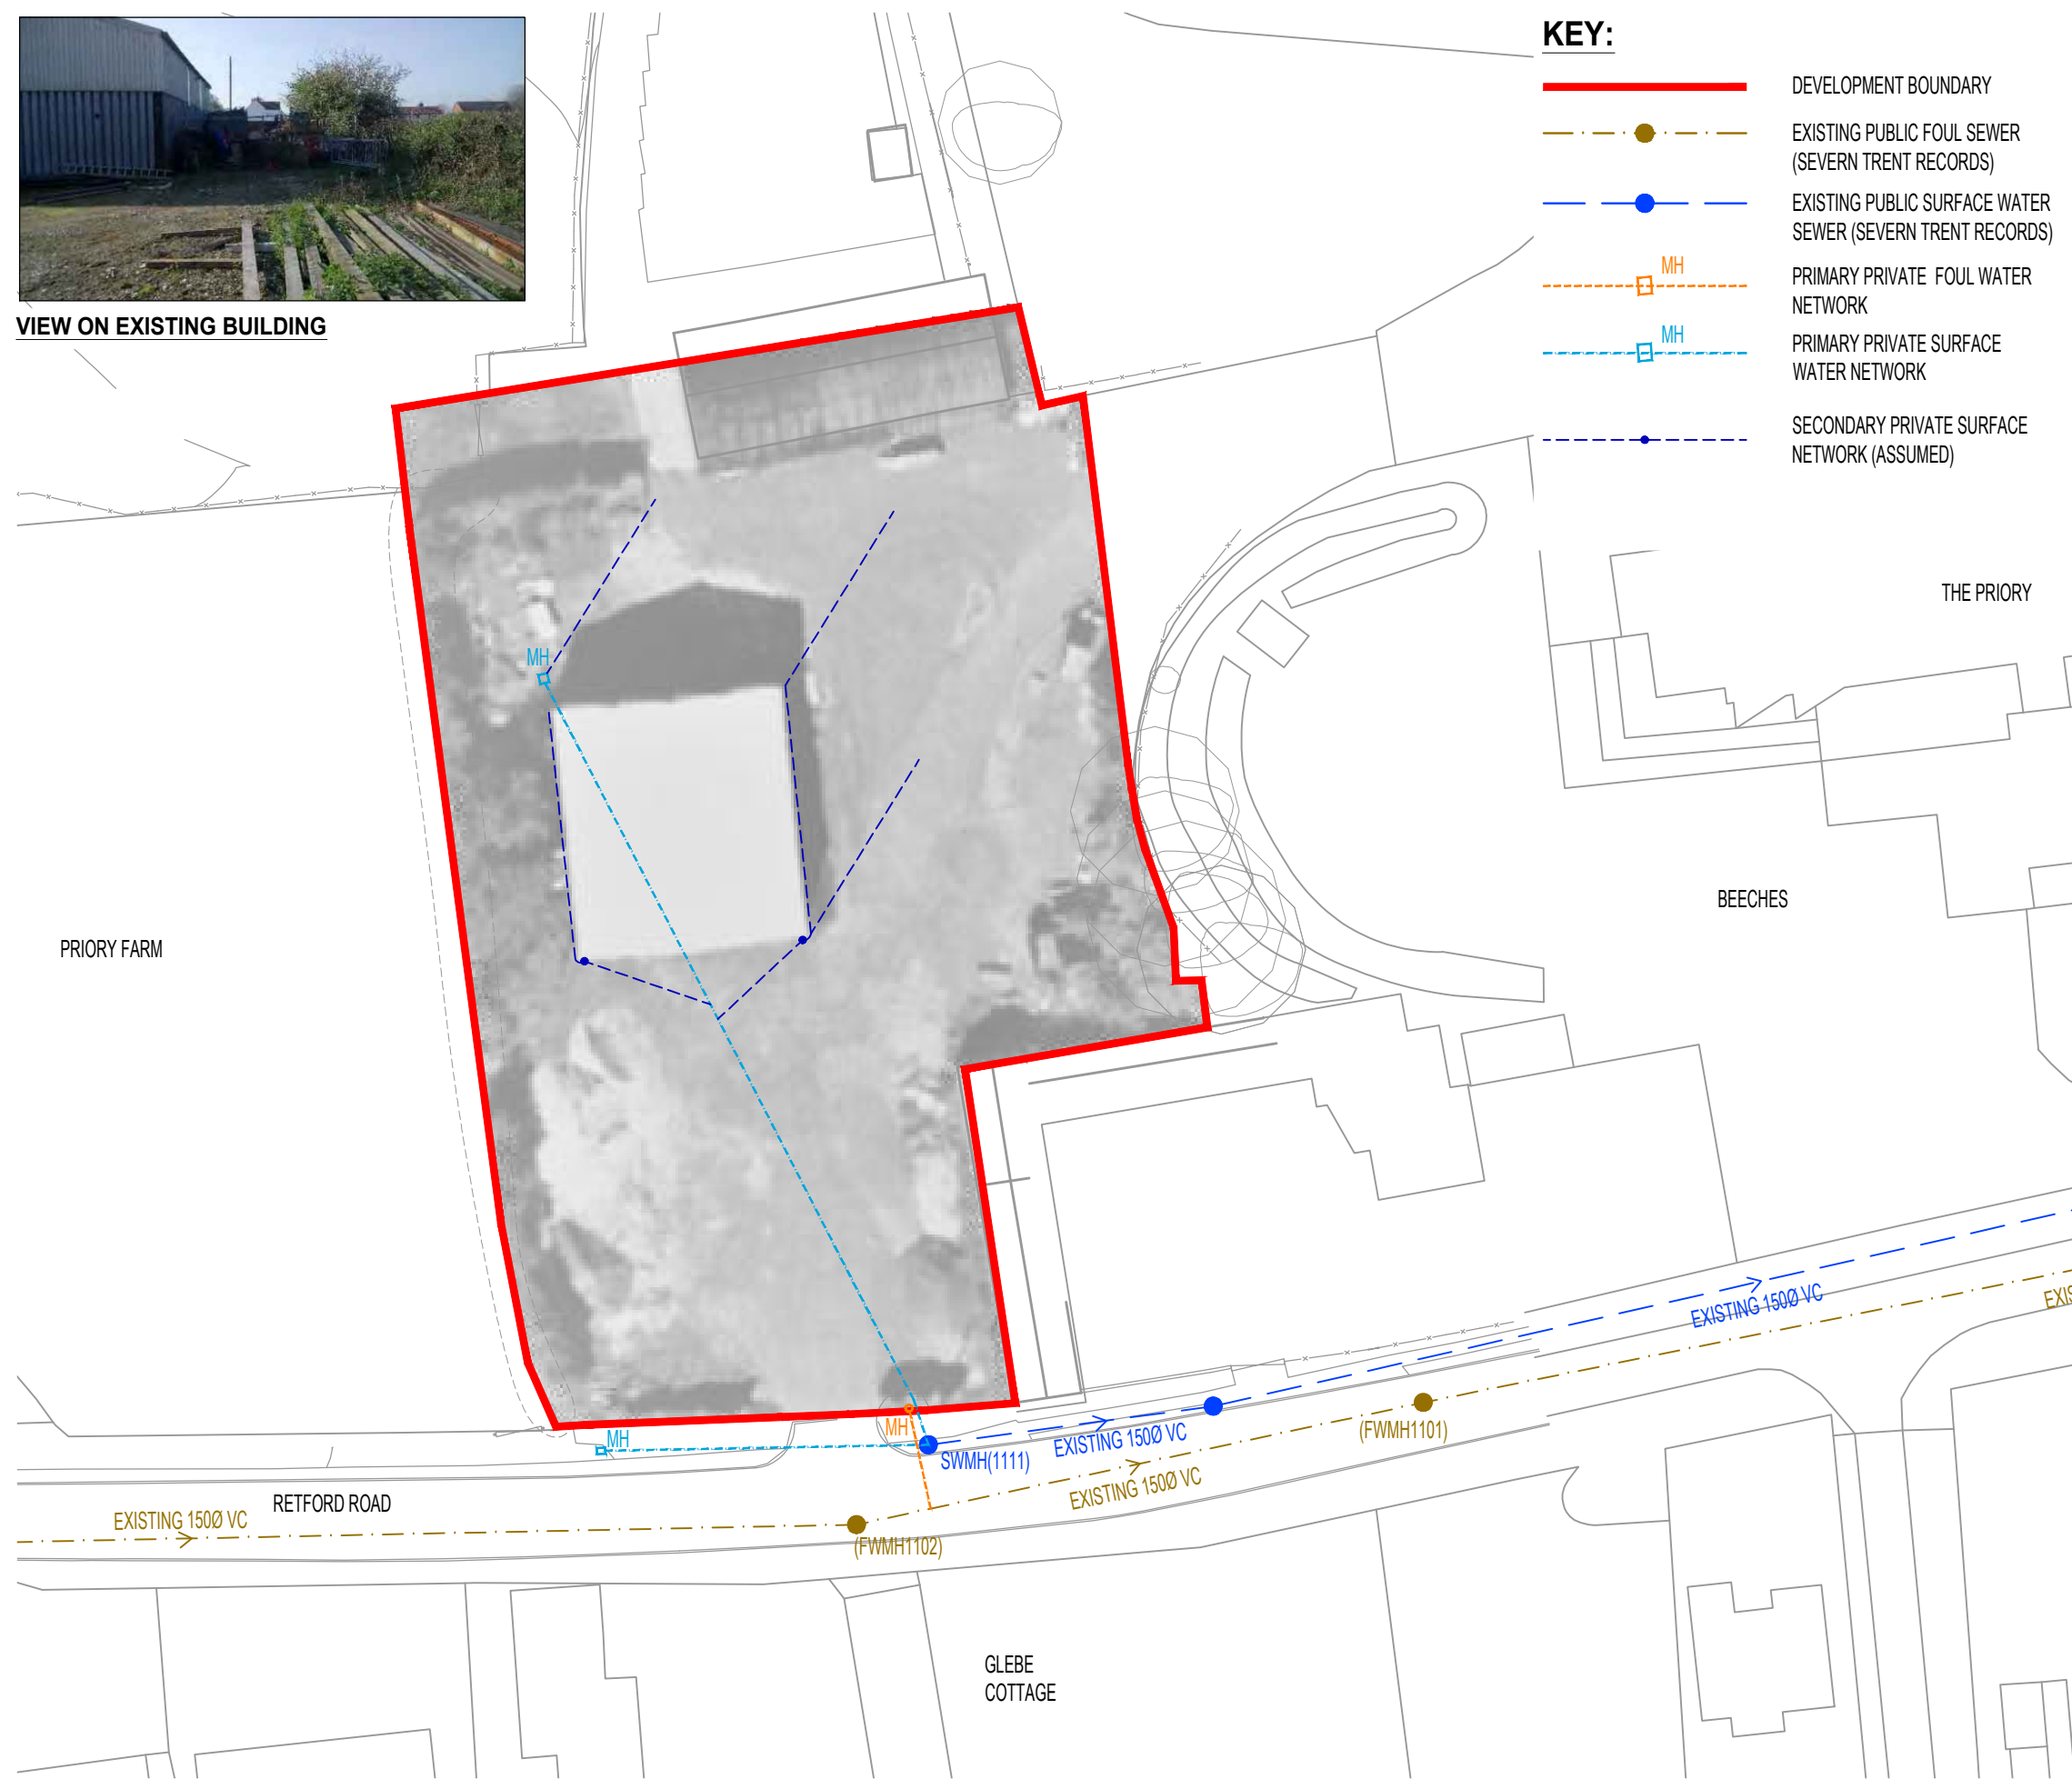
Severn Trent Water (STW) records confirm an existing 150mm diameter surface water sewer located in Retford Road (south of site), crossing part of the site frontage. Within the site is a private surface water drainage system serving the agricultural buildings and hard standings which were used as part of the sites previous use. The private surface water system discharges to the STW sewer in Retford Road (manhole MH1111), see attached FORTEM drawing 1158-001 - Existing Site Drainage.

- DEVELOPMENT BOUNDARY
- - - ● EXISTING PUBLIC FOUL SEWER (SEVERN TRENT RECORDS)
- - - ● EXISTING PUBLIC SURFACE WATER SEWER (SEVERN TRENT RECORDS)
- - - □ MH PRIMARY PRIVATE FOUL WATER NETWORK
- - - □ MH PRIMARY PRIVATE SURFACE WATER NETWORK
- - - ● SECONDARY PRIVATE SURFACE NETWORK (ASSUMED)

The existing surface water drainage system has been assessed from records and an intrusive site visit on 28.04.21. As part of this assessment the existing impermeable area was assessed and recorded as 0.24ha. Therefore the existing brownfield runoff for the site is:

STW records confirm an existing 150mm diameter foul water sewer located in Retford Road (south of site), crossing part of the site frontage. Within the site there is an existing private foul manhole connecting to the foul sewer network within Retford Road (MH1102), please see attached FORTEM Drawing 1158-001 Existing Site Drainage.

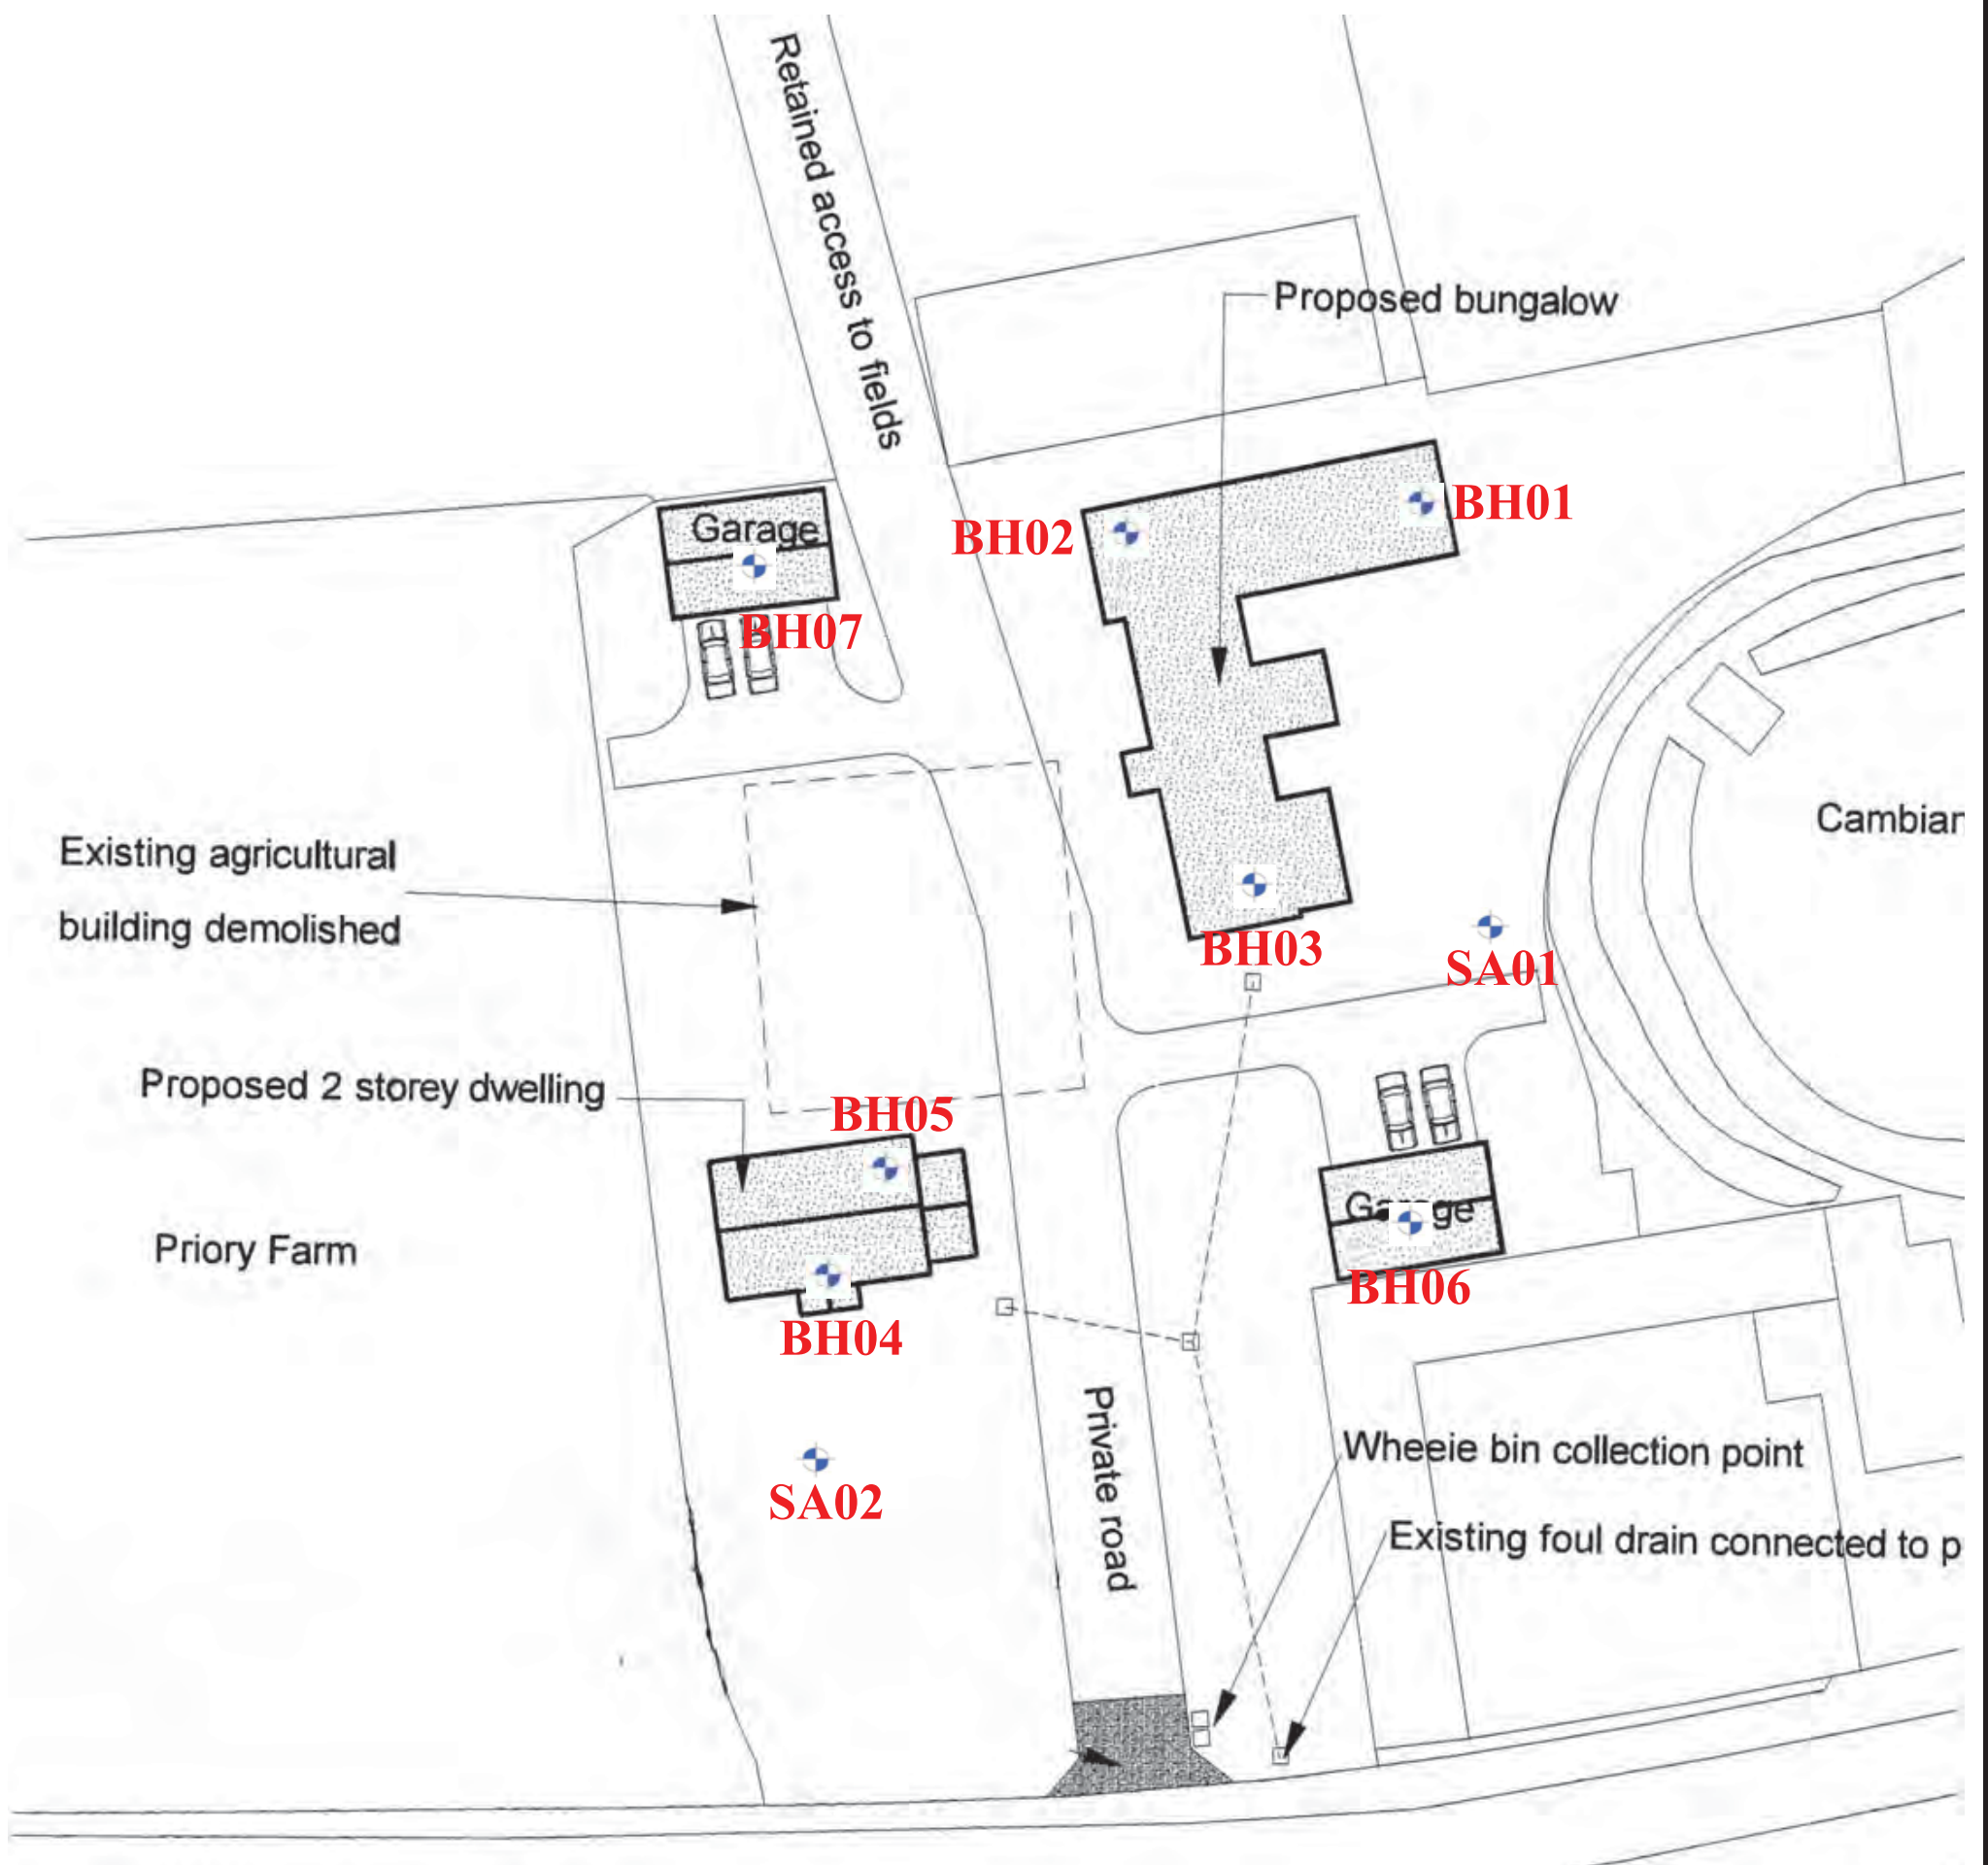
Exploratory Hole Location Plan

Key: BH / SA – Borehole

- Seven windowless sampler boreholes advanced to a maximum refusal depth of 2.45m below existing ground level (begl) in order to investigate the ground and groundwater conditions underlying the proposed development site;
- Standard Penetration Tests (SPTs) in order to determine soil / rock strength;
- Installation of standpipes in three of the boreholes for subsequent ground gas / groundwater level monitoring;
- Two windowless sampler boreholes, both advanced to a maximum depth of 2.00m below existing ground level and including the installation of temporary standpipes in each of the boreholes for subsequent falling head / infiltration testing;
- In-situ testing and soil sampling for environmental and geotechnical laboratory testing;
- Logging and description of soil / rock samples.

Two windowless sampler boreholes (ref. SA01 & SA02) were advanced using the window sampling rig at 101mm outside diameter, to depths of 2.00m, in order to undertake falling head / infiltration testing.

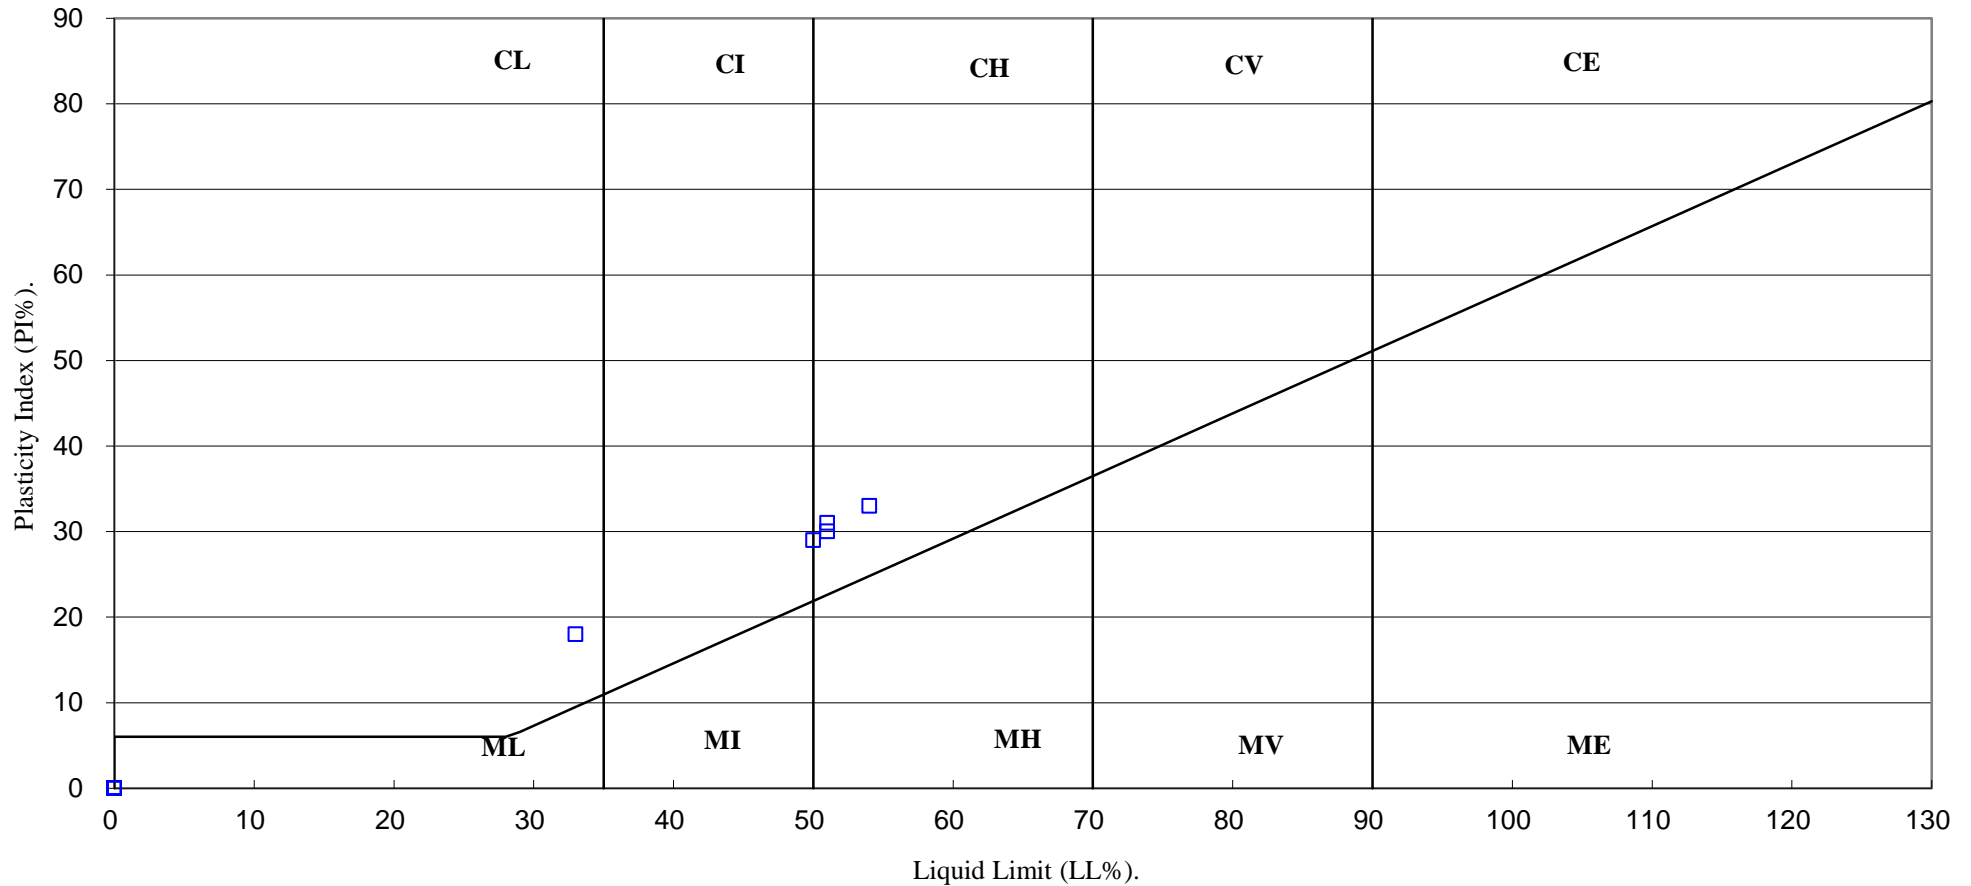
PLASTICITY CHART FOR CASAGRANDE CLASSIFICATION.

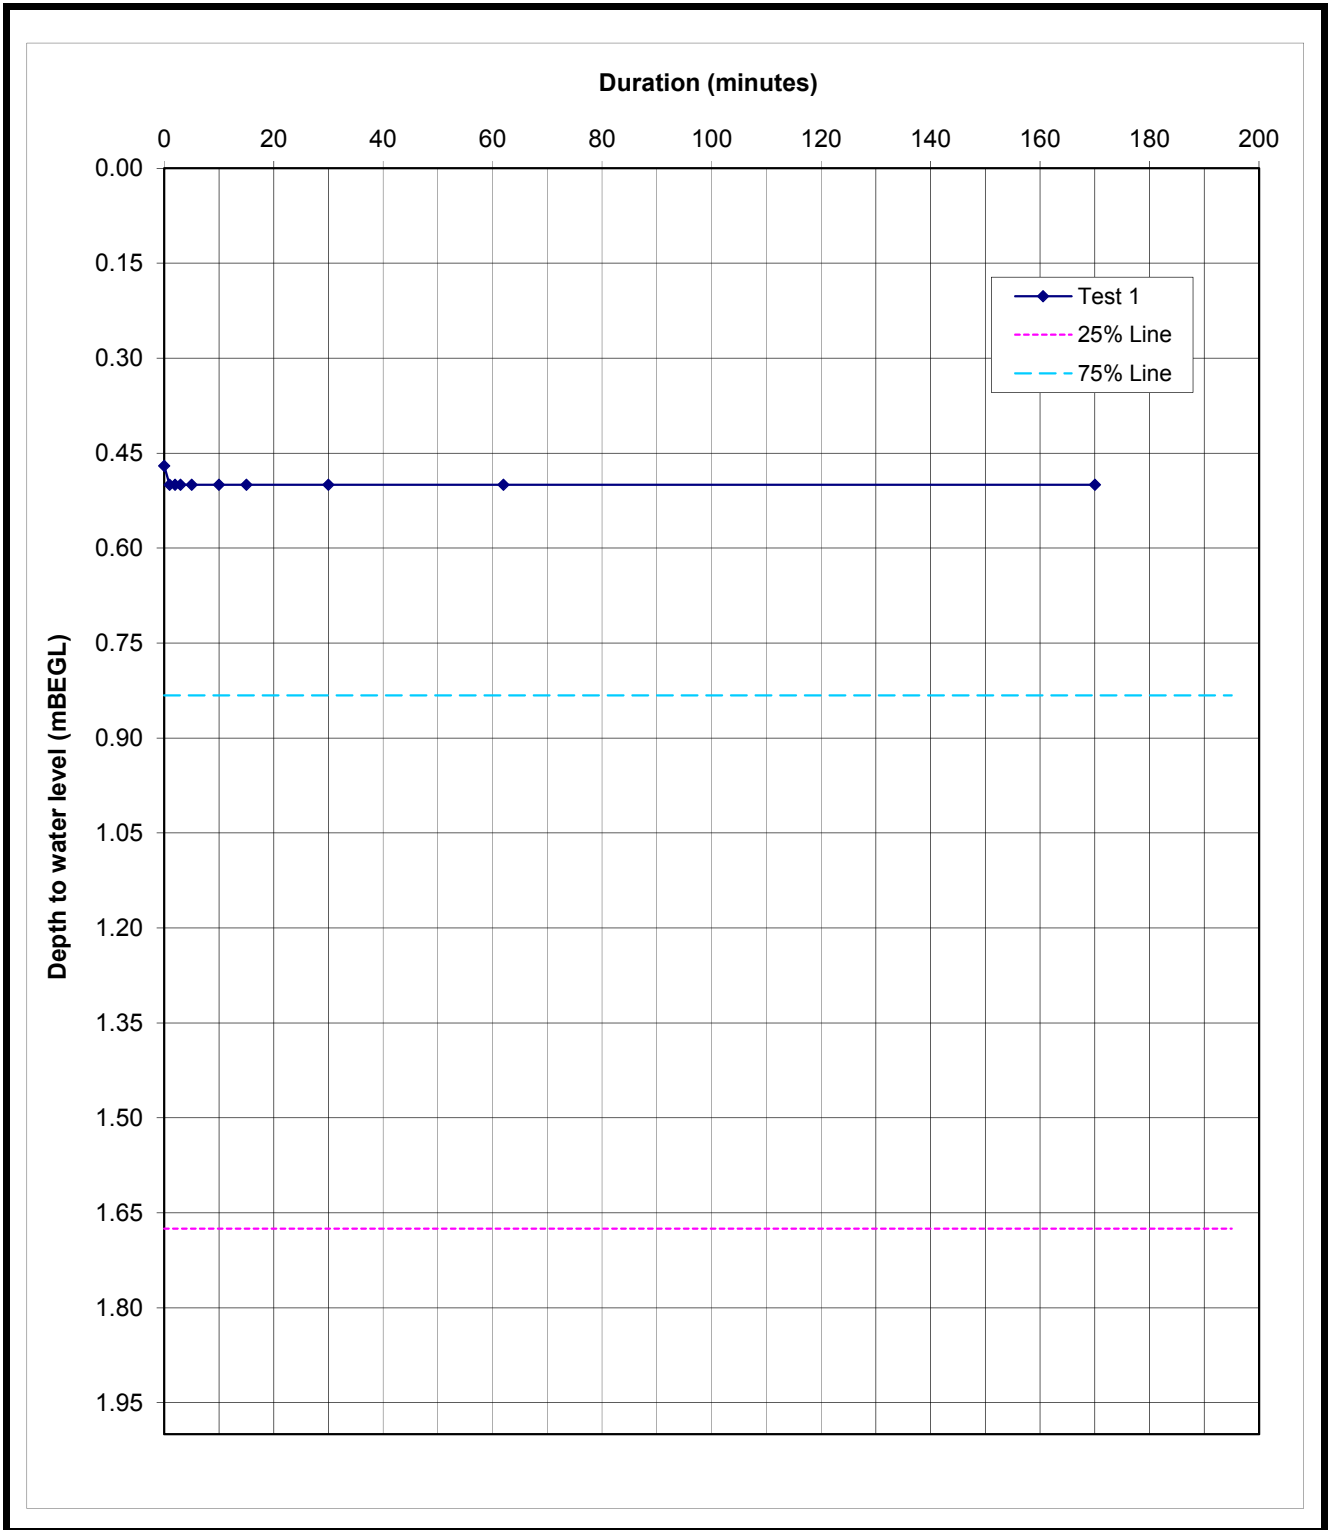
CRG Project Ref.	180401N
Project Name	PRIORY FARM, SOUTH LEVERTON, NOTTS.
Project Managers	Mr & Mrs W. Tompkins
Test Location	SA01
Test No.	T1
Test Date	19th April 2018
By	RWJP
Checked By	RAL

Falling head infiltration tests were undertaken in each of the boreholes following installation of a temporary 38mm nominal diameter perforated HDPE standpipe with a gravel filter medium. Testing was carried out by adding water to each of the boreholes and monitoring its rate of percolation into the surrounding substrate. Normally this would be undertaken on three occasions in each borehole, however, the infiltration rates were non-existent, therefore, only a single fill was carried out at each position.

The records of the falling head infiltration tests are presented in **Appendix VIII** and include graphical plots. No infiltration rates could be determined using the methodology provided within BRE Digest 365 (DG365, February 2016). It should be noted that undertaking tests in boreholes is not in strict compliance with BRE Digest 365 'Soakaway Design'.

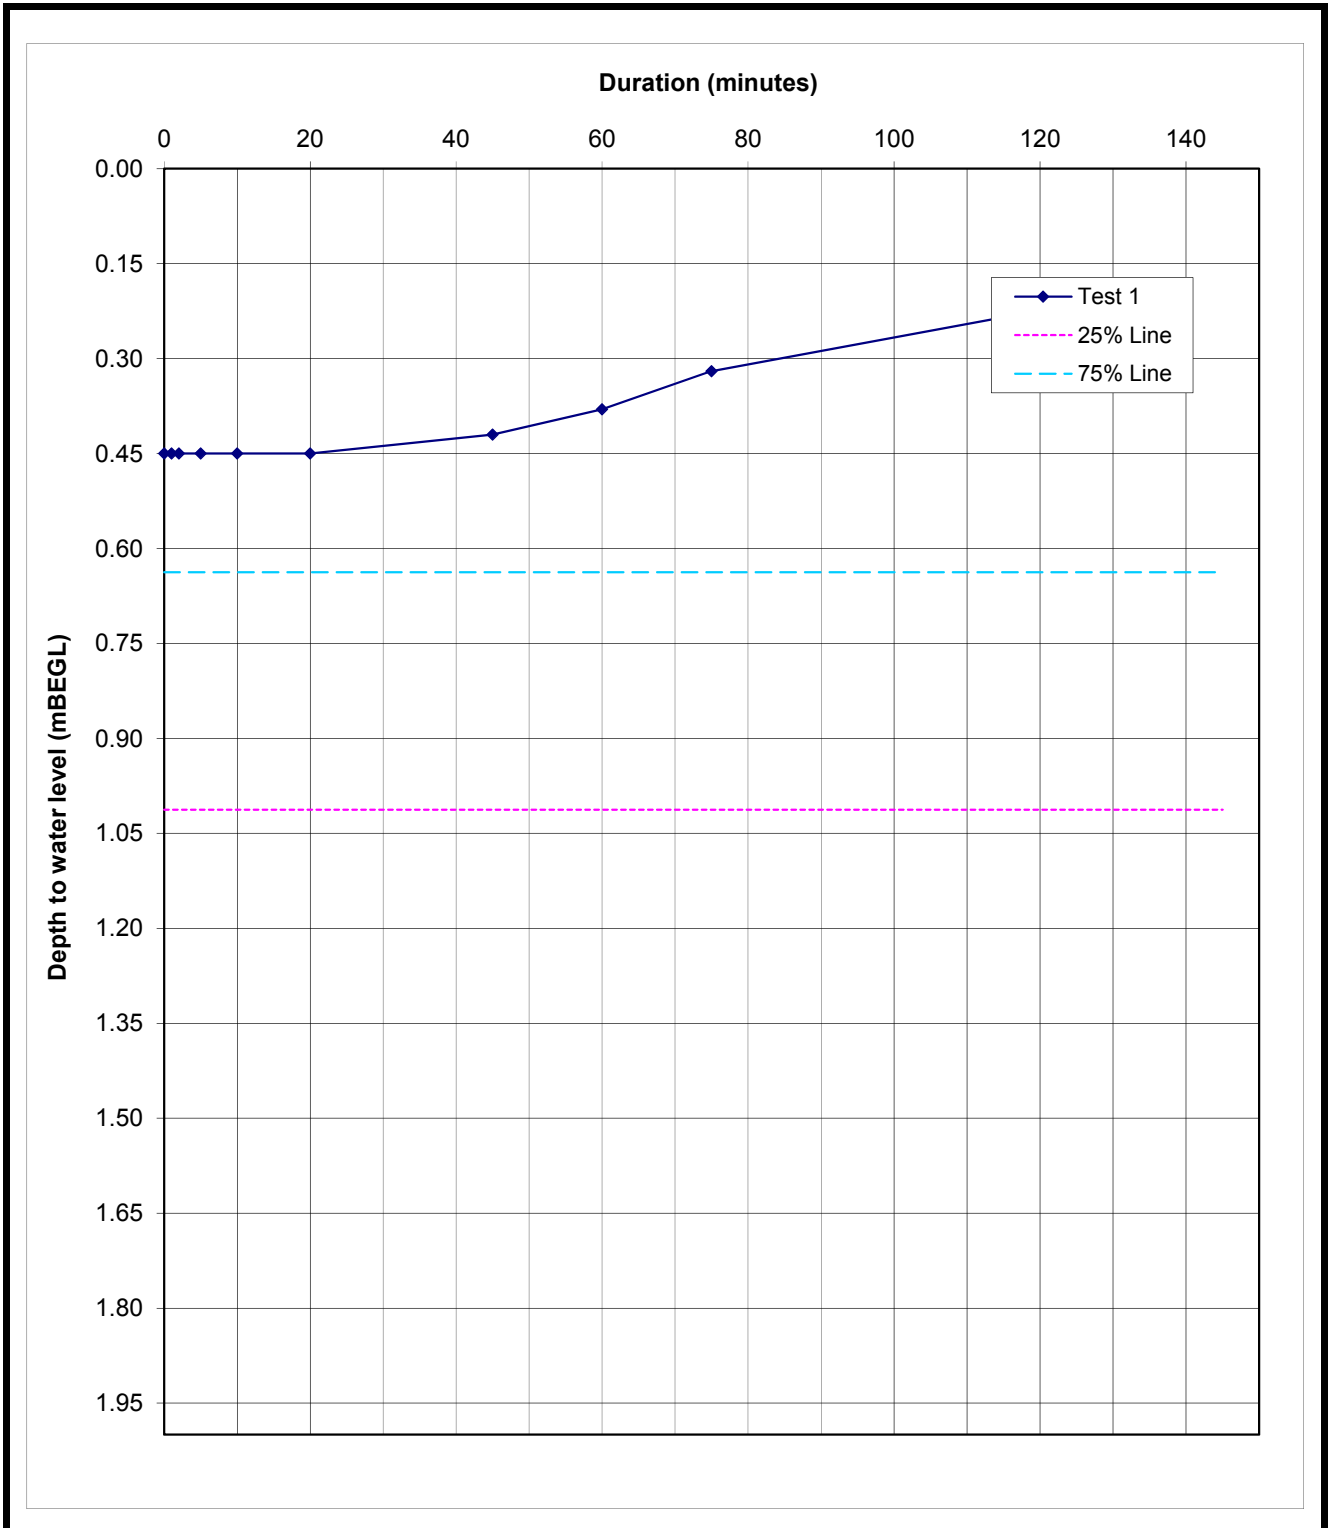
CRG Project Ref.	180401N
Project Name	PRIORY FARM, SOUTH LEVERTON, NOTTS.
Project Managers	Mr & Mrs W. Tompkins
Test Location	SA02
Test No.	T1
Test Date	19th April 2018
By	RWJP
Checked By	RAL
