PROTECTED SPECIES REPORT: Bat Roost Characterisation Survey

Outbuildings at Holly House Farm, Huncote,
Leicestershire

Report Reference: BG21.169.1

June 2021

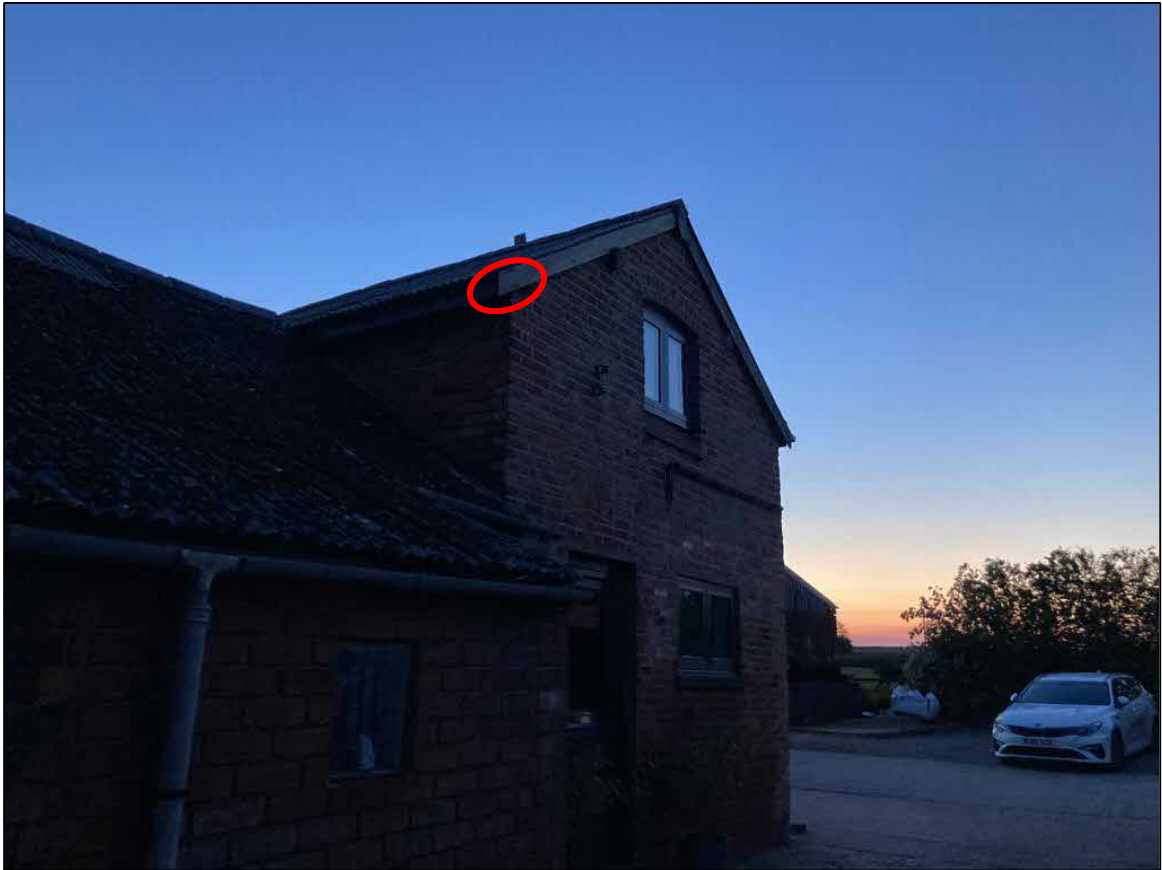
Figure 3. Roost Location 1 circled in red. Pertaining to a cavity within the brickwork behind the barge board. Following inspection, the cavity does not allow access into the interior of the building.

- 6.1 The dusk emergence and dawn re-entry surveys confirmed a day roost for a single common pipistrelle on the exterior of Building 1 Holly House Farm, Forest Road, Huncote, Leicestershire. A single common pipistrelle was confirmed to be roosting within a gap in the brickwork under the barge board on the southern corner of the eastern elevation.

- 6.2 The roost is considered to be of low conservation significance due to the low number of non-breeding individuals from a locally common species recorded. Furthermore, the building and roost location did not support suitability for roosts of higher conservation significance such as maternity or hibernation colonies as the roost location did not extend into a cavity or the interior of the building.

- 6.4 As the proposed redevelopment does not incorporate external works to the building, and the recorded roost location does not provide access into the building there is no risk or injury, or entrapment of bats during the renovation works. The bat roost will not be impacted by the internal renovation works proposed including the fitting of windows and doors, internal plastering and the addition of internal fixtures and fittings. There are no tasks proposed which would be considered to disturb roosting bats such as timber removal, roofing works, demolition or tasks involving loud machinery, such as concrete breaking with a jackhammer.
