The Old Barn, Main Street, Flintham

Bat Surveys Report

September 2020

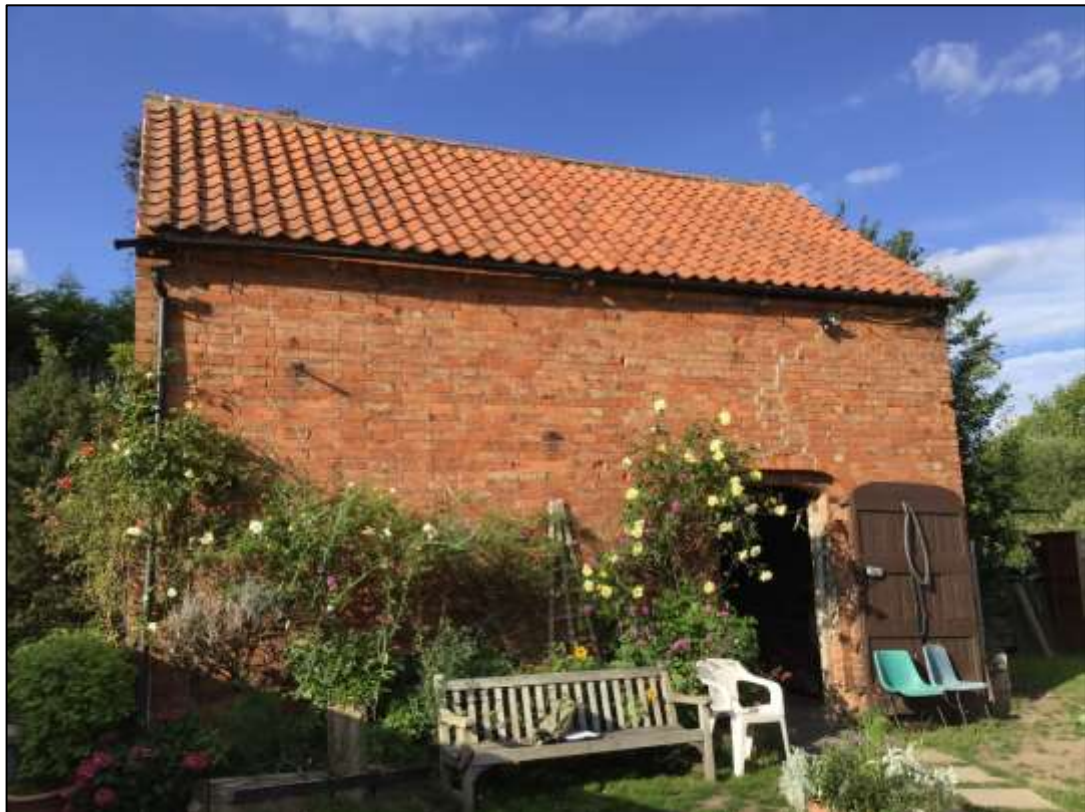
Photograph 1.1: The southern elevation of the surveyed barn viewed from the driveway.

- 1.4.1 The surveyed building is shown in Photographs 1.1 to 1.5. It comprises a small barn constructed from solid brick walls. The barn has two doors, opposite each other on the north and south elevations, and no windows. The two gables and the southern elevation of the building are all at least partially obscured by shrubs and climbing plants.

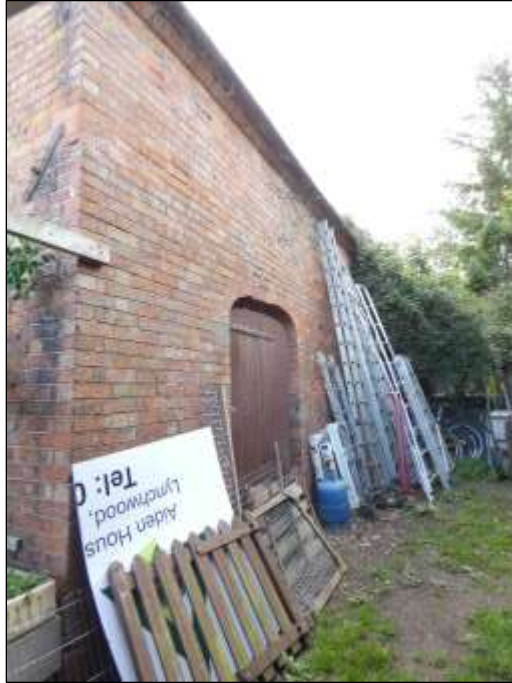
Photograph 1.2: The northern elevation of the barn, viewed facing west.

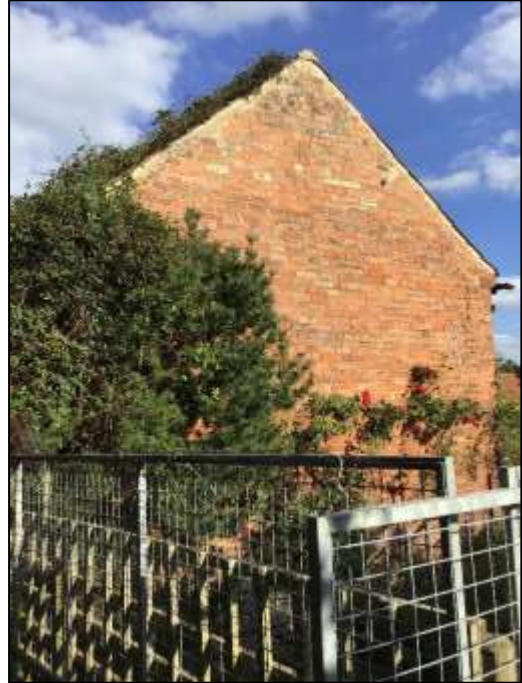
Photograph 1.3: The western gable of the barn.

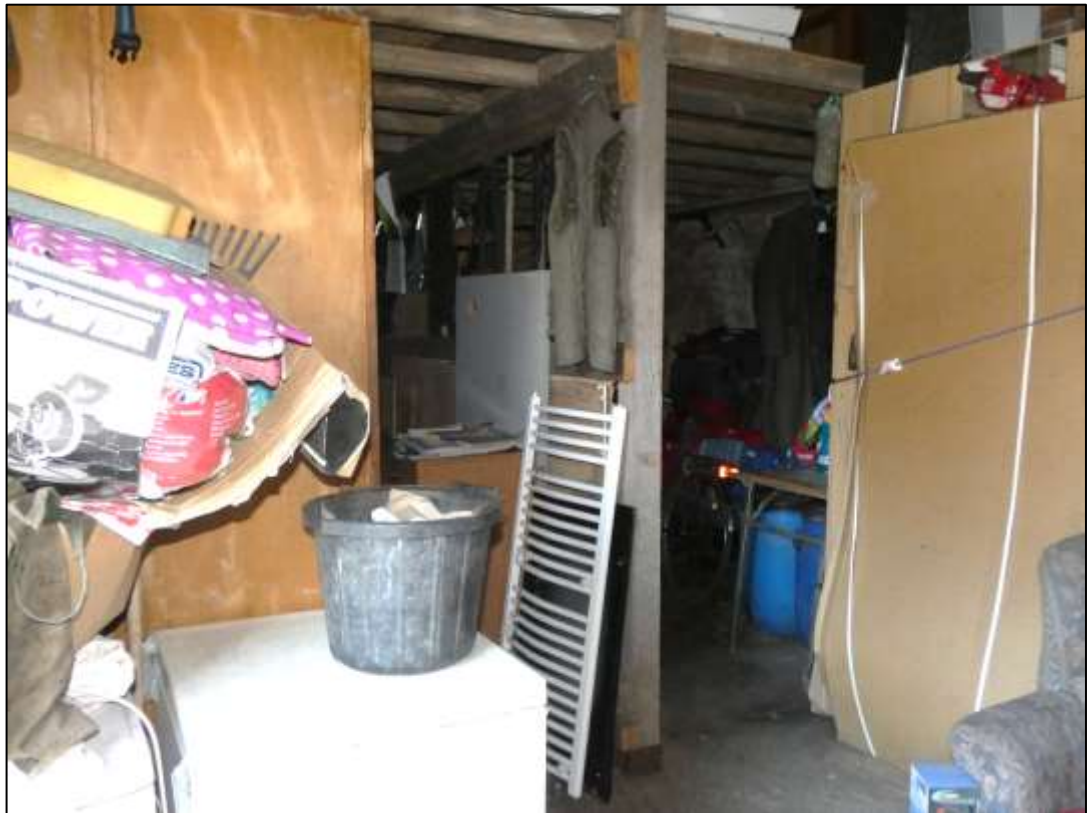
Photograph 1.4: Internal view of the partitioned western half of the ground floor of the barn, below the hayloft shown in photograph 1.5.

- 1.4.3 Internally, the barn is vaulted to the roof. The western half of the building is partitioned into two parts by a timber framed wall (see photograph 1.4) and above this is a mezzanine hayloft (see photograph 1.5). The barn is primarily used for storage and as a workshop.

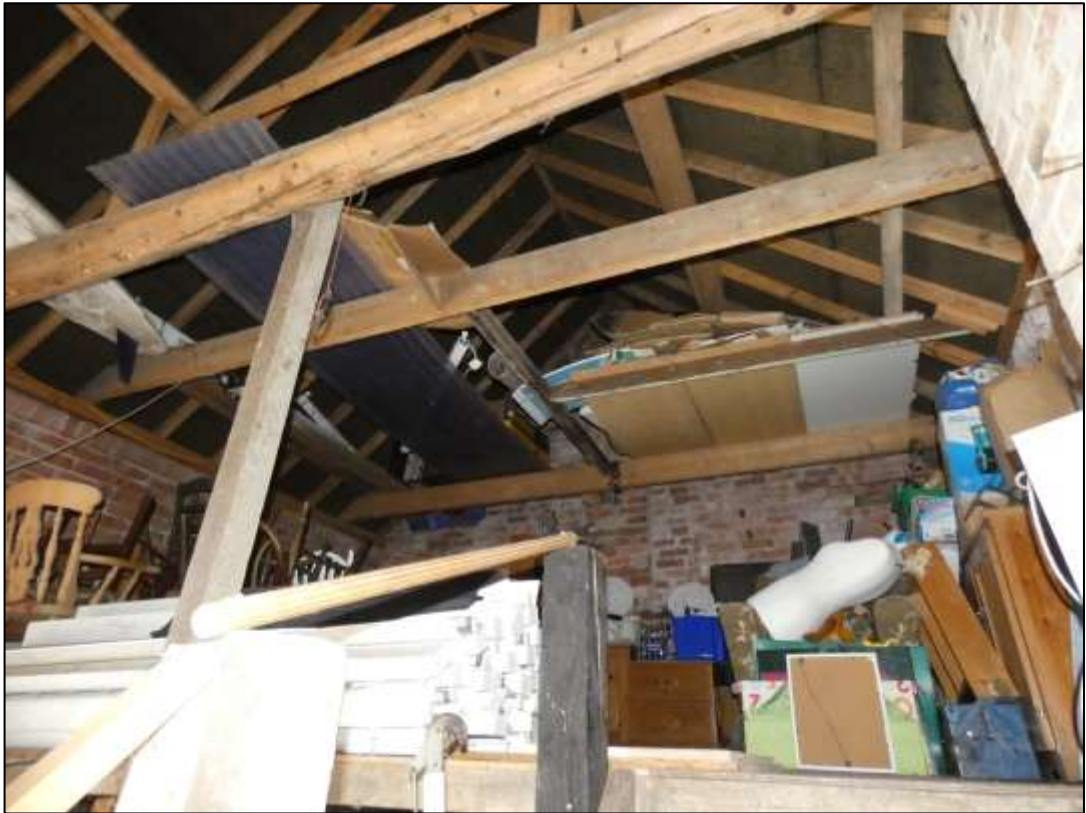
Photograph 1.5: Internal view of the mezzanine hayloft in the western half of the building, above the area shown in photograph 1.4 above, and the roof structure.

- 1.4.2 The cut and pitched, timber-framed roof of the building is covered with clay pantiles, which are underlined with bitumen roofing felt. This overlaps the central ridge board below the clay ridge tiles set in mortar. The roof has no finishing fascias, soffits, or barge boards. The verges also comprise mortar.

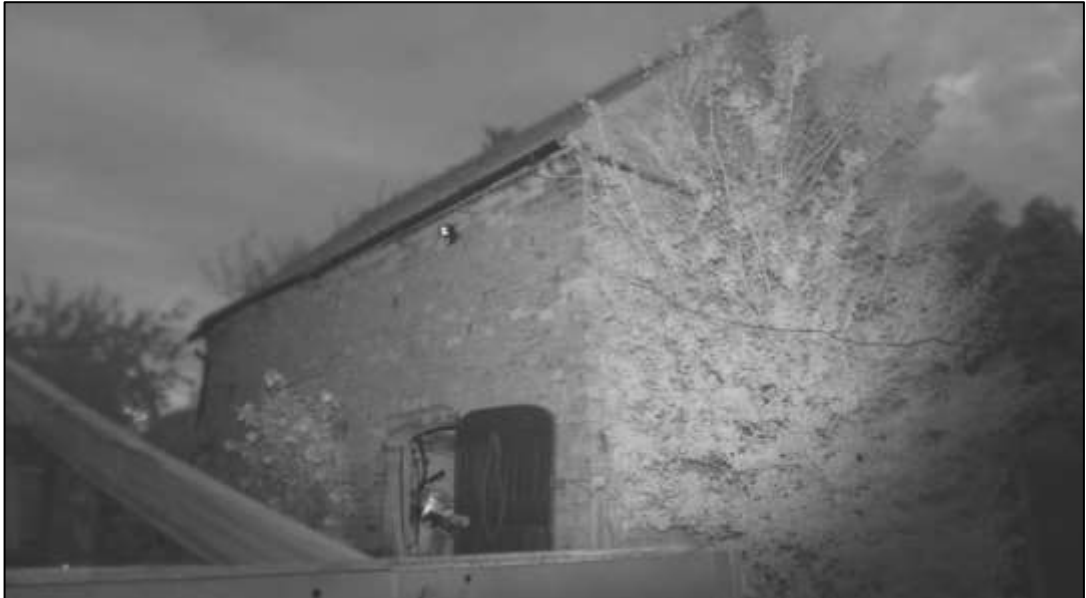
- 4.2.8 At 22:02 on this survey, a brown long-eared bat was recorded on the infra-red camera entering the barn via the open doorway on the southern elevation. This was timed at 43 minutes after sunset and four minutes before civil twilight. The bat arrived from a north-easterly direction around the eastern gable. The same bat was recorded exiting the same doorway approximately two minutes later. It flew away from the building in a southerly direction.

Photograph 4.1: A screenshot of the infra-red footage which captured the brown long-eared bat entering and exiting the barn on 17 July.

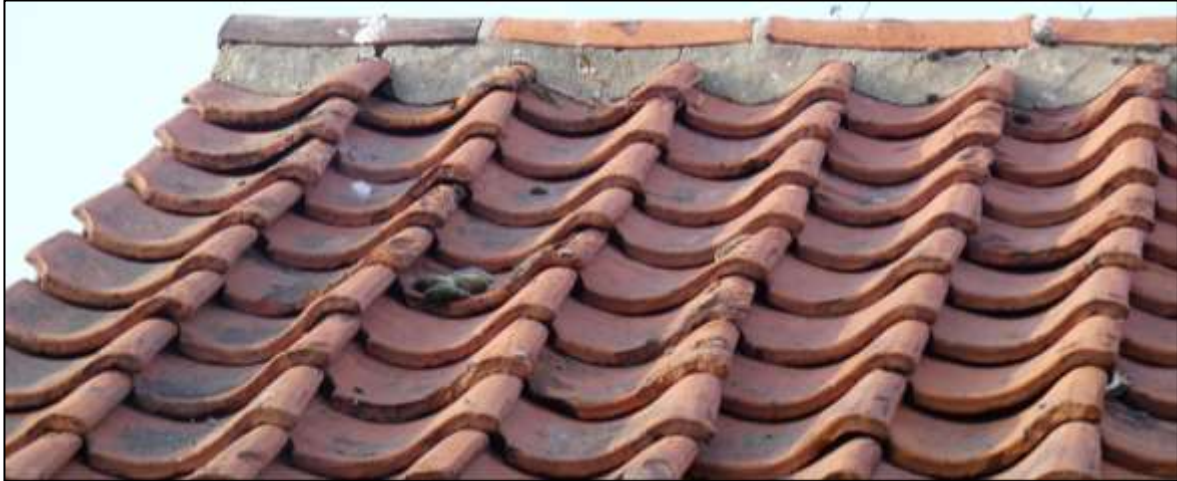
Photograph 1: There are small gaps beneath and between many of the interlocking pantiles covering both elevations of the pitched roof (including below the eaves and above the wall plate, not shown). There are also some small cracks and crevices associated with the bedding mortar below the ridge tiles. Such apertures could potentially be exploited by small bats to access or egress roosts – also see Appendix 2, TN 1 and TN 2.

- Small cracks and crevices associated with the bedding mortar below the ridge tiles – see Appendix 1, Photograph 1, and Appendix 2, TN 2.
- Small subsidence cracks, and apertures in the brickwork due to missing mortar - see Appendix 1, Photographs 2 and 3, and Appendix 2, TN 3 and TN 5.

TN 1 – There are small gaps beneath and between many of the interlocking pantiles covering both elevations of the pitched roof, including below the eaves and above the wall plate e.g. Appendix 1, Photograph 1.

TN 2 – There are a few small cracks and crevices associated with the bedding mortar below the ridge tiles e.g. Appendix 1, Photograph 1.

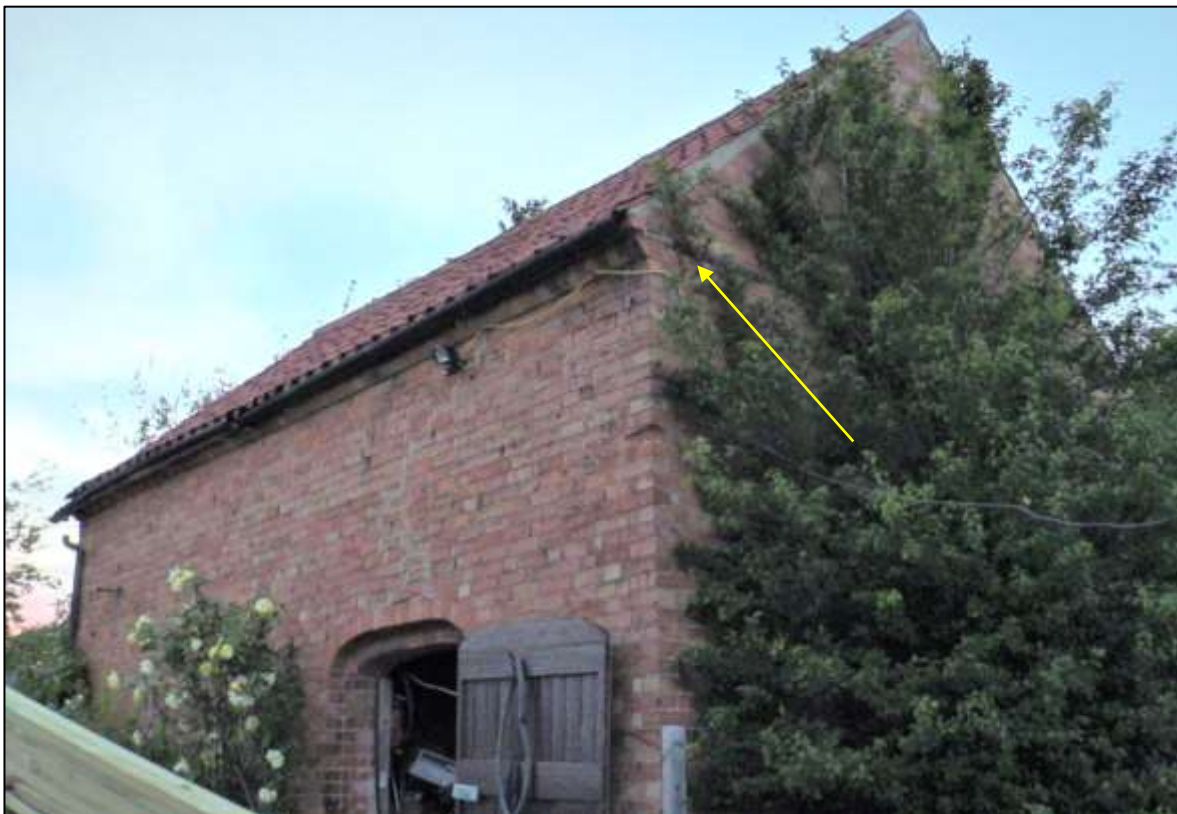
Photograph 2: There are a small number of apertures in the brickwork of the barn including where mortar is missing. A common pipistrelle emerged from such a feature – see yellow arrow - on the dusk emergence survey conducted on 18 August 2020 – see Appendix 2, TN 3.

This photograph also shows the door on the southern elevation of the building, which is left open and therefore provides ready access for bats into the barn interior. A brown long-eared bat was recorded accessing the building via this door on the first nocturnal survey conducted on 17 July 2020 – see Appendix 2, TN 4.

TN 3 - There are a small number of apertures in the brickwork of the barn including where mortar is missing. A common pipistrelle emerged from such a feature on the dusk emergence survey conducted on 18 August 2020 – also see Appendix 1, Photograph 2.

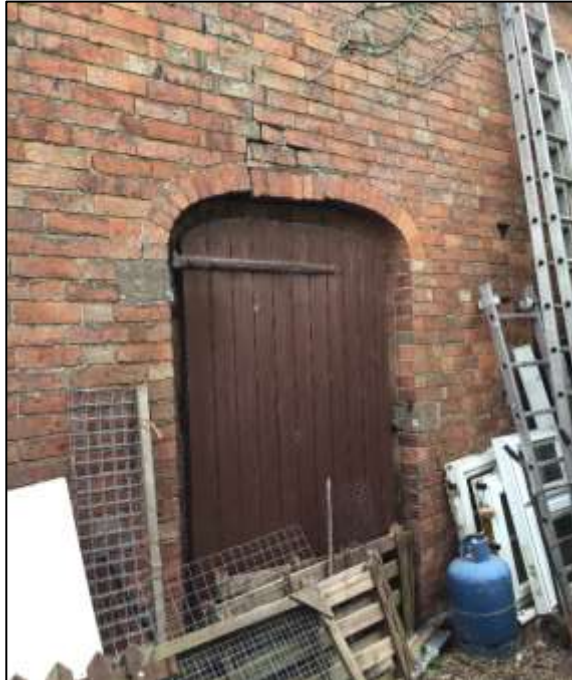
Photograph 3: There are a few subsidence cracks in the brickwork of the barn, including this one above the rear (north-facing) door. There are also small gaps which are accessible for small bats around the doors – also see Appendix 2, TN 5 and TN 6.

TN 5 – There are a few subsidence cracks in the brickwork of the barn, including above the rear (north-facing) door – also see Appendix 1, Photograph 3.

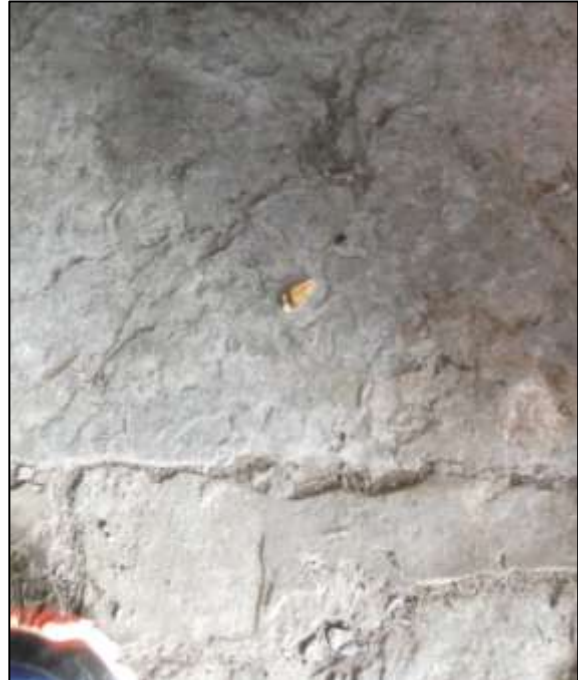
Photograph 4: A single wing from a large yellow underwing moth was present on the floor inside the barn – see Appendix 2, TN 10. These moths are a favoured prey item of the brown long-eared bat and the discarded wings of this moth can often indicate the presence of a feeding roost for this bat species.

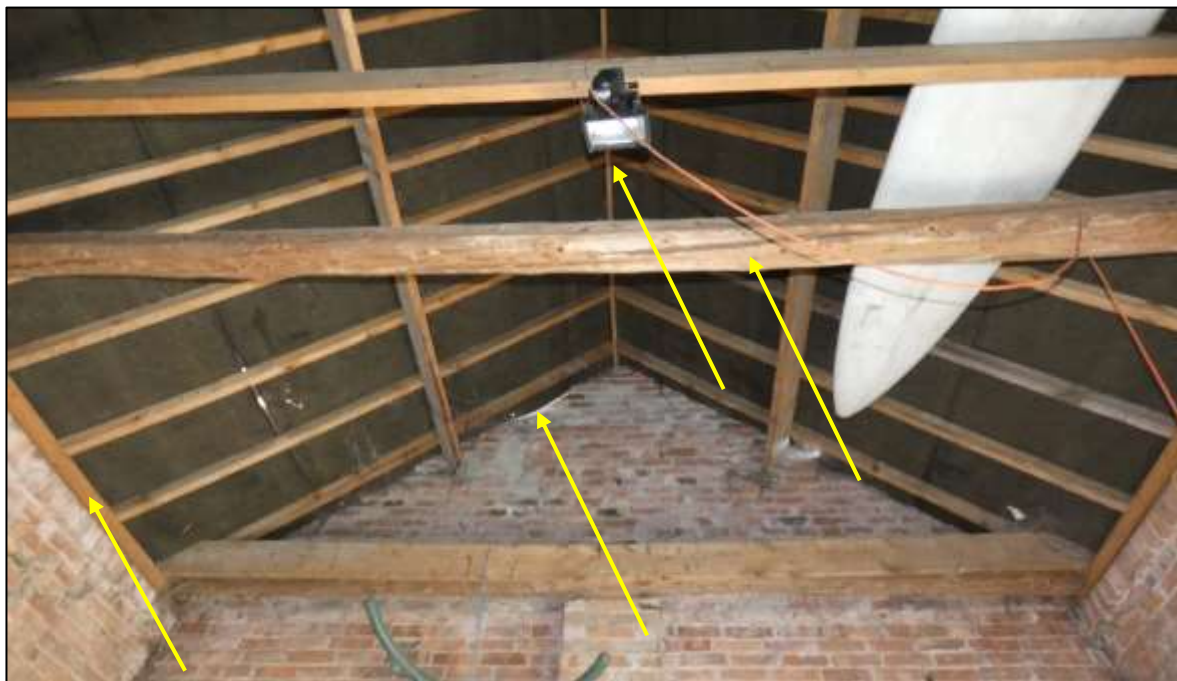
Photograph 5: Inside the building there are a few features where individual or low numbers of bats could conceivably roost. These principally comprise the central ridge board and recesses where roof timbers join, small fissures within main beams, and apertures on the tops of walls. Some examples of these features are shown by the arrows on this photograph taken facing the eastern gable – see Appendix 2, TN 7, TN 8 and TN9.

- Inside the building there are a few features where individual or low numbers of bats could conceivably roost. These principally comprise recesses where roof timbers join, small fissures within larger beams, and apertures on the tops of walls – see Appendix 1, Photograph 5, and Appendix 2, TN 7, TN 8 and TN 9.

Inside the building there are a few features where individual or low numbers of bats could conceivably roost. These principally comprise the central ridge board and recesses where roof timbers join (e.g. **TN 7**), small fissures within larger beams (e.g. **TN 8**), and apertures on the tops of walls (e.g. **TN 9**) – see Appendix 1, Photograph 5.
