Refurbishment Proposals for Cottages 1 & 2 Knights Hill Farm Westmill Buntingford

June 2022

Executive Summary

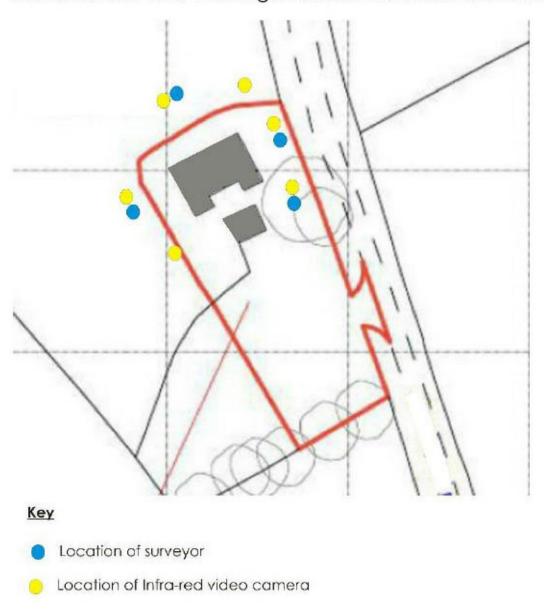
2.5.1 Following the published guidelines from the document mentioned above, three evening emergence surveys were carried out on the 30th of May 2022, the 22nd of June 2022 and the 28th June 2022. Four licensed bat surveyors were positioned on all four corners of the building (as illustrated below), each with an infrared video camera observing and filming and recording from 15 minutes before sunset and finishing one and half hours after sunset.

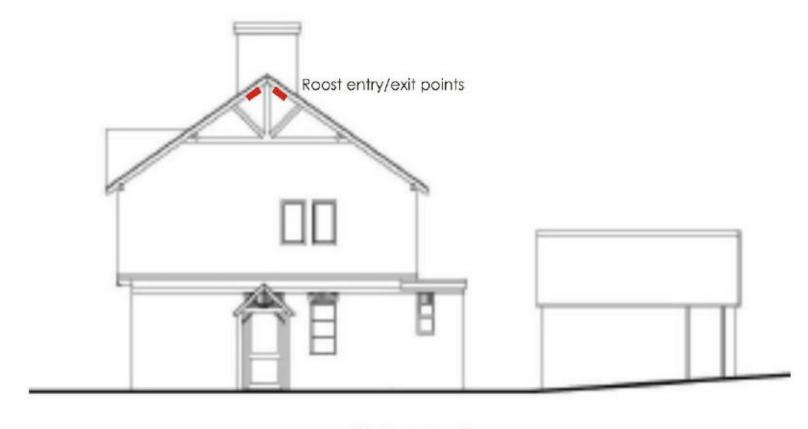
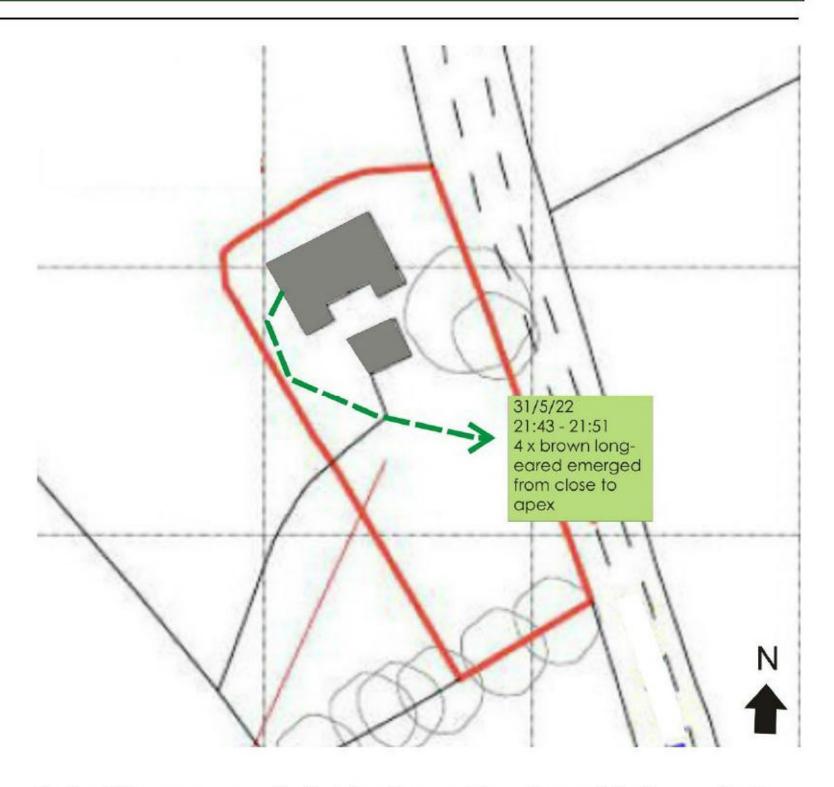
Western elevation

- 3.1.1 This survey was commenced fifteen minutes before sunset, which was logged at 21:08. The weather was mild and still (BS=0), with very light cloud. The temperature at the start of the survey was 11°C and at the end was 10°C. Light conditions were considered to be good and insects were flying.
- 3.1.2 At 21:28 (20 minutes after sunset), a single common pipistrelle was observed arriving on site from the south and fed over the fields to the west of the cottages.
- 3.1.3 Between 21:43 (35 minutes after sunset) and 21:51 (43 minutes after sunset), four brown long-eared bats were observed emerging from the roof void at the apex of the western gable end of the cottages and flew towards the trees to the south-east of the cottages (as shown on the drawings below):

3.1.4 During this survey, some limited feeding and foraging activity from a single or very low number of common pipistrelles was observed and recorded around the trees and fields surrounding the cottages.

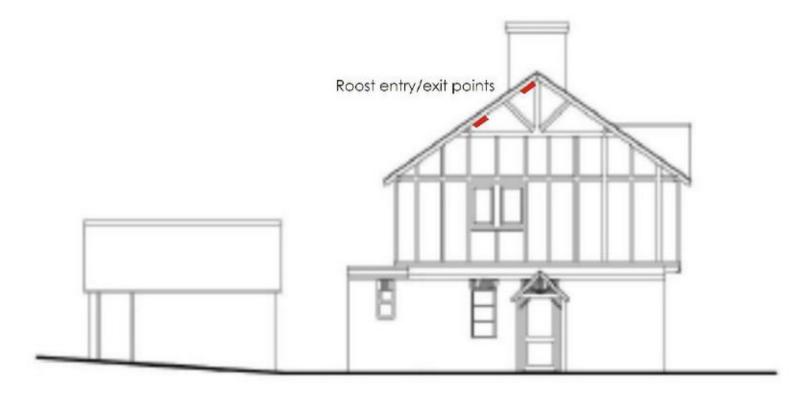
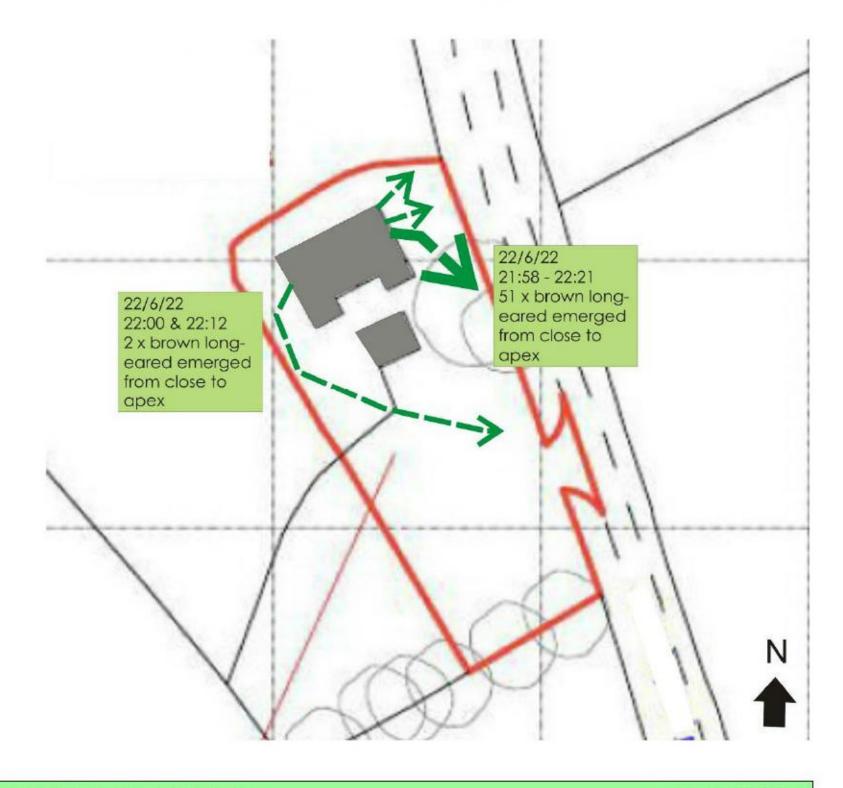
Eastern elevation

- 3.1.5 This survey was commenced fifteen minutes before sunset, which was logged at 21:24. The weather was very warm, with a light breeze (BS=1) and very light cloud. The temperature at the start of the survey was 19°C and at the end was 16°C. Light conditions were considered to be excellent and insects were flying.
- 3.1.6 At 21:47 (23 minutes after sunset), a single common pipistrelle was observed arriving on site from the west and flying straight past the northern side of the site, apparently commuting.
- 3.1.7 Between 21:58 (34 minutes after sunset) and 22:21 (57 minutes after sunset), 51 brown long-eared bats were observed emerging from the roof void at the apex

of the eastern gable end of the cottages. The majority flew towards the trees to the south-east of the cottages, with some flying north-east and some east across the unmade road (as shown on the drawings below).

3.1.8 In addition, at 22:00 (36 minutes after sunset), a single brown long-eared bat was observed emerging from close to the apex of the western gable end of the cottages and this was followed by a second brown long-eared bat, emerging at 22:12 (48 minutes after sunset).
