PHASE 1 BAT REPORT

10 PEMBERTON ROAD,
LYNDHURST
HAMPSHIRE
SO43 7AN

AUGUST 2019

ON BEHALF OF
DRAYCOTTS CHARTERED SURVEYORS LTD.

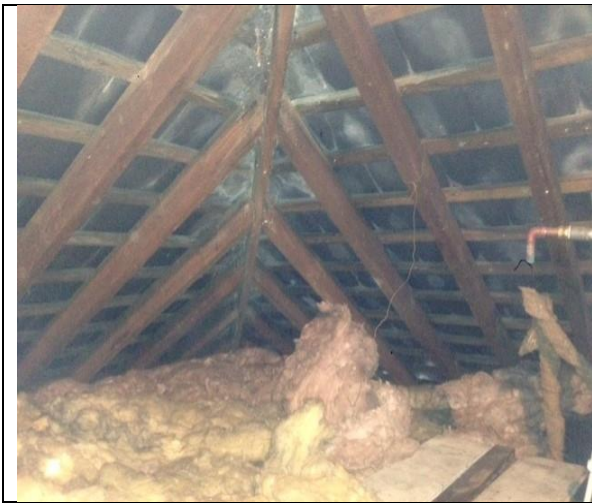
Photograph 1: Loft void showing cobwebs and internal roof structure

- Loft void is approximately 8 metres long x 6 metres wide x 1.5 metres high at the apex.
- The loft is separated from the neighbouring house's roof void by a well-sealed breeze block wall.
- The roof does not have any lining and the temperature in the loft is therefore unstable.
- Structure is typical truss with a wooden ridge beam.
- Fibre glass insulation in a moderate condition.
- Cobwebs present throughout the loft space.

The building was well-sealed throughout, with minimal access/egress points for bats. Internal wooden beams provide limited roosting opportunities for bats. The roof not being lined and the extent of cobwebs and lack of evidence upon the internal inspection of the site do not suggest the site is a bat roost. The overall potential of house as a bat roost is outlined in table 3 below:

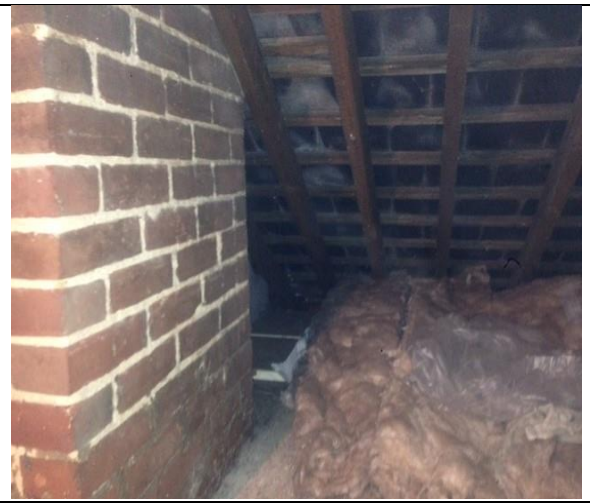
Photograph 2: Internal chimney – well-sealed

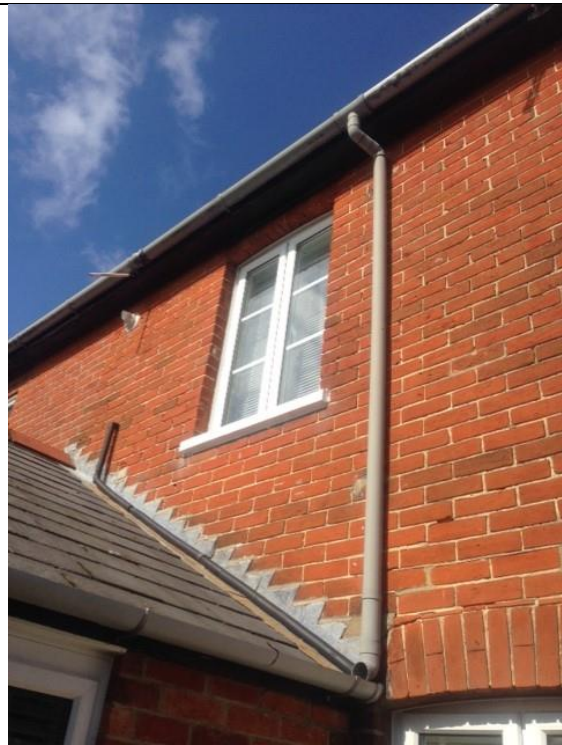
Photograph 3: well-sealed roof tiles, soffits and lead flashing on current first floor extension – new extensions to be added here on ground and in part on second-storey level.

- The building is a semi-detached, two-storey house of brick construction.
- The roof is single-pitched slate tiled roof with a concrete roof ridge
- The roof is in a good state of repair with no slipped tiles or obvious gaps under the tiles.
- Windows and doors are uPVC-framed and in good condition.
- There are two internal chimneys both with lead-flashing that is in good condition.
- The soffits are wooden and well-sealed.

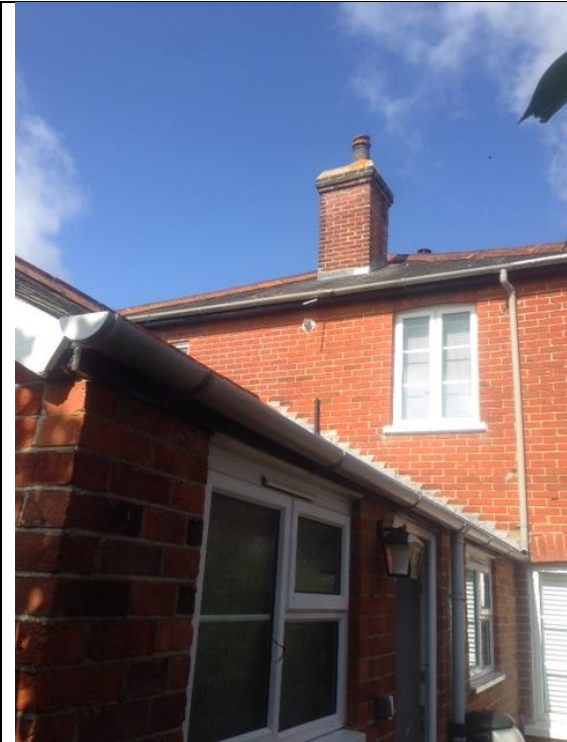
Photograph 5: Extensions are to be added on to the eastern and north eastern elevation of the first storey area. No loft void is present in this section of the house.

The house was assessed as holding negligible potential to support roosting bats due to limited access/egress points and the potential bat roosting areas and no evidence of bat being recorded during the phase 1 survey. Therefore, no further action is required in terms of the extension work to the house. Additionally, the plans do not indicate any works directly affecting the roof void or roofing as works are only on the first floor, ground level.

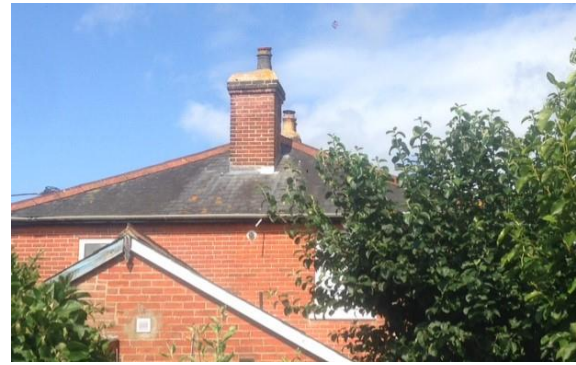
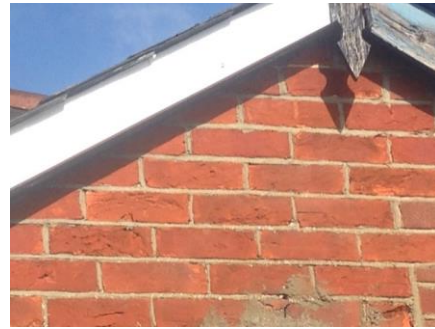
Photograph 6: Eastern elevation. Extension to be added here. Soffits are in good condition with no gaps.
