BRYNTAIL AND MINERS COTTAGE; LLANIDLOES

BAT EMERGENCE SURVEYS

Report Ref EE.895.21.KW

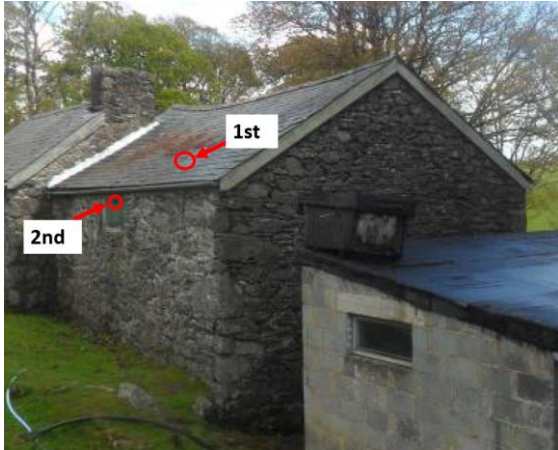
21:59 – End of survey	C.pip	Occasional passing and foraging	No	Around and in between both cottages; individual or small number of bats
22:25; 22:32; 22:34	BLE	Brief calls – Heard not seen	No	The first recorded call was from the centre of the site, between the two cottages. The others were recorded to the north west of the Miner’s cottage.
Approx. 22:30 – 22:35	Unknown bat x 2 (35 seconds apart)	Recorded emerging on infrared camera; not seen by surveyors but BLE’s were recorded around the same time	Yes	The first bat appeared to emerge from the north west roof pitch where there are loose slates and the second appeared to emerge from the hole in the window.

Individual, or very low numbers of common and soprano pipistrelles were observed and recorded foraging around both of the cottages, and mature trees on site, throughout the survey; occasionally but not consistently. Two bats appeared to emerge on the infrared camera from the north west elevation of Miner’s Cottage between 22:30 and 22:35; the bats were not seen or heard by surveyors but the timing coincides with BLE calls recorded to the north west of Miner’s cottage. There was one brief noctule pass, recorded on one detector, likely commuting over the site from a distance. No other bats emerged from the buildings and no other species of bat were heard or seen throughout the survey.
