Report prepared for: Wilsons Wood Ltd

For the Site of: The Barn, Hogg Pitts Bottom, Flaunden, Hertfordshire, HP3 0QB

# Emergence and Activity Bat Survey (EBS)

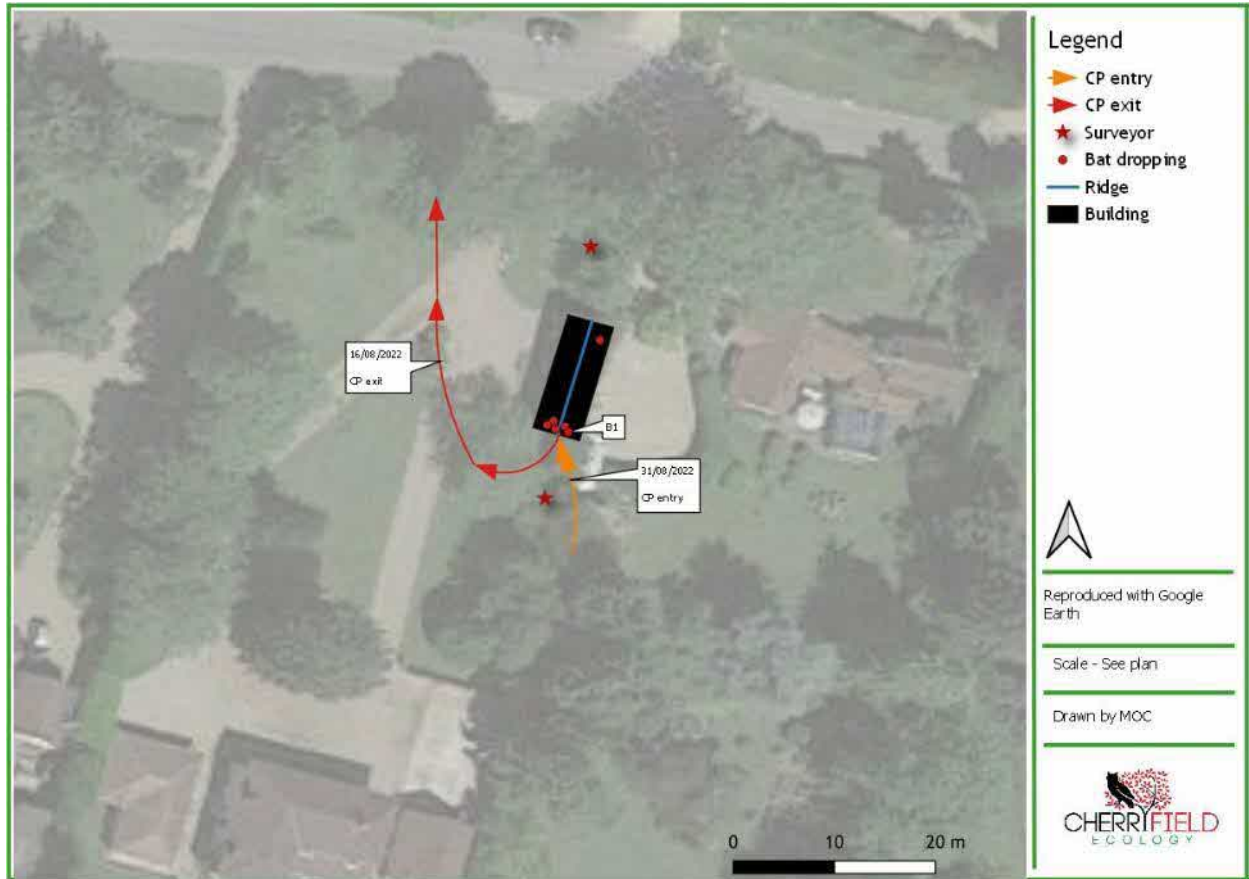
Figure 3: Site Plan

The following section details the structure(s) reference, bats located, evidence located and observed emergence/re-entry (see Figure 3 for Site Plan).

Building/tree/structure reference - B1 (Main Building)

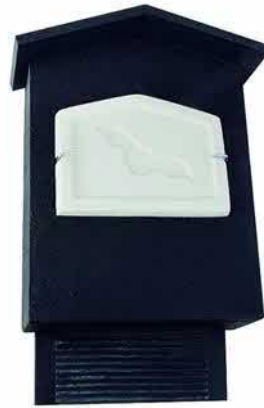
Figure 4: Chillon Woodstone Bat Box (British-made)

A minimum of two Chillon Woodstone bat boxes will be hung on the trees or the building at a minimum of 3m from ground level and face south/southwesterly. These boxes are known to be used by Brown Long-Eared bats (BLEB) and crevice-dwelling species.
