# New Children's Home, Pegswood

## Geo-Environmental Interpretative Report

**REPORT TITLE:** Geo-Environmental Interpretative Report

**DOCUMENT NUMBER:** D/I/D/136018/07 Issue 2

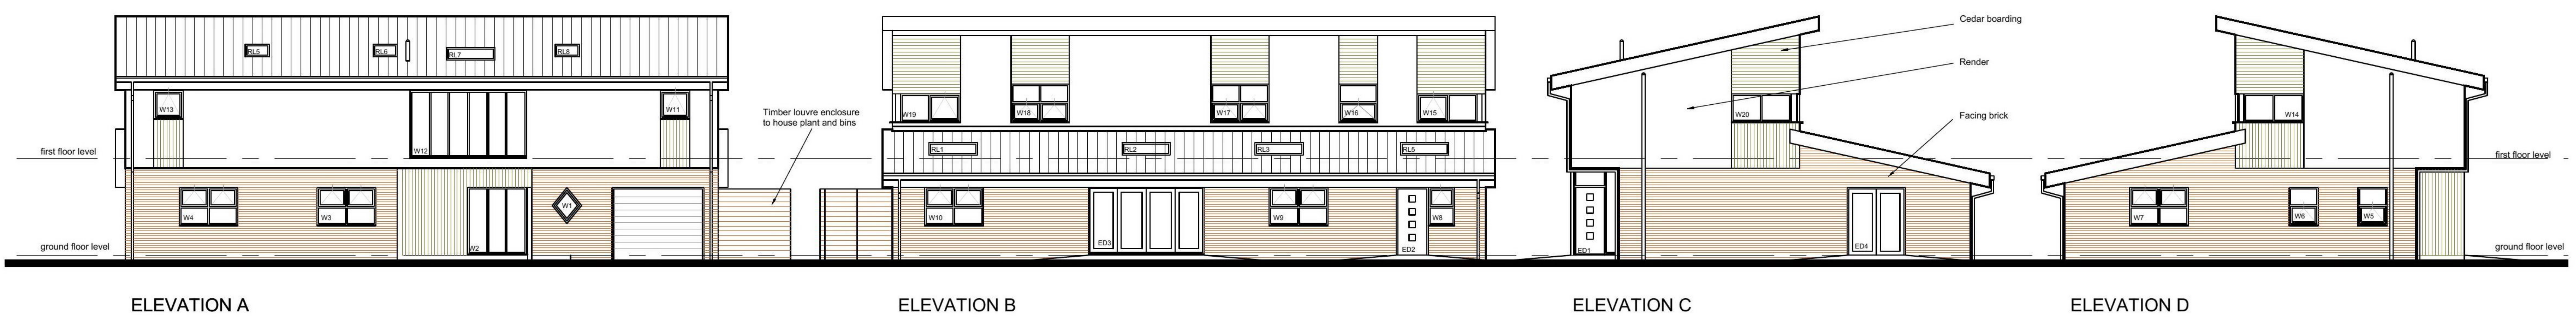
P191009 (0)01

**Proposed External Materials**  
Walls: facing brick/cedar boarding/render  
Roof: Calmic standing seam roof colour grey  
Windows-Doors: Aluminum double glazed powder coated colour grey  
Rainwater goods: Aluminum powder coated colour grey

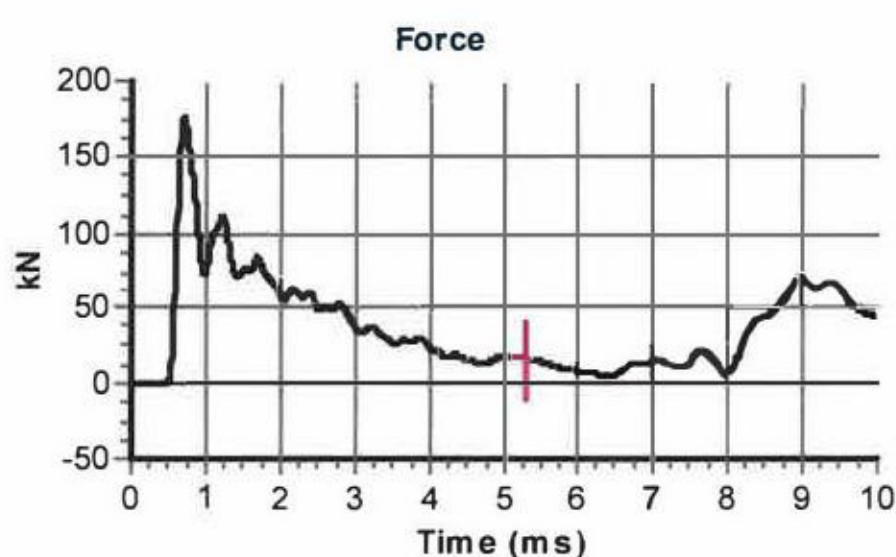
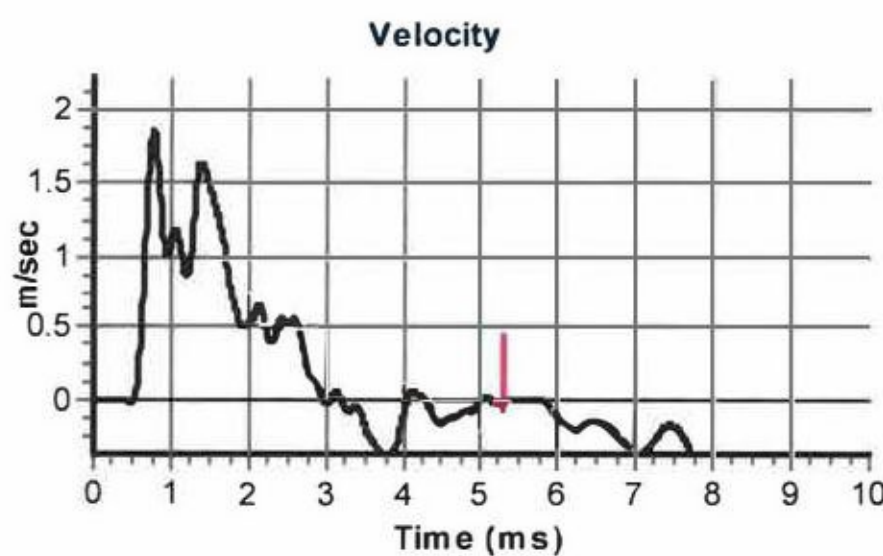
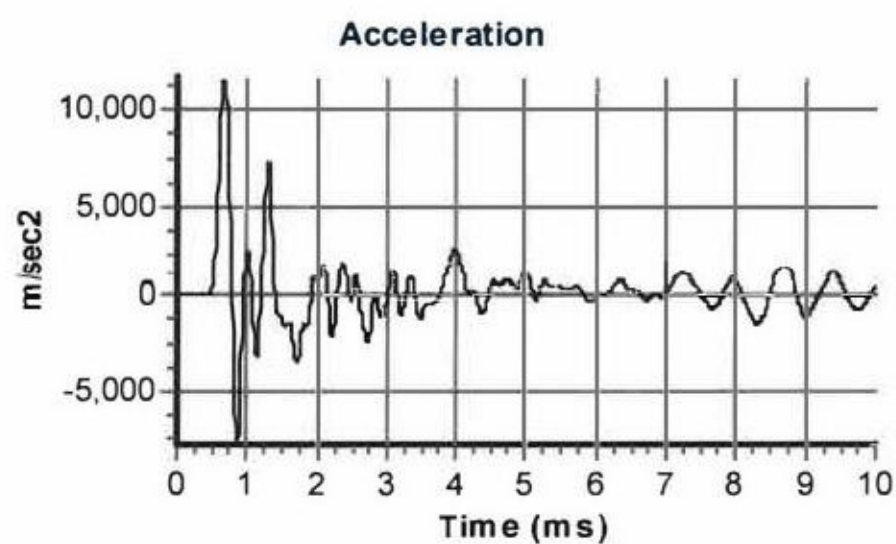
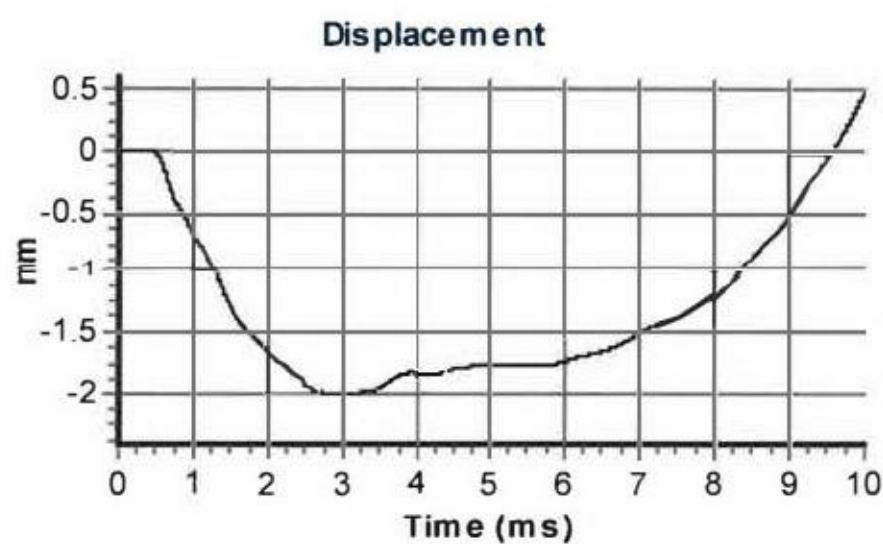
Hammer Mass  $m$  (kg): 63.5  
 Falling Height  $h$  (mm): 760  
 SPT String Length  $L$  (m): 14.0

Area of Rod A (mm<sup>2</sup>): 970  
 Theoretical Energy  $E_{theor}$  (J): 473  
 Measured Energy  $E_{meas}$  (J): 282

**Energy Ratio  $E_r$  (%):** 60

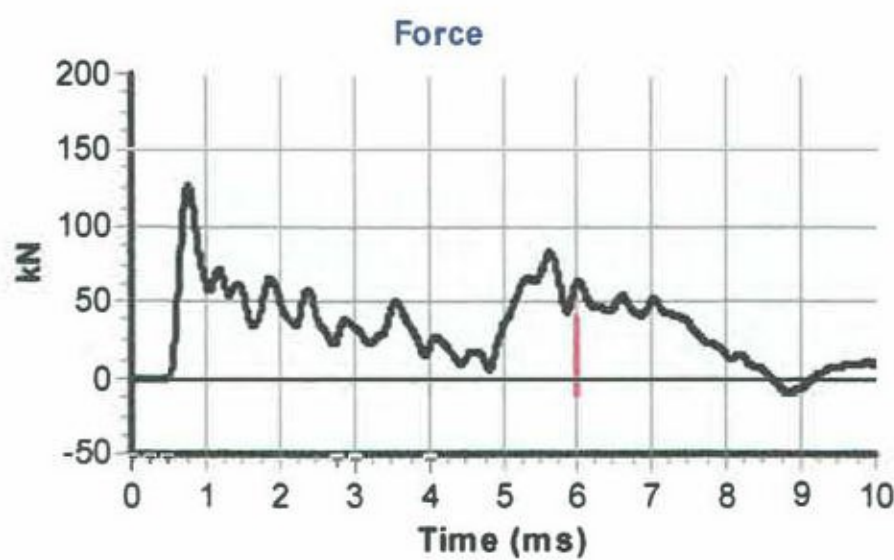
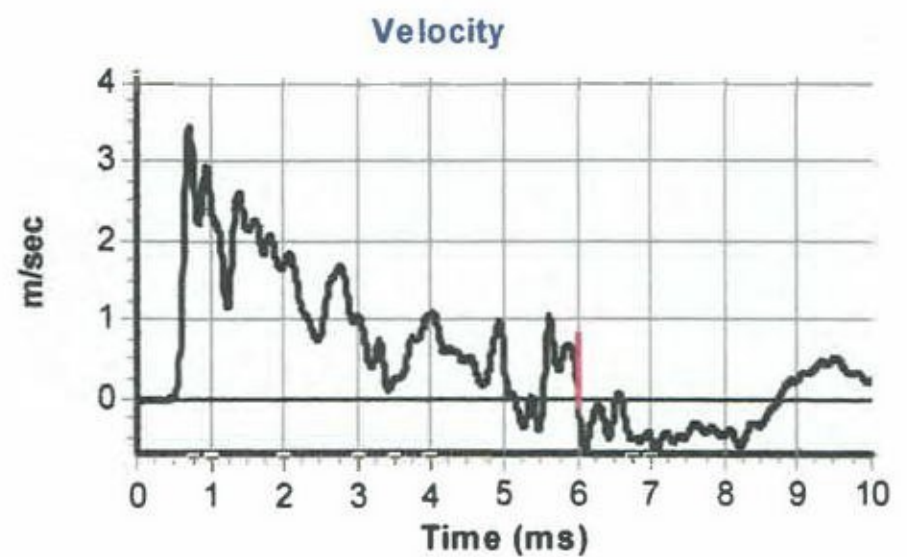
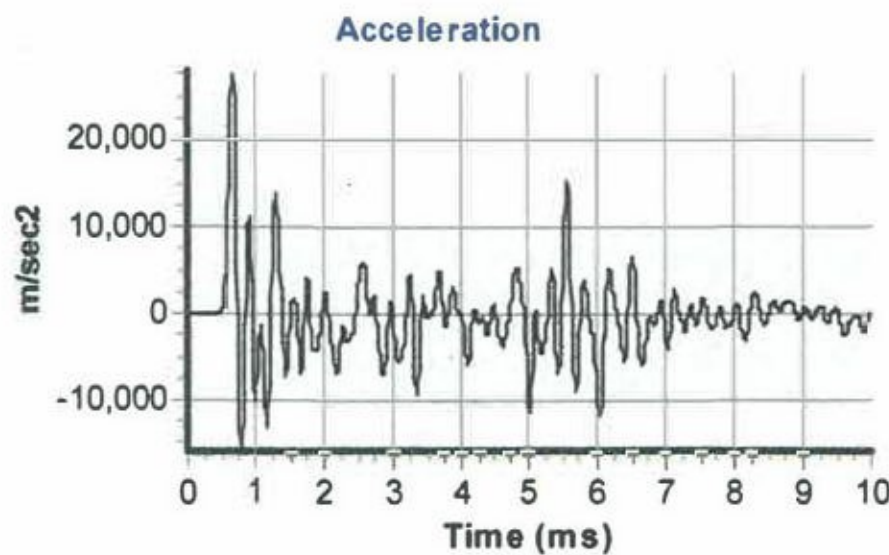
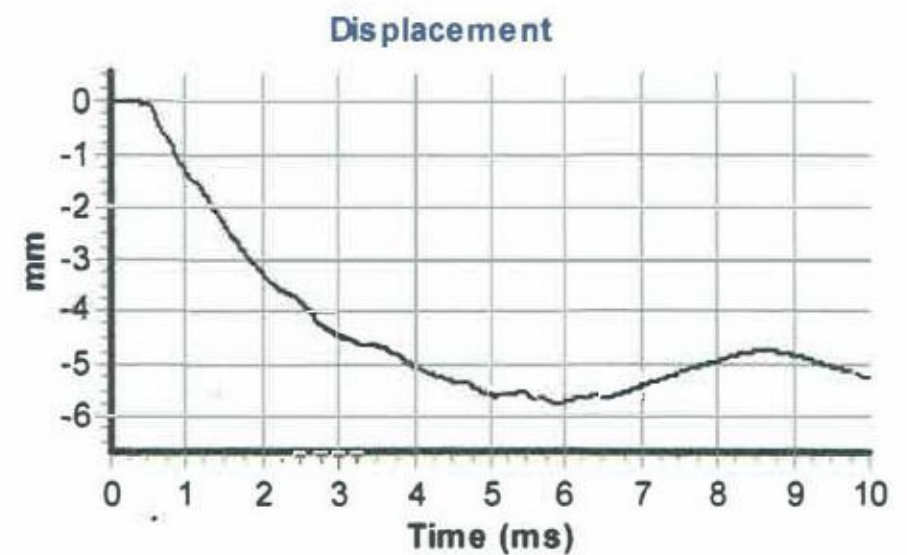
DUNELM/70449

Area of Rod A ( $mm^2$ ): 905  
 Theoretical Energy  $E_{theor}$  (J): 473  
 Measured Energy  $E_{meas}$  (J): 304

**Energy Ratio  $E_r$  (%):** **64**

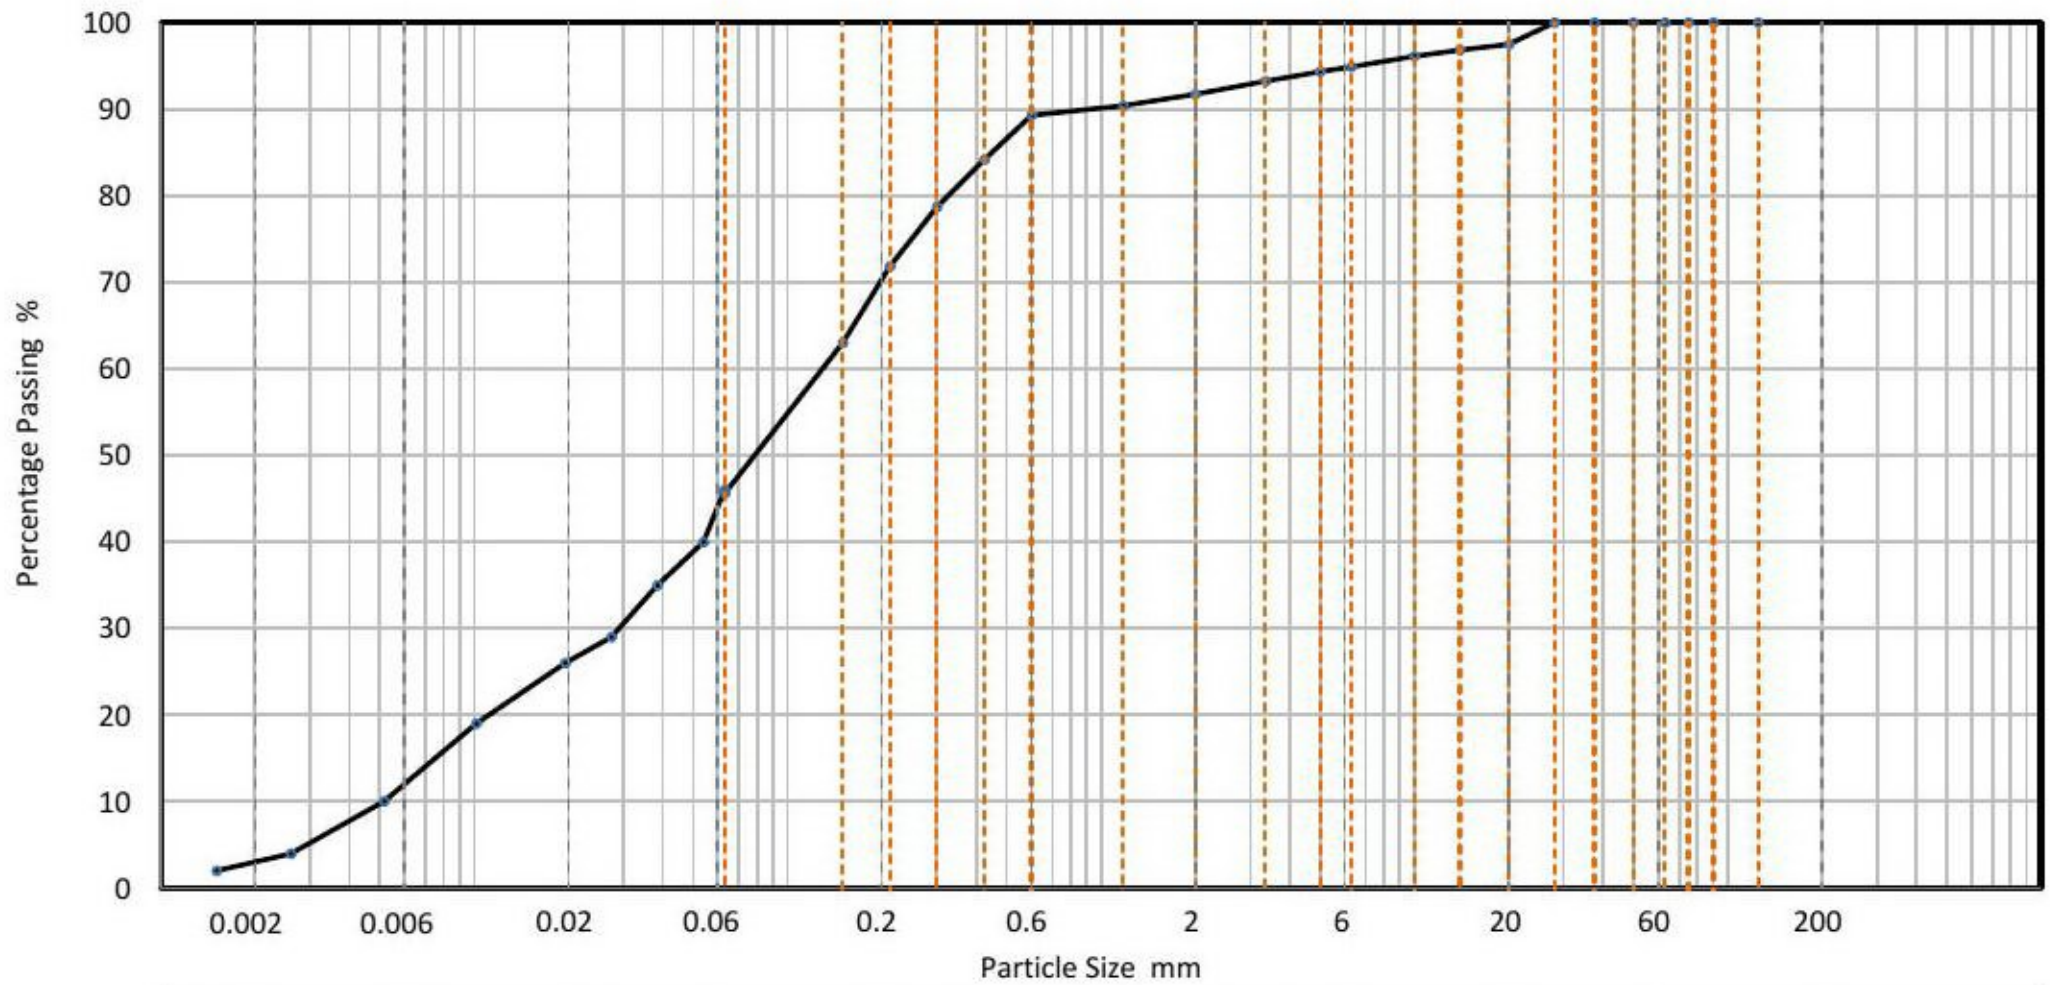
# PARTICLE SIZE DISTRIBUTION

Hole	PWS03	Lab sample ID	SLMK2021021012
Depth (Top)	m 0.50	Test Method	BS 1377 - 2 : 1990 Clauses 9.2 and 9.5
Depth (Base)	m	Soil Description	Brown, slightly clayey, slightly gravelly, Very Silty SAND
Sample type	B

Sieving		Sedimentation	
Particle Size mm	% Passing	Particle Size mm	% Passing
125	100	0.0630	46
90	100	0.0538	40
75	100	0.0384	35
63	100	0.0274	29
50	100	0.0195	26
37.5	100	0.0102	19
28	100	0.0052	10
20	98	0.0026	4
14	97	0.0015	2
10	96		
6.3	95		
5	94		
3.35	93		
2	92		
1.18	90		
0.6	89	Particle density (assumed)	
0.425	84	2.65 Mg/m3	
0.3	79		
0.212	72		
0.15	63		
0.063	46
