**BROADFIELDS INNOVATION & BUSINESS PARK
TILBURY ROAD
EAST HORNDON
BRENTWOOD
ESSEX
CM13 3LS**

TRANSPORT ASSESSMENT

Volume 4 of 5

REDW-3235-104-B- Approved Roundabout - A128 Tilbury Road/Tilbury Road junction

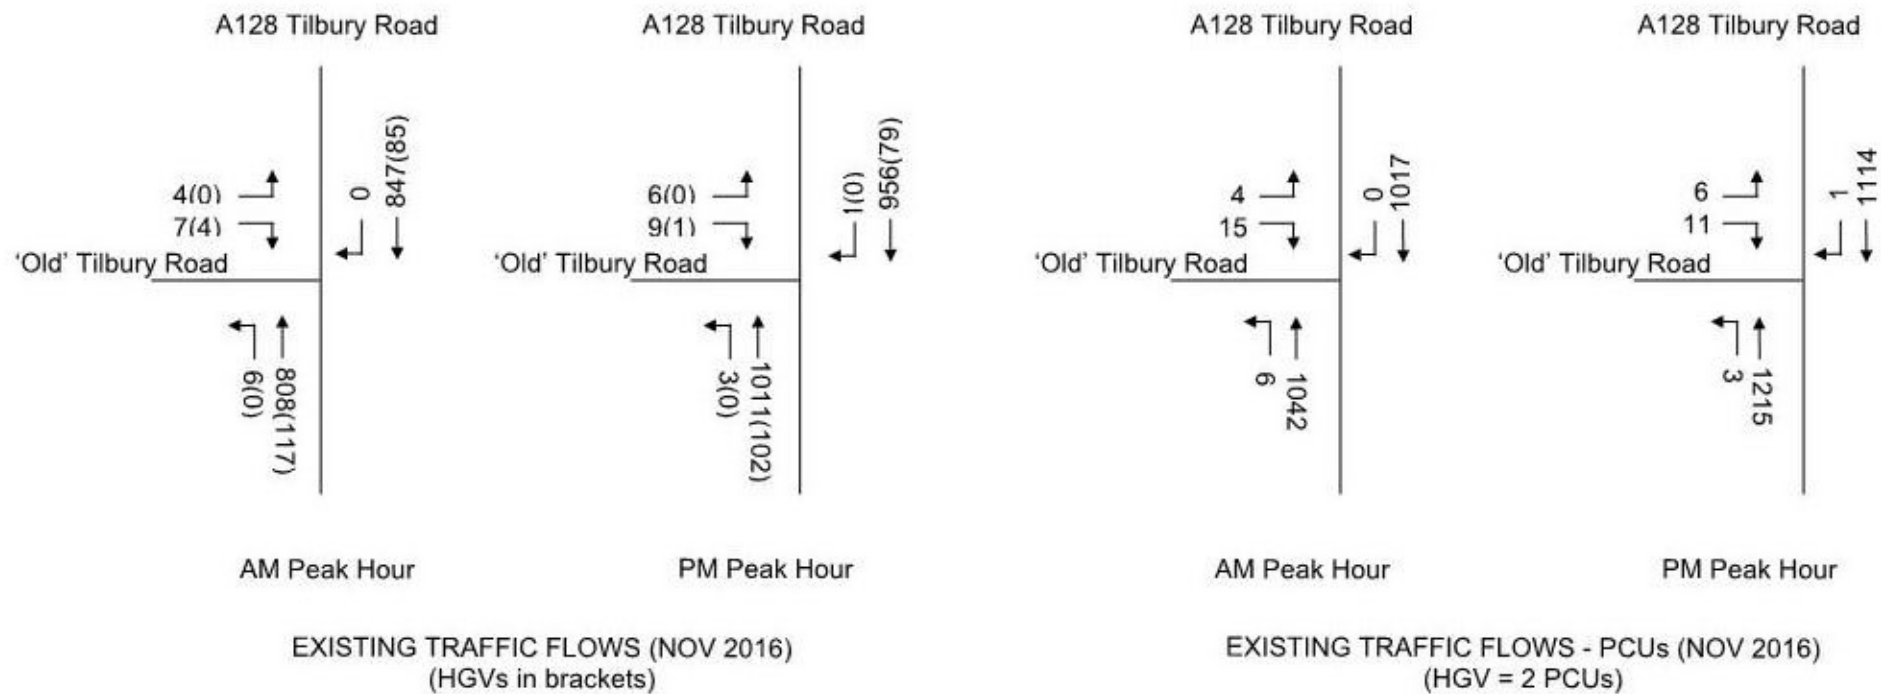
FIGURE A300

3386 Broadfields Mixed Use Development, Tilbury Road, East Horndon
Year 2016 Existing Peak Hour Traffic Flows - A128 Tilbury Road / Tilbury Road

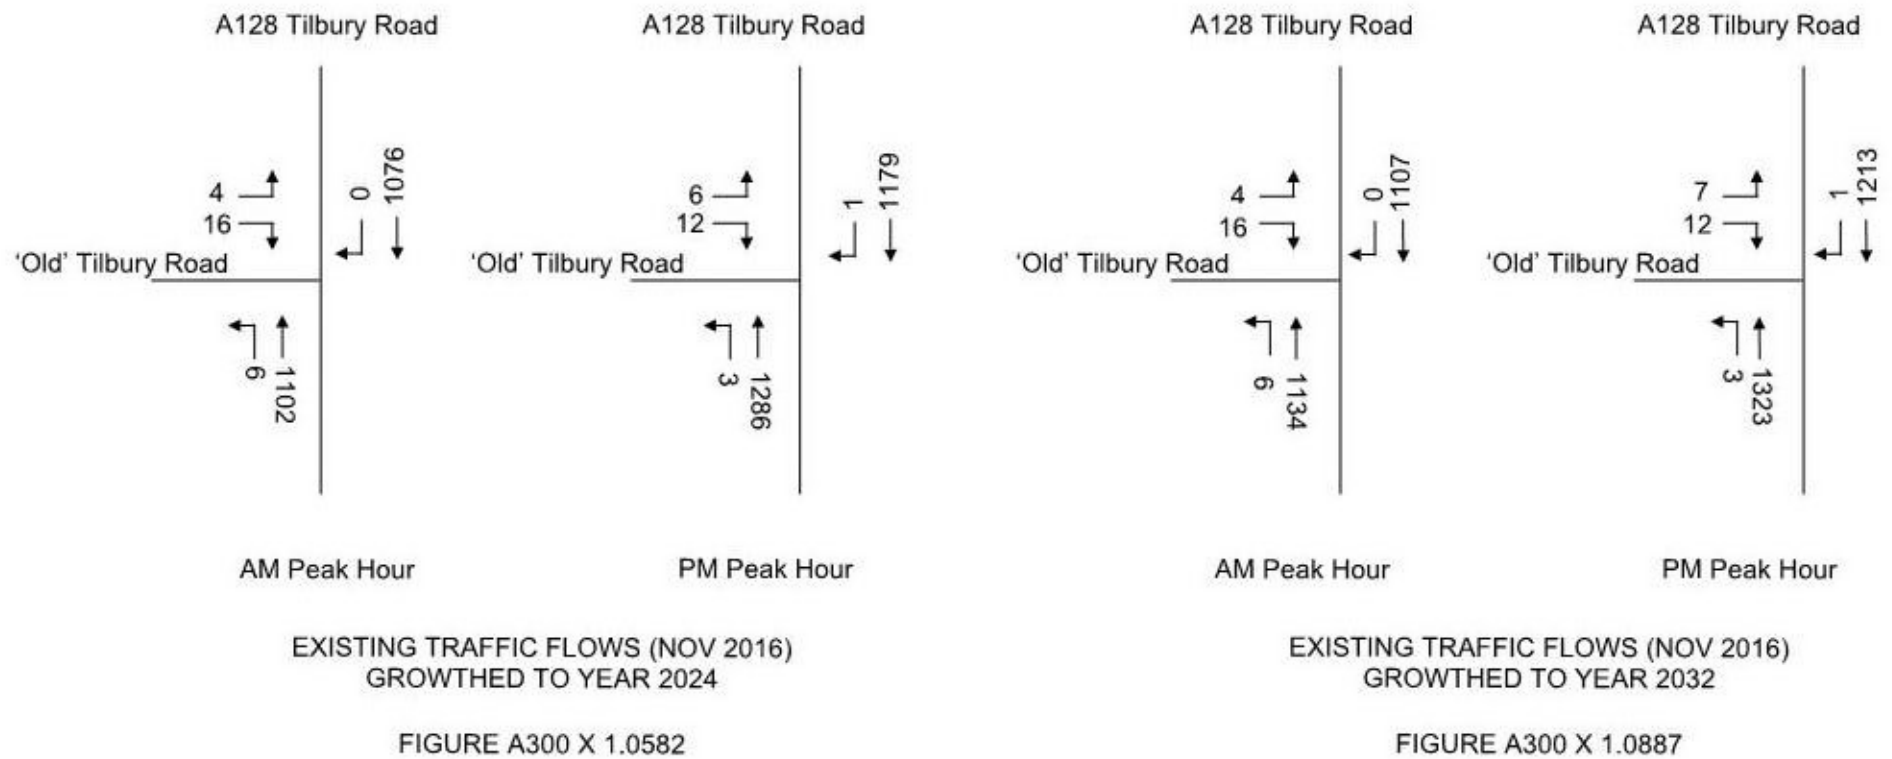
FIGURE A301

3386 Broadfields Mixed Use Development, Tilbury Road, East Horndon
 Existing Peak Hour Traffic Flows (PCUs) - A128 Tilbury Road / Old Tilbury Road

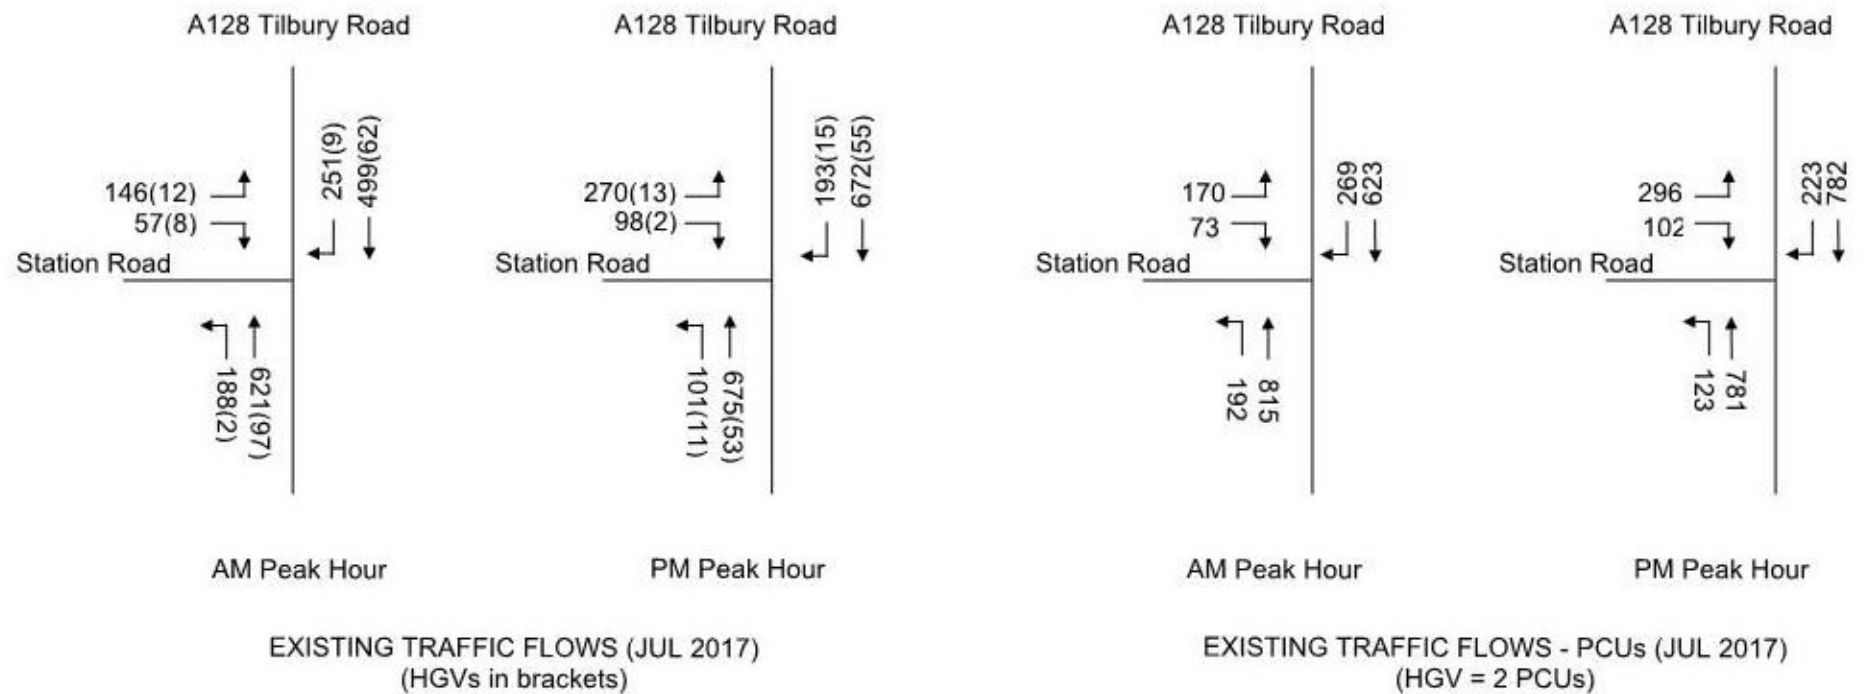
FIGURE A307

3386 Mixed Use Development, Tilbury Road, East Horndon
Existing Peak Hour Traffic Flows - A128 Tilbury Road / Station Road Junction

EXISTING 2017 TRAFFIC FLOWS GROWTHED TO YEAR 2024
 (FIGURE A307 PCUs x 1.0454)

EXISTING 2017 TRAFFIC FLOWS GROWTHED TO YEAR 2032
 (FIGURE A307 PCUs x 1.0810)

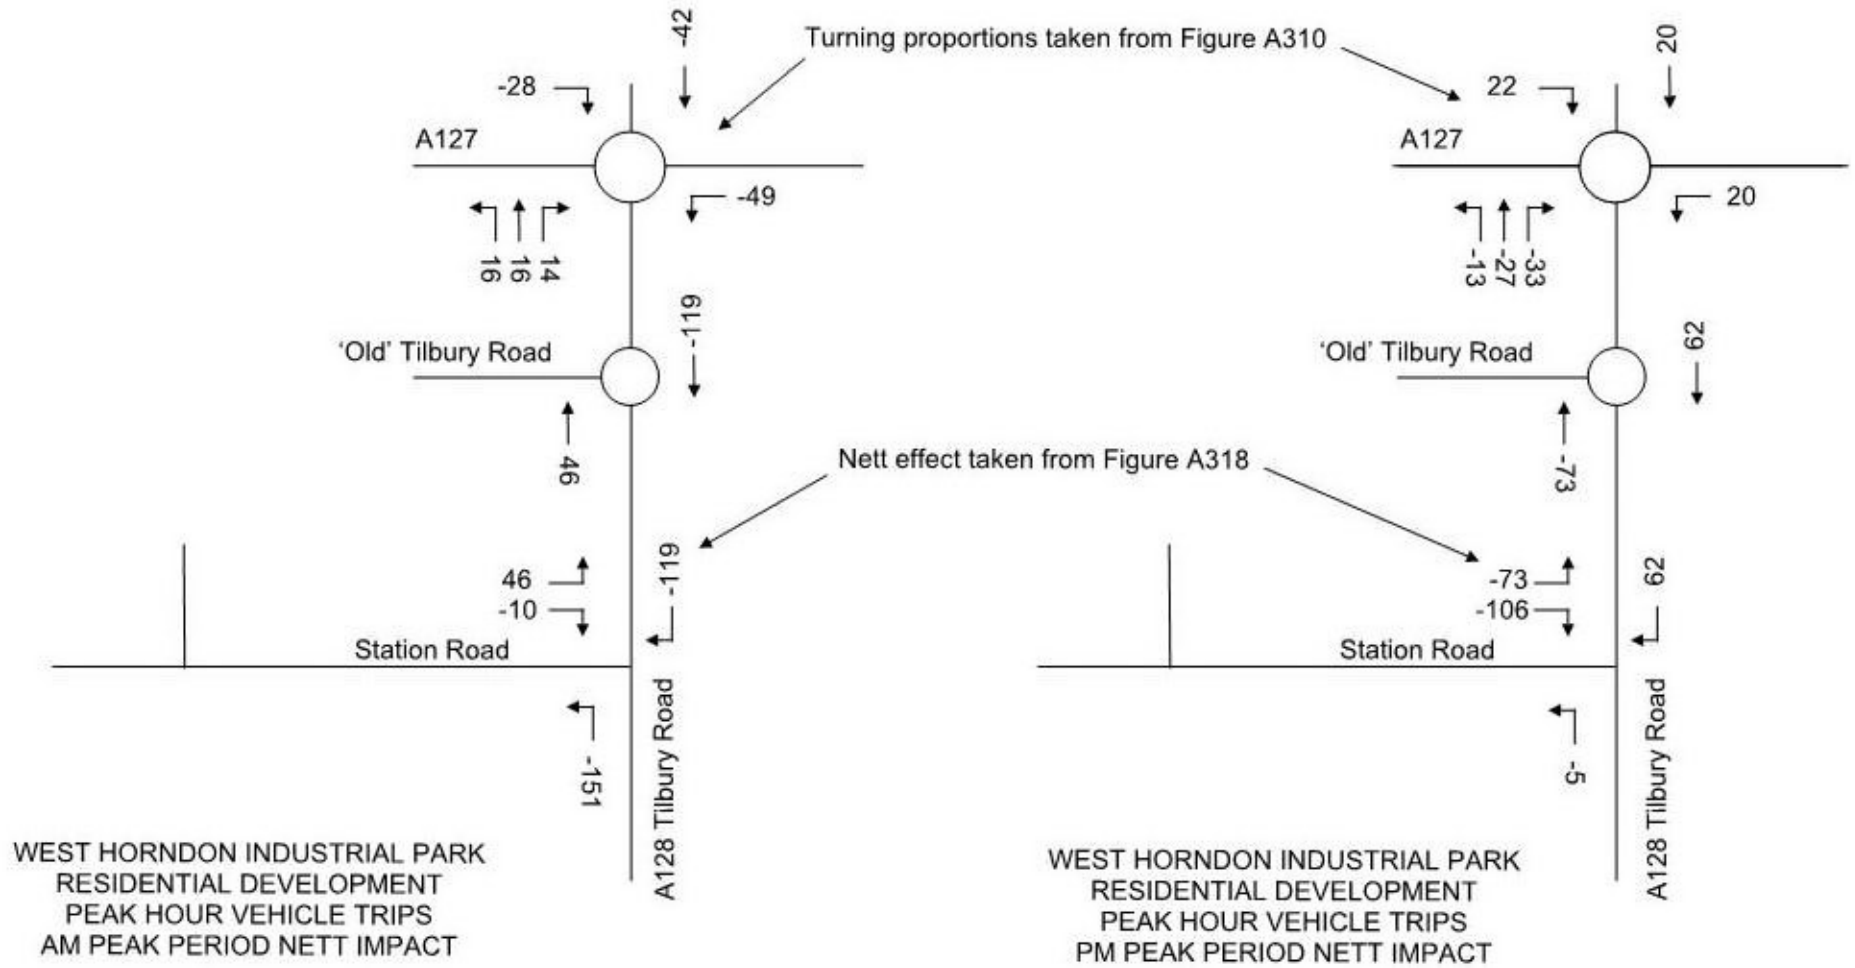
FIGURE A319

Note: 580 new dwellings proposed on West Horndon Industrial Park

3386 Mixed Use Development, Tilbury Road, East Horndon
West Horndon Industrial Park - Re-development Peak Hour Traffic Distribution

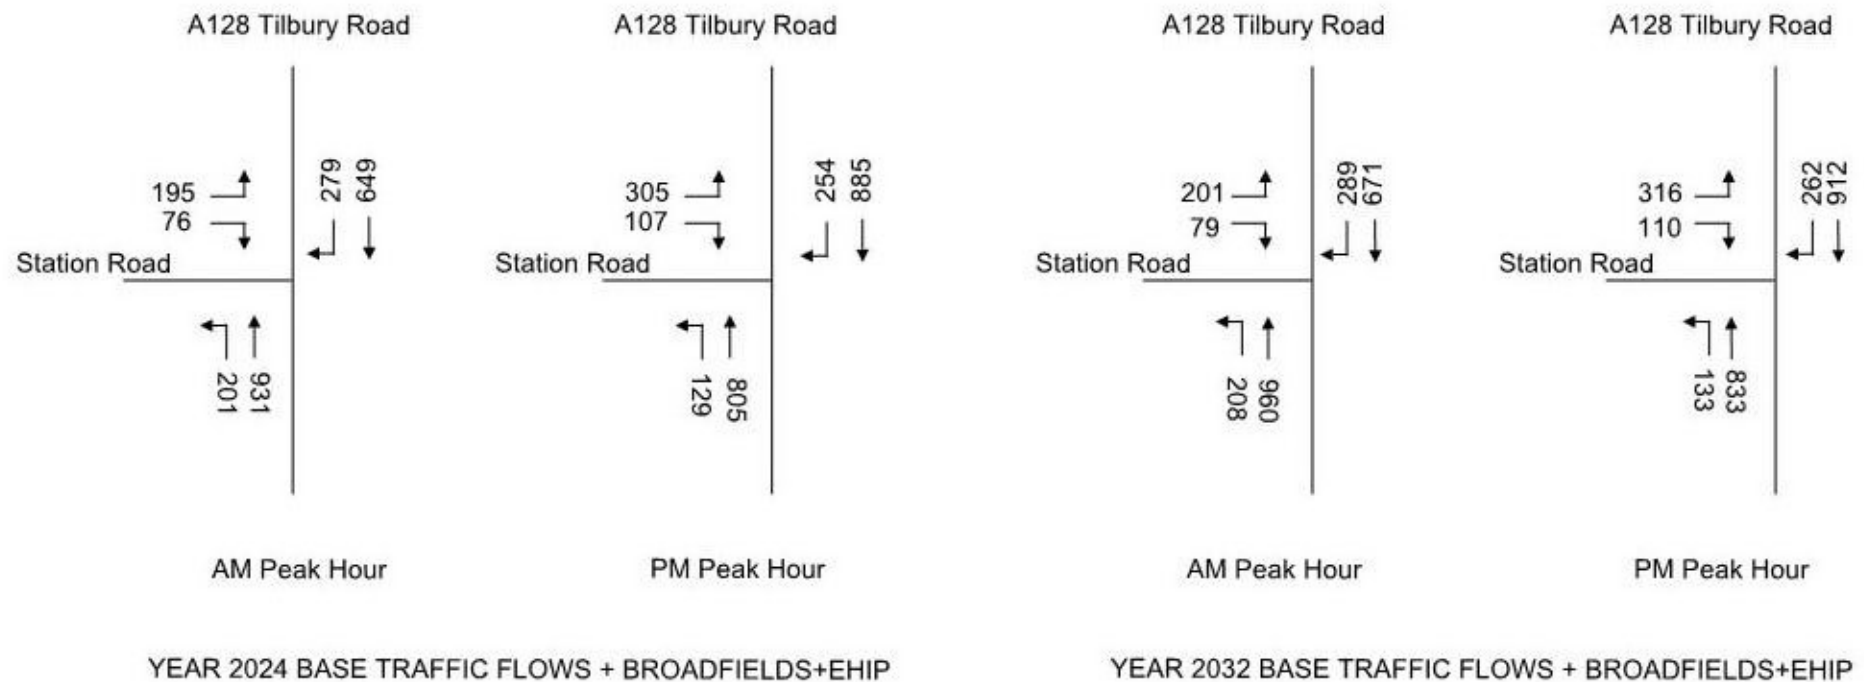
FIGURE A321

FIGURE A308 + FIGURE A314

3386 Mixed Use Development, Tilbury Road, East Horndon
Total Traffic Traffic Flows - A128 Tilbury Road / Station Road Junction

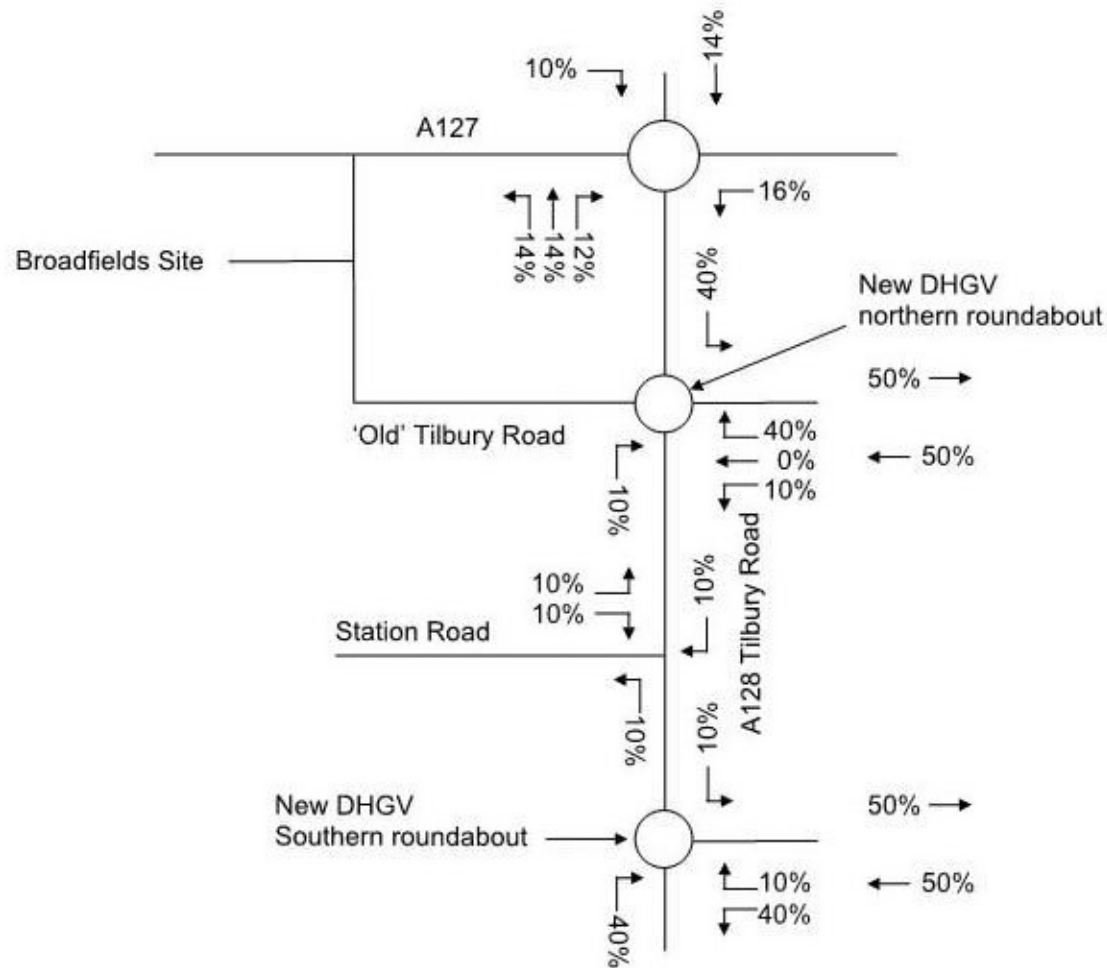
FIGURE A329

3386 Broadfields Mixed Use Development, Tilbury Road, East Horndon
 DHGV Peak Hour Traffic Distribution

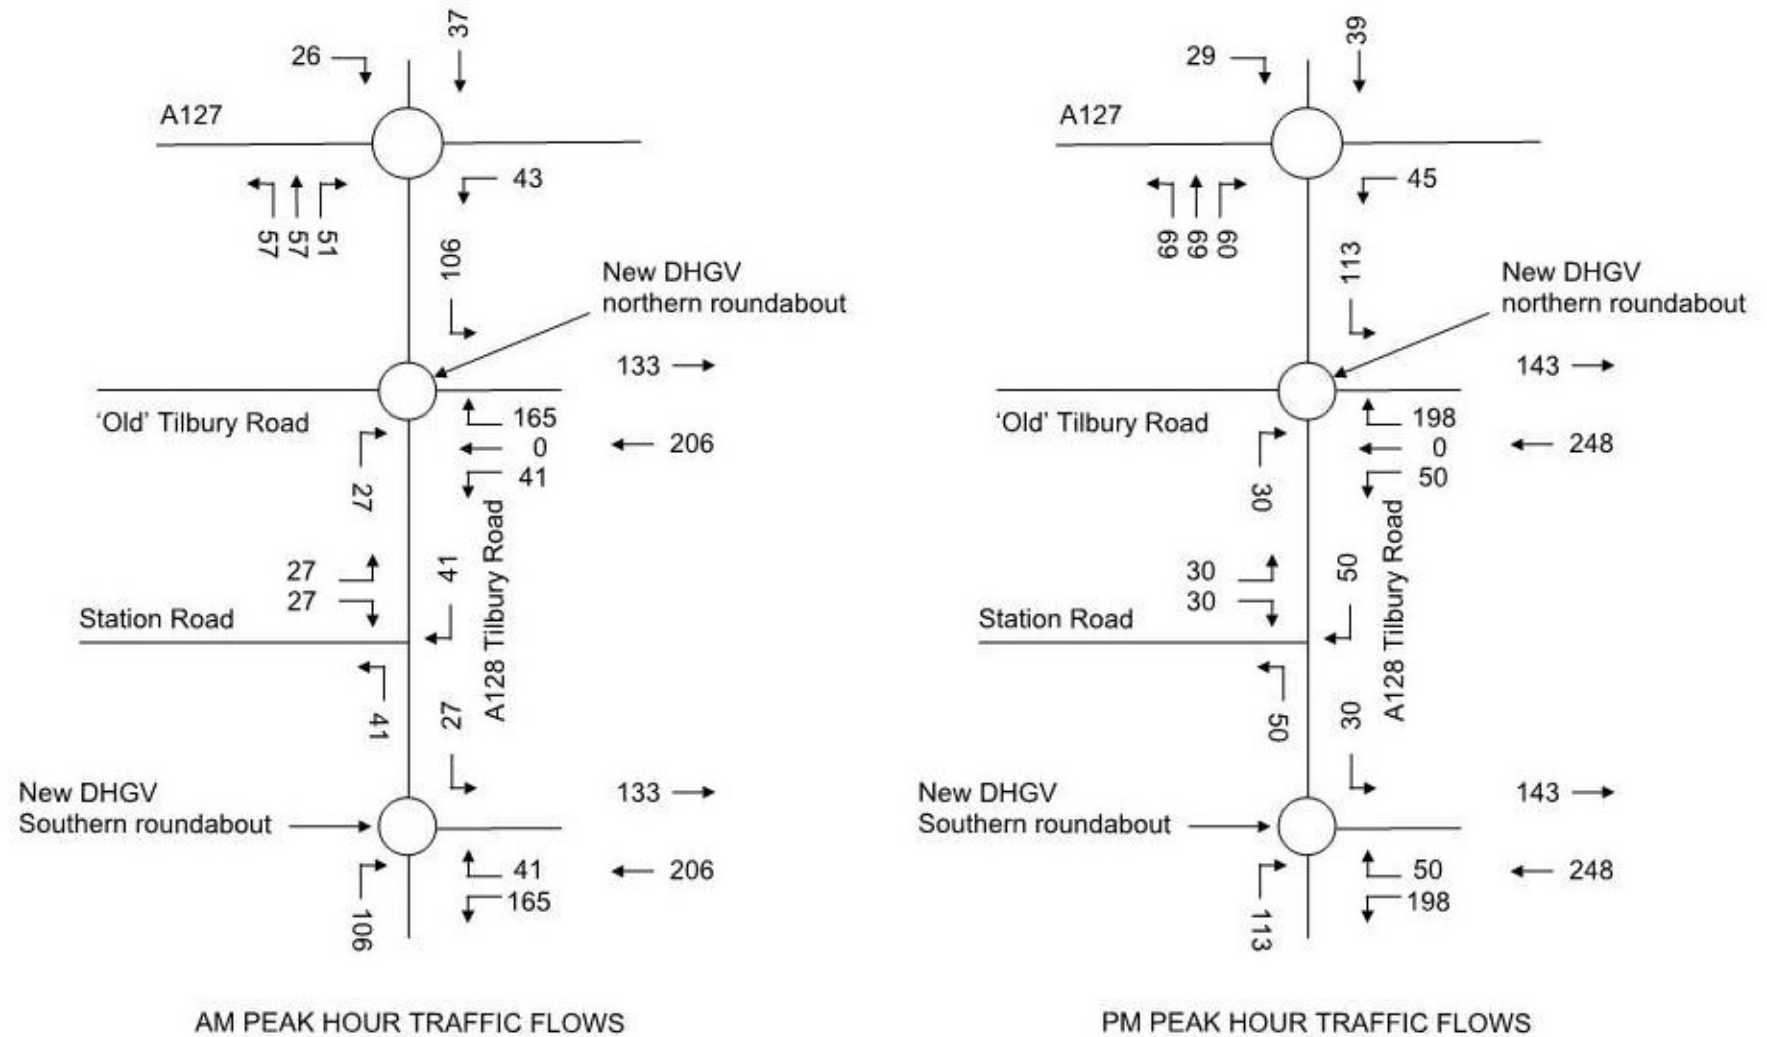
FIGURE A330

**3386 Broadfields Mixed Use Development, Tilbury Road, East Horndon
 DHGV Peak Hour Traffic Flows**

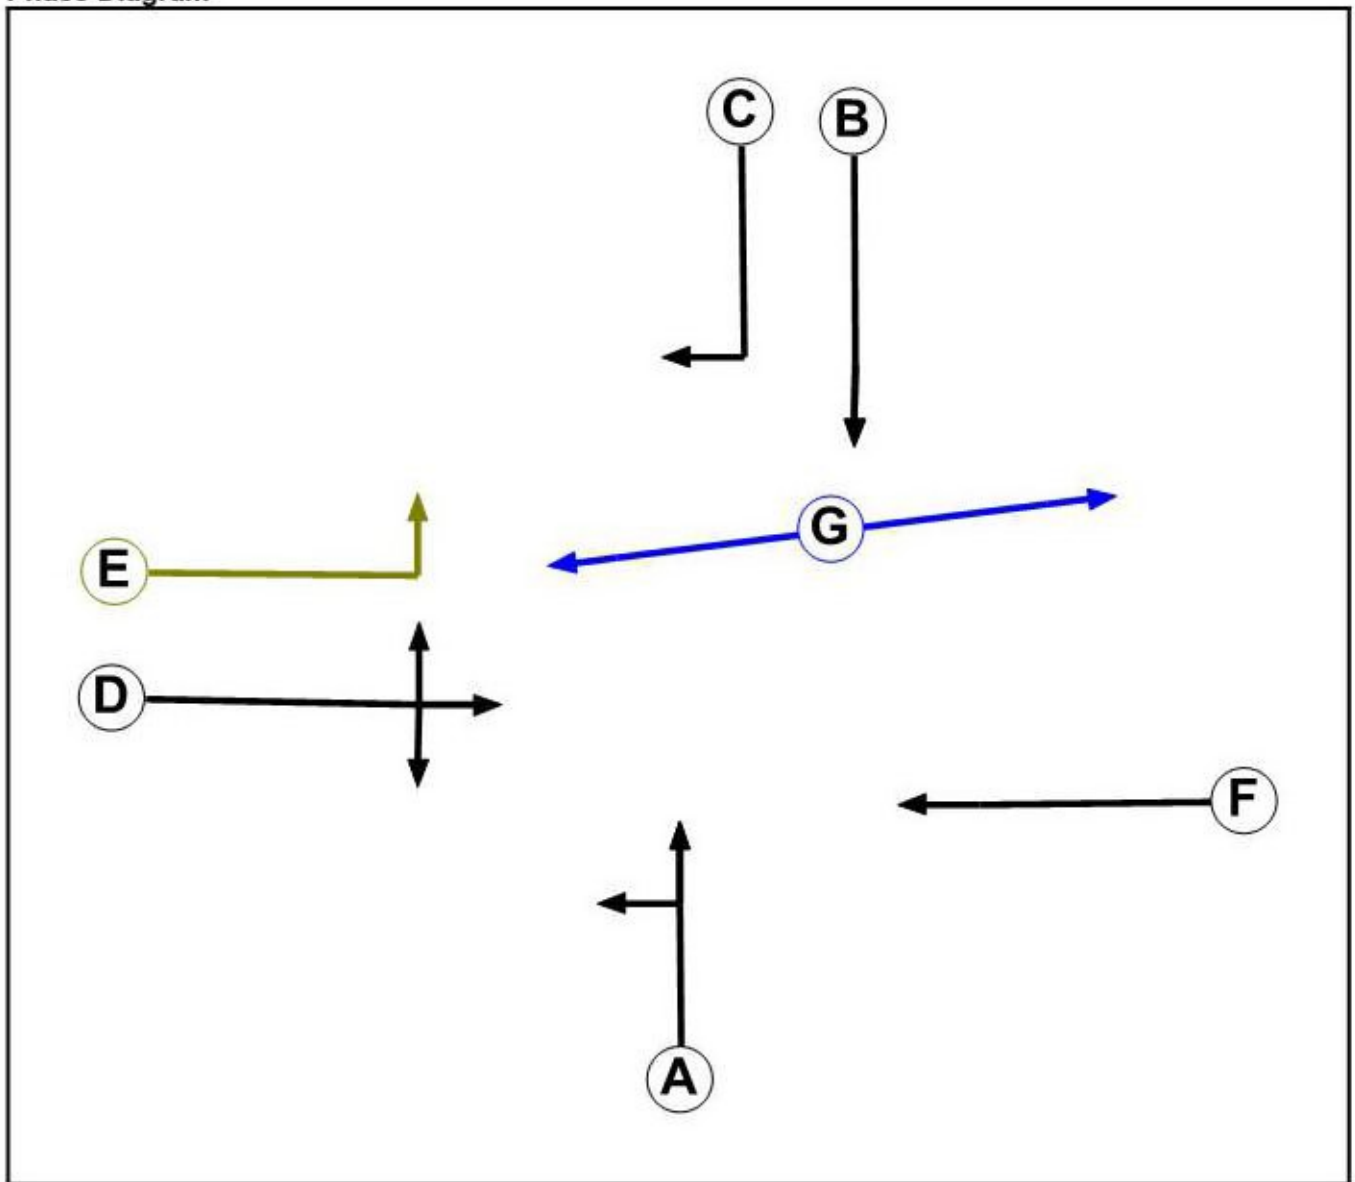
Phase Diagram

Phase Name	Phase Type	Assoc. Phase	Street Min	Cont Min
A	Traffic		7	7
B	Traffic		7	7
C	Traffic		7	7
D	Traffic		7	7
E	Filter	D	4	0
F	Traffic		7	7
G	Pedestrian		7	7

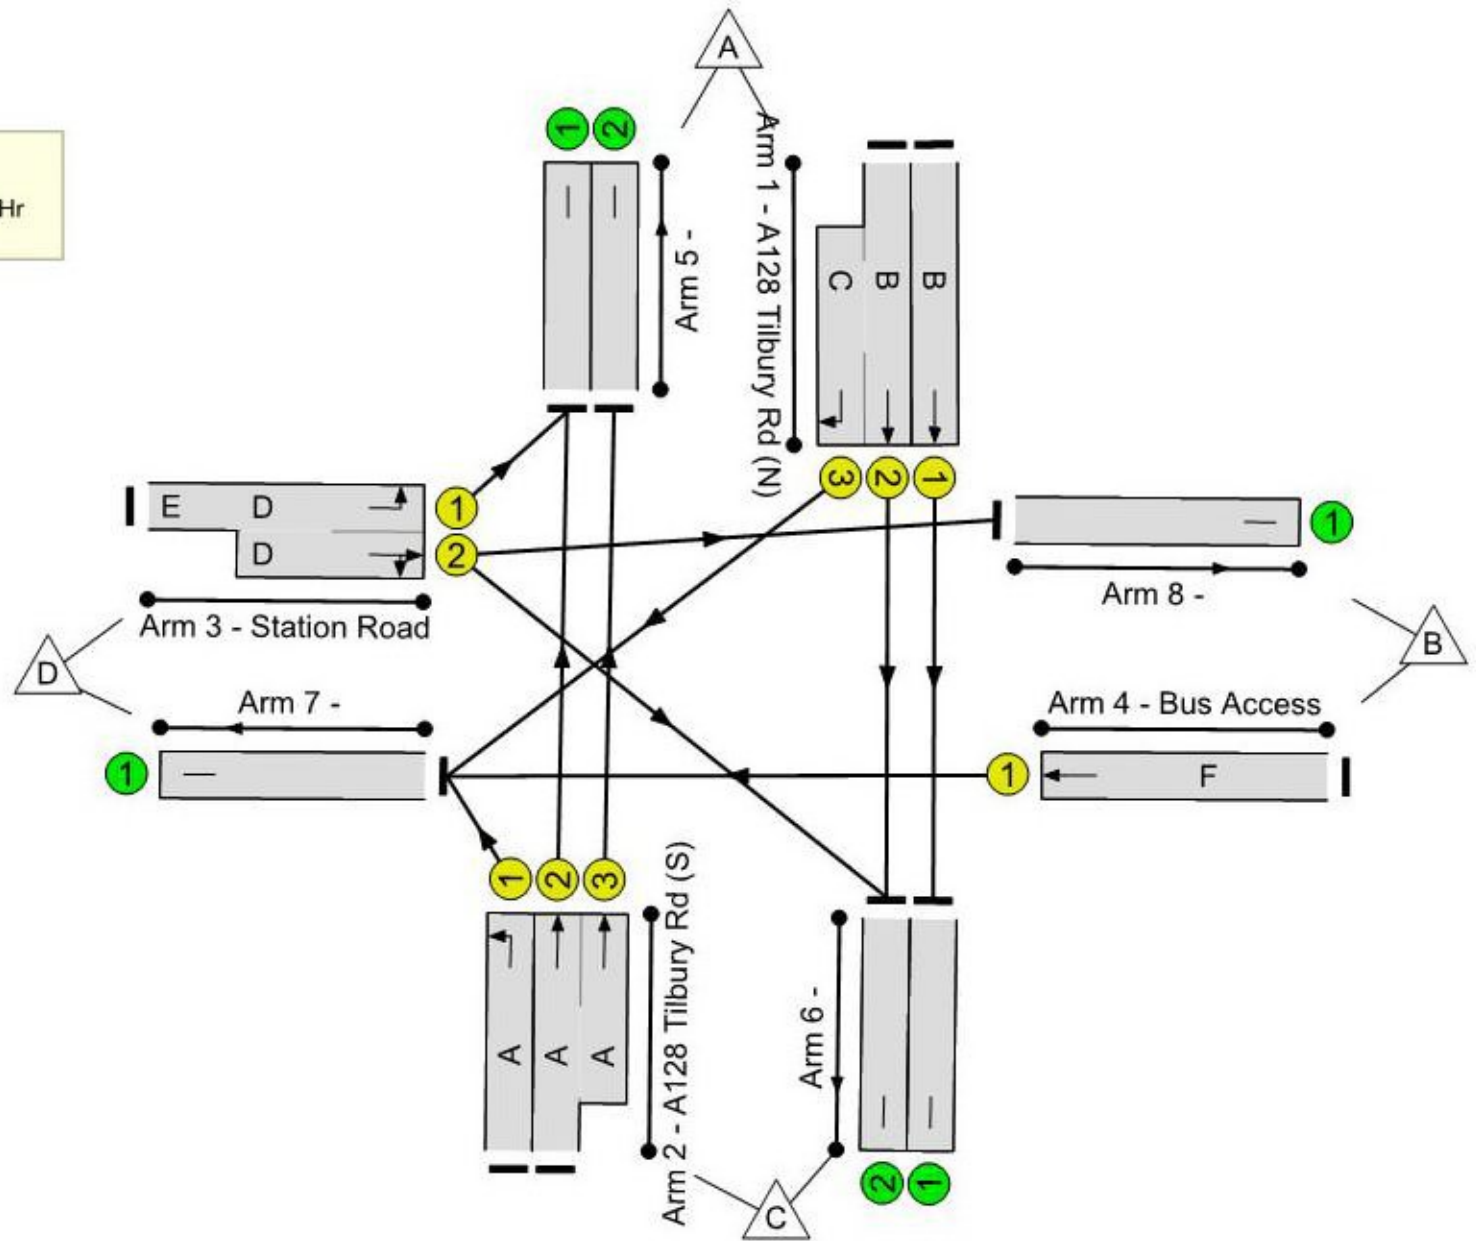
**Unnamed Junction**
PRC: 21.3 %
Total Traffic Delay: 14.9 pcuHr

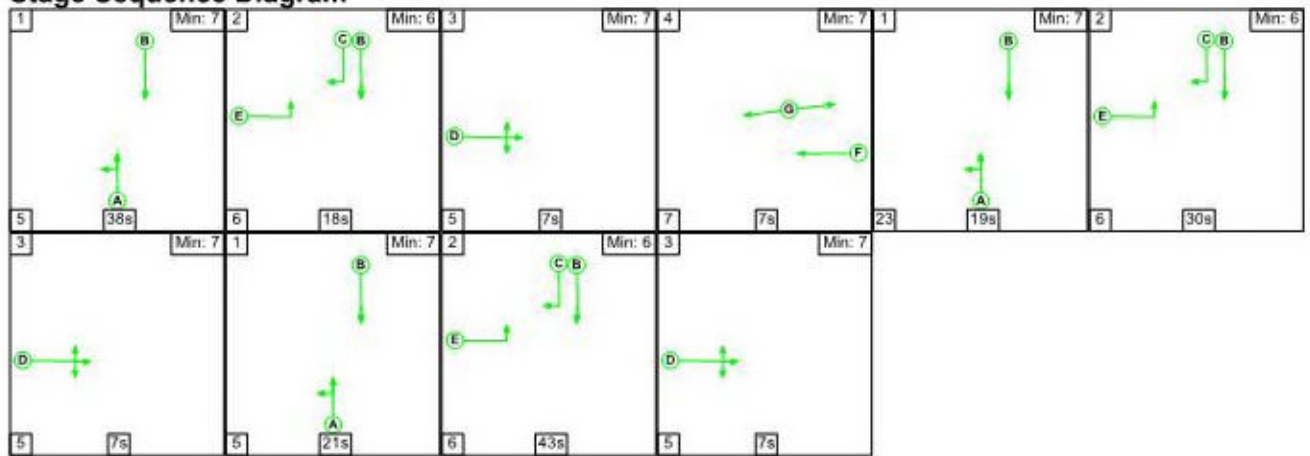
Stage Sequence Diagram

Scenario 2: 'Scenario 2' (FG2: '2033 Base+DH PM', Plan 1: 'Network Control Plan 1')

Stage	1	2	3	4	1	2	3	1	2	3
Duration	38	18	7	7	19	30	7	21	43	7
Change Point	0	43	67	79	93	135	171	183	209	258

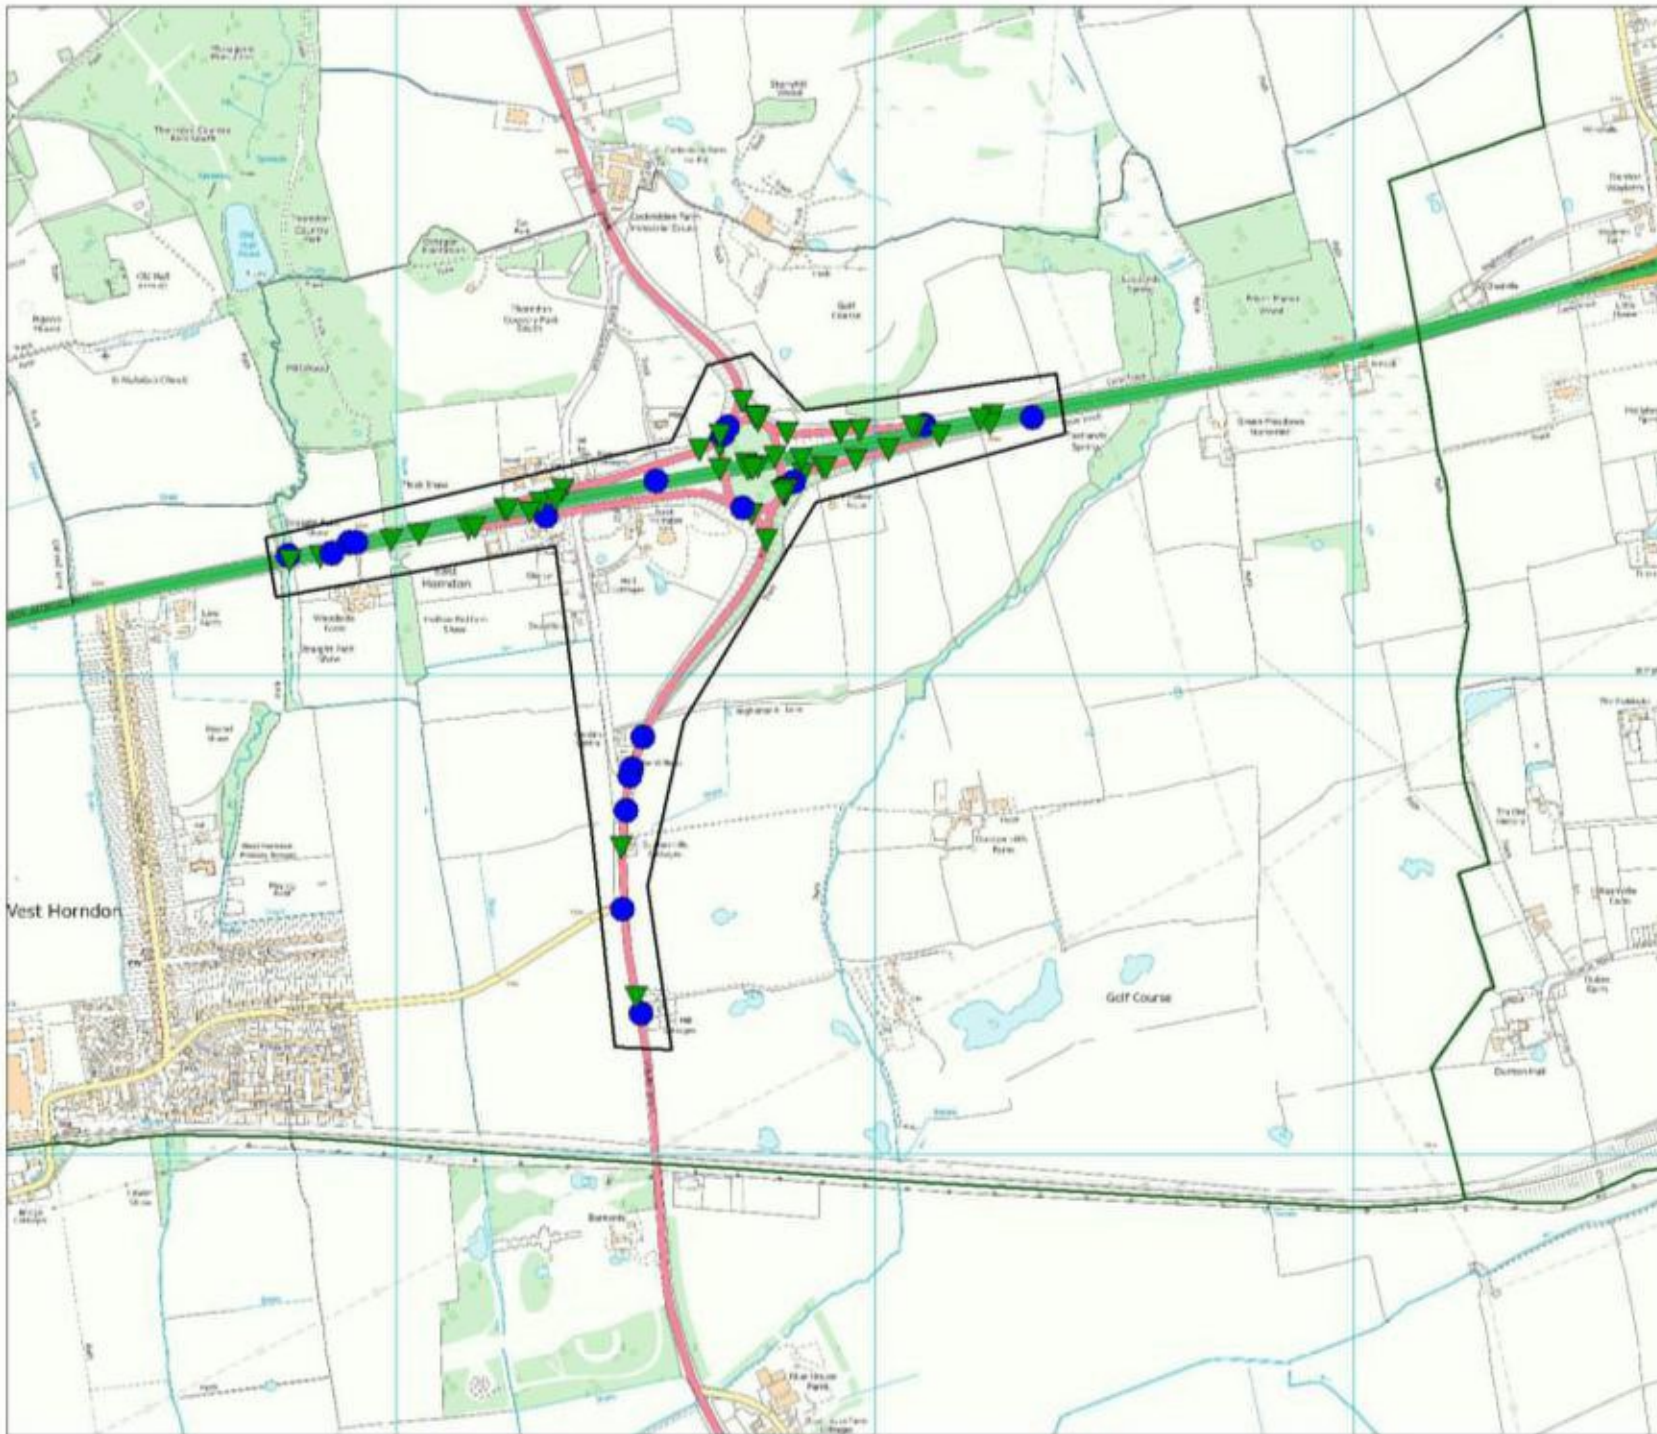
Colour-coding by SEVERITY
Total Accidents (79)

- ★ Fatal (0)
- Serious (18)
- ▼ Slight (61)
