**Fairways Cottage
Newton
Sudbury
CO10 0QN**

Stage 1/ Tier 1 – Contaminated Land Assessment

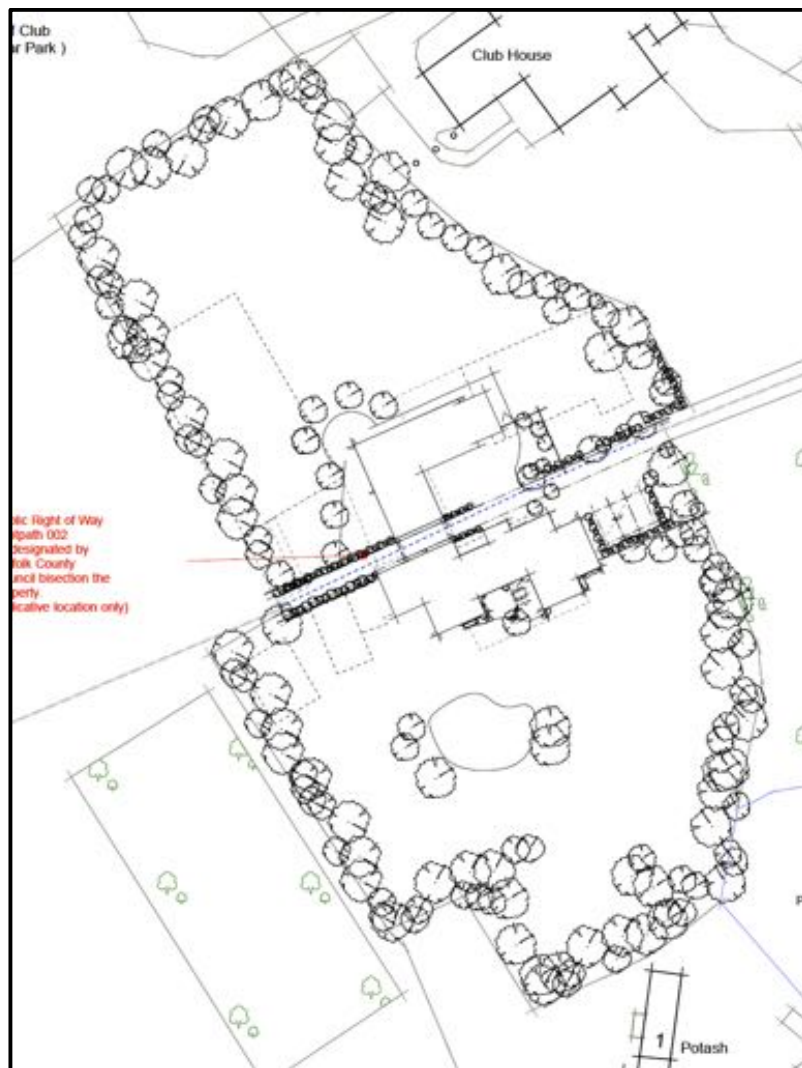
Figure 1 – Architect's Proposed Sketch Layout (extract)

- 1.04.1 We understand that the intention is to demolish the existing structures and construct 4 No. new residential dwellings.
- 1.04.2 An extract of the proposed development layout is shown below. A full-scale copy of the Architect's layout drawing is presented within the appendices.

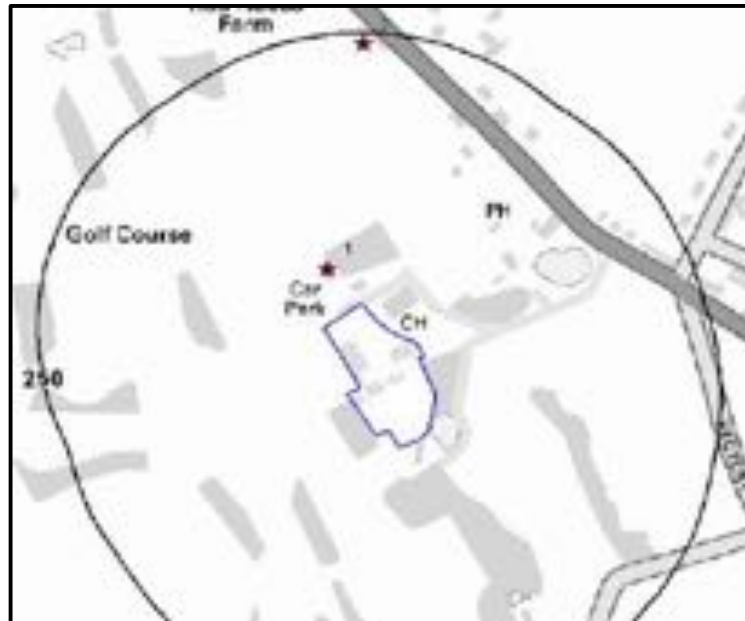
Figure 2 – Extract from Current Land Use map – Enviro Insight Report

*The Enviro Insight report records the existence of an on-site pond. This is likely a mistake and instead refers to an adjacent pond on the site boundary.

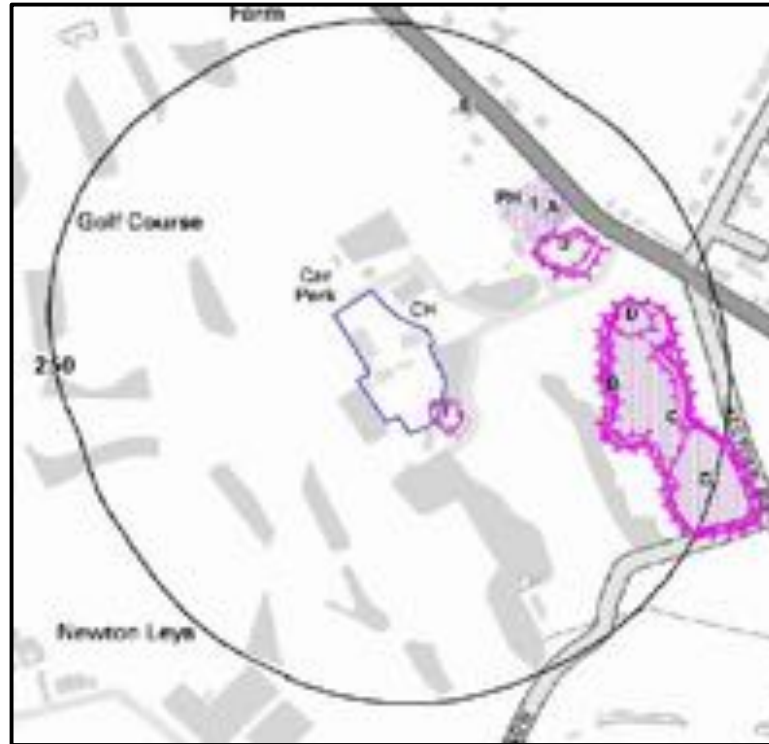
Figure 3 – Enviro Insight Infilled Land and Industrial Uses Map

2.07.1 The historical map review, along with the Enviro Insight report, highlighted several potentially infilled ponds and an old gravel pit near to the study area. A study of both aerial photographs and modern mapping shows that the ponds still exist as ponds and that the old gravel pit still forms a slight depression.

2.07.2 The report also mentions ‘Unspecified Ground Workings’ in the area of the old gravel pit on 1955 and 1973 maps. A review of the 1955, 1958 and 1976 maps shows that the area is used as a golf course with no mention of other activities.

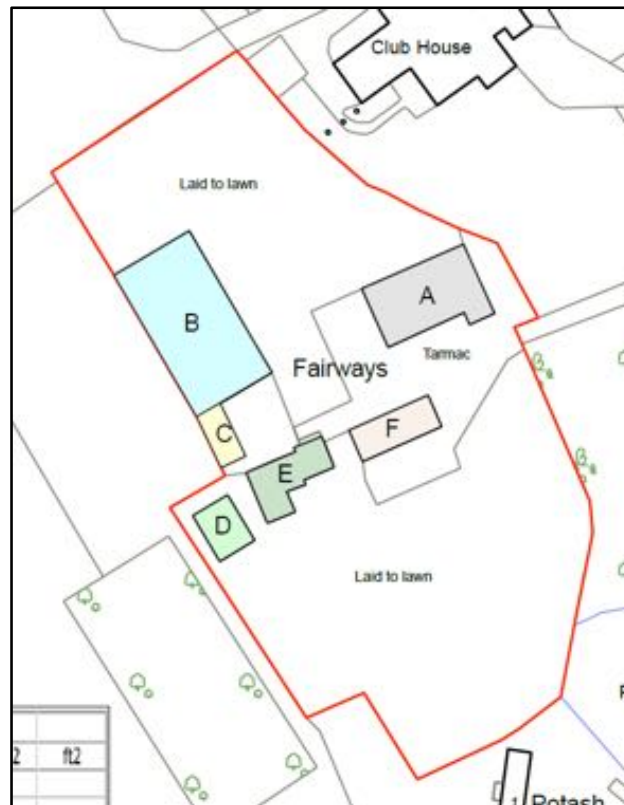
Figure 4 - Schedule of accommodation (extract)

- 2.11.1 The site walkover was conducted on Tuesday, 30 March 2021 by Andrew Cartwright on behalf of JPC Environmental Services.
- 2.11.2 The site is accessed via an unnamed road to the east, leading from Sudbury Road. This leads to an area of asphalt hardstanding and several buildings. Please see an extract from the Architect's schedule of accommodation overleaf.

- 2.11.3 Building A is constructed from bricks with a tiled roof and is currently being used as the client’s primary residence. To the east is a large pile of rusted metal, gas bottles, timber, a trailer, and a heating oil tank. The oil tank holds 2,500 litres and appears to be of modern construction on concrete hardstanding. To the south-west of building A is an area of gravel with a second heating oil tank. This tank holds 1,300 litres and also appears to be of modern construction on concrete hardstanding.

- 2.11.4 Building B is clad in corrugated suspected asbestos sheeting, painted brown, with a concrete floor. The building is being used for vehicle storage with some fuel and oil containers and a small workshop. To the north is an area used for bonfires, including 2 No. fire barrels and a suspended fire box. There is evidence of burning on the ground around the fire box.

- 2.11.5 Buildings C and E comprise timber structures with felt cladding and suspected asbestos roofs. The buildings are being used to store general items including glass panels, timber and items of furniture. To the south of building E, there is a caravan and a large pile of demolition arisings including damaged suspected asbestos sheeting.
