## Barn at Hanworth Common

Protected Species  
Survey

Prepared by  
Glaven Ecology

Reference: 109-2101-GE-HB

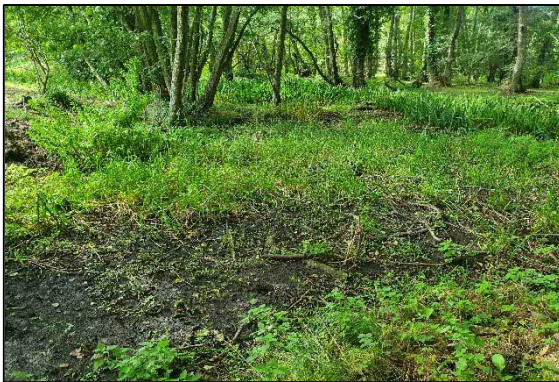
5.3.4 There was one pond with 250m of the site showing on Magic Maps. This was 100m west of site. The pond was completely shaded by trees and dry (Figure 1). The basin of the pond was very shallow and it likely dries out annually.

Figure 1 The dry, shallow pond 100m west of site.

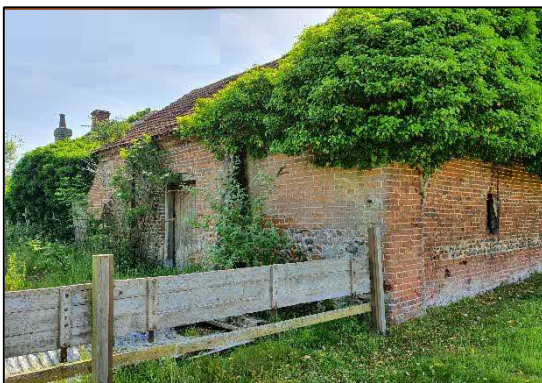
2.2.3 A single storey barn split into five rooms. The barn was of red brick with some flint detailing and a partially collapsed pantile roof (Figures 2 and 3). There was heavy vegetation growth on the southern and western aspects.

2.2.2 As already mentioned the roof was partially collapsed and there were lifted tiles throughout and several gaps in the ridge tiles.

2.2.3 Much of the brickwork on the western gable and southern aspect was covered by vegetation and difficult to view, but other external brickwork was intact.

Figure 2: The barn northern and western aspect.

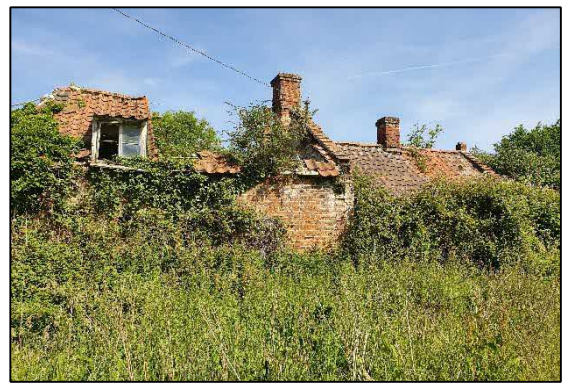
2.2.2 There was an open dormer window on the southern aspect as well as the collapsed roof, offering potential access into the building.

Figure 3: The barn – southern aspect.

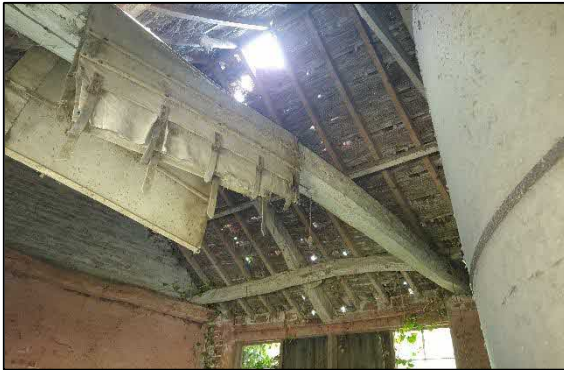
2.2.3 The first room (western end) was open to the roof space which was lined with straw, although this was loose and missing in places, with obvious holes in the roof where tiles had slipped (Figure 4). The beams were very narrow, with a larger cross beam, but no cracks and splits were present.

4.2.10 There was a large silo taking up much of the space in the room with the internal brickwork appearing intact.

Figure 4: Internal view of western-most room

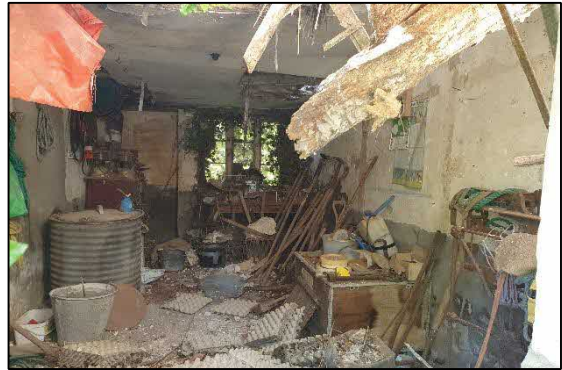
5.4.11 The second room had a collapsed ceiling and large open areas in the roof (Figure 5). There was a window in the southern aspect and the room was very bright and draughty. Despite the collapsed ceiling the internal walls were intact.

Figure 5: Room 2 – collapsed ceiling

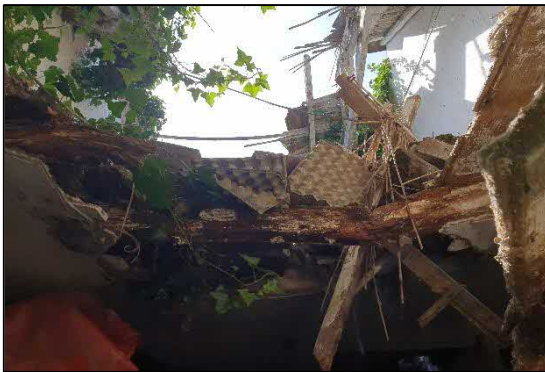
4.2.10 The third room wasn't safe to access, but it could be seen that the whole roof had collapsed (Figure 6).

Figure 6: Room 3 collapsed roof.

2.3.1 There were old barn owl pellets found in room 1 during the initial survey. A barn owl observed entering the central area of the barn (room 3 collapsed roof) and chicks were heard calling in the eastern end (room 5) on the first dusk survey.

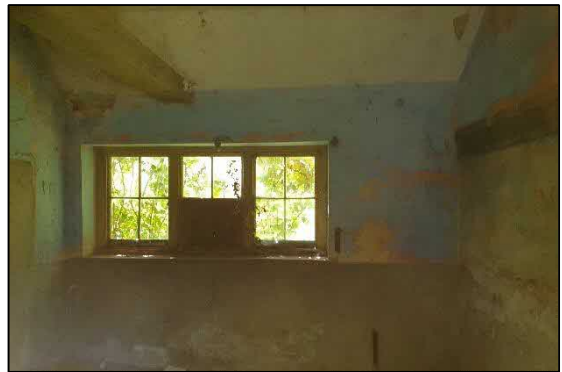
4.2.10 The fourth room had a partially vaulted ceiling which left a low roof void. There were gaps in the ceiling showing a roof lined with loose straw (Figure 7).

Figure 6: Room 4 – boarded ceiling leaving a low roof void.

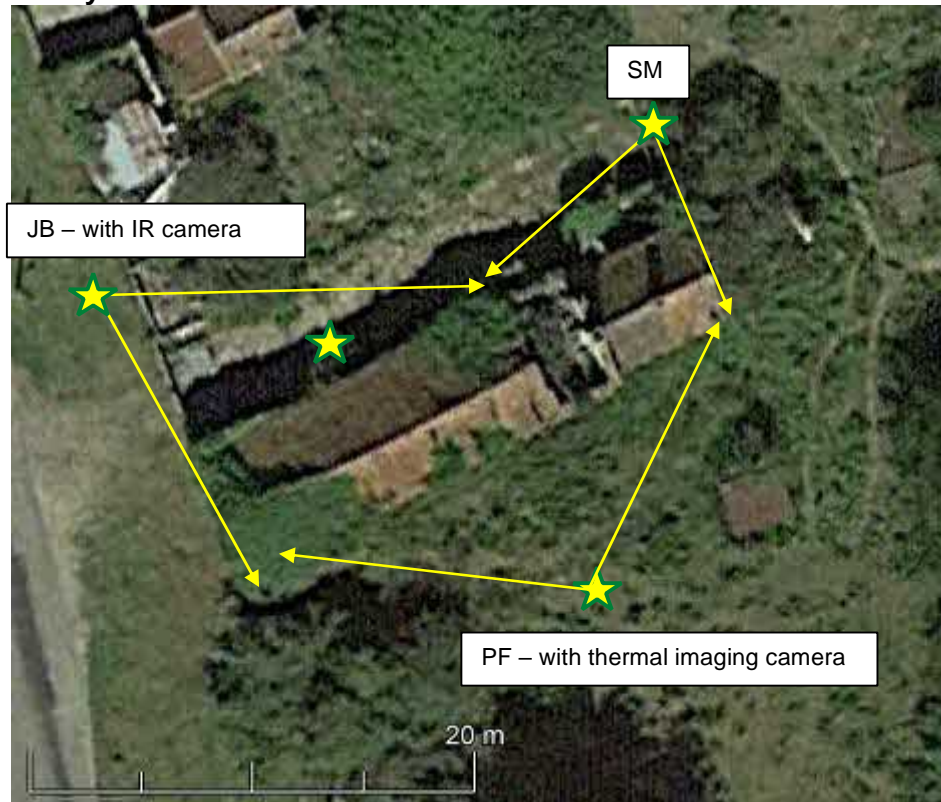
Surveyor Locations:

Dusk survey results – 20<sup>th</sup> July 2022

Sunset: 21.06 - Start time: 20.50; End time: 22:45  
 Surveyors: Sally McColl (SM), Juliette Banwell (JB), Phil Farndon (PF)

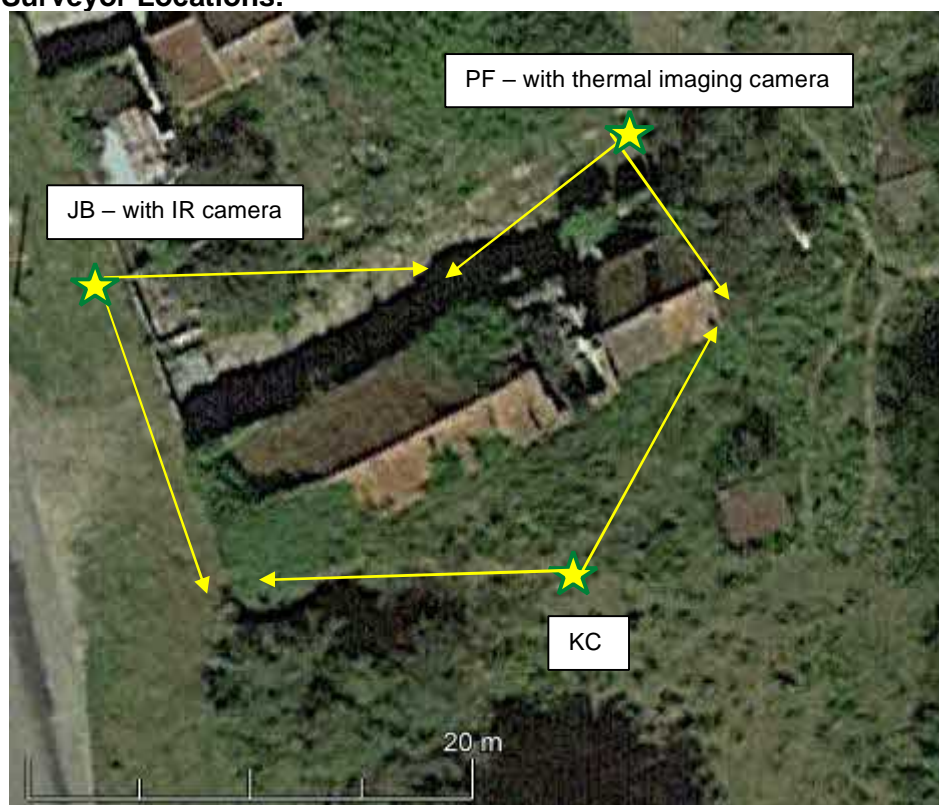
#### Surveyor Locations:

### Dawn survey results – 4<sup>th</sup> August 2022

Sunrise: 05.17 - Start time: 03.10; End time: 05.32  
 Weather conditions: 13°C, BWS 0, dry, 0% cloud cover.  
 Surveyors: Phil Farndon (PF), Juliette Banwell (JB), Keith Cotgrove (KC)

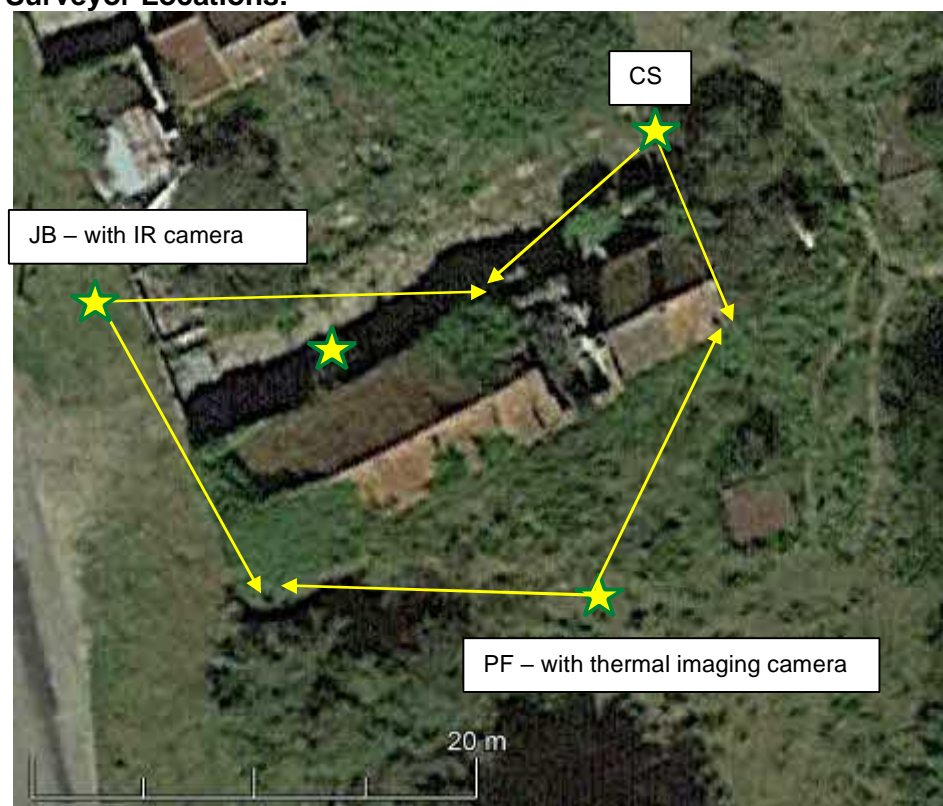
### Surveyor Locations:

## Dusk survey results – 17<sup>th</sup> August 2022

Sunset: 20.17 - Start time: 19.55; End time: 22.50  
 Surveyors: Carolyn Smith (CS), Juliette Banwell (JB), Phil Farndon (PF)

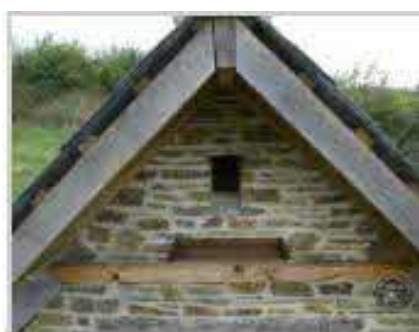
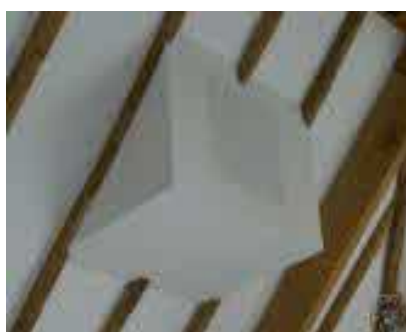
- The internal box depth from bottom of entrance hole to floor of nesting area must be not less than 700mm.
- Floor area of nest chamber: minimum 0.4m<sup>2</sup> (e.g. 500mm x 800mm or 400mm x 1m), ideal size is 1m<sup>2</sup> (1m x 1m).

- Depth from bottom of entrance hole to floor of nesting area must be not less than 450mm provided that there will definitely be an easy-to-grip external exercise platform for fledglings to stand on outside the owl hole.

*Example barn owl access and internal view within vaulted ceiling: Barn Owl Trust, 2022*
