PROTECTED SPECIES (BAT) SURVEY & BAT MITIGATON STRATEGY

OUTBUILDING
AT
ABBEYFIELDS FARM
STATION AVENUE
NEWSTEAD ABBEY PARK
NOTTINGHAM
NG15 8GE

August 2022

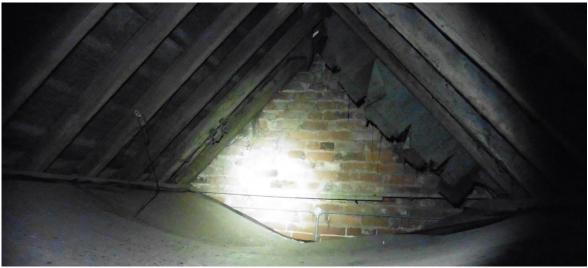
Photograph 4: Attic space at west end of traditional part of outbuilding

The search identified droppings upon this sheet, which remained unmoved, of the shape and size of those typically voided by Brown long-eared bats (*Plecotus auritus*). A scattering of droppings was also found in the attic space at the eastern end of the stables along with the feeding remains of Yellow Underwing moth which is characteristic of gleaning bat species such as Brown Long-eared bats. There is ease of access into the interior of the pitched roof section of the building via the stables at the south elevation. The gaps at the top of the dividing walls means it is possible for a flying animal to access either of the attic spaces.

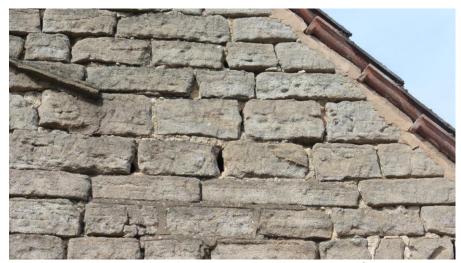
The inspection of the exterior fabric of the building identified gaps in the stonework where the mortar has deteriorated resulting features with potential to support crevice dwelling species such as Common Pipistrelles. At the west gable the timber lintel has shrunk resulting in gaps around the lintel which have potential to appeal to roosting bats. As with the stonework there are areas of deteriorating mortar in the brickwork resulting in crevices.

Photograph 6: East gable with gaps in stonework due to erosion of mortar

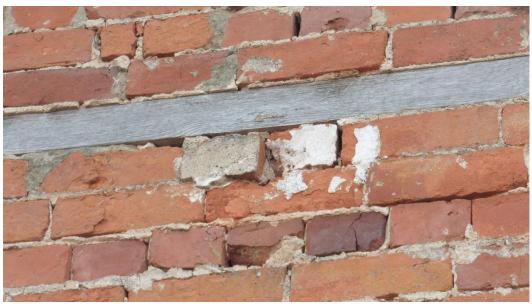
Photograph 7: West gable with deteriorating mortar in brickwork and gaps around timber lintel

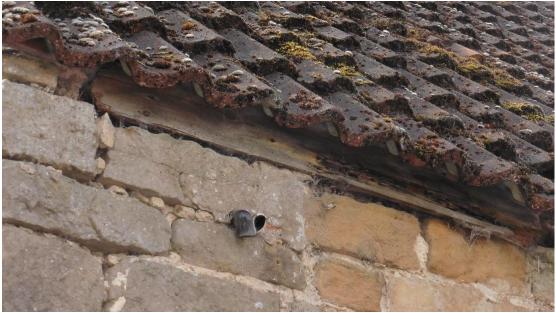
At the north elevation there is a section of exposed timber wall plate of the pitched roof section. This timber has also shrunk resulting in gaps which were cobwebbed at the time of the first emergence and activity survey indicating this feature has not recently been used for roosting purposes.

Photograph 8: Exposed wall timber wall at north elevation

A review of the footage recorded by the digital video camera of the timber wall plate at the north elevation of the pitched roof section found that no bats emerged from this feature during the survey.

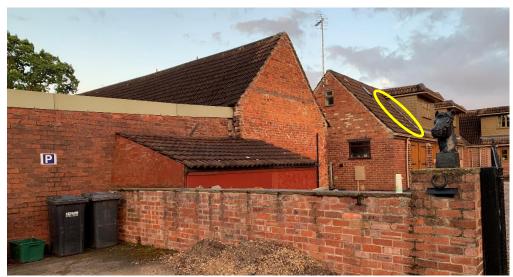
Between 21:04 and 21:11 six bats, all Common Pipistrelle, were observed coming from the former coach and stable yard to the south west of the survey building and either commuting north past the west aspect or over the roof the survey building and heading north east. Three of these bats were observed emerging from a building outside the survey area by the surveyor (AR) positioned at the north west aspect. The roost location is underneath a piece of lead flashing that seals the junction between the dormer window above the garage located at the northern end of the east projection of the converted stables and coach house (see photograph below).

Photograph 9: Location of roost utilised by 3 Common pipistrelles on the adjacent building (outside survey area) 4th May 2022

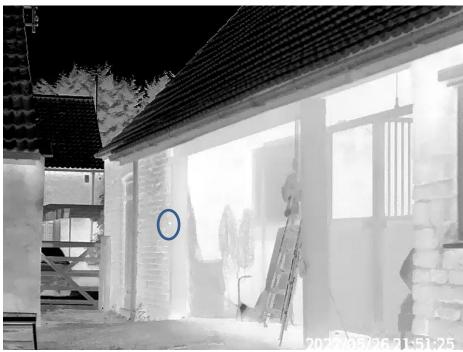
A review of the footage from the thermal imaging camera of the south elevation identified a Soprano Pipistrelle emerging from the west side of the frame of the opening at 21:51. The bat was determined to species level by the echolocation recorded upon emergence by the surveyor (PC) positioned at the south east corner of the outbuilding.

Photograph 10: South elevation of outbuilding at Abbeyfields farm with location of day roost of Soprano Pipistrelle indicated as identified during bat emergence and activity survey 26th May 2022

It is the conclusion of this report that based on the results of the bat emergence and activity surveys that the pitched roof section of the outbuilding supports day roosting by an individual Soprano Pipistrelle.

The survey can say conclusively that as a minimum the redevelopment of the outbuilding to residential use will result in the disturbance and the destruction of a roost site used by an individual Soprano Pipistrelle and consequently an EPS licence will be required in advance of works to the traditional pitched roof section of the outbuilding. An application for an EPS licence can only be issued by Natural England once planning permission has been granted and all conditions relating to wildlife species have been formally discharged.

The removal of any roof coverings and the bitumen roofing membrane are to be supervised by a licensed bat worker, likewise the cart door frame and the brick work surrounding the cavity used by the bat for roosting must also be dismantled with great care and by hand and under the supervision of the bat ecologist. Any bats found during this process are to be transferred by hand to the timber bat box by the licenced bat worker.

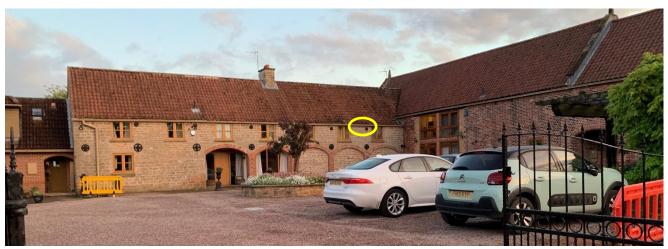
A roost site was located in the converted coach and stable block situated to the south west outside the survey area. The roost location is indicated in the photograph below. Approximately 43 Common Pipistrelle bats emerged from this area during the survey. This number of bats utilising a single roost during summer is characteristic of a maternity roost.

Photograph 11: North elevation of converted coach house and stables situated to the south west of the survey area with location of Common Pipistrelle maternity roost indicated as per bat emergence and activity survey 26th May 2022

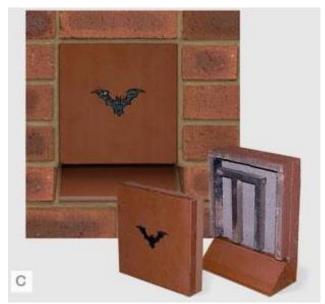
Figure 1: An example of an enclosed bat box, Ibstock bat box C

To conserve the bat species roosting at the site it is recommended that two enclosed bat tubes are installed in the exterior walls of the redeveloped building. The bat tubes will provide an enclosed roosting environment. An example of an Ibstock enclosed bat box is provided below, other makes and finishes are available. The facade of the box is to sit flush with the exterior wall as such a bat can land on the wall below and crawl up to the access slot. The box locations must be agreed with the ecologist before installation and should include a box on the south to southwest side and west to north sides of the building, as the final elevations allow.
