Environmental Phase 1 Report

Construction of single dwelling-house
in
garden to 5 Ayre View, Old Town, Hebden Bridge
HX7 8SX

Date: 10th March 2020

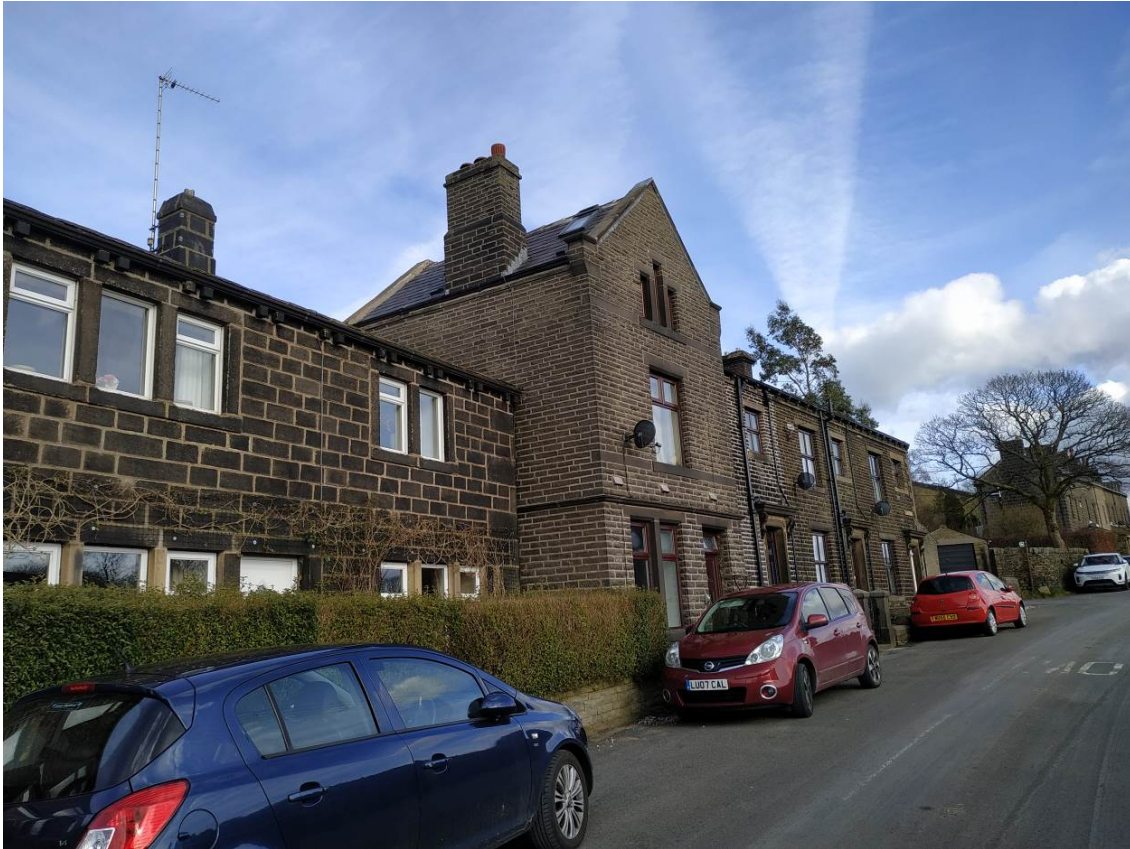
P1 Left to right: No.s 5 to 1 Ayre View fronting onto Akroyd Lane

2.1. Nos 1 to 6 Ayre View Comprise a row of 2 storey sandstone terraced houses variously constructed during the nineteenth century on the north side of Akroyd Lane.

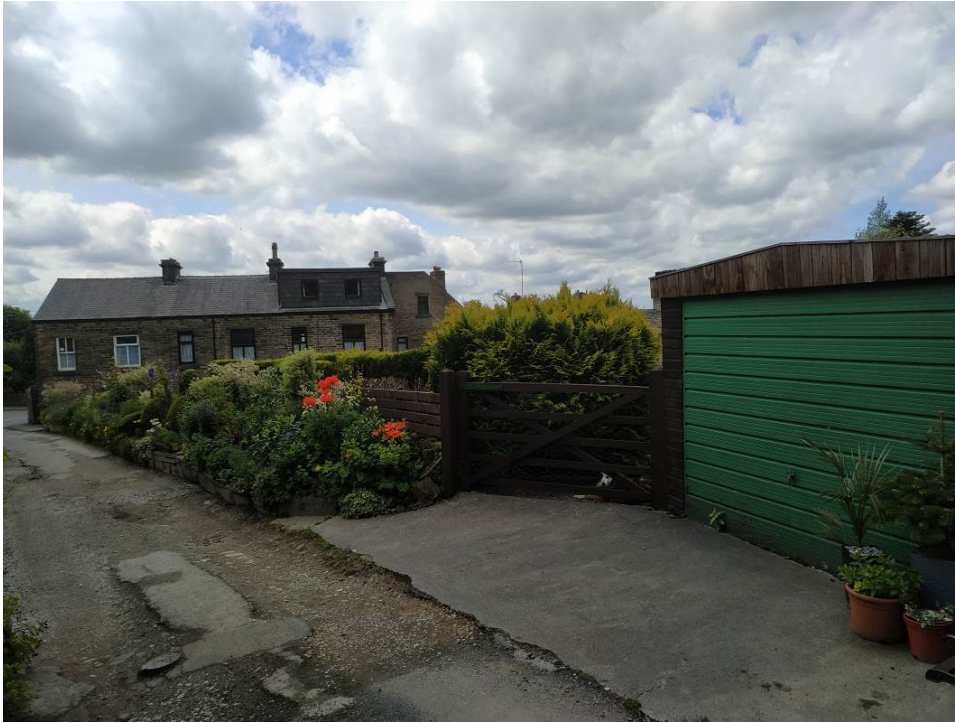
P2 Wainsgate Lane, looking south at backs of No.s 1 to 4 Ayre View and with subject site access and garage in foreground.

2.3. The subject site has a frontage with Wainsgate Lane on the east side where there is both an existing vehicle entrance and a garage admitting onto the Lane.
