DESIGN, ACCESS & HERITAGE STATEMENT

Manor Farm Cottage, Bell Hill, Norton St Philip, Bath BA2 7LT

October 2022

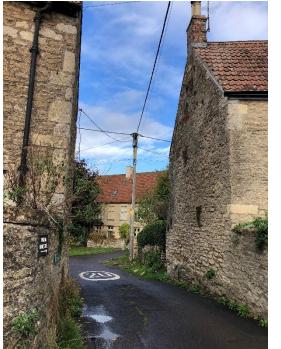
Fig.05 View looking towards Manor Farm House

- 3.01 Manor farm Cottage and Corner Cottage frame the view of Manor Farm House and entrance to The Barton from Bell Hill. This area has mature trees, stone boundary walls and small open areas of grass, see Fig.05.

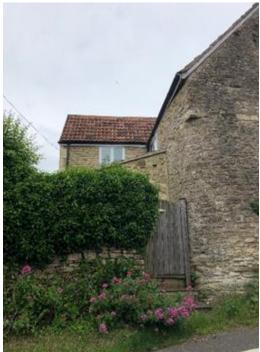
Fig.06 Manor Farm Cottage stepped access and collection point for wheeled bins and recycling

- 3.02 There is an existing gate opening with stepped access positioned at the rounded north-west external corner of Manor Farm Cottage. The gate is positioned within the narrowest part of the road between Manor Farm Cottage and Corner Cottage where traffic passes close to the wall and steps. This is the route used by the residents of both Manor Farm Cottage and the adjoining neighbours in Red Hill Cottage to put out their wheeled bins and recycling boxes for collection and for taking bicycles to and from the properties, see Fig.06.

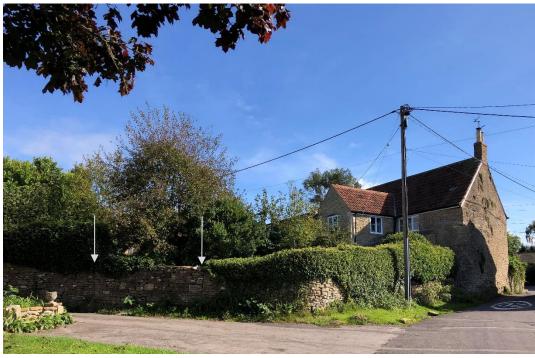
Fig.07 View of stone boundary wall with signs of previous opening indicated

- 3.03 The existing drystone boundary wall to Manor Farm Cottage garden contributes to the character of the space. There are two continuous vertical joints visible within the garden wall which suggest that there was a wide gate opening at some time, see Fig.07. This opening would lead onto the drive for Manor Farm House.

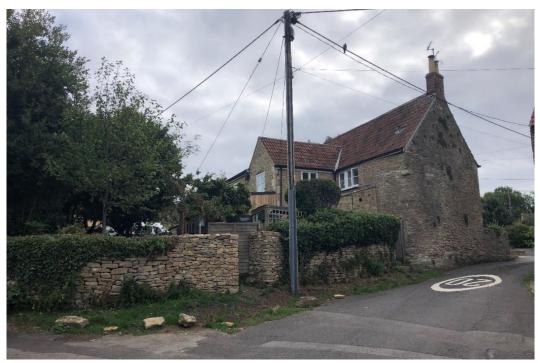
Fig.08 New opening within stone boundary wall with ramped access/egress on to the grass verge

5.01 The new opening within the stone boundary wall offers a ramped access/egress for bicycles, wheeled bins and recycling on to the grass verge. The existing gate opening will be infilled with stone to match the existing boundary wall in respect of type, colour and texture. The new wooden gate will be in keeping with the cottage and be a positive addition to the immediate area.

6.01 The relocated gate opening, and new timber gate will not significantly affect the character of the space. The walling material remains as existing, and a new good quality wooden gate would be in keeping.

7.01 The proposals have minimal impact on the external appearance of the property or the character of the immediate surroundings. The new gate opening position offers a safer exit on to a wider section of verge and a significant improvement to the accessibility of the garden and the weekly movement of wheeled bins and recycling for the owners of both Manor Farm Cottage and adjoining Redhill Cottage.
