Project: THE MALTINGS, WEYBOURNE, NORFOLK NR25 7SY.				
Subject: EXTERNAL ELEVATION.				
Scale: 1 : 100.	Date: May, 22.	Project Ref: TM.	Drwg. No.: 232.	Rev.:
Architects: Big Brown Dog Limited		The Old Post Office, Brookside, Dalham, Suffolk CB8 8TG		
T: 01638 500234	F: 01638 500343	E: bigbrowndog@keme.co.uk		
Original size: A2				© BIG BROWN DOG LIMITED

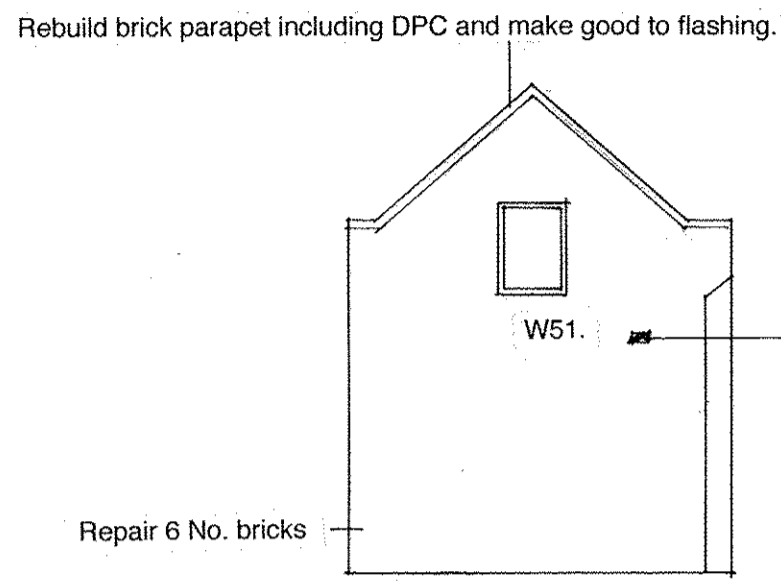
SIDE COTTAGE EASTERN END ELEVATION

Remove existing sign and all wiring
Black LED floodlight on PIR.

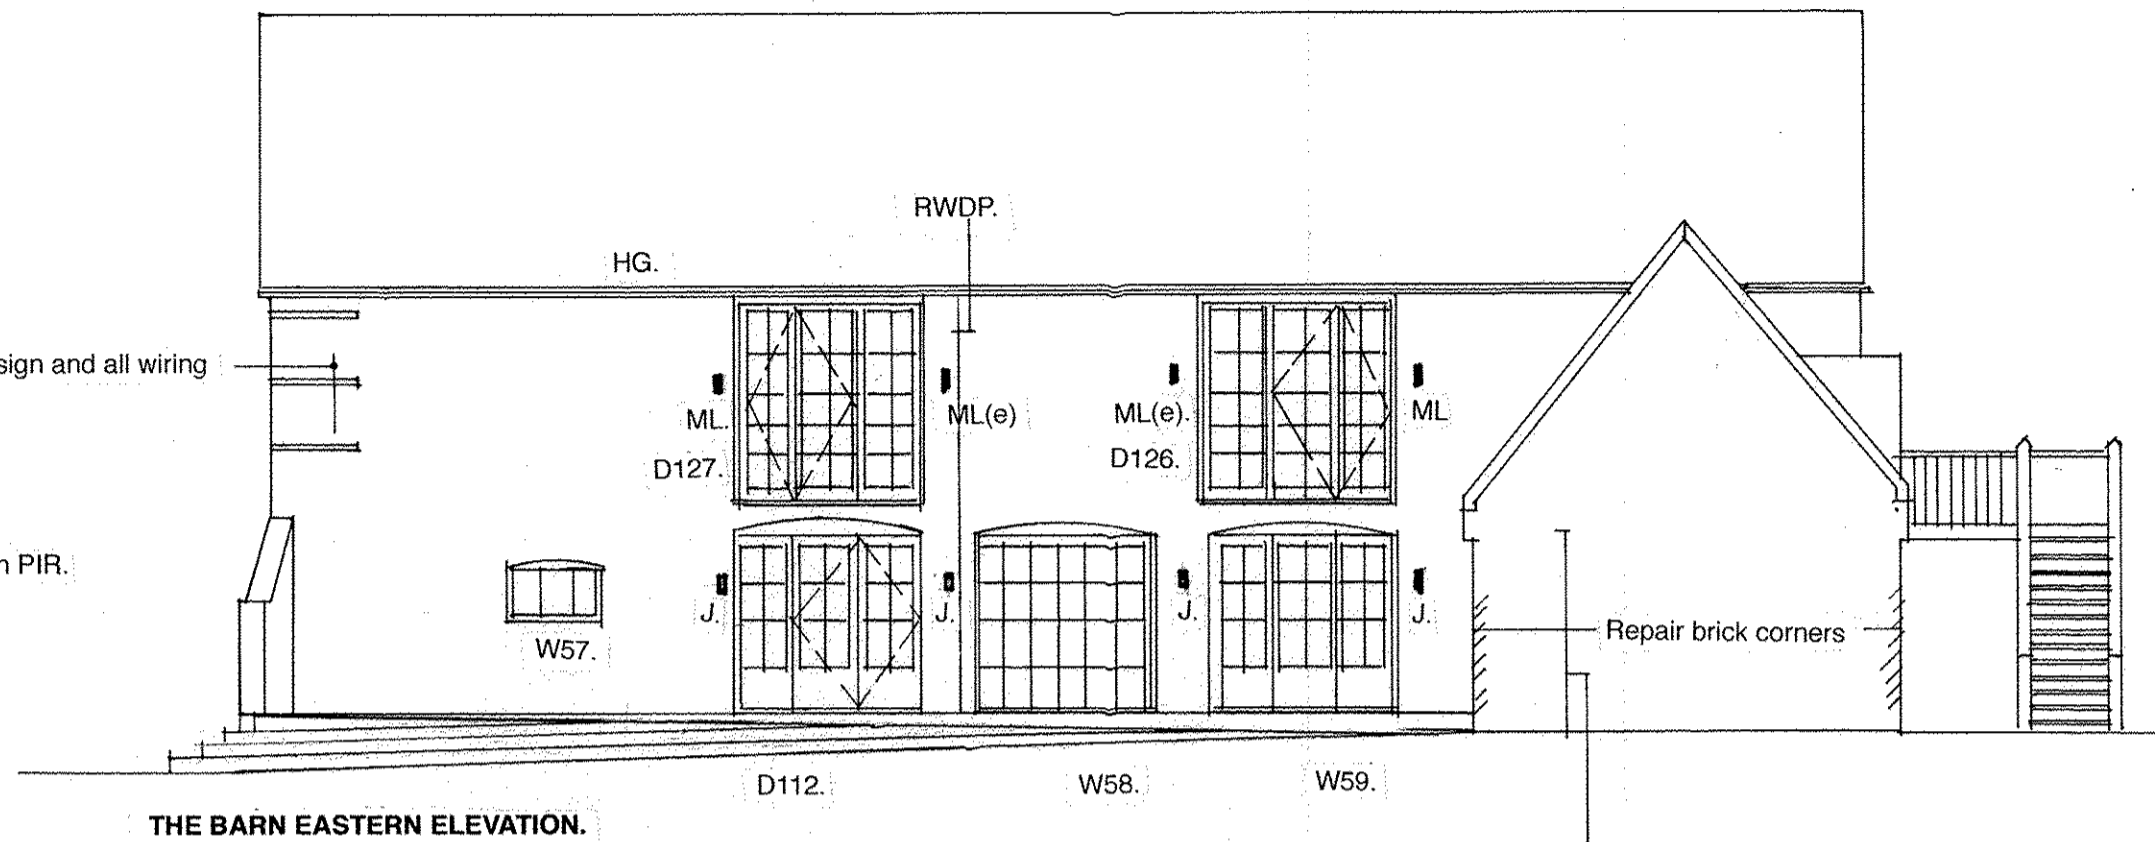
THE BARN EASTERN ELEVATION.

Remove vent pipe and make good building fabric.

Remove existing pantiles, battens and felt
Check for rafter and eaves soffit condition and report as necessary
Supply and install new 100mm Celotex insulation between the rafters, proprietary breather membrane, 50 x 25 tantalise tile battens and install recovered pantiles and ridge tiles. Include for all flashings and soakers to the gable ends.

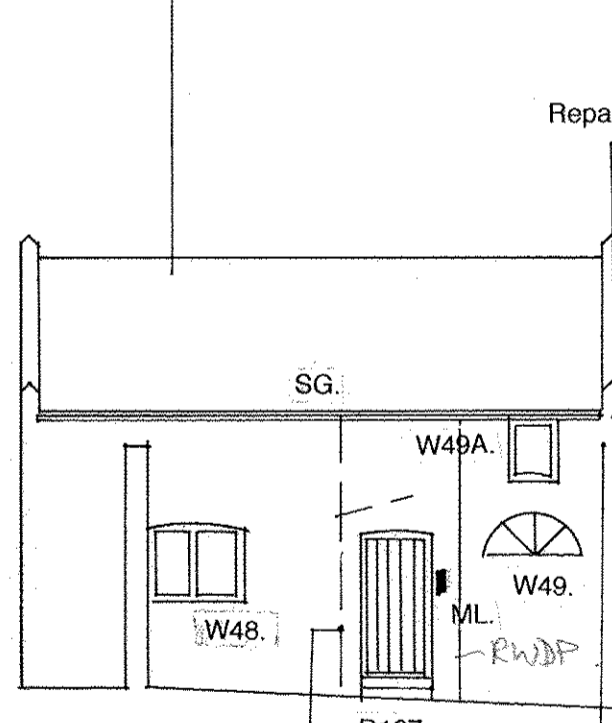
SOUTH ELEVATION.

Repair 'pulled' brickwork

Remove all wires and cables

Existing waste removed and rebuilt internally

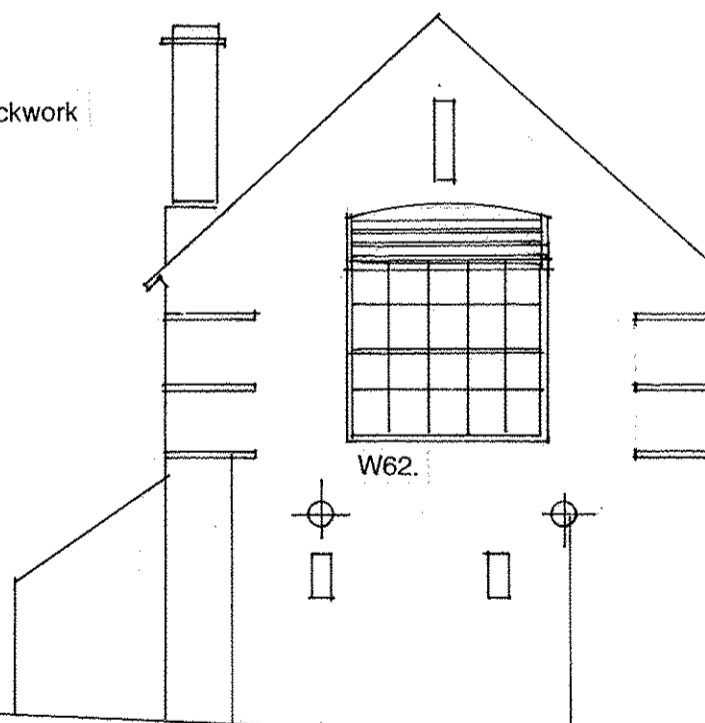
THE BARN.

Strengthening plates refer to structural engineers details

Remove existing first floor link structure
Install a 1800mm high close boarded fence

Repair brickwork

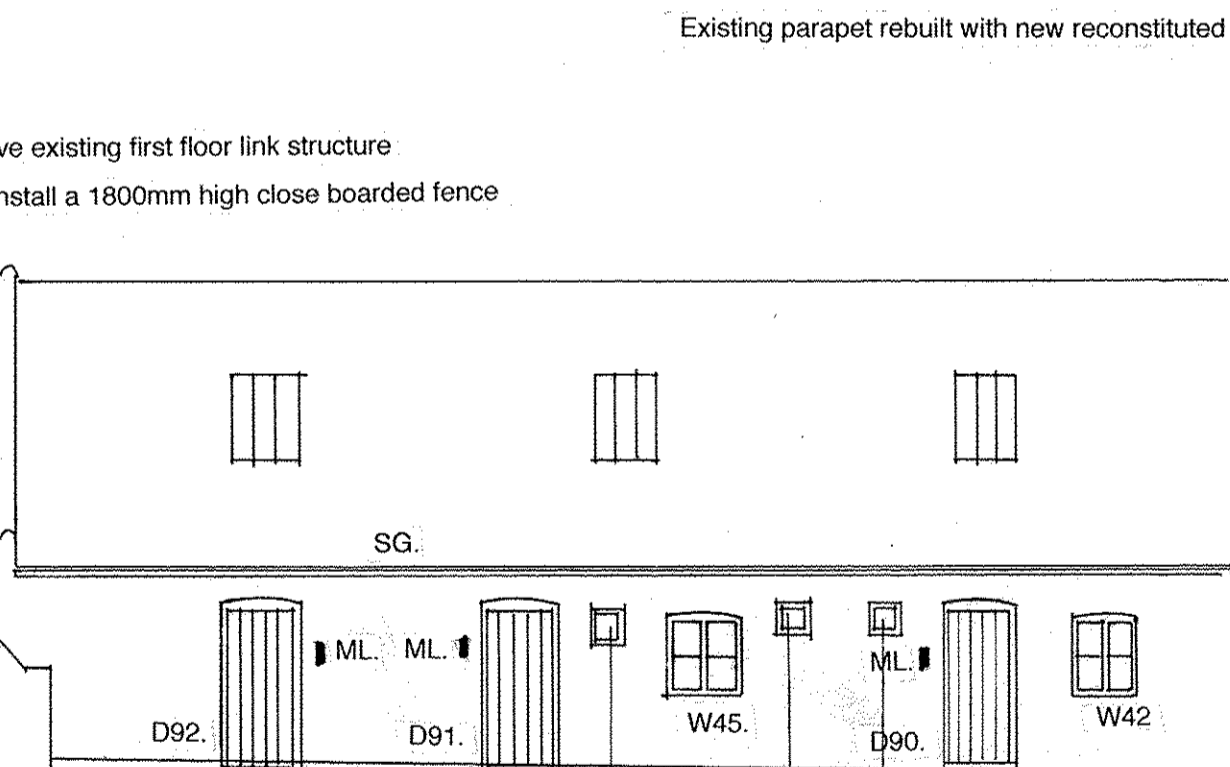
STABLE

Existing parapet rebuilt with new reconstituted stone coping parapet to match existing.

Line of existing lean to roof structure to be carefully removed

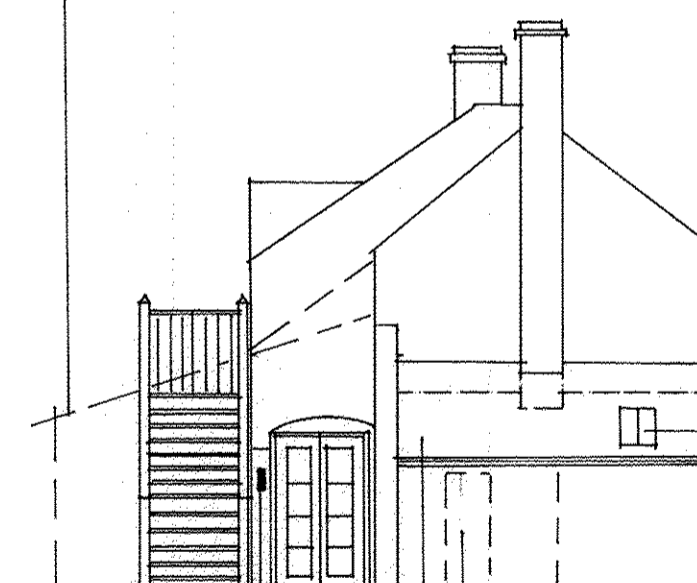
REAR BUILDING

Carefully remove existing roof and rebuild a new lean to roof structure including the additional bathroom
Approximately 400mm higher to accommodate the first floor waste connection internally.
Remove door and frame and block up.
Apply a 2 No. Coat sand cement render.

J JURA TWIN Wall mounted up / downlight code 7809 in antique brass by Astro Lighting
