ECOLOGICAL IMPACT ASSESSMENT
and Bat Activity Survey

The Cloggau,
Newchurch,
Powys

A Report for
Mr & Mrs C. Rogers

Report Information	
Project name	Ecological Impact Assessment and Bat Activity Survey for The Cloggau, Newchurch
Project reference:	KG2021/057
Status:	Final Date of Issue: 17 th October 2022
Produced by:	Katie McMinn BSc (Hons) MCIEEM
Reviewed by:	Joseph McMinn MSc MRSB
Prepared for:	Mr & Mrs Rogers

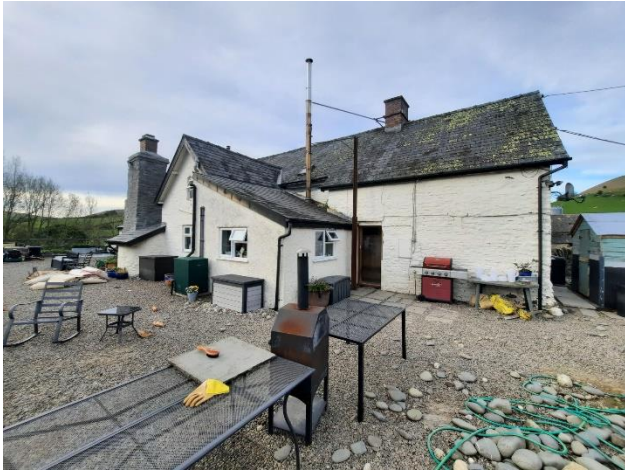
Plate 1: Southwest elevation.

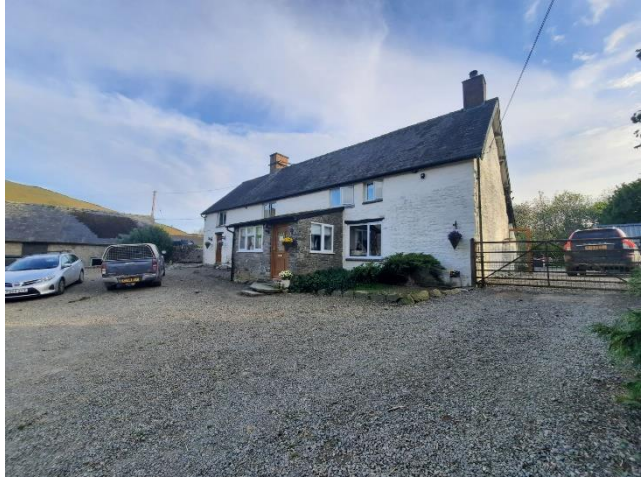
The Site is a detached farmhouse with farm buildings located against the east of the house. The farm buildings are a mixture of traditional stone and timber barns and modern agricultural buildings. The Site is set within a managed garden with lawn off the southwest and northwest elevations. There is patio slab against the southwest elevation and southeast gable with gravel against the northeast elevation and northwest gable.

Plate 2: northeast elevation showing gravel driveway.

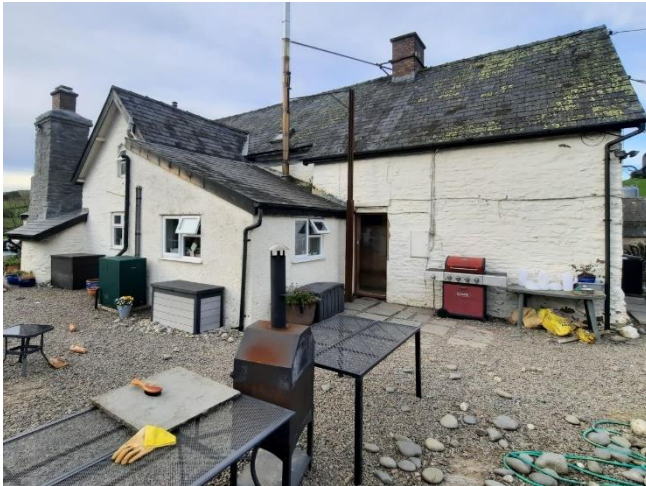
The southwest elevation has open eaves leading onto the wall plate (Plate 3). There are large cavities allowing access onto the top of the wall. The northeast elevation has overhanging eaves sealed with a timber board, the timber has a tight seal to the stonework and roof features without gaps (Plate 4). Both gable ends have six exposed purlin timbers and ridge timbers fitted with an overhanging bargeboard (Plate 5). There is a tight seal between the stonework and soffit. There is a tight fit between the roof tiles and bargeboards.

1970's ground floor lean-to: The lean-to is clad in slate. The tiles are intact and in place. There is a tight seal between the rendered walls and bargeboards of the roof. The roof tiles have a tight fit to the bargeboards, except for a single tile against the ridge tiles. The ridge tiles are in place and without gaps. The windows have a tight fit to the rendered walls.

Plate 3: Southwest elevation showing 1970's extension. Plate 4: Northeast elevation.

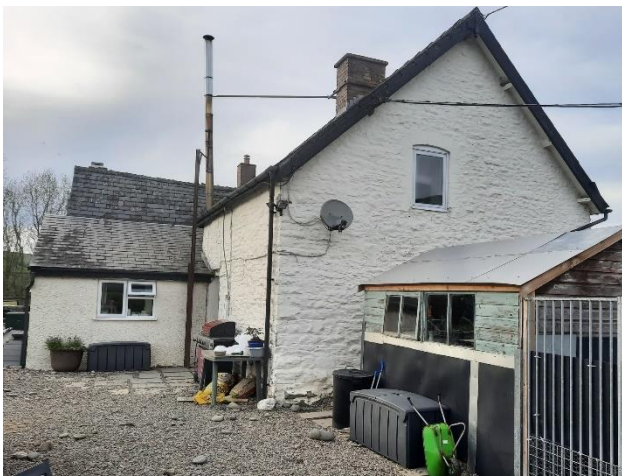
Two storey extension: The extension has a pitched roof clad in slate. The tiles are intact and in place. The ridge tiles have gaps leading under some sections. At the gable end there is a tight seal between the painted stonework and soffit timbers. There are gaps between the bargeboards and roof tiles.

Plate 5: Southeast gable end and 1970's extension. Plate 6: Main loft space showing timber frame.

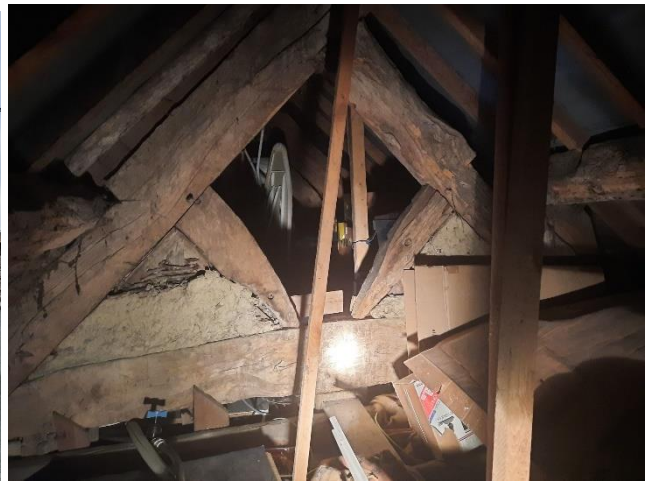
The loft is insulated throughout the northern section and partly boarded for storage. The south section, beyond the central chimney was not insulated. The roof is supported by a three original timber with a tie beam and struts supporting the main rafters. One frame has wattle and daub between the strut and rafter timbers (Plate 6). The timbers have tight joints. All timbers and the loft void had cobweb and debris cover.

The loft is clad in a breathable roofing membrane and appears intact.

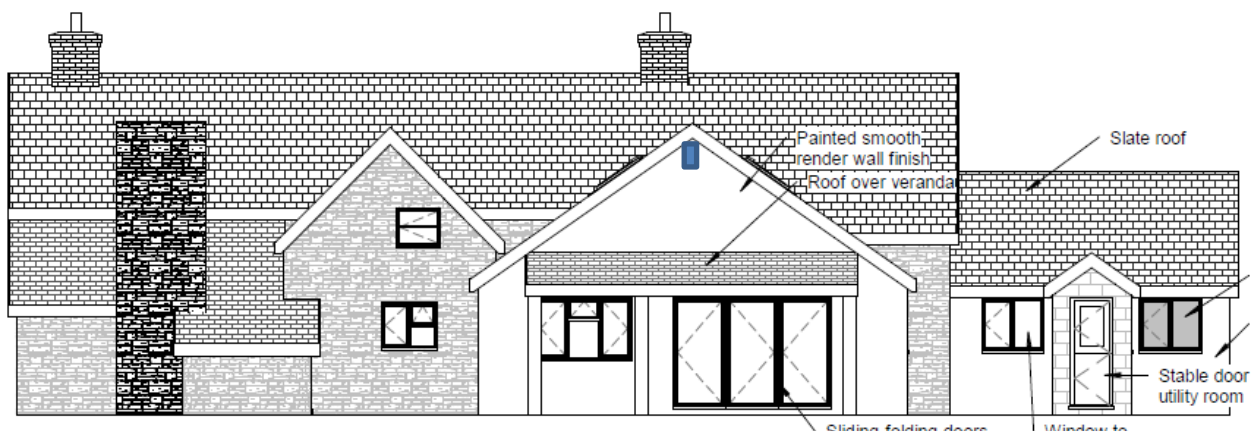
Figure 2: Southwest elevation and extension gable showing proposed bat box location (blue box).

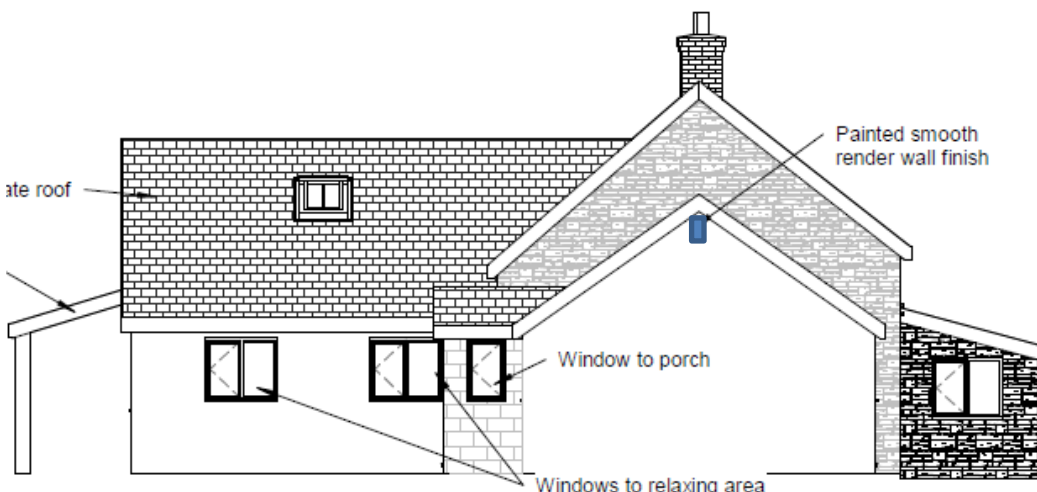
Figure 3: Southeast gable and extension gable showing proposed bat box location (blue box).
