## 107 Charlestown Road, St Austell

Design, Access & Heritage Statement and  
Validation Checklist

This Design, Access & Heritage Statement and Validation Checklist is written in support of an application to Cornwall Council for planning, conservation area and listed building consent for alterations to and extension of **107 Charlestown Road, St Austell**.

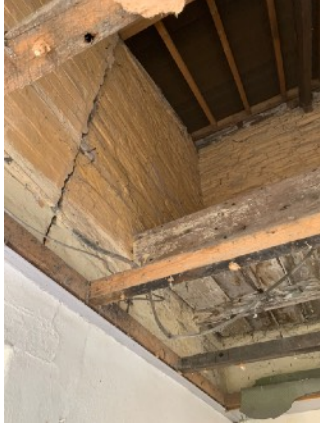
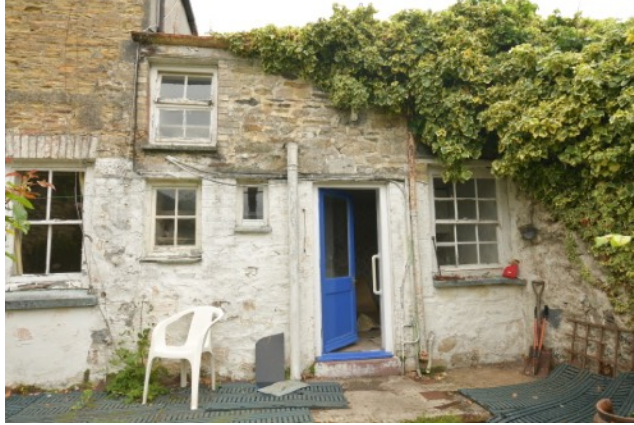
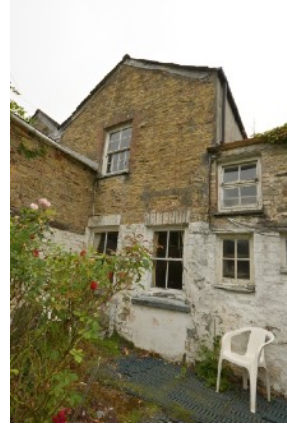
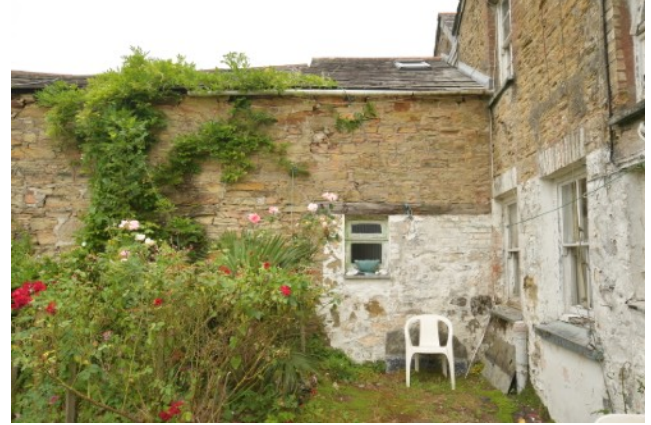
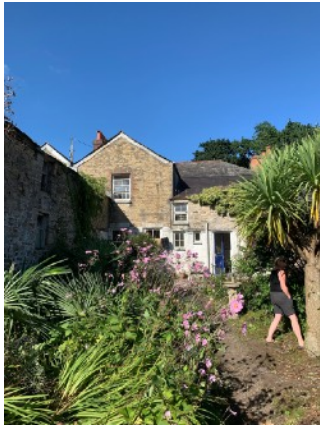
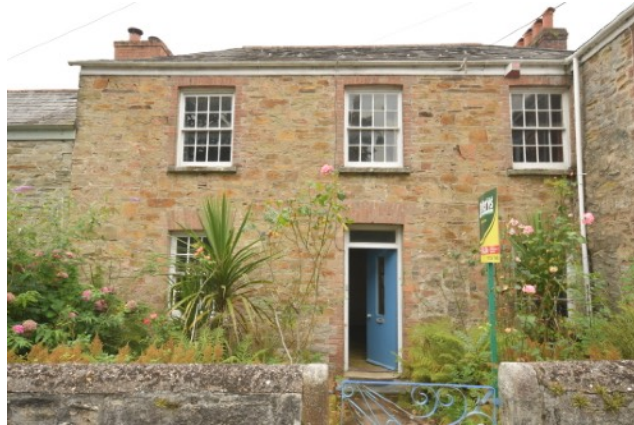
## Site Photos

Examination of timbers in the catslide roof infill between the right hand rear projection of 107 and the rear facade of 105 suggest that this element has been rebuilt in relatively recent times (see *Site Photographs* below).

The wall thicknesses of 107 Charlestown Road suggest that the original and primary building was 'L' shaped; a rectangular form with projecting rearward wing to the West. The area between the projecting wing and 105 Charlestown road is of separate and later construction, with examination of the roof timbers showing that this has been rebuilt several times with a catslide roof that attaches below the line of the primary and original hips. The absence of bonding between the infill and the thicker walls of the original house support this interpretation, as does the ramshackle collection of windows and lintels.
