**107 Charlestown Road, Charlestown, St. Austell, Cornwall PL25 3NL**

**Bat Survey - Preliminary Roost Assessment**

4<sup>th</sup> November 2022

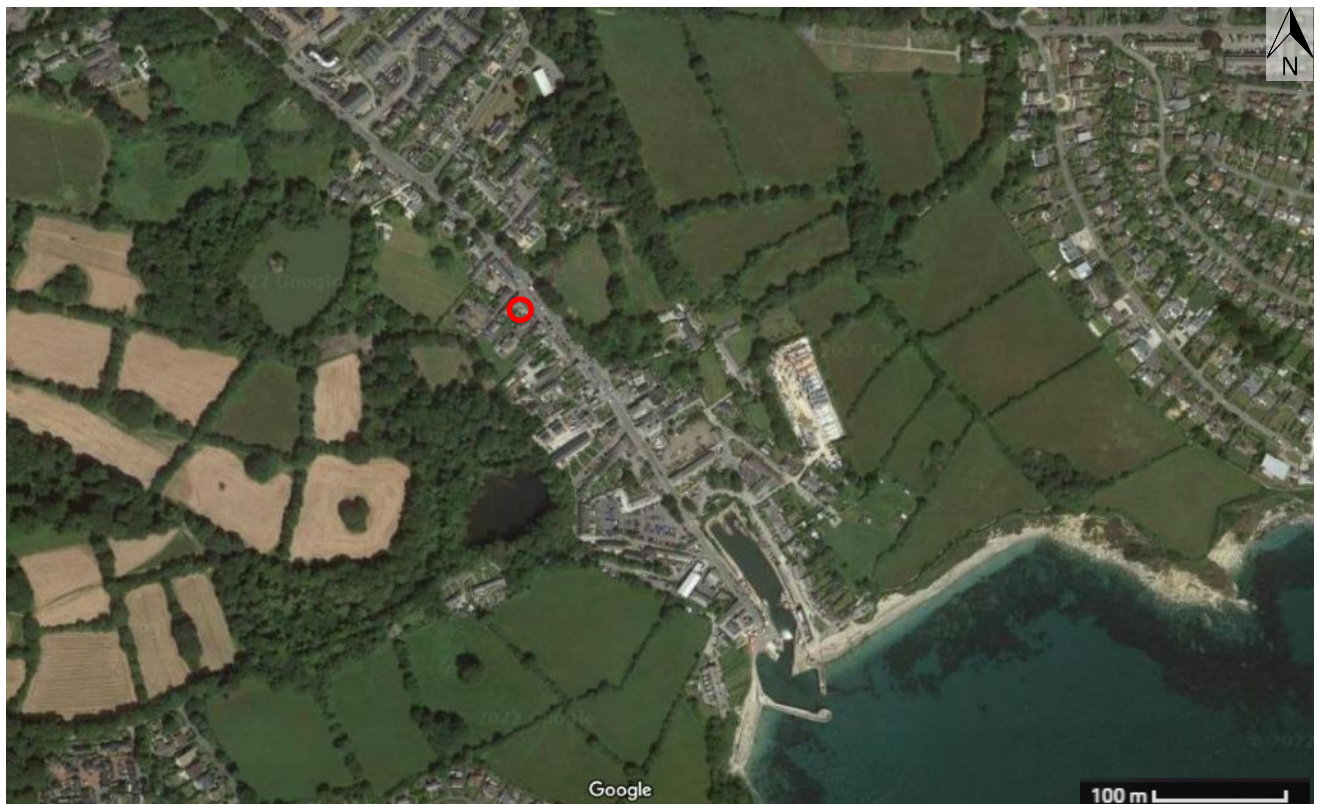
Figure 1: Aerial photo of site, showing landscape structure

A review of aerial photographs (Figure 1) and OS maps shows how the site is situated in relation to the wider landscape.

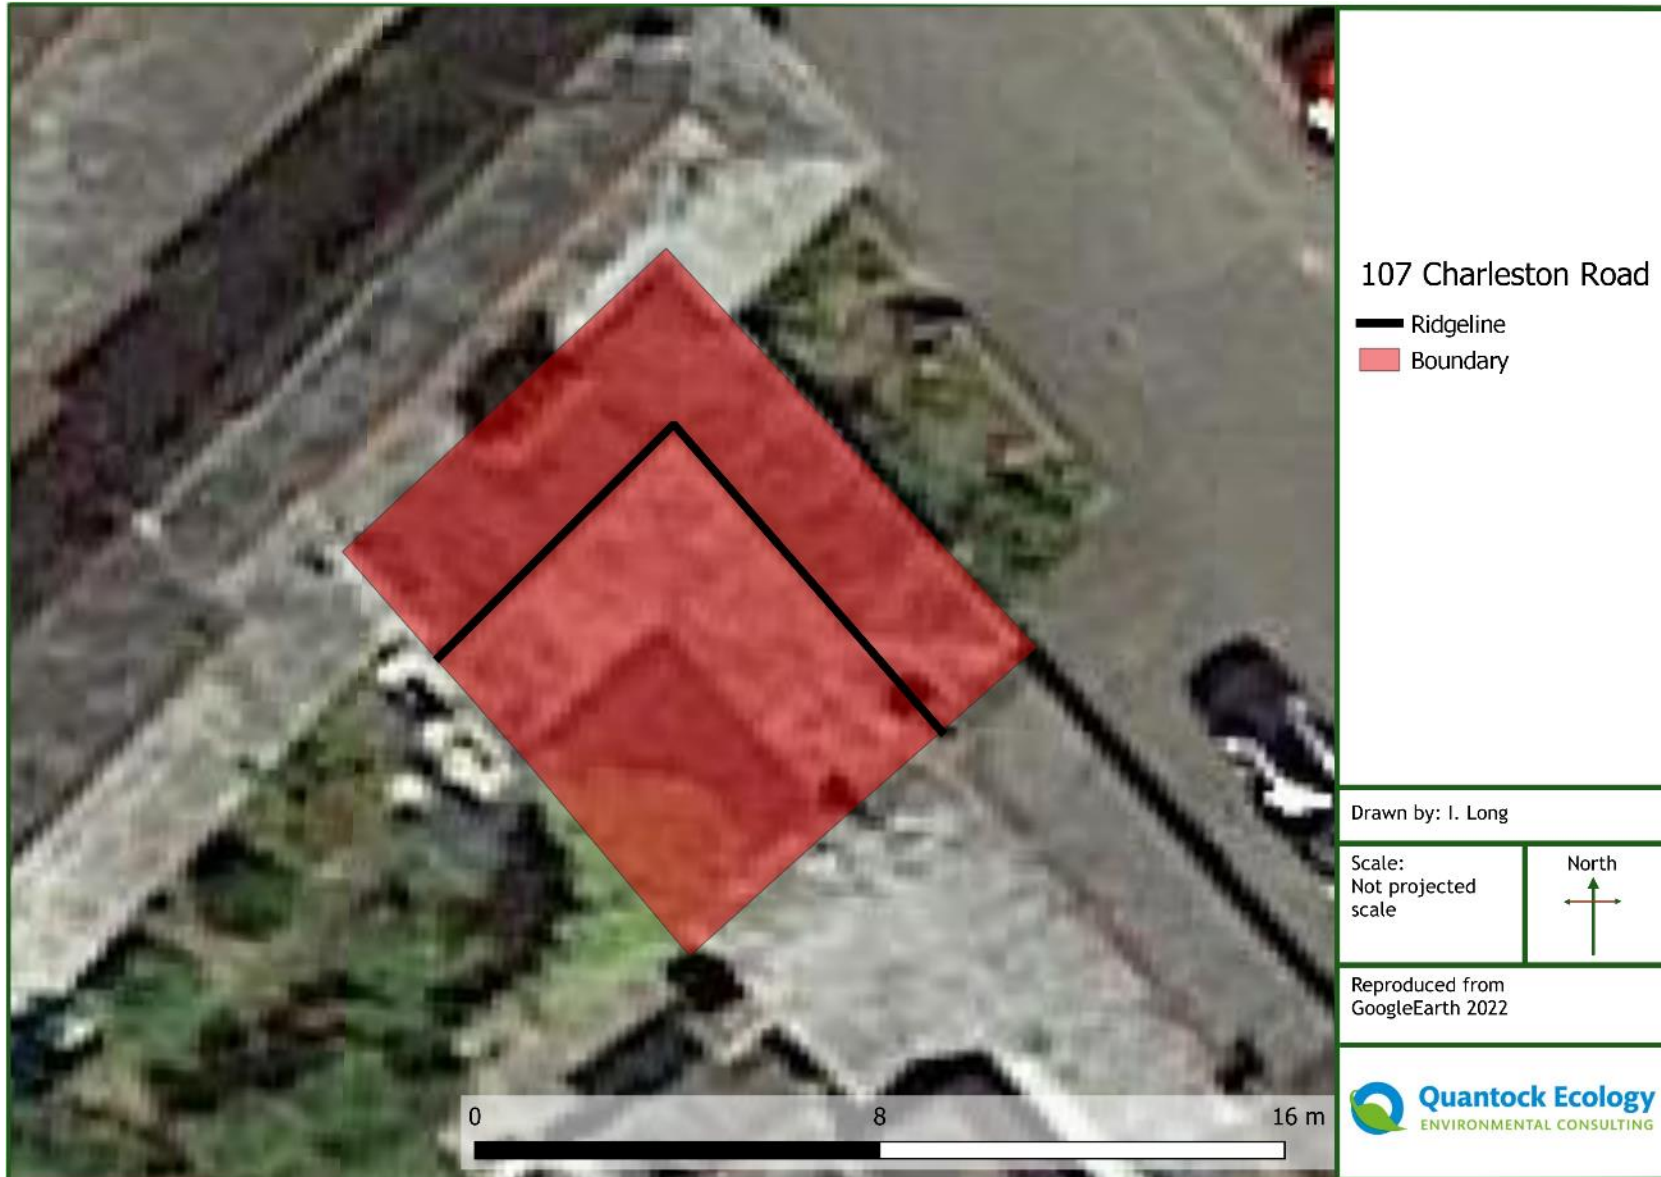
### Appendix 1: Survey Plan

The building within the survey area comprised a stone built dwelling that had no main roof. The structure is referenced, as illustrated in the map in Appendix 1.

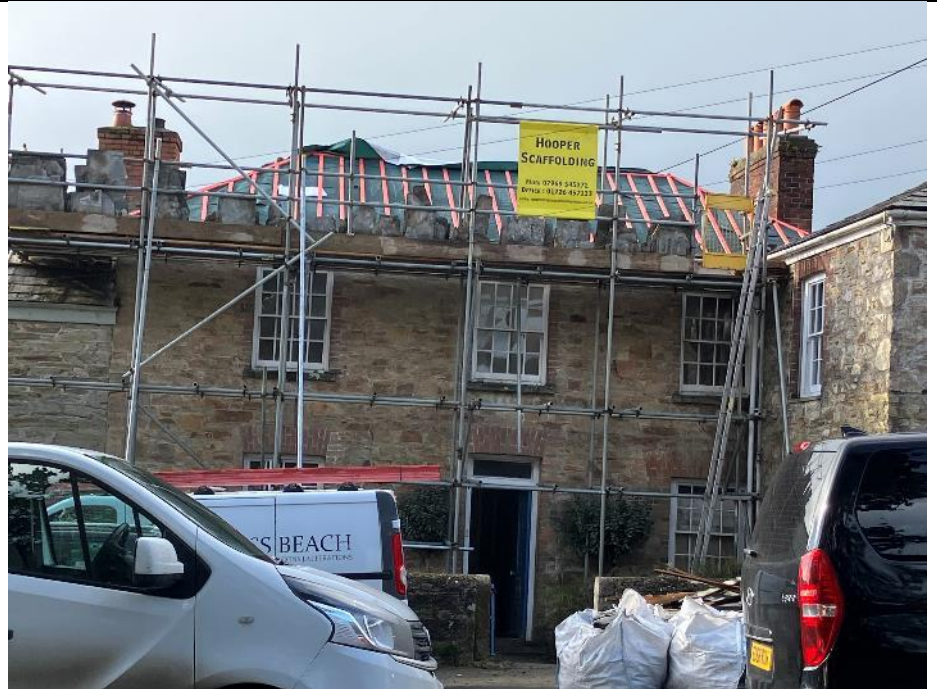
Photo 1: Showing the front elevation of the building.

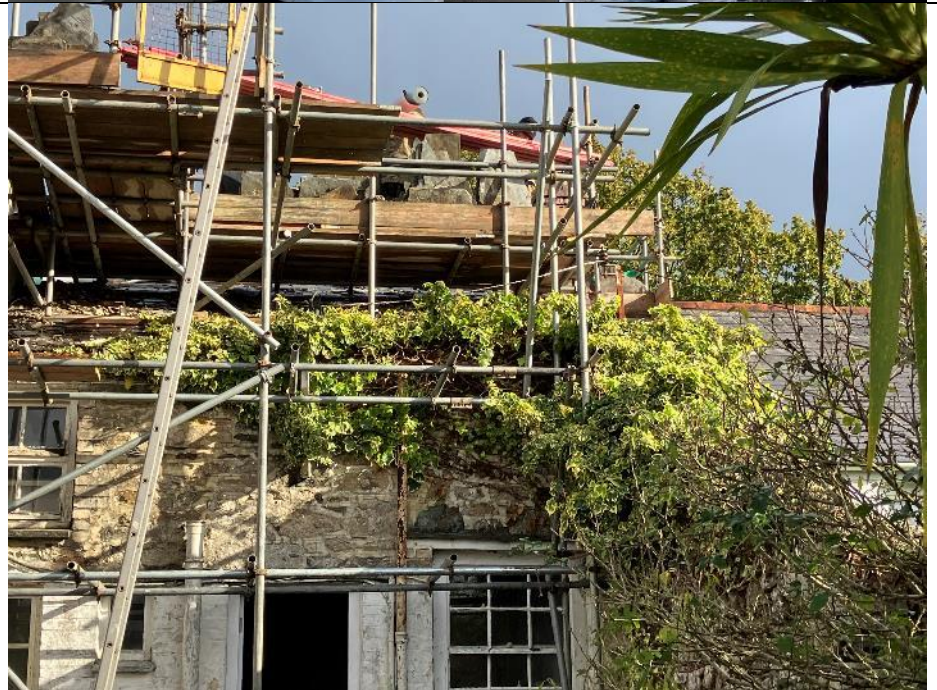
Photo 2: Showing the extension at the rear elevation of the building. Although some tiles remained on this elevation, they were tight fitting and no gaps were identified in which bats or birds could access the building.

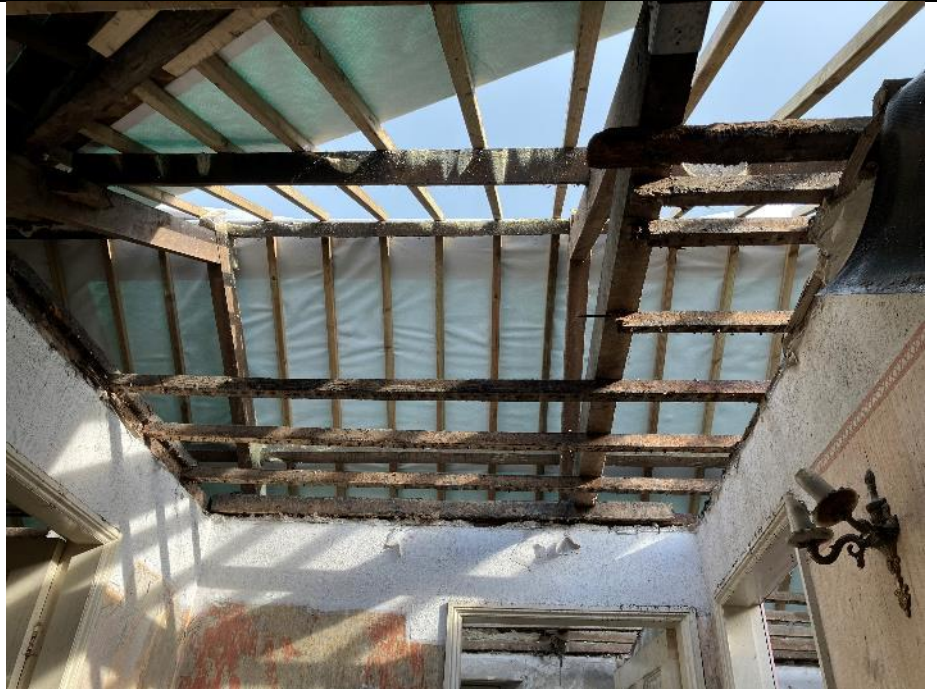
Photo 3: The building was inspected internally and due to ongoing re-roofing was mostly exposed to the elements creating a bright and draughty atmosphere.

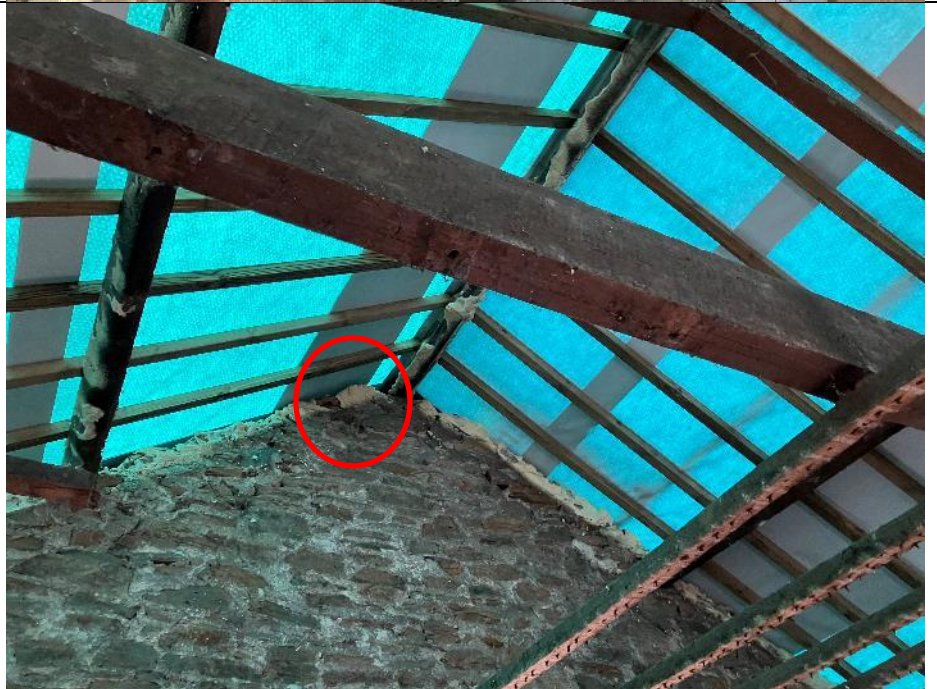
No evidence of bats, such as droppings, urine staining and discarded insect wings/casings were noted during the survey. Any gaps identified during the survey had been previously filled with expandable foam, preventing access into the building by bats or birds (see Appendix 3, photo 4).

Photo 4: No gaps were identified that bats or birds could access the building. Any gaps present were filled with expanding foam including at both gable ends.

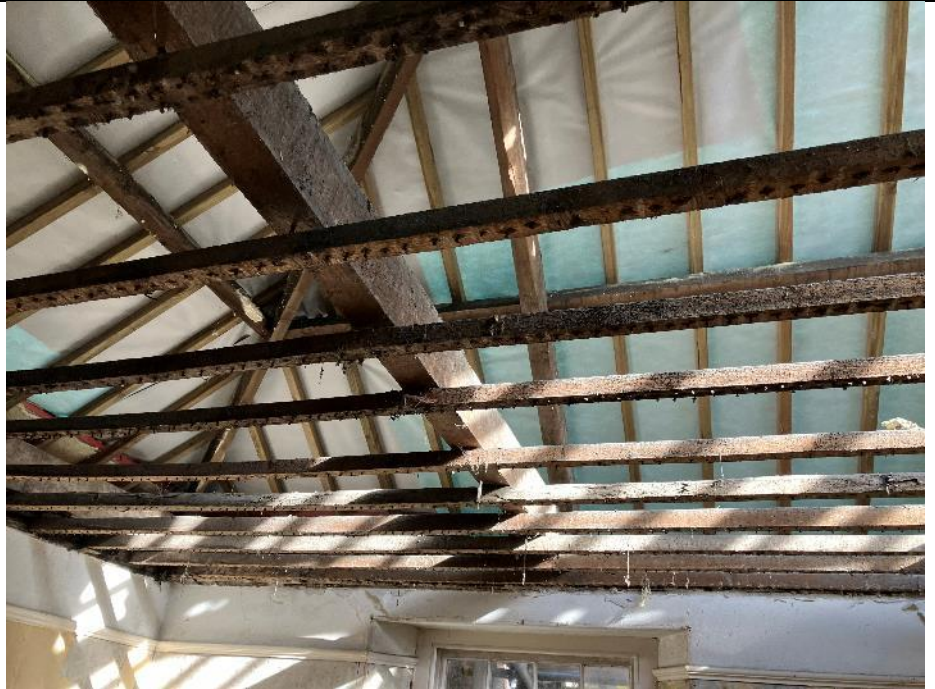
Photo 5: Showing the roof exposed from all elevations.

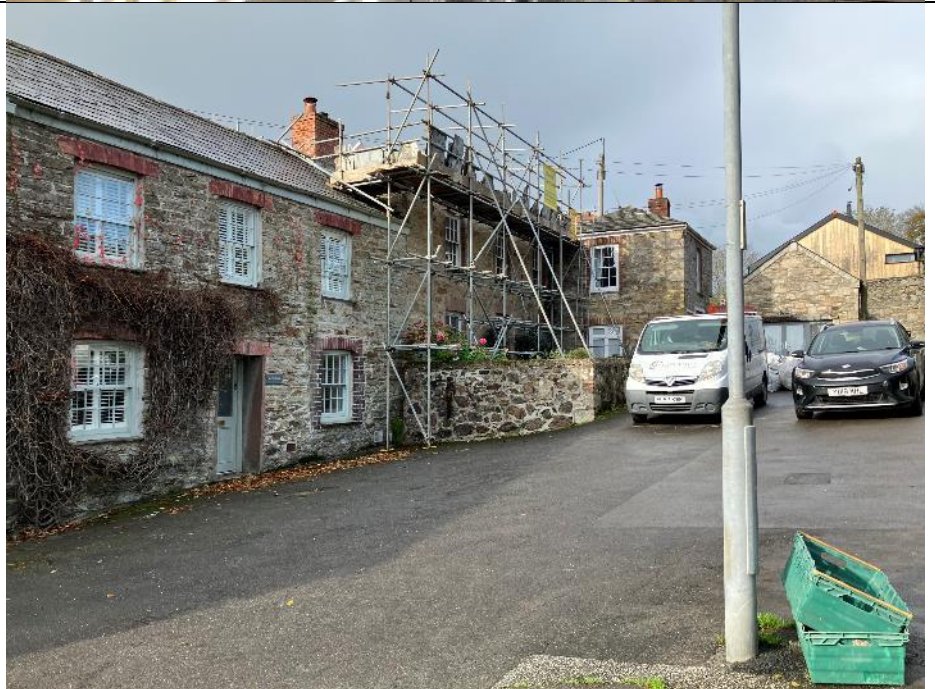
Photo 6: The front elevation of the building showing its mid terrace positioning.
