# NEWLANDS FARMHOUSE

NEWLANDS FARM, NEWLANDS LANE,  
PURBROOK HEATH, HAMPSHIRE, PO7 5SH

REPAIR AND REPOINTING OF BRICKWORK AS ALTERNATIVE  
TO LIME RENDERING, BLACK FLUE AS ALTERNATIVE TO  
CHIMNEY ON BAKEHOUSE APPROVED UNDER PREVIOUS  
CONSENTS. TILE HANGING TO GABLE ENDS AND PARTIAL  
REBUILDING OF CHIMNEYS.

DESIGN AND ACCESS STATEMENT  
INCLUDING HERITAGE STATEMENT

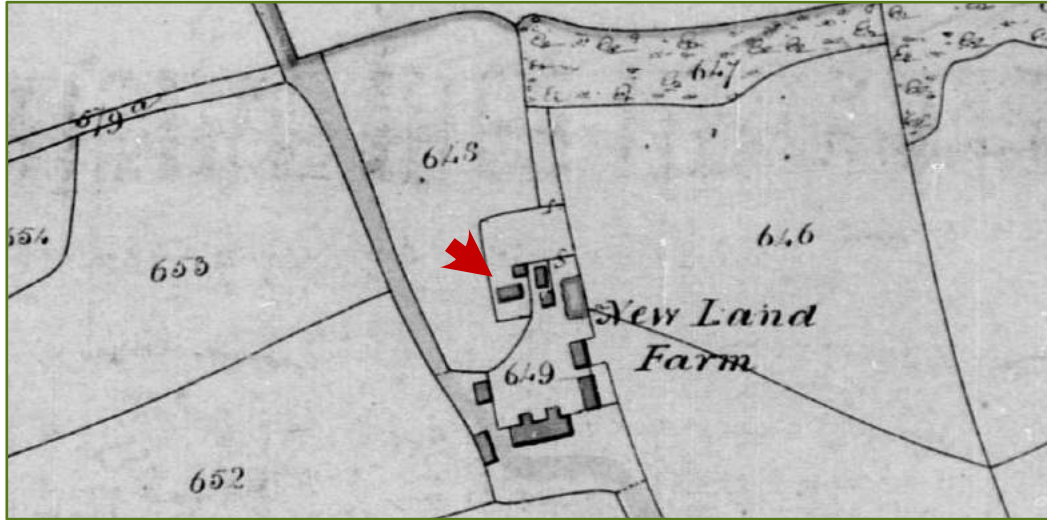
Detail of Southwick Parish Tithe Map showing Newlands Farmhouse, 1839.

- 3.14 The Tithe Map from 1839 provides a detailed depiction of the layout of Newlands Farm. The farmhouse is to the north of the farmstead with three outbuildings to the north and east, which include the former coach house that is now part of the outbuilding range. Immediately to the east is a pond that still survives on site. To the south of the domestic group, there is a large open farmyard formed by the barn and four agricultural buildings. By the time of the Tithe Map, the house appears to have been still a single-piled building. This is confirmed by the OS Map from 1870, which illustrates the building was extended to make it double-piled. The 1870 OS Map also shows the porch to the front of the farmhouse.

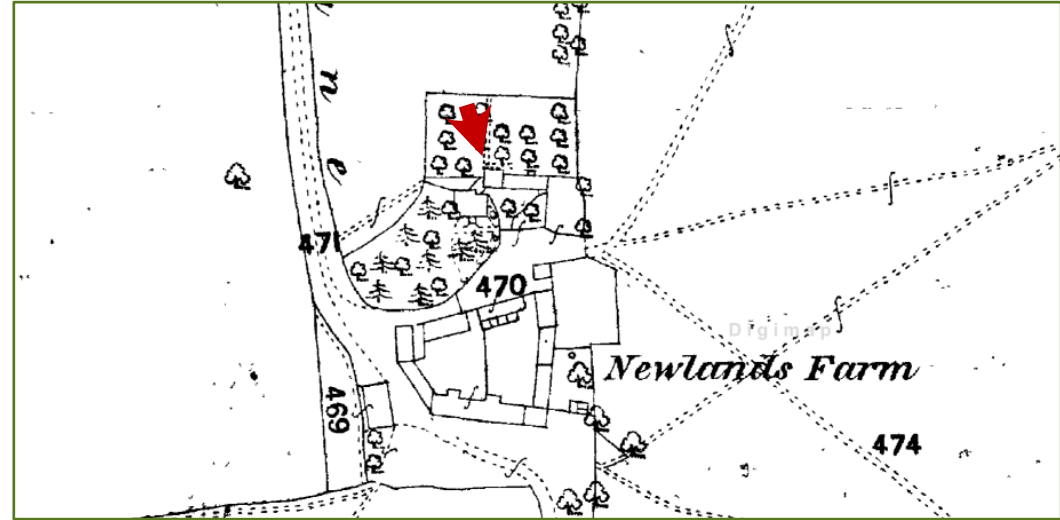
Detail of Ordnance Survey showing Newlands Farmhouse, 1870.

- 3.15 The existing range of outbuildings to the northeast of the farmhouse was also built between 1839 and 1870, following the removal of the two outbuildings to the east of the farmhouse. The outbuilding to the north was retained and incorporated into the new range, which was connected to the farmhouse by small link.

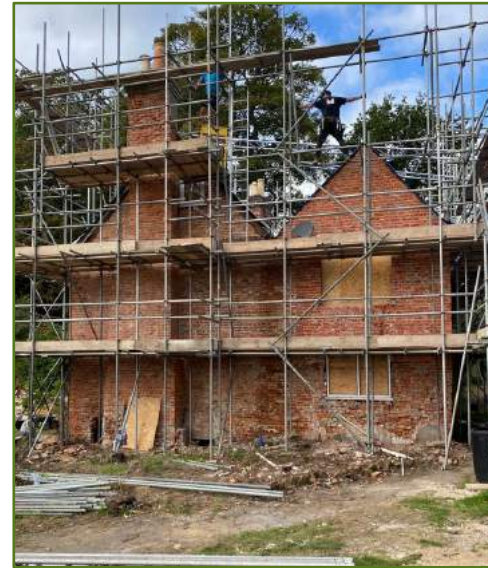
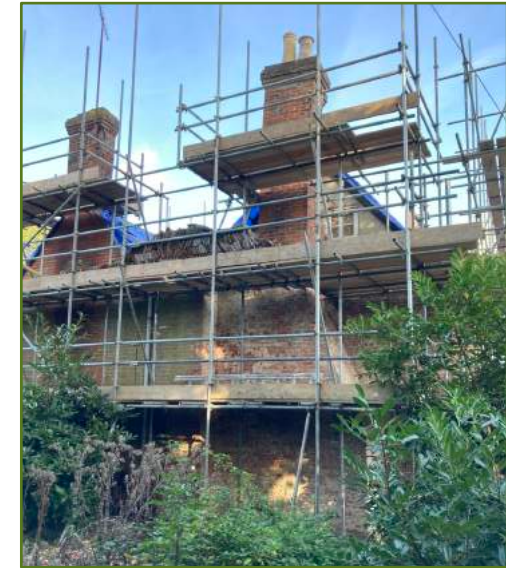
*East and west elevation after the removal of the cementitious render.*

5.5 The impervious nature of the cementitious render, however, has caused significant damage to some areas of the building, particularly to the chimney stacks and gables. As a result, the areas to be left exposed are in need of repair works to ensure the long-term preservation of the building.

5.6 A degree of rebuilding is expected as some areas of brickwork are in very poor condition. The areas that need rebuilding have been assessed and this approach is limited to the gables and the top section of the chimneys.

5.7 The eastern chimney will need to be dismantled down to the corbel and rebuilt reusing as many original bricks as possible, reducing the loss of historic fabric to the strictly necessary. The brick shortfall will be covered using handmade brick matching the existing to preserve the character of the building. Structural movement has caused the chimney to detach from the building up to 3 inches in the widest gaps. The chimney will be tied back to the building using a suitable Helifix product. This approach has been used successfully in order areas of the building resulting in the salvage of large areas of original fabric which, otherwise, would have had to be replaced.

5.8 The western chimney will have to be taken down just below the ridge. The middle and top section of the western stack was rebuilt somewhere in the 20<sup>th</sup> century using modern bricks and sand cement. It will be rebuilt on a like-for-like basis to preserve the legibility of the building's evolution.

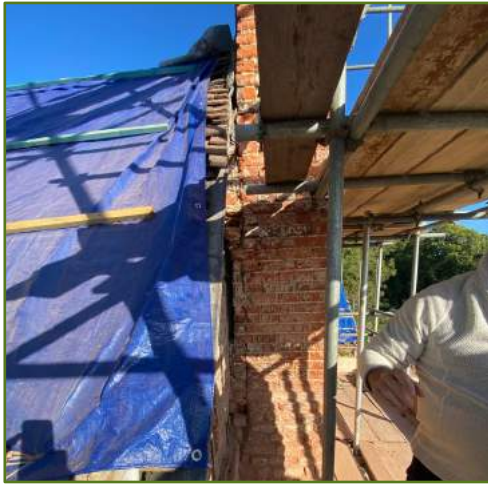
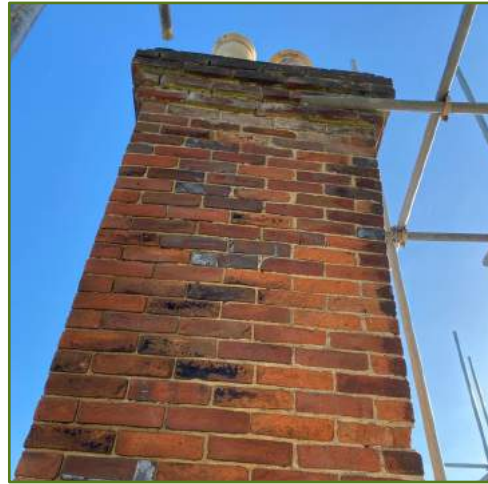
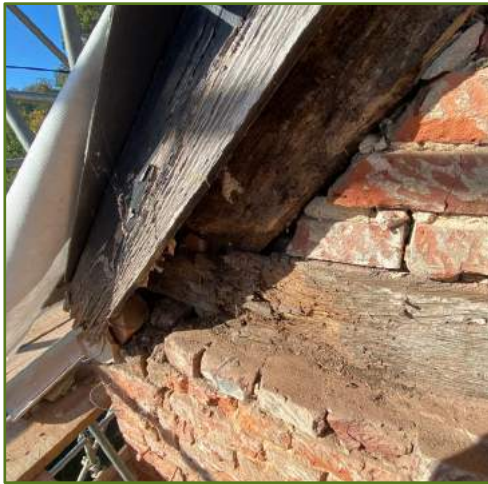
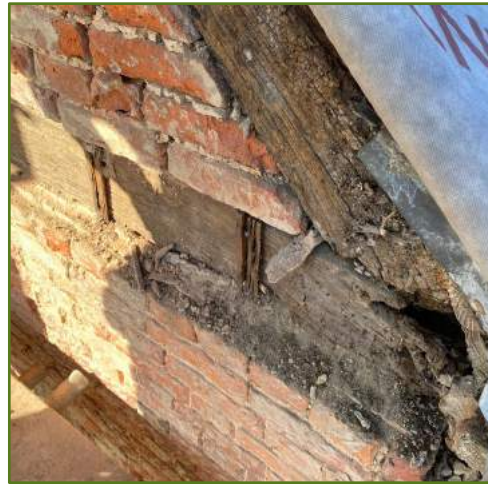
*Eastern chimney stack to be rebuilt and reattached (top) and original frame's joints to be strapped (bottom).*

5.10 The removal of the render also revealed part of the original framing which was retained in the eastern gable. The exposed tie beam and principal rafter have suffered from significant decay and their joint has failed. The repair of this joint by scarfing a new joint would result in the loss of a significant section of the original timber. It is therefore proposed to reinstate the connection between

the principal rafter and the tie beam with metal strapping. This approach will result in a more discreet repair that will also allow for the retaining of most of the original framing.

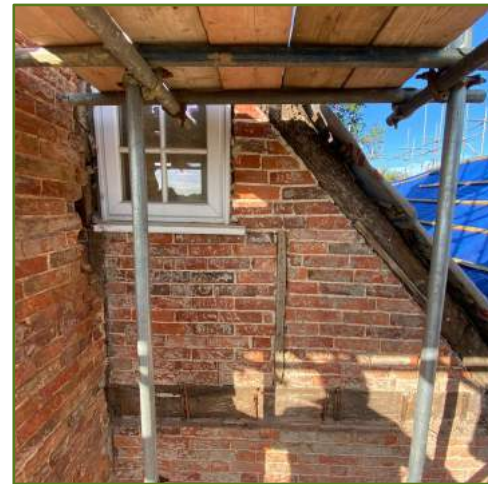
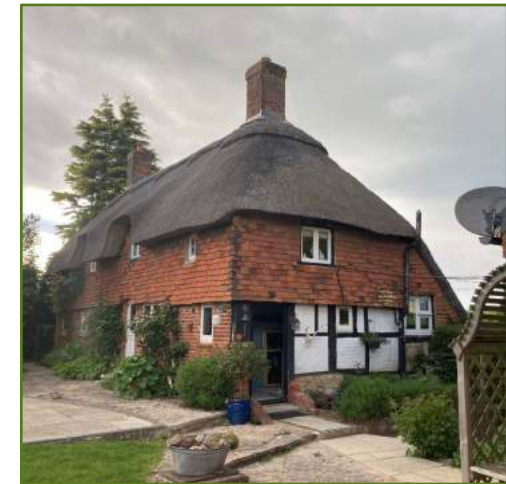
*Tile hanging proposed to gable ends (left) and example of traditional tile hanging in a timber-framed cottage in Binsted (Hampshire).*

- 5.11 The removal of the render from the east elevation means that the surviving framing is now exposed to the elements. As stated above, the framing has already suffered from significant decay during its time under the render and a solution is now required to protect the framing from the elements whilst preserving the character of the building. The scheme, therefore, proposes the installation of tile hanging to cover the gable ends and protect the original framing.

- 5.12 Tile hanging first appeared in south-eastern England towards the end of the 17<sup>th</sup> century to provide weather protection to exposed timber frames and the thin infill panels of wattle and daub, and normally to the upper storeys only. Whilst historically tile hanging is particularly associated with Kent, Surrey and Sussex, it can also be found in some parts of Hampshire, Berkshire, Wilshire and Buckinghamshire. That means that the proposed approach to protecting the framing sits comfortably with the historical and geographical context of the building and so, it will preserve its character and special interest.

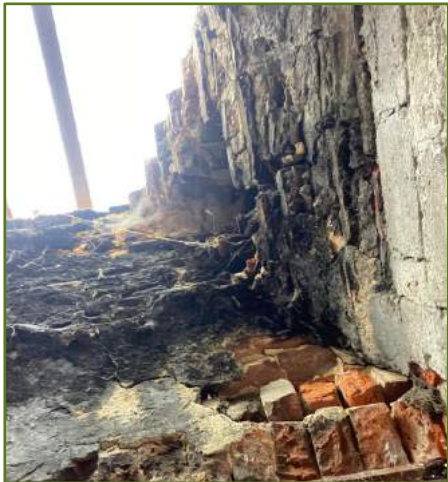
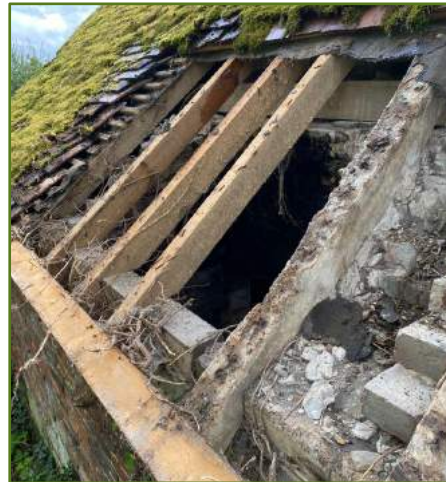
*Location of proposed metal flue and chimney gather.*

- 5.13 The scheme approved under applications 22/00776/LIS and 22/00775/HOU included the rebuilding of the bakehouse/coach house's brick chimney stack. The bakehouse/coach house's chimney breast is in very poor condition, meaning that it is incapable to support the weight of a new chimney stack, without having been previously rebuilt. This approach, however, would result in a significant loss of historic fabric.

- 5.14 For this reason, an alternative approach is proposed. This is the installation of a new metal flue with a chimney gather supported by brackets mechanically fixed to the existing brickwork. This approach will make the fireplace usable without the need to replace part of the historic fabric.

- 5.15 The proposed metal flue is also considered to provide the building with a slightly industrial appearance that is considered to sit comfortably with the historic context and utilitarian nature of the building.
