Beal Station, Berwick

Geo-Environmental Ground Investigation Report

For: Defra Group Property

Ref: 3812-01
Job: 3812
Rev: -
By: AL

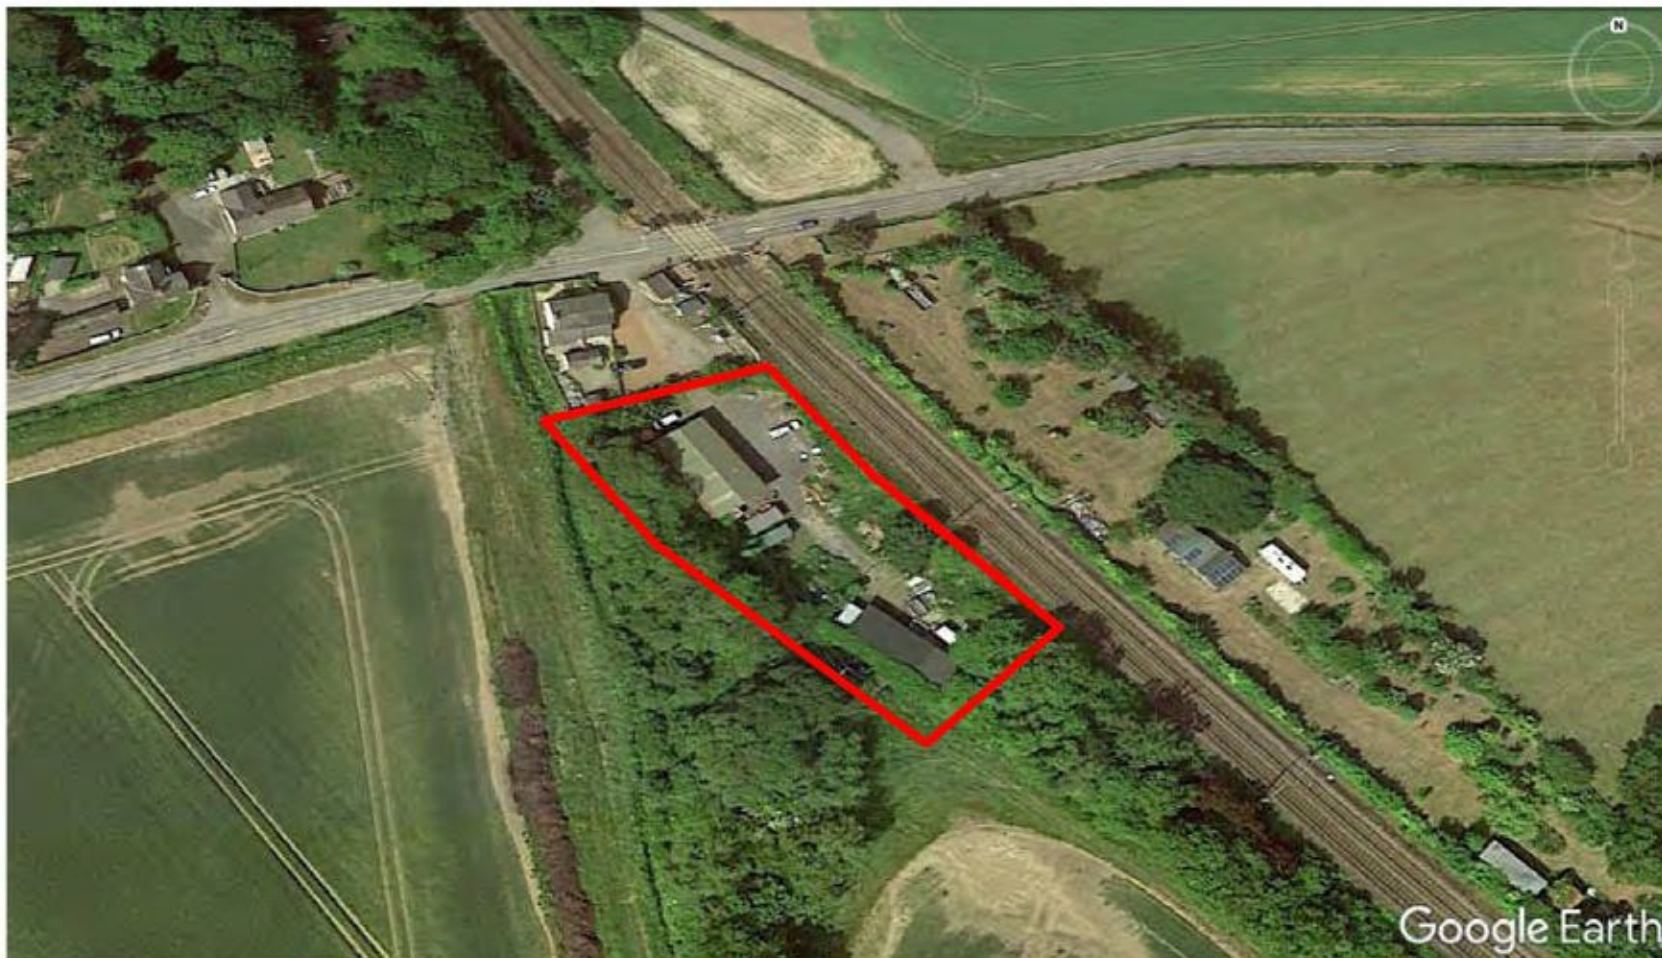
Figure 1: Aerial image of the site dated January 2018. The approximate site boundary is highlighted in red.

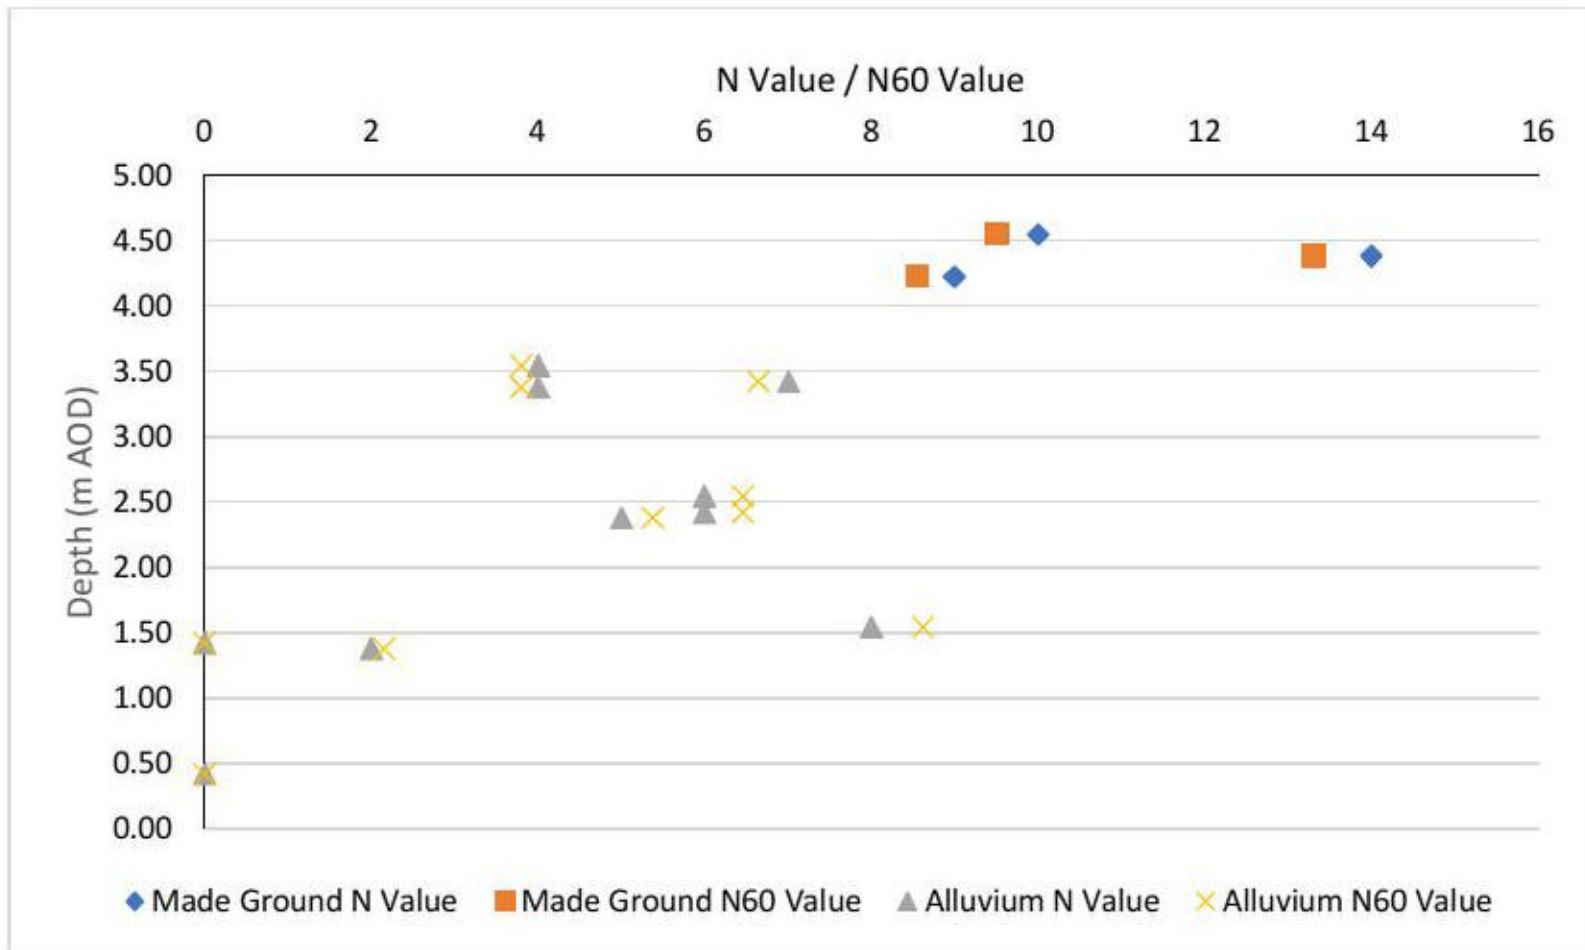
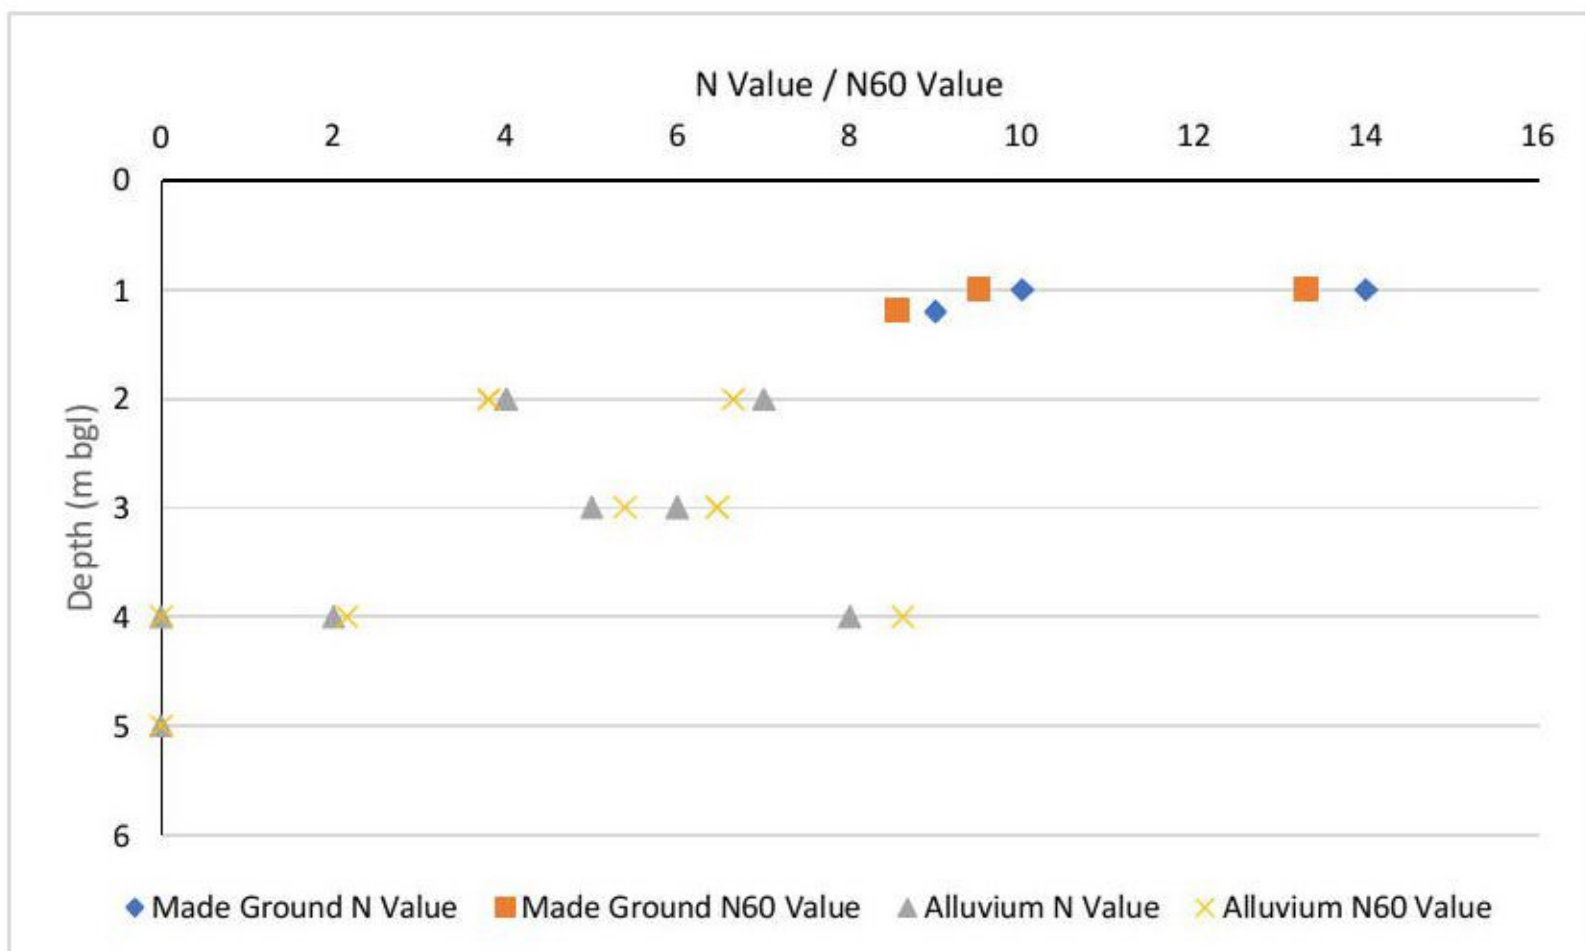
The following scatter graph shows that there is a negative correlation between uncorrected N-value / corrected N₆₀ and depth within the dynamic sample boreholes. This is indicative of the strata encountered with dense / cobbly Made Ground encountered at surface, underlain by firm clays, underlain by soft to very soft silts.

Given the very low SPT N values at the base of the dynamic sample boreholes, dynamic probe holes were undertaken to provide continuous density data at a greater depth.

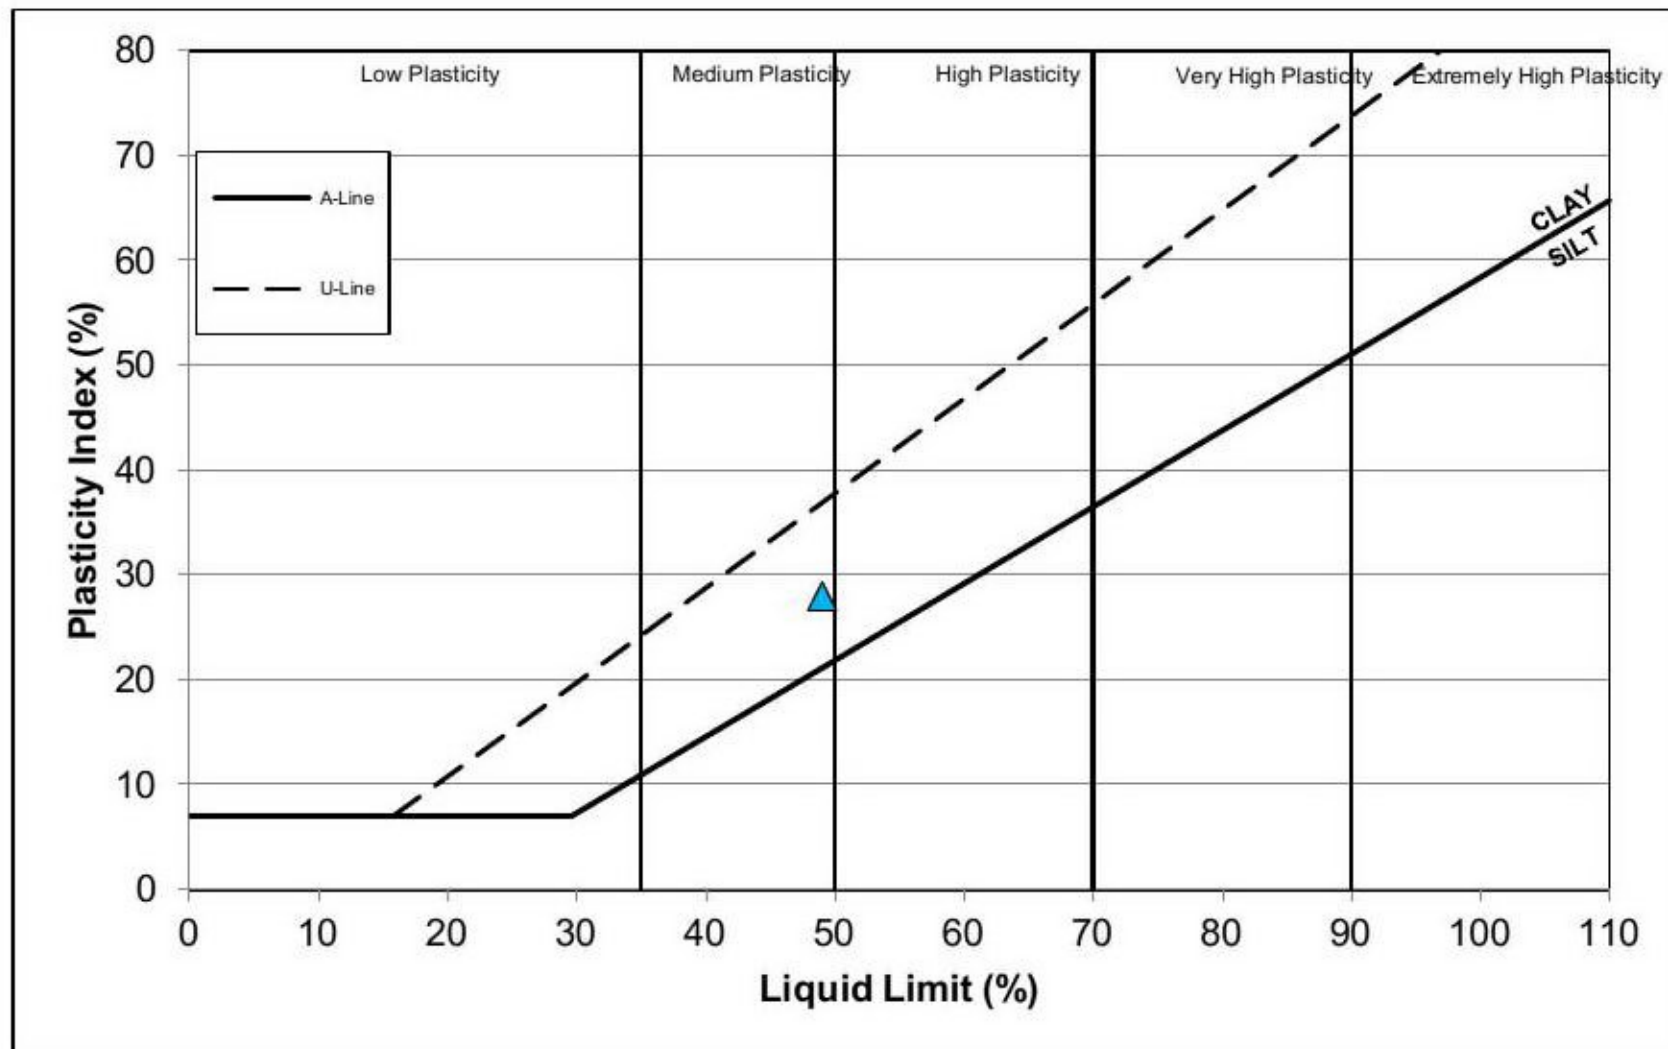
The Atterberg Limit tests indicate that the Alluvium are of medium plasticity in-line with BS14688 Part 2 and of medium volume change potential in-line with NHBC Chapter 4.2 guidance. Full geotechnical test results are contained in Appendix 9.

Numerous established trees were noted to be present along the site boundaries. Due to the medium volume change potential of the clays recorded on-site, it is recommended that an arboricultural survey is undertaken for detailed foundation design and heaver precaution requirements.

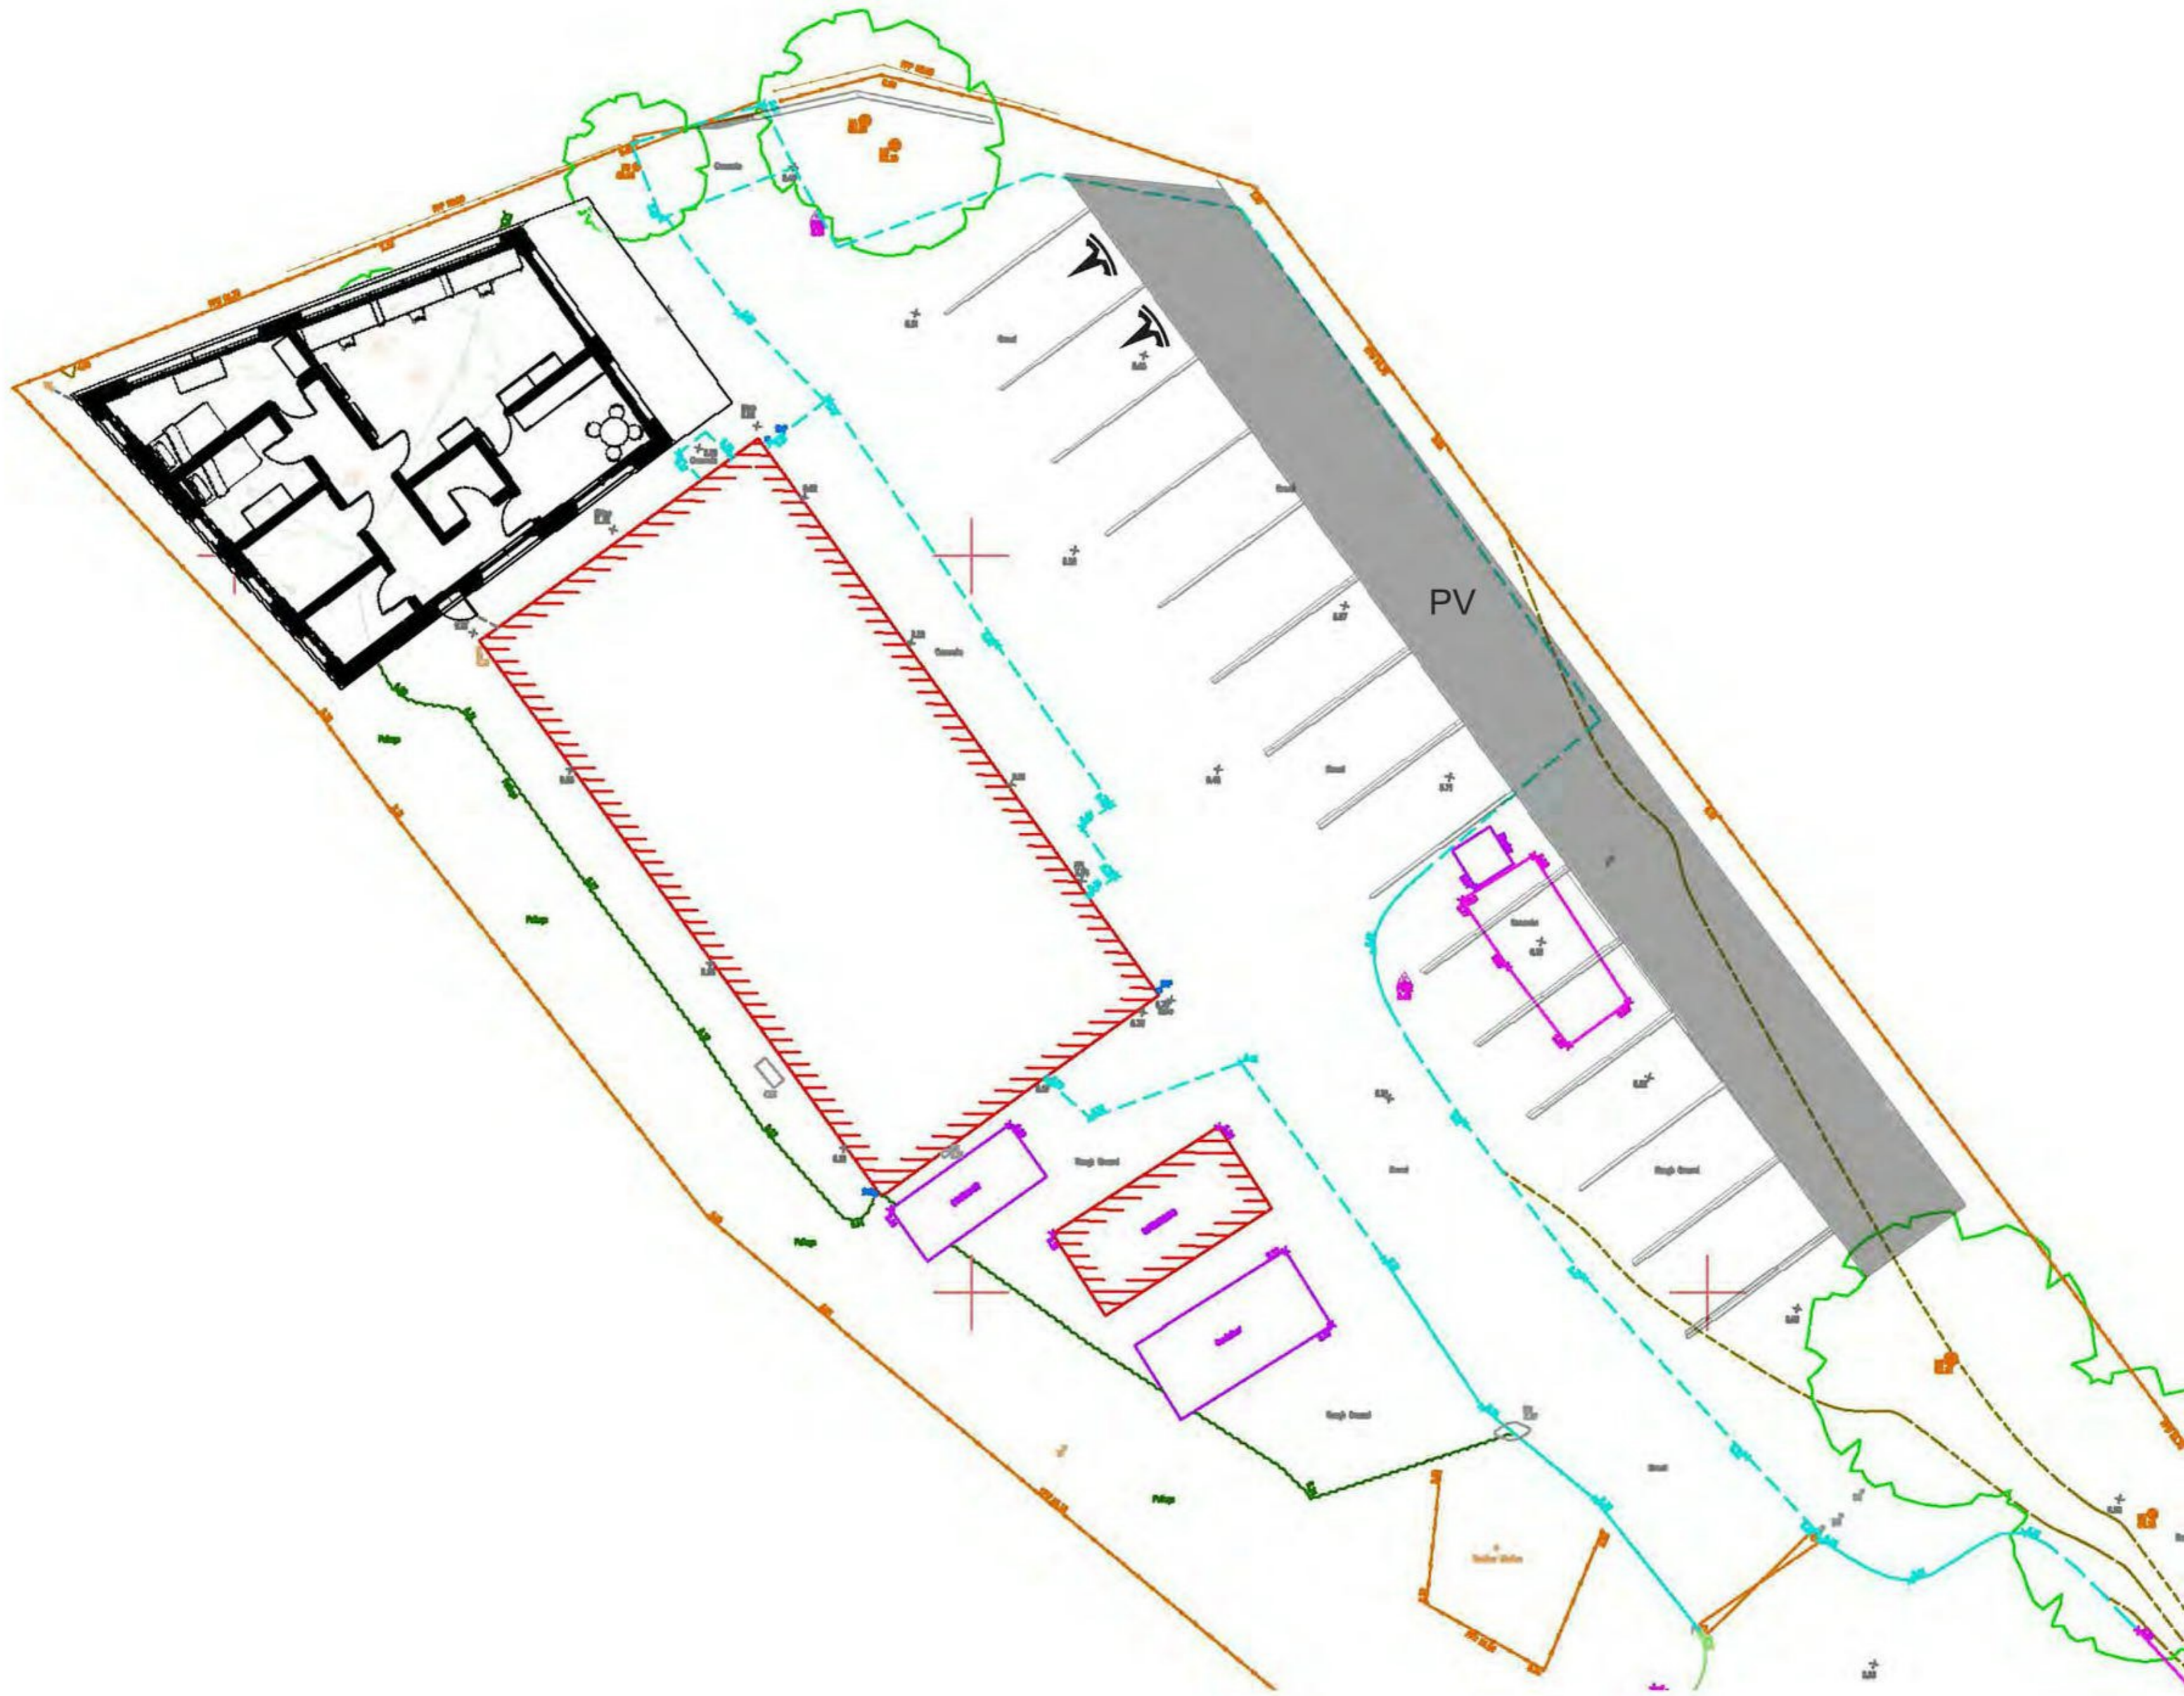
Drawn By: CFC
 Project start date: 07/22
 Checked By: JF
 Date: 13.07.22
 Drawing Scale: 1:200 @ A3
 Drawing Status: CONCEPT
 This drawing is to be read in conjunction with all engineers and specialists drawings along with all relevant specifications.
 All permissions & approvals are to be obtained prior to commencement of any works on site.
 All gridlines, dimensions, building lines, etc. are to be checked carefully on site prior to the commencement of any works.
 All workmanship and materials shall comply with current Building Regulations, British Standards, Codes of Practice and N.H.B.C. requirements.
 All materials shall be fixed, applied or mixed in accordance with manufacturer's instructions or specifications and all materials shall be suitable for their purpose.
 Dimensions are not to be scaled from this drawing.
 Any discrepancies between the information given by engineers and other specialists must be brought to the attention of the designer prior to the commencement of any works.

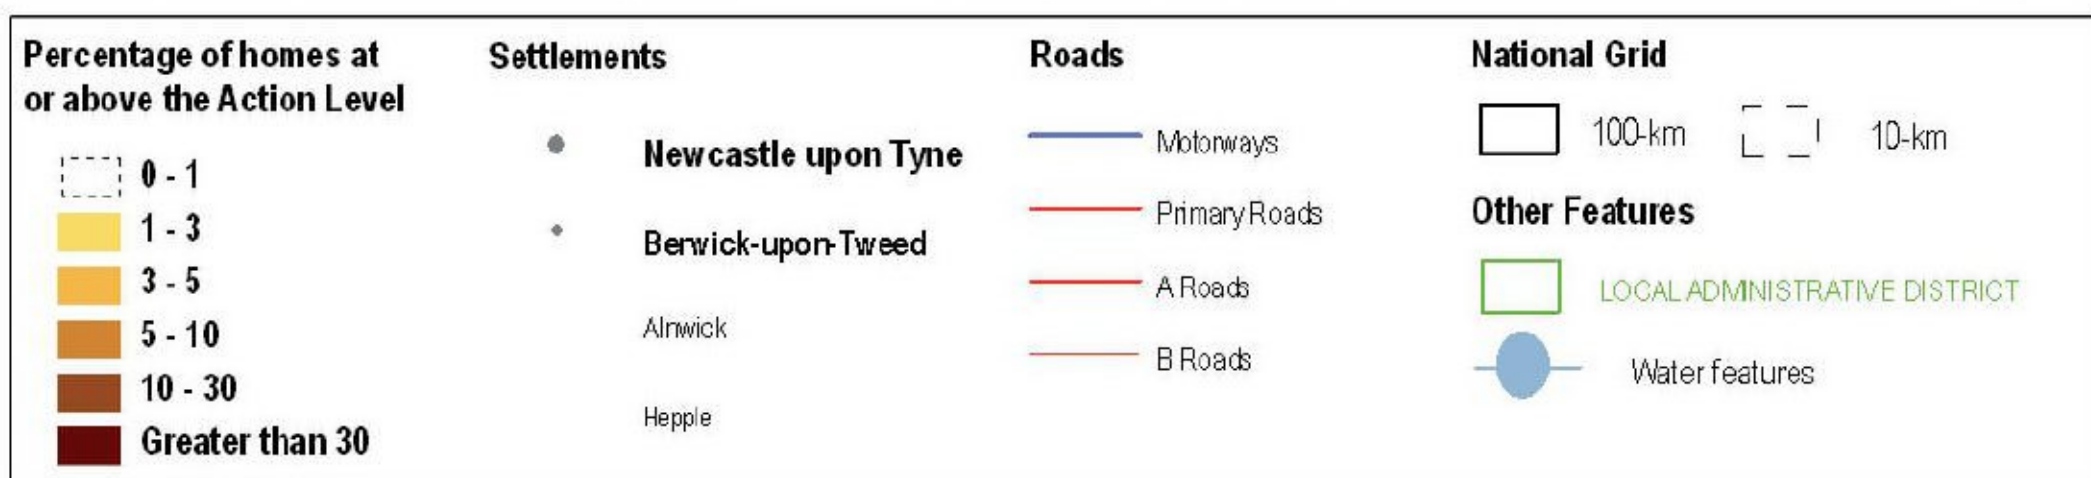
MAP 20 Northumberland, 100-km grid squares NT and NU (axis numbers are the coordinates of the national grid)

The colours show the maximum percentage band within each 1-km grid square of the national grid (see page 4). The best estimate for an individual property in a coloured square can be obtained for a small charge from www.ukradon.org. The white squares, the 0-1% band, contain no Affected Areas as defined by the HPA.

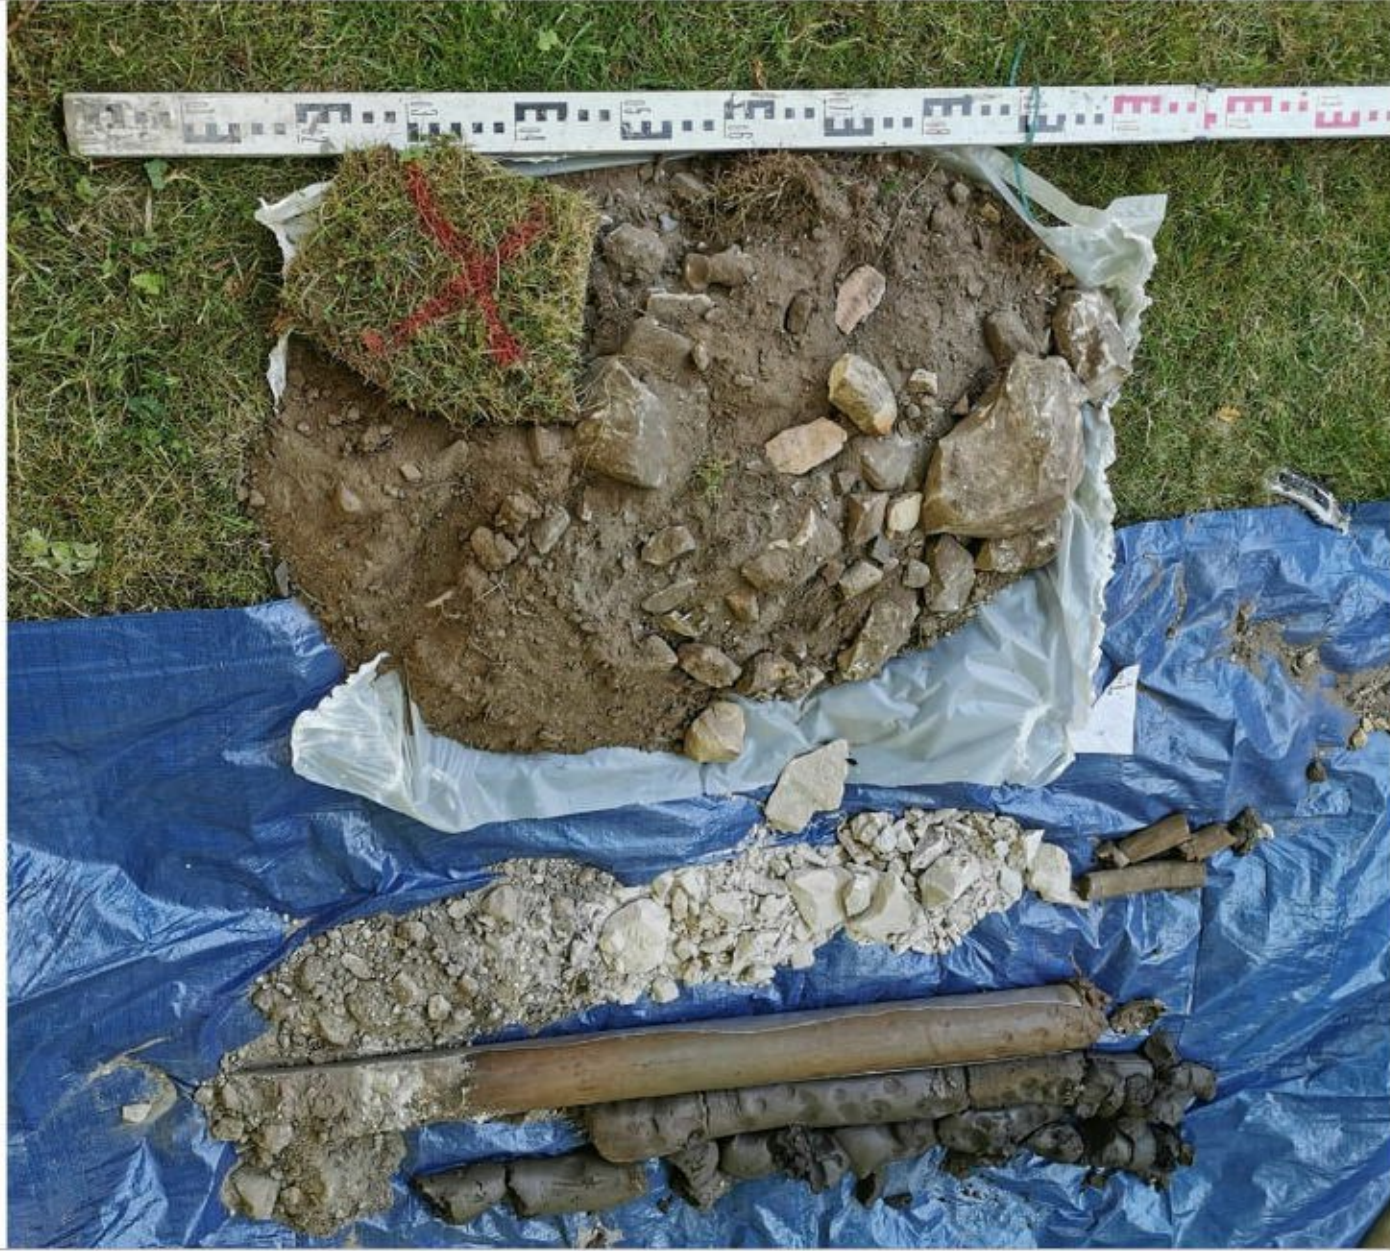
Remarks: SPT at 4.00m bgl - 500mm self weight penetration. SPT at 5.00m bgl - 700mm self weight penetration.	Water Strike		Casing Details		Sample Sleeve Runs		
	Depth Strike	Remarks	Depth Base	Diameter	Depth Top (m)	Depth Base (m)	Diameter (mm)
		No strike	3.00	100	0.00	1.00	HDP 100% rec
					1.00	2.00	87 100% rec
					2.00	3.00	77 100% rec

Image 1. WS01 runs :
Viewed left to right and top to bottom:
1.00-2.00m bgl
2.00-3.00m bgl
3.00-4.00m bgl
4.00-5.00m bgl
5.00-6.00m bgl

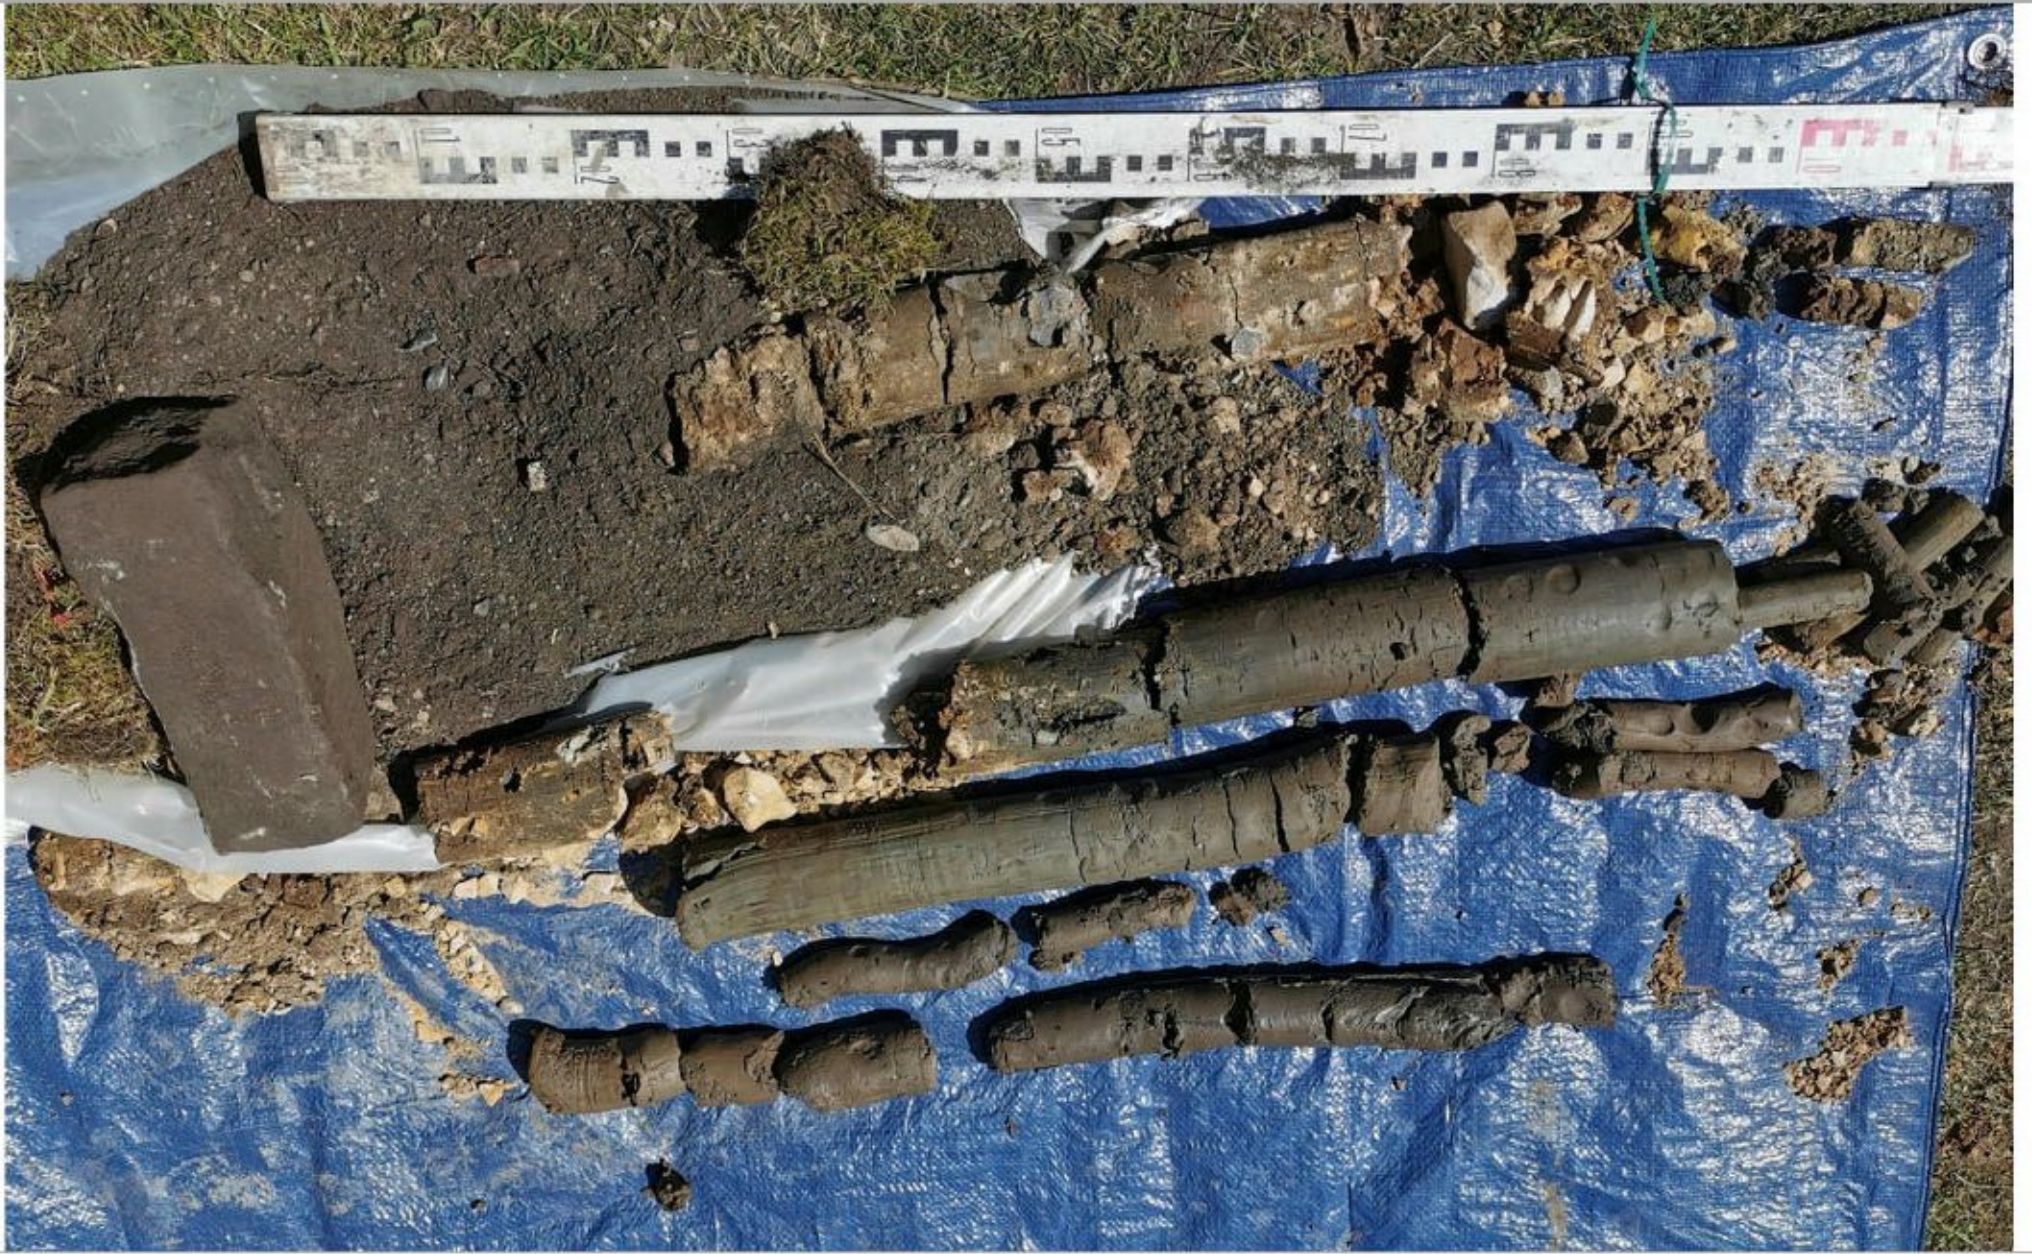
Remarks: SPT at 4.00m bgl - 300mm self weight penetration. Barrel sunk under self weight from 4.00m - 4.50m bgl.	Water Strike		Casing Details		Sample Sleeve Runs		
	Depth Strike	Remarks	Depth Base	Diameter	Depth Top (m)	Depth Base (m)	Diameter (mm)
		No strike	2.00	100	0.00	1.00	HDP 100% rec
					1.00	2.00	87 90% rec
					2.00	3.00	77 90% rec
				3.00	4.00	67 10% rec	
				4.00	5.00	57 80% rec

Image 1. WS02 runs:
Viewed left to right and top to bottom:
0.00-1.00m bgl
1.00-2.00m bgl
2.00-3.00m bgl
3.00-4.00m bgl
4.00-5.00m bgl

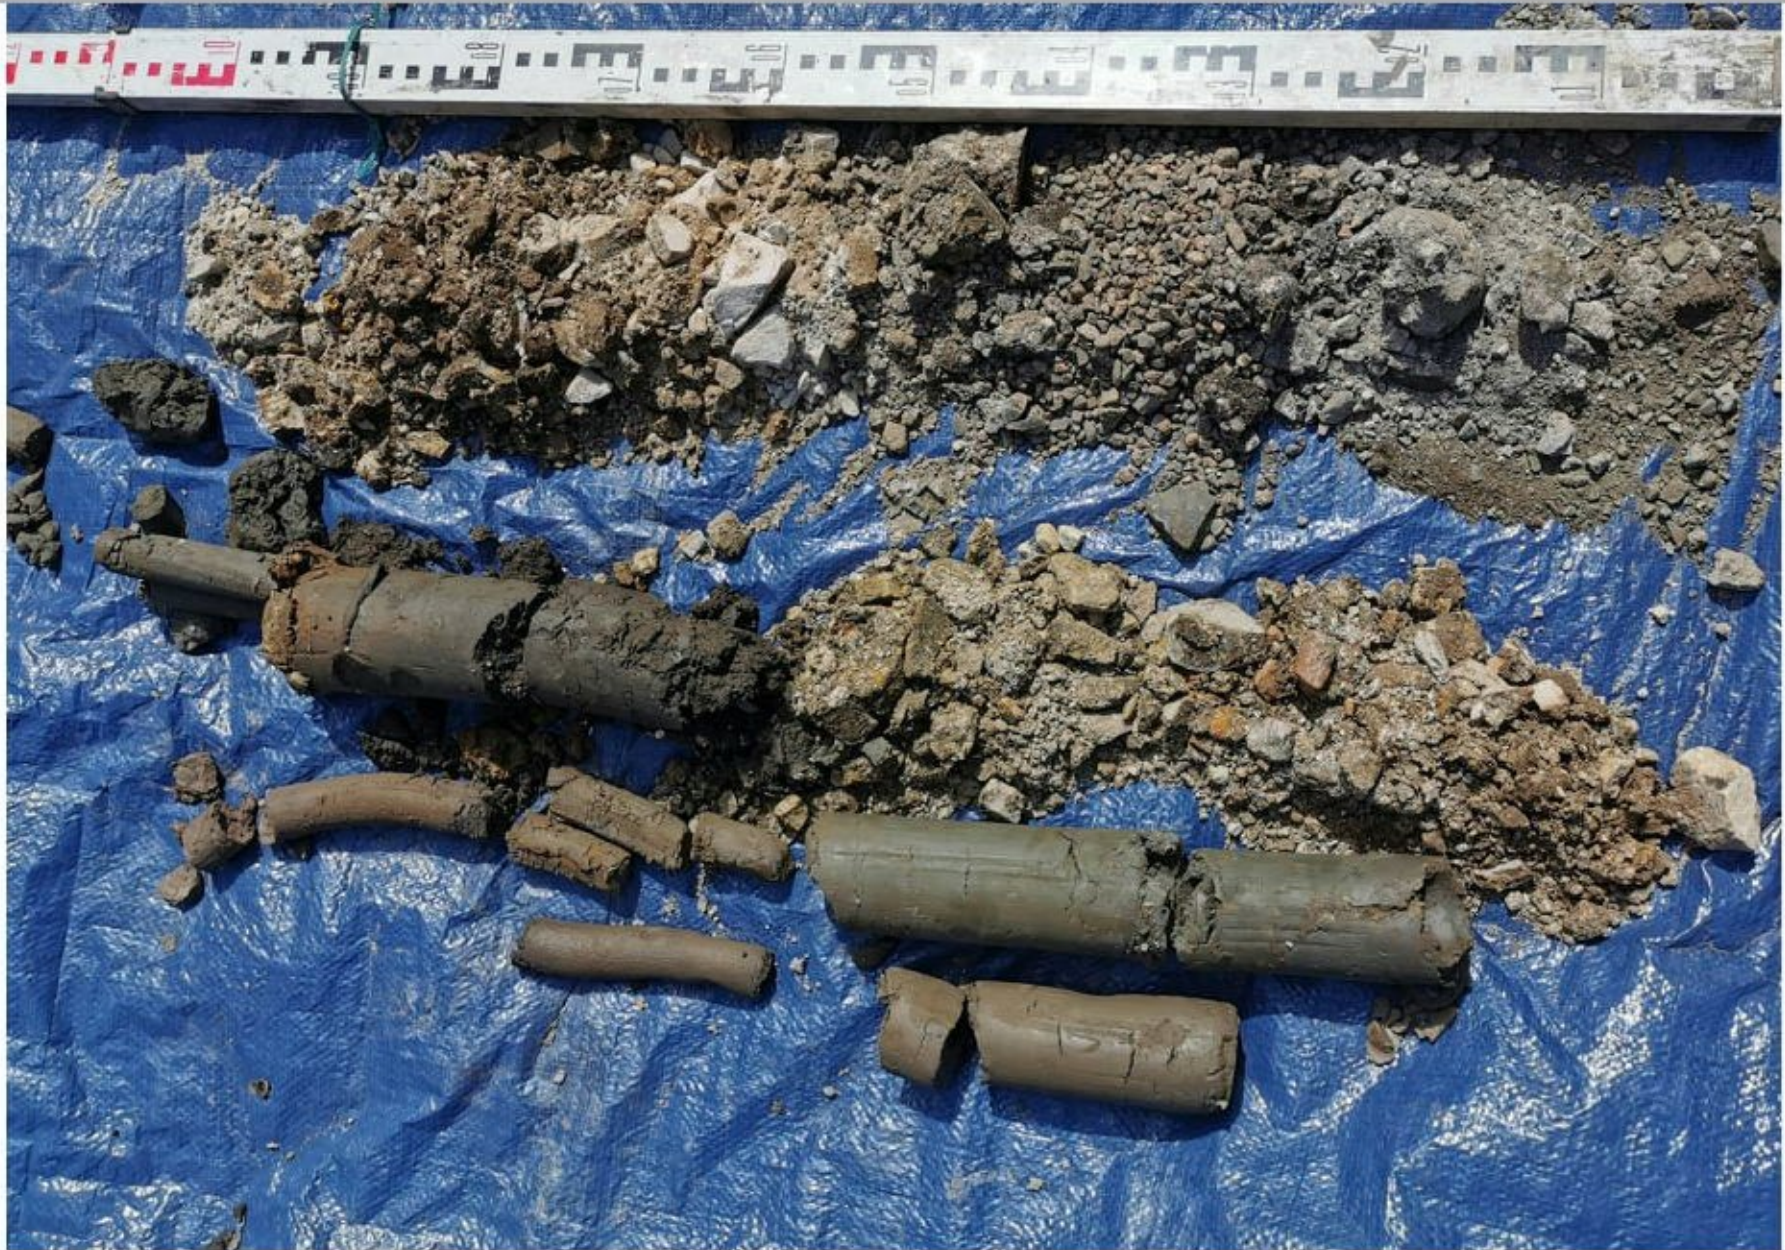
Remarks: Sample liner barrel sunk under self weight from 4.00m - 4.50m bgl.	Water Strike		Casing Details		Sample Sleeve Runs		
	Depth Strike	Remarks	Depth Base	Diameter	Depth Top (m)	Depth Base (m)	Diameter (mm)
		No strike	2.00	100	0.00	1.00	HDP 100% rec
					1.00	2.00	77 100% rec
					2.00	3.00	67 40% rec
				3.00	4.00	57 20% rec	
				4.00	5.00	57 5% rec

Image 1. WS03 runs :
Viewed left to right and top to bottom:
0.00-1.00m bgl
1.00-2.00m bgl
2.00-3.00m bgl
3.00-4.00m bgl
4.00-5.00m bgl

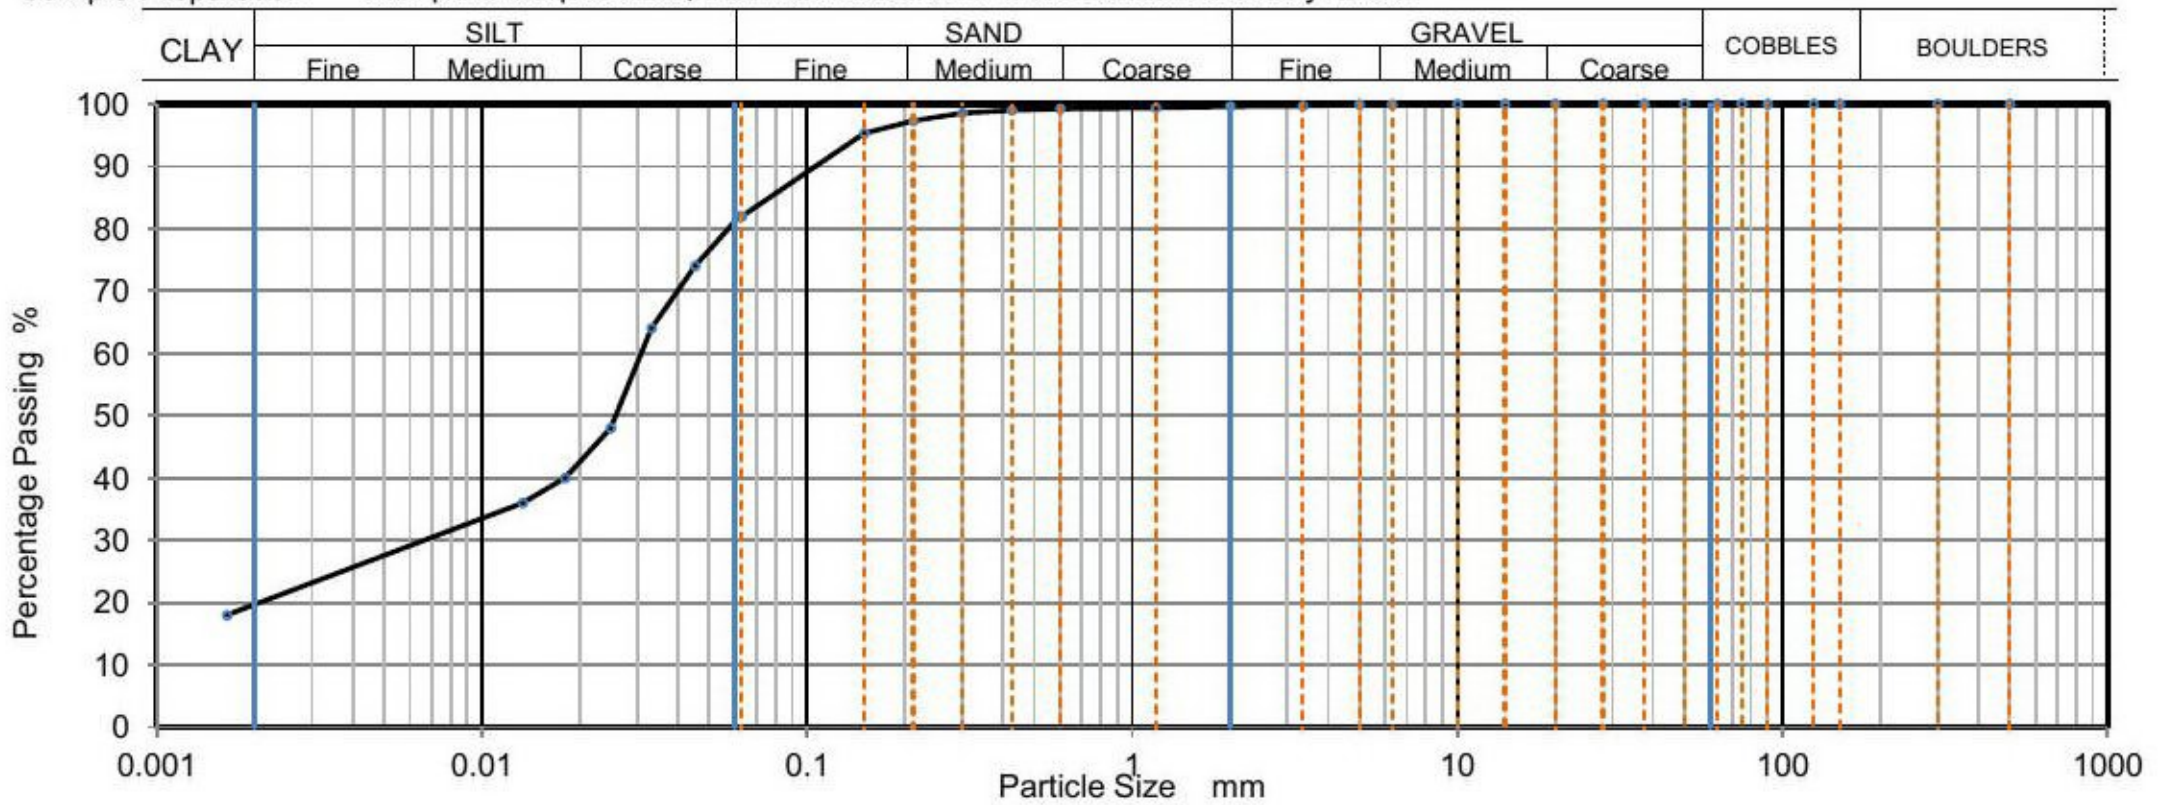
Laboratory Reference: 2371333
Hole No.: DS01
Sample Reference: Not Given
Sample Description: Brown sandy clayey SILT
Sample Preparation: Sample was quartered, oven dried at 106.8 °C and broken down by hand.

Sample Proportions	% dry mass
Very coarse	0
Gravel	0
Sand	18
Silt	62
Clay	20
