## **Preliminary Bat Roost Assessment**

**Nissen Building at Does Farm, Wallow Lane,  
Great Bricett, Suffolk, IP7 7BZ.**

<b>Survey Commissioned by:</b>	Wilkinson Planning Ltd.
<b>Project Number:</b>	REP22010
<b>Report issued:</b>	1 <sup>st</sup> May 2022
<b>Date of survey:</b>	6 <sup>th</sup> April 2022
<b>Surveyor:</b>	Odette Robson BSc (Hons) PhD MCIEEM

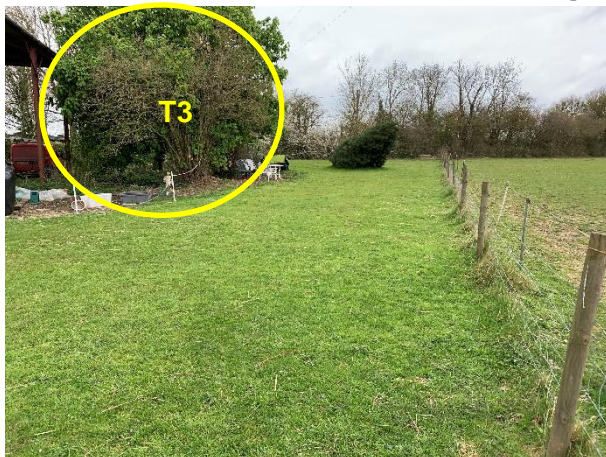
### Curtilage/Garden

Proposed garden area is short-mown lawn grass dominated by common amenity grass species. A tree group (T3) included mature Horse Chestnut *Aesculus hippocastanum* and Hazel *Corylus avellana*, with ruderal ground cover (bare earth and Nettle *Urtica dioica*). Surrounded by a hedge to north and west, predominantly Blackthorn *Prunus spinosa*. A fence to the eastern boundary separated the site from horse-grazed pasture.

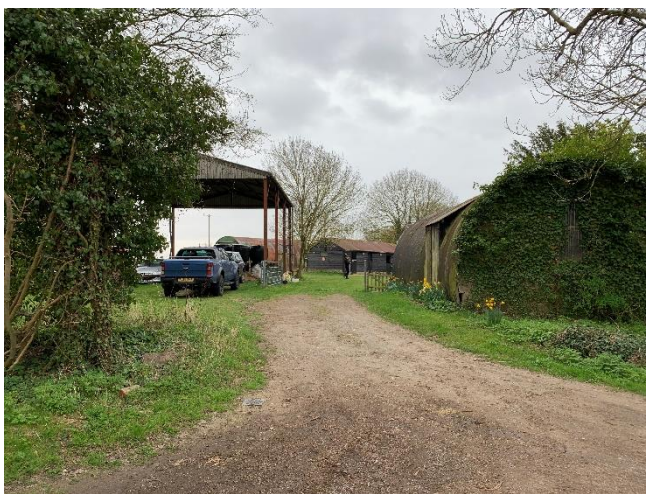
### Access Track

Existing vehicular access track from the road (to the north-west of the Nissen building), past another Nissen hut, pole barn and stables, to the northern end of the Nissen building.

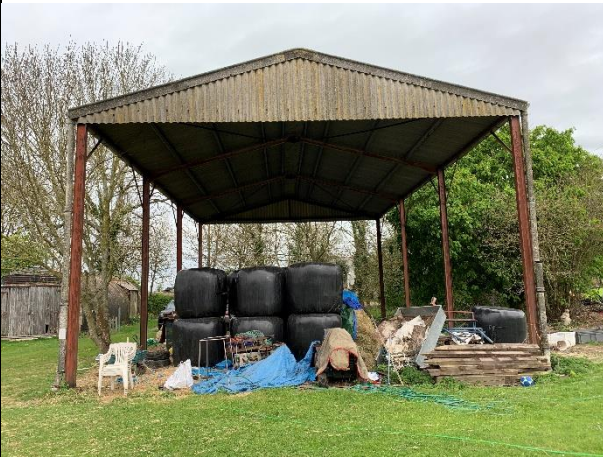
Pole barn adjacent to access track and to the north-west of the Nissen building. Open-sides, steel frame, corrugated-sheet roof and upper gables, and no voids or lining.

Negligible bat roosting potential and no barn owl nesting opportunities/ledges.

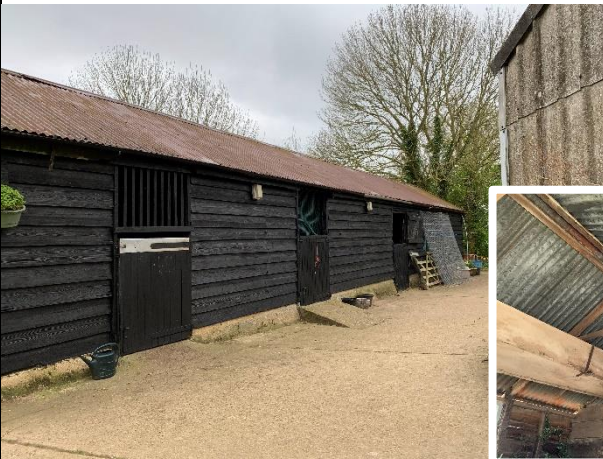
Former stables housing poultry/fowl at the time of the survey (due to bird-flu housing order). Corrugated tin sheet roof (double-pitched) with no internal lining. Light and drafty internally.

Weather-boarded walls were intact and sealed.

Negligible bat roosting potential.

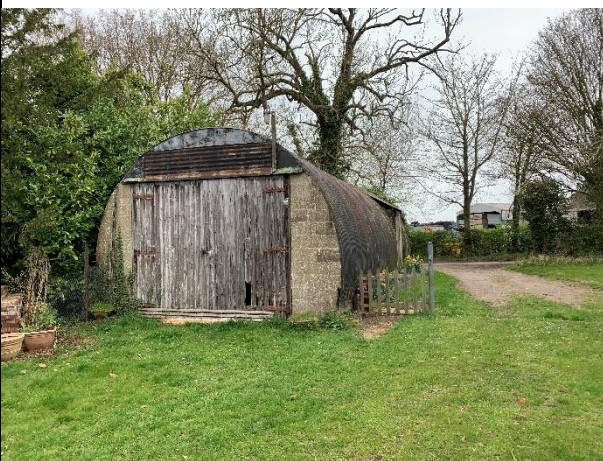
Nissen Hut adjacent to site entrance and road.

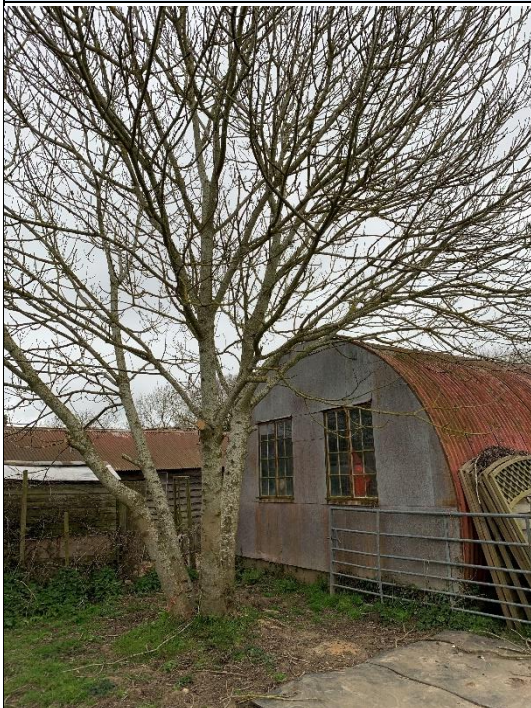
**T1**

Sub-mature Ash *Fraxinus excelsior* tree directly adjacent to the southern end of the Nissen structure: Multi-stemmed and intact with no cracks, crevices, internal rot-seams, or other potential roosting features. Well-sealed pruning cuts.

Negligible bat roosting potential.

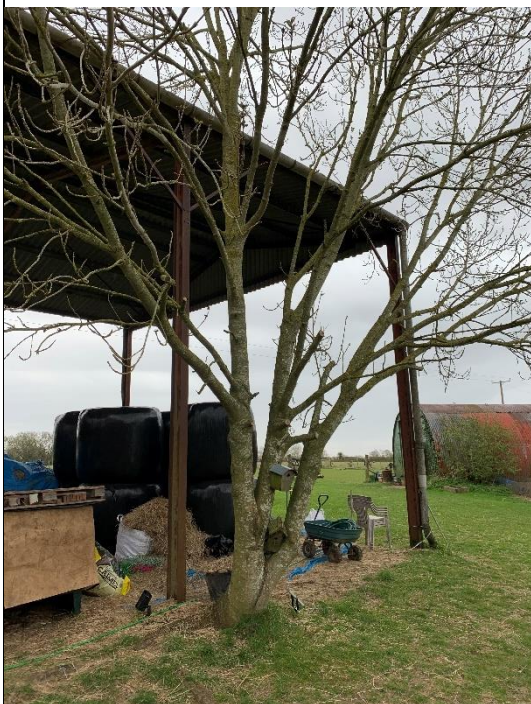
**T2**

Semi-mature, self-sown Ash tree adjacent to access track and pole barn: Multi-stemmed and intact with no cracks, crevice, or other potential roosting features. A low bird box (west-facing) was no used at the time of the survey.

Negligible bat roosting potential.

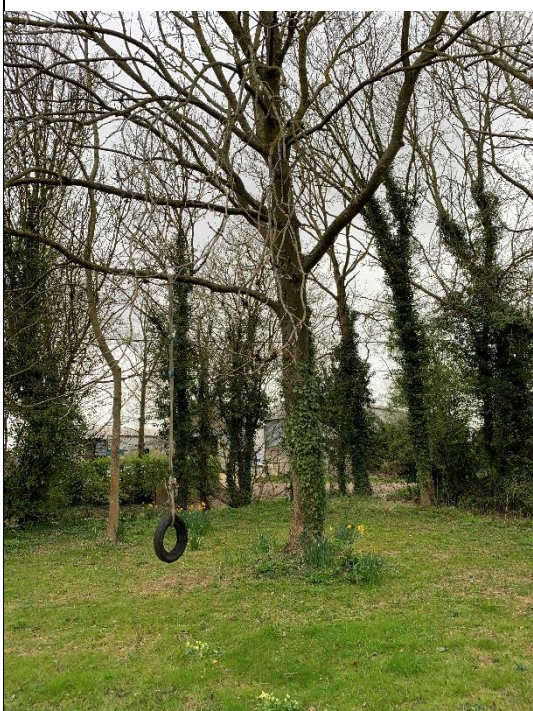
**T3**

Group of mature trees to the north of the access track and adjacent to the road:

Ash, Hawthorn *Crataegus monogyna*, Field Maple *Acer campestre*, and Blackthorn.

These trees would not be impacted by proposed change of use and barn-conversion.

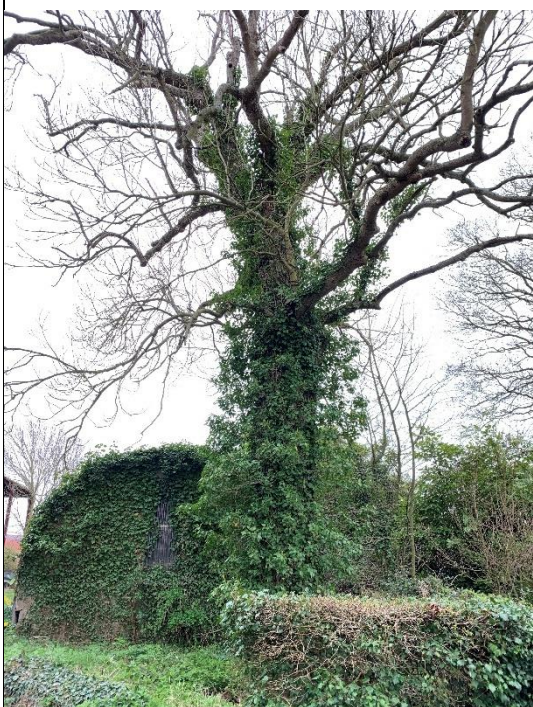
**T4**

Mature Ash tree to the south-west of the access track and adjacent to the road: Ivy-clad, with aerial deadwood and high woodpecker holes:

High bat roosting potential but will not be directly impacted by proposed change of use and conversion.

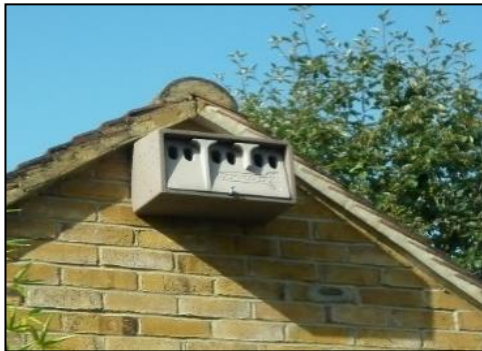
<p><b>Schwegler 1SP Sparrow Terrace</b></p> <p>This terrace provides nesting opportunities for three families. Made of wood-concrete mix, this terrace is durable, breathable and will last many decades. The terrace can be fixed on to the surface of a suitable wall or incorporated into the wall. Place the terrace two metres or more above the ground or install directly into the wall. Cleaning is advisable but not necessary. The front panel can be removed by turning the screw hook.</p>

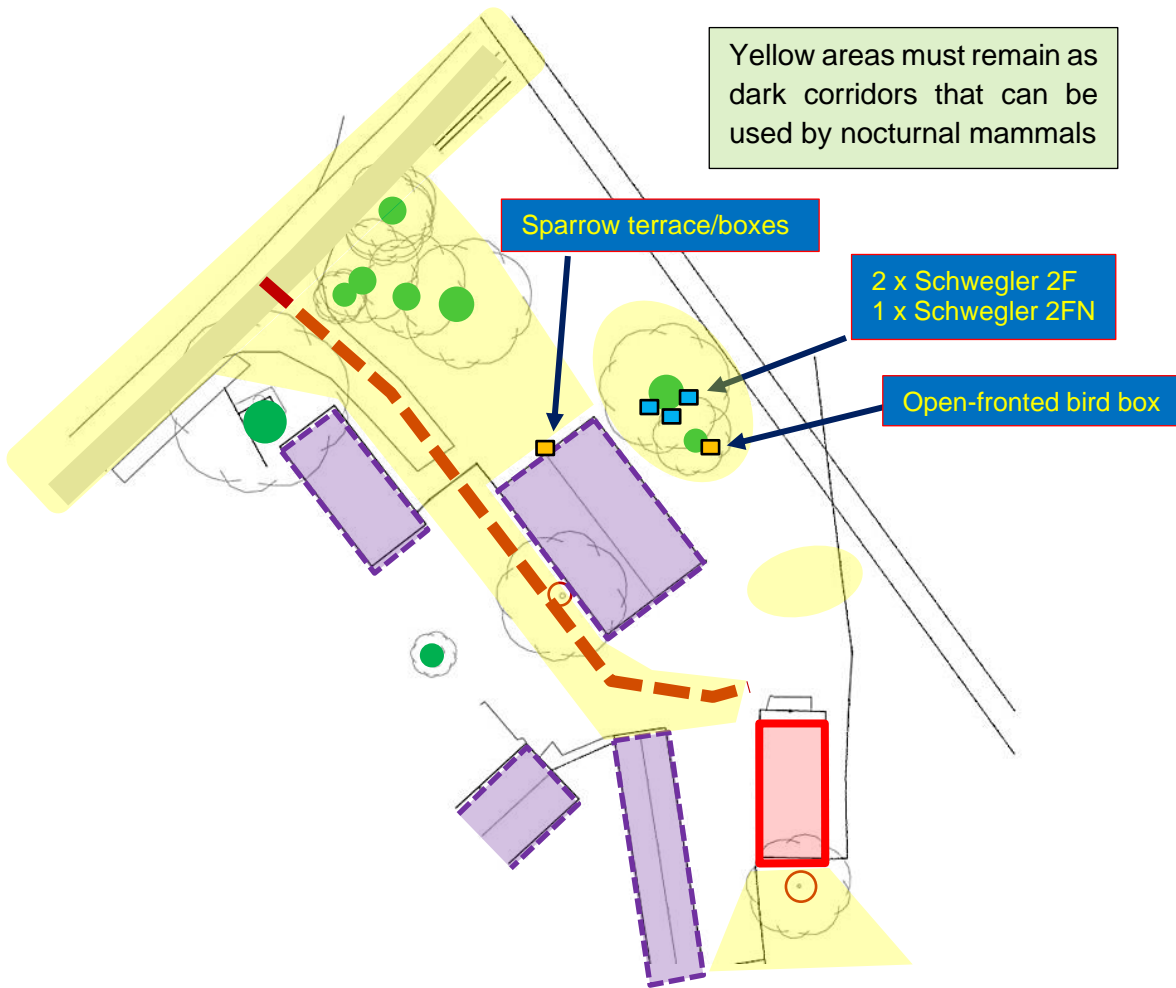
## 8 Appendix B: Biodiversity Enhancement Plan and Lighting Strategy for Wildlife

The areas which should be retained as dark corridors are shown in Appendix B.

Song thrushes and spotted flycatchers use open-fronted nest-boxes: The Schwegler 2H open-fronted nest boxes, or other boxes to approved BTO-standards, should be installed in retained garden trees, such as the Hazel in the proposed garden to the north of the Nissen structure. Suggested locations for the bird and bat boxes are shown in Appendix B.
