1 Bridges Cottages, Darmsden, Suffolk

Heritage Asset Assessment

March 2021

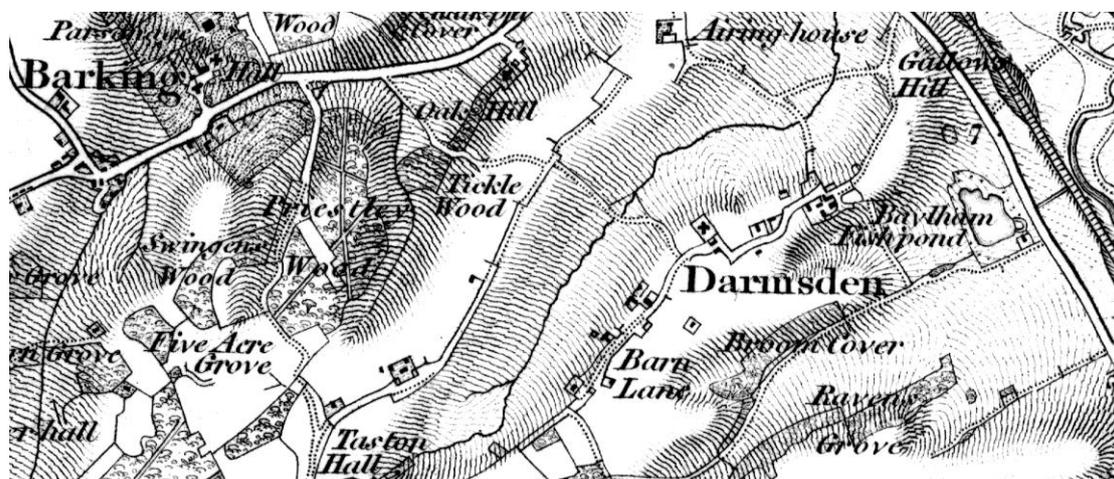
Figure 2. The 1838 one-inch Ordnance Survey showing Barking Hall to the north-west with Bridges Cottages to the west of Barn Lane (to the left of the name 'Darmsden').

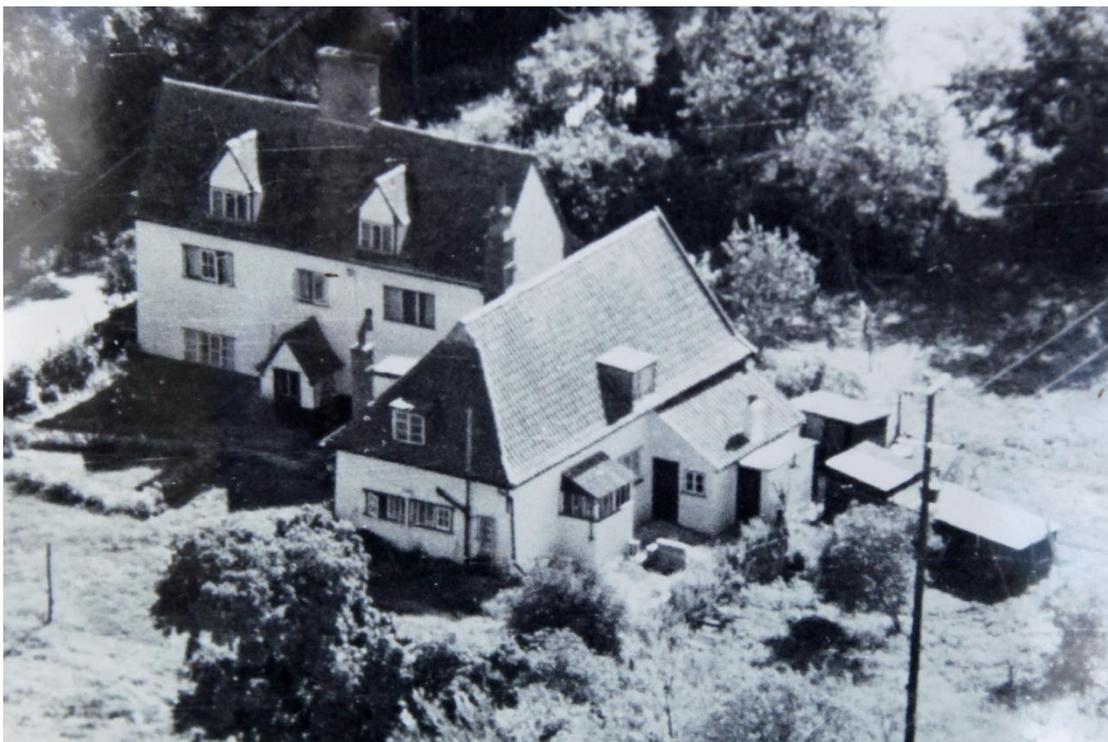
Figure 8. An aerial photograph from the north dated 1964 in the possession of the owners of 2 Bridges Cottages. The modern sheds and garages had yet to be added, and the large axial chimney with multiple flues of the two-storied wing had yet to be rebuilt.

The aerial image of 1964 suggests no. 1 remained largely unaltered until the major renovations of the late-1970s and 80s recalled by the occupants of no. 2. These changes were dramatic, and involved the replacement of all but one window (illus. 3-5), the rebuilding of the chimney and the insertion of the present stair along with various partitions of plasterboard and re-used timber. The previous stair is said to have risen in the opposite direction and may have been the original newel stair against the chimney which appears from the aerial photograph to have contained at least four fireplaces. Its replacement possessed only the two shown in illustrations 10 and 17. The 17th century entrance porch was blocked and a new porch added to the back wall, effectively changing the building’s historic orientation from front to rear. The dormer windows were similarly moved from the north-east to the south-west, and many of the internally exposed timbers were probably stripped of their original lath-and-plaster at the same period. French doors were inserted into the parlour (1) and the south-western wall of the sitting room and kitchen was rebuilt in masonry below the level of its mid-rails with the exterior of the entire property rendered in cement. Cement tiles were installed on the roof, replacing the earlier peg-tiles, and a series of new single-storied sheds of rendered brick and cement block-work was built to the north-west as shown to the left in illustration 4. These sheds include a timber conservatory and are of no historic significance

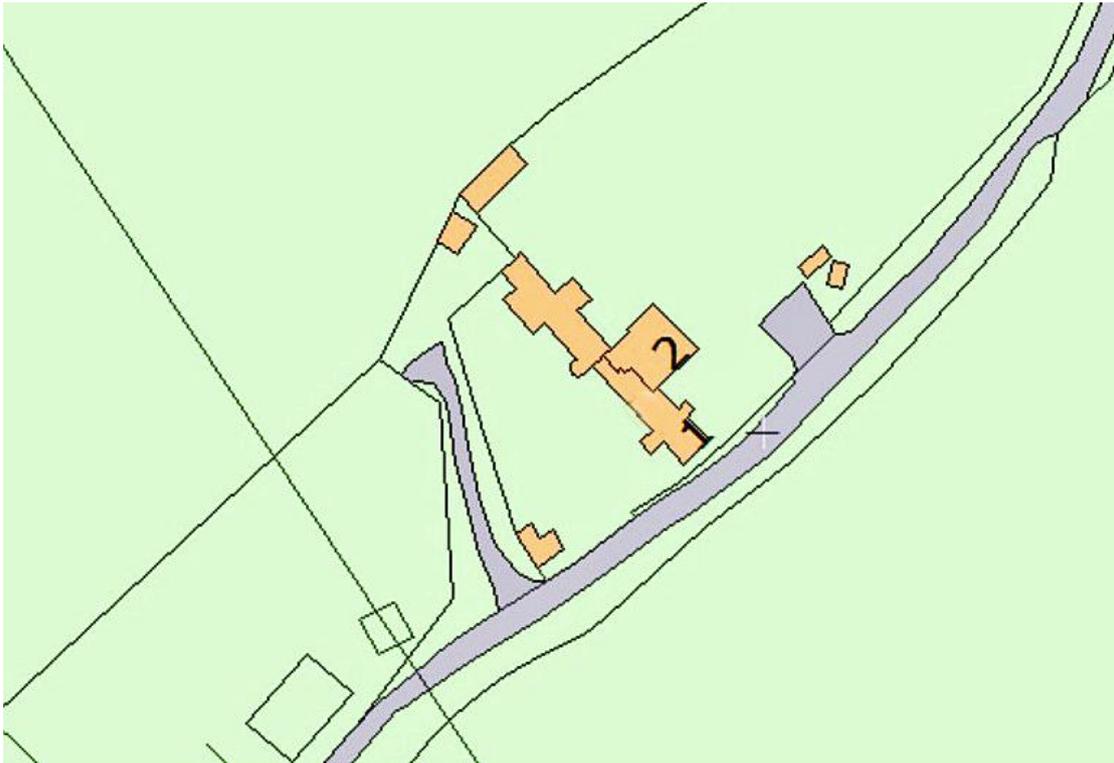
Figure 9. A current plan of the site indicating nos. 1 and 2.

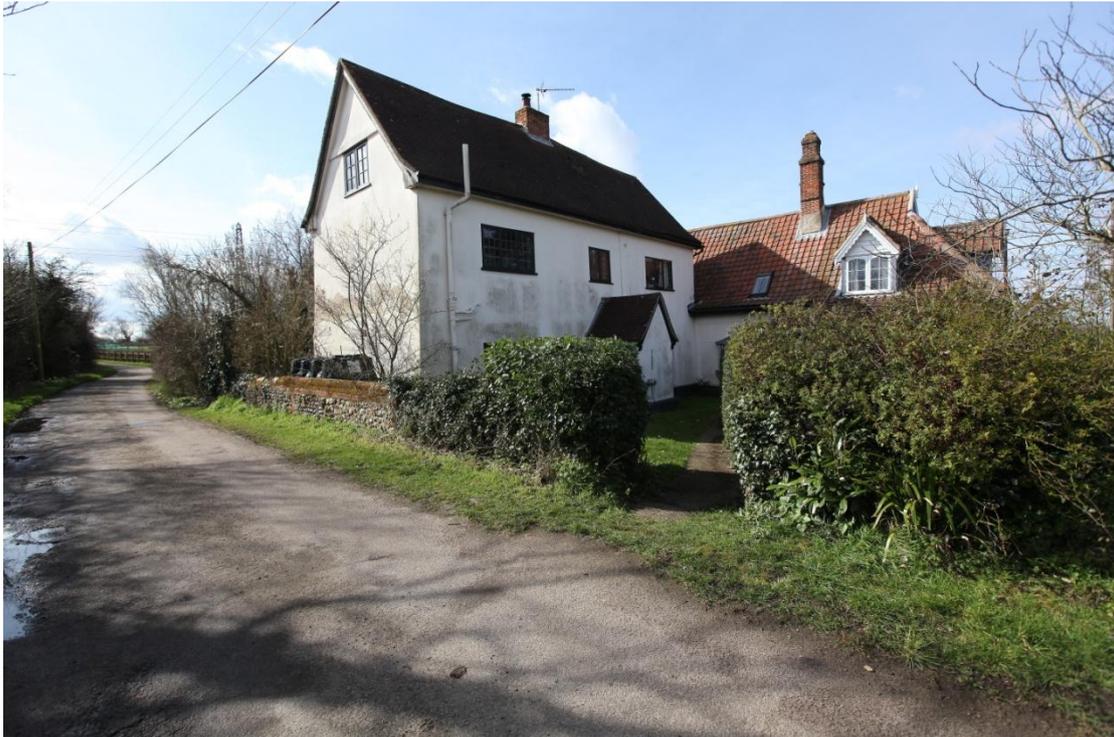
Illus. 1. The former farmhouse from the lane to the east with no. 1 adjoining the road at right-angles on the left and the original 16th century house at no. 2 parallel to the road in the rear.

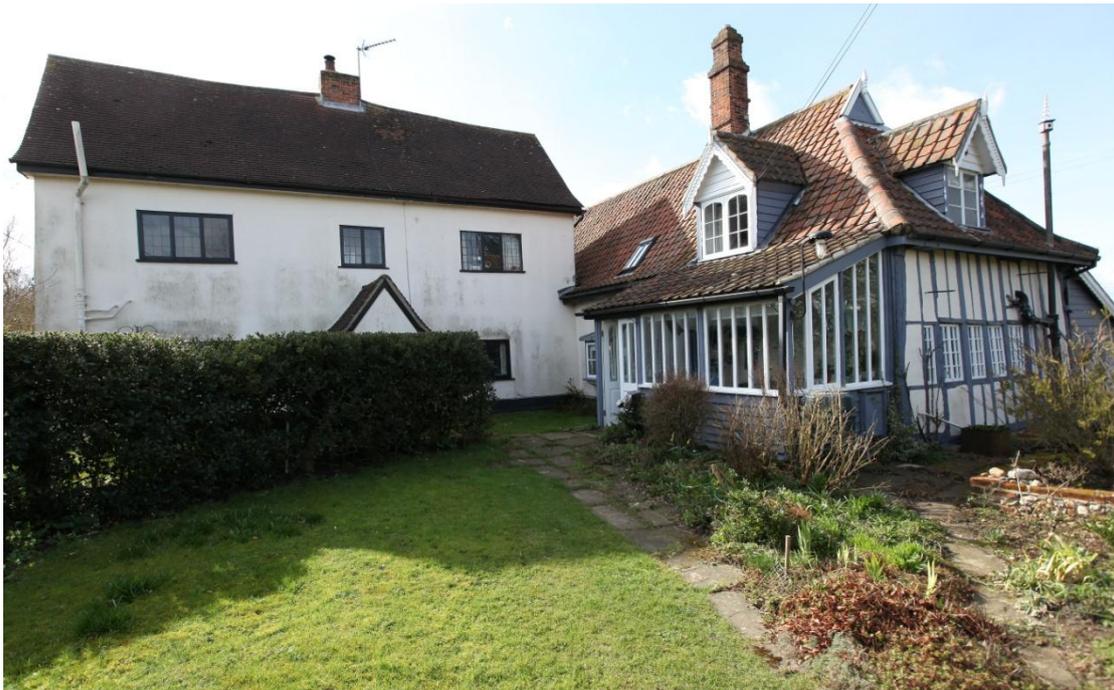
Illus. 2. The original north-eastern facade with the complete early-16th century 1.5 storied house on the right and the two-storied 17th century extension that probably formed a 'unit' house in front of its parlour on the left. No. 1 comprises the extension and the 16th century ground-floor parlour. Note the dramatically reduced size of the chimney since 1964.

The oldest part of the timber-framed former farmhouse is the 1.5 storied pantiled structure to the right in illustrations 1 and 2. This was built as a complete early-16th century house that faced the road to the south-east and reflected the standard domestic layout of its period as described in the Appendix: a central hall was flanked on the right by a pair of service rooms and on the left by a single parlour with a ceiling of neatly chamfered joists (illus. 6-8). The hall may have been open to its largely rebuilt crown-post roof initially despite the presence of an original chimney backing onto its cross-passage: the evidence on this question is inconclusive as the roof-plates contain no traces of open-hall windows yet the present ceiling appears to have interrupted an arch-braced tie-beam in the rear wall. A stair rose from the back of the cross-passage in the usual way, with another adjacent to the doorway linking the hall and parlour as indicated in figure 11. This doorway is now blocked and the parlour belongs to no. 1 while the chamber above and the rest of the 16th century house form part of no. 2. The parlour gable was originally hipped to match the service gable but was remodelled with a vertical gable to increase first-floor headroom in the 18th or 19th century. The ground floor ceiling survives intact with a blocked trap for the stair and empty mortices for missing wall studs in the underside of the mid-rail adjoining the extension. There is no evidence of a window in this elevation and the room was presumably lit from its gable which now contains a set of late-20th century French doors. Any other evidence of the original wall fabric in the parlour is concealed by render. At 5.8 m or 19 ft in total the early-Tudor house was unusually wide by the standards of its day, despite its relatively low height, and would have formed a respectable farmhouse with a significant landholding of perhaps 50 acres.

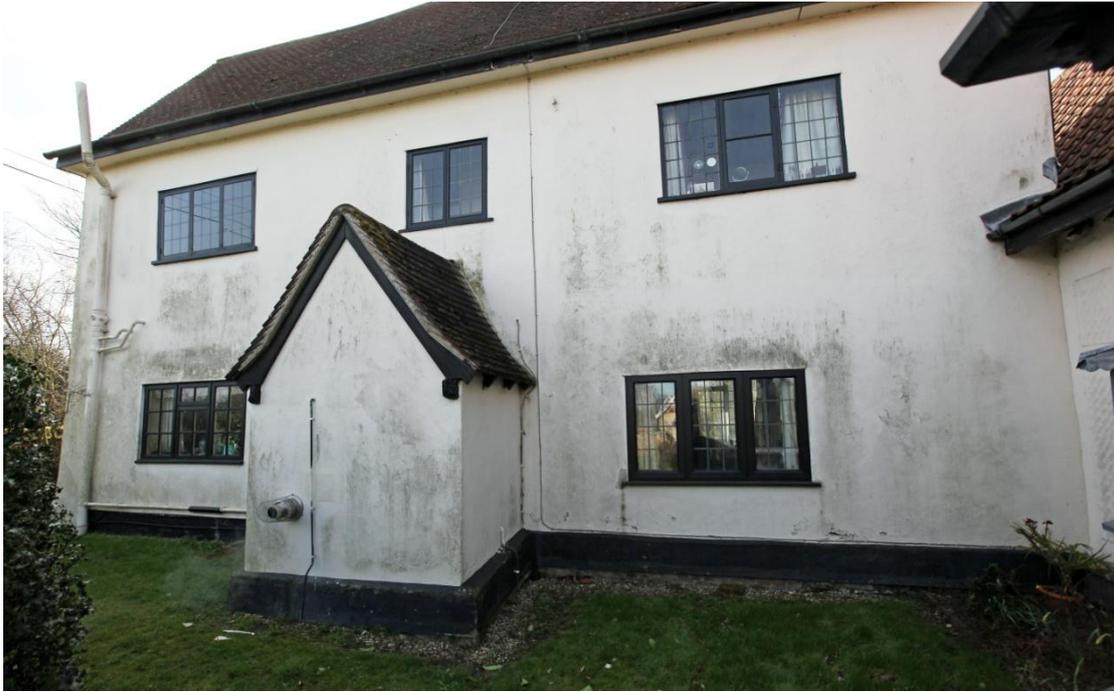
Illus. 3. The north-eastern facade of the extension with its ostensibly original timber-framed entrance porch. Two dormer windows have been removed from this elevation since 1964 and both ground-floor windows replaced (the right-hand example in PVC). The only window that survives from 1938 is the right-hand example on the upper storey which replicates the style of the 18th century but dates from the early-20th. The small central window was inserted between 1938 and 1964 and is identical to its larger counterpart on the left.

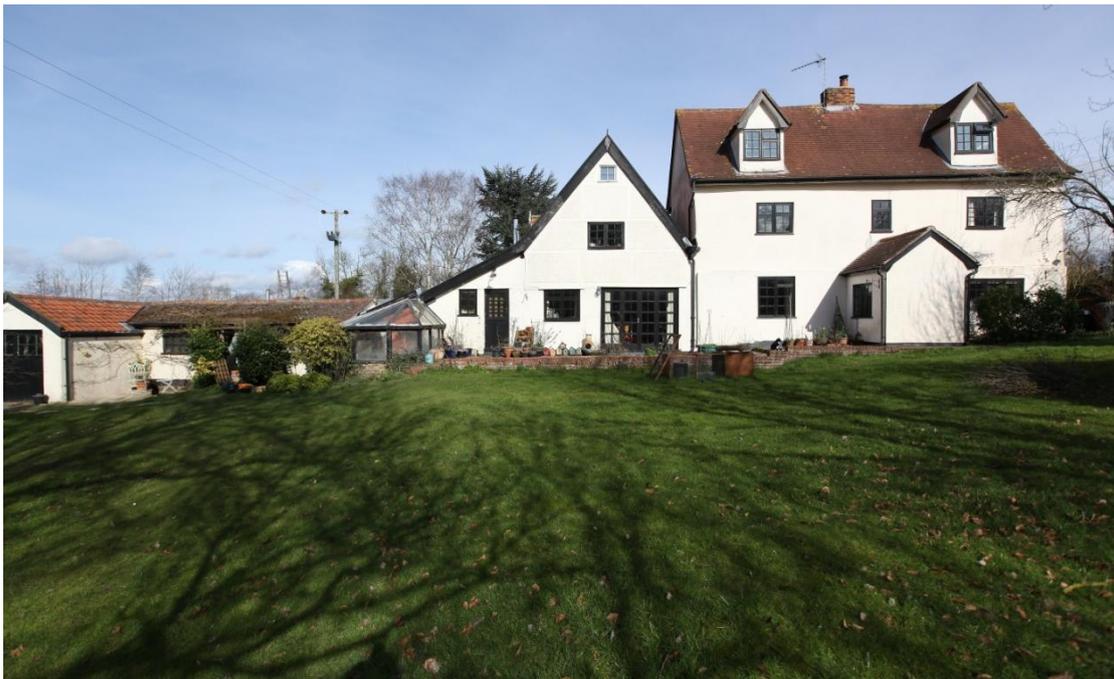
Illus. 4. The house from the site of the demolished farm buildings to the west with the formerly hipped parlour gable of the original house in the centre and the various single-storied extensions of the 1980s on the left. These extensions form part of no. 1 along with the original ground-floor parlour lit by French doors and the two-storied addition to the right. The first-floor room above the parlour belongs to no. 2.

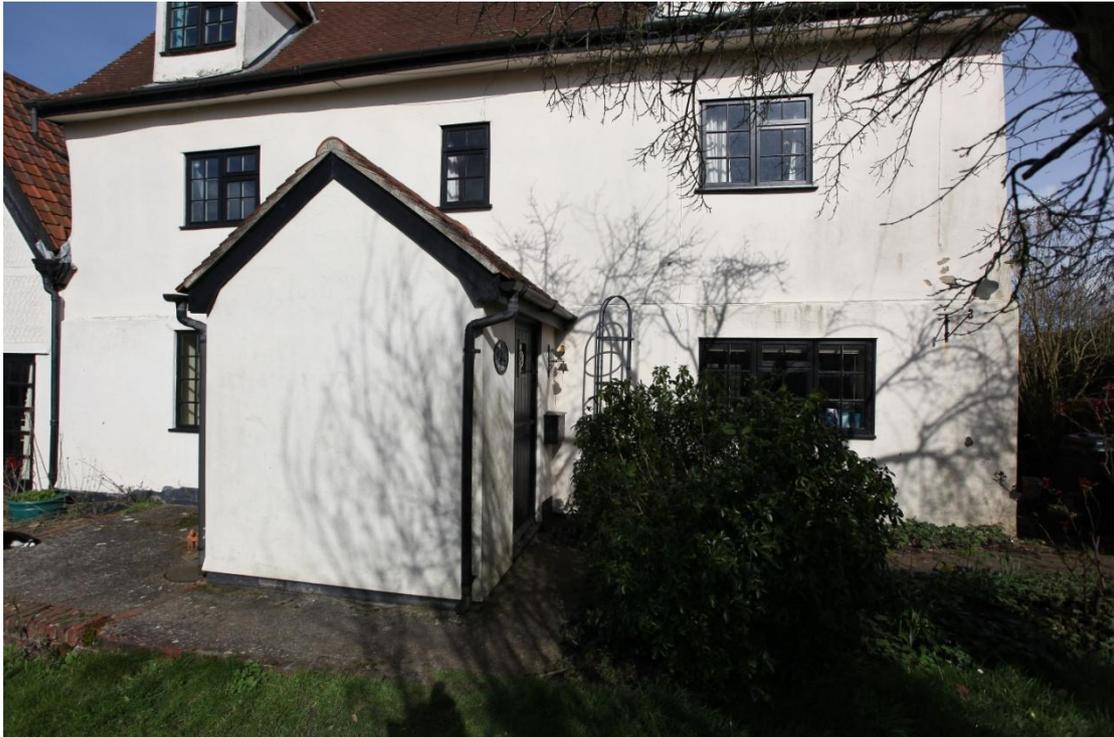
Illus. 5. The orientation of the house was altered as part of a major refurbishment in the 1980s which included the insertion of new dormer windows in the original rear (south-western) elevation and the addition of a new porch with a side-entrance facing the road. The ground and first-floor windows were renewed at the same time and the lower storey rebuilt in cement-rendered brick or block-work.

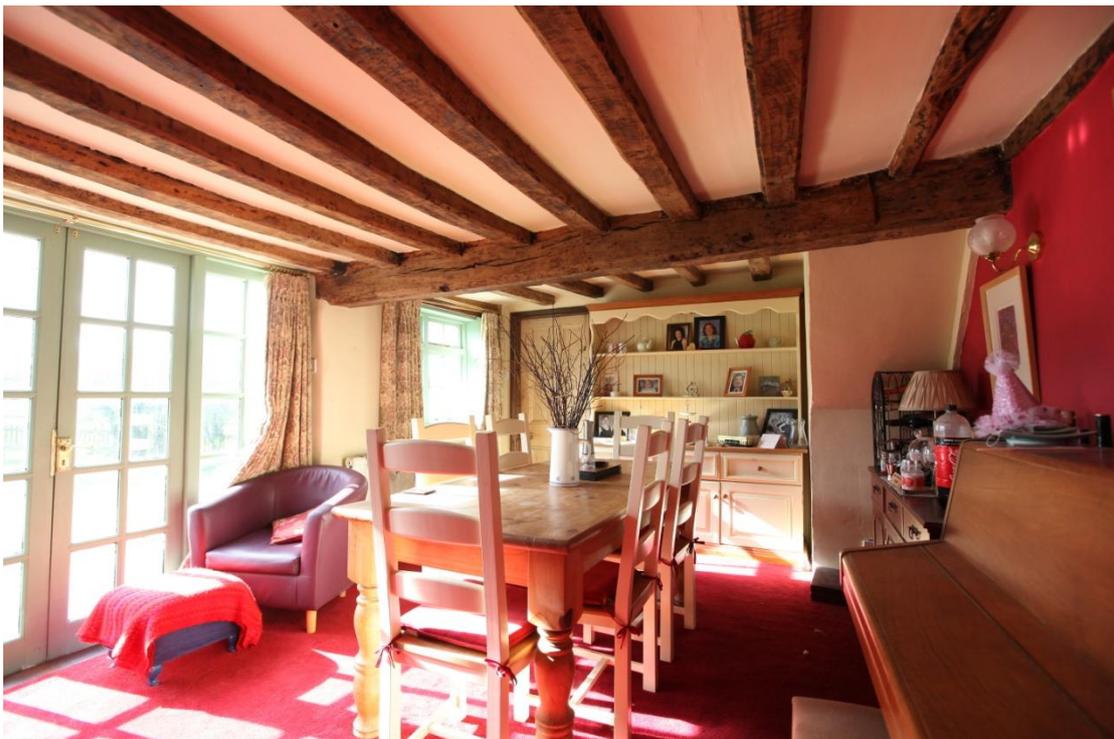
Illus. 6. The early-16th century parlour (1) seen from the south-east with the 1980s French doors shown in illustration 4 on the left. Of the original framing only the neatly chamfered ceiling joists are exposed with a trap adjoining the hall on the right for the missing stair. The hall and the room above belong to no. 2.

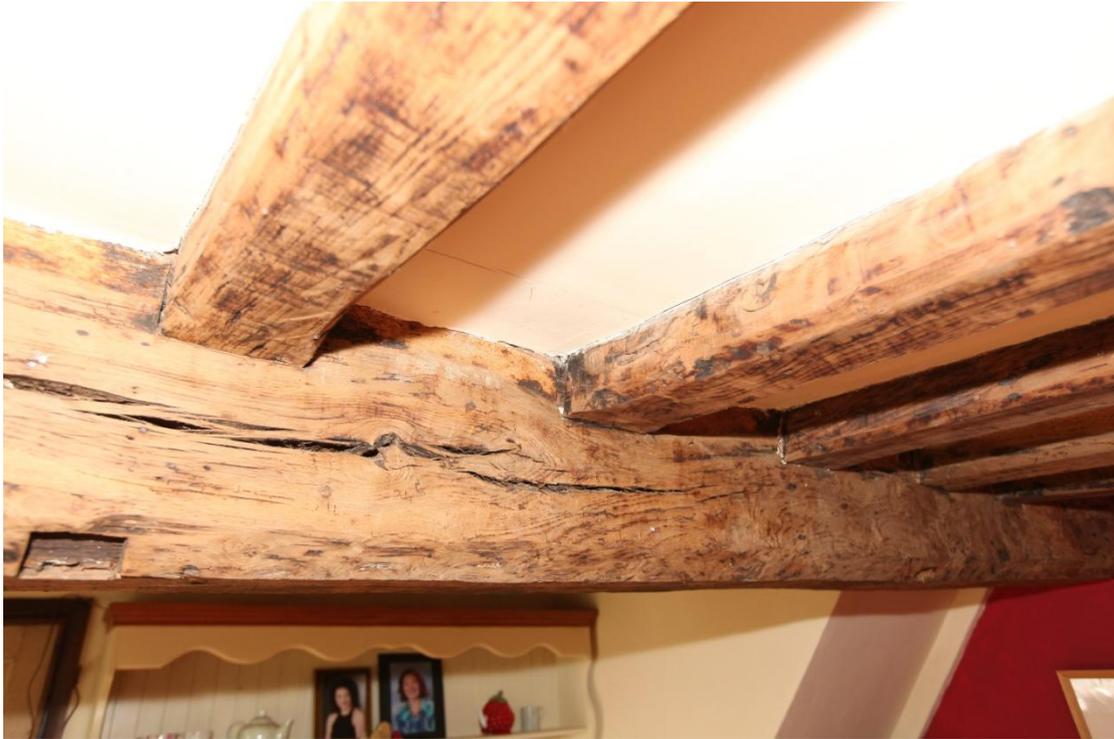
Illus. 7. A detail of the chamfered ceiling joists with small step-steps in the early-16th century parlour (1). The timber has been cleaned by abrasion.

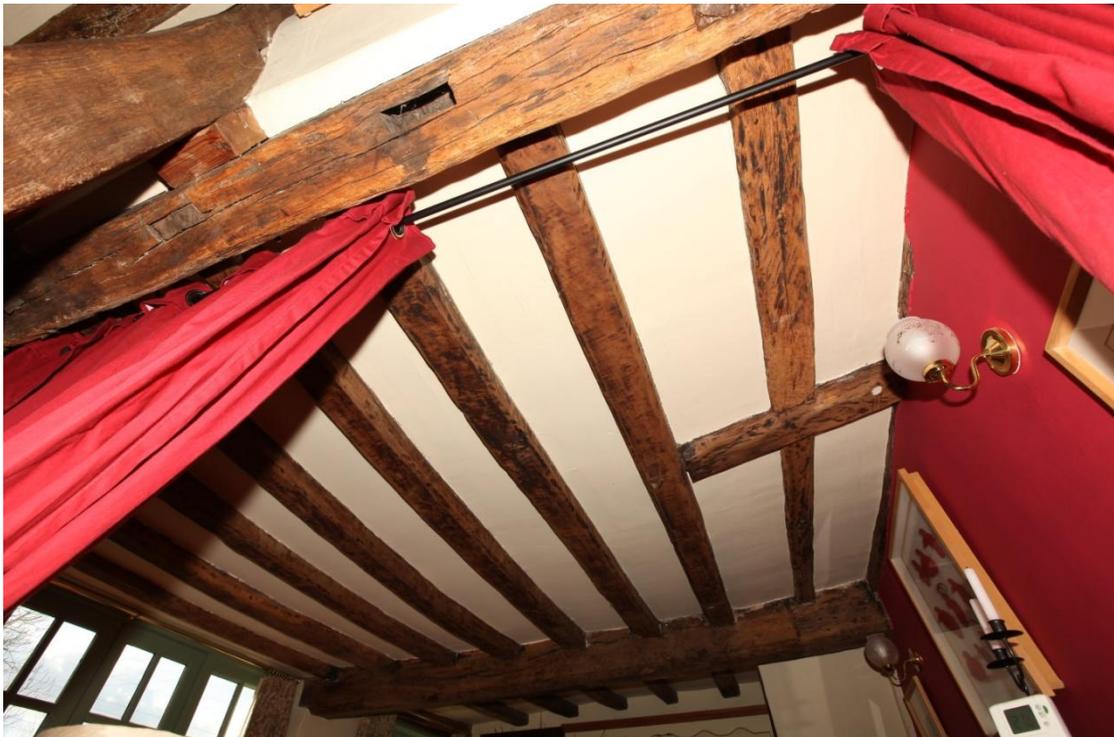
Illus. 8. The early-16th century parlour ceiling (1) from the sitting room in its front extension (2). Empty mortices for the missing studs of the original front wall are visible in the mid-rail above with no gaps for windows. The stair in the blocked trap would have risen from the foot of the original doorway to the hall on the extreme right in a standard late-medieval arrangement.

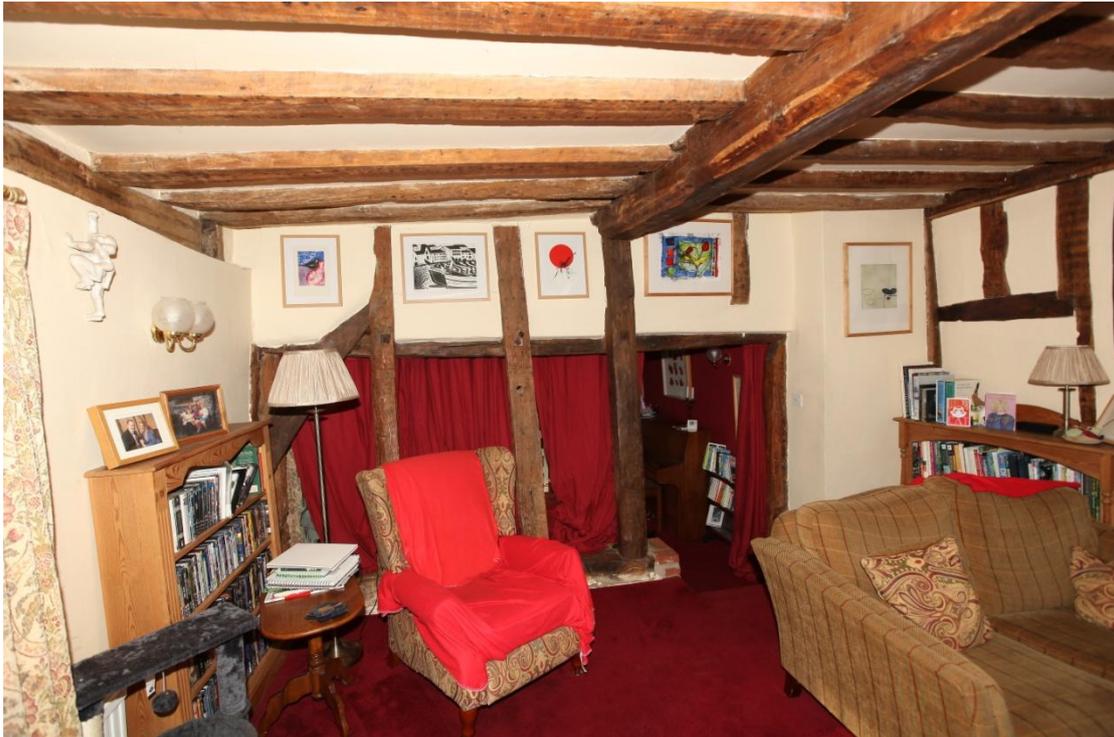
Illus. 9. The north-western wall of the sitting room (2) in the two-storied extension showing the much lower ceiling of the earlier parlour beyond. The blocked door on the right opened into the demolished lean-to shown in figure 7 and is a later insertion.

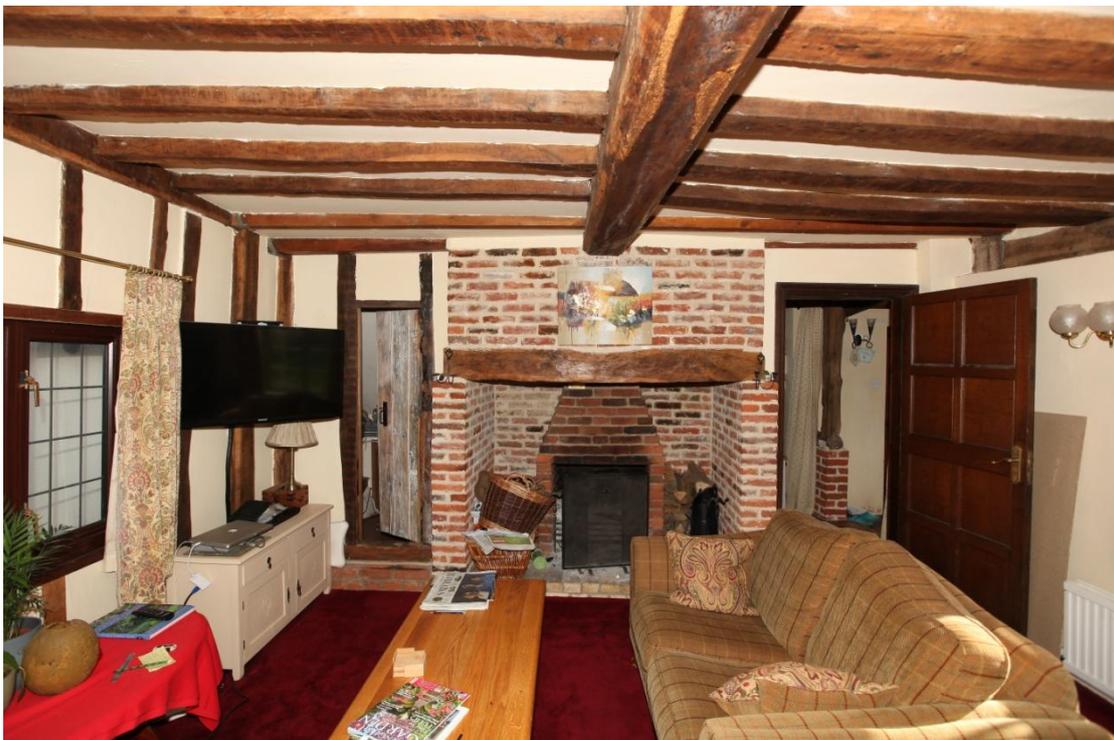
Illus. 10. The fireplace to the south-east of the sitting room (2), with lobbies on each side that open into the original porch on the left and its modern counterpart on the right. The fireplace consists of re-used bricks, some of which are soot-encrusted, and appears to date only from the late-20th century. Curiously the tall-sectioned ceiling joists to the left of the room are tenoned to the mid-rail while their counterparts to the right are flat-sectioned in the earlier tradition and lodged on the mid-rail.

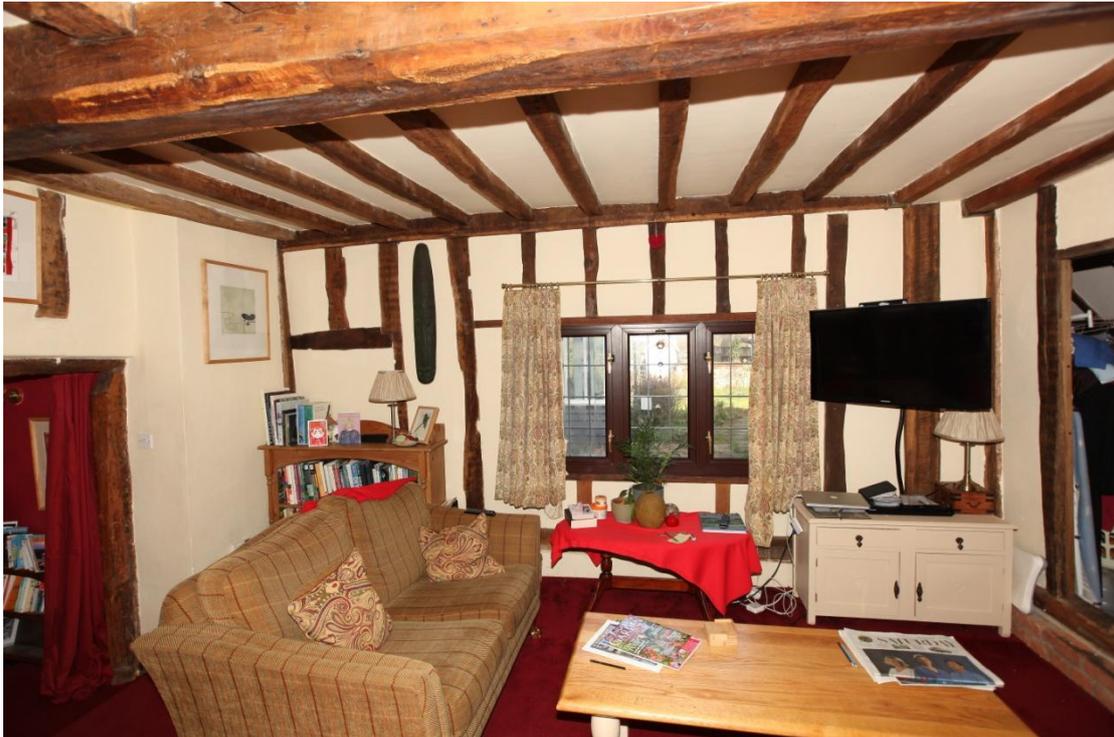
Illus. 11. The original north-eastern facade of the sitting room (2) with its modern PVC window and the blocked secondary door to the former lean-to addition on the left. The tall-sectioned ceiling joists are tenoned to the mid-rail, with no evidence of flat-sectioned predecessors, and the rail contains pegged mortices for three studs on each side of a central window. The narrow studs above the present window are later replacements.

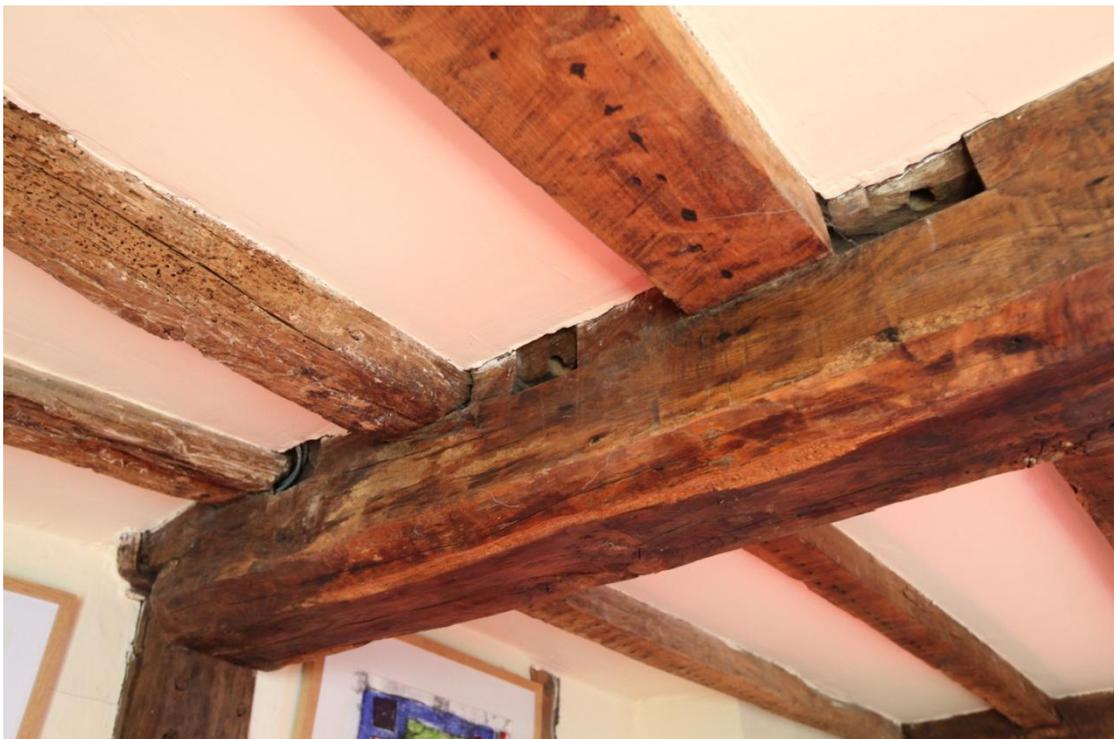
Illus. 12. A detail from the south-west of the axial ceiling joist in the sitting room (2) showing pegged mortices for original smaller, tall-sectioned joists matching those visible in the rear. The large, flat-sectioned joists in illustration 13 are either replacements or more probably re-used timbers intended to be hidden by plaster.

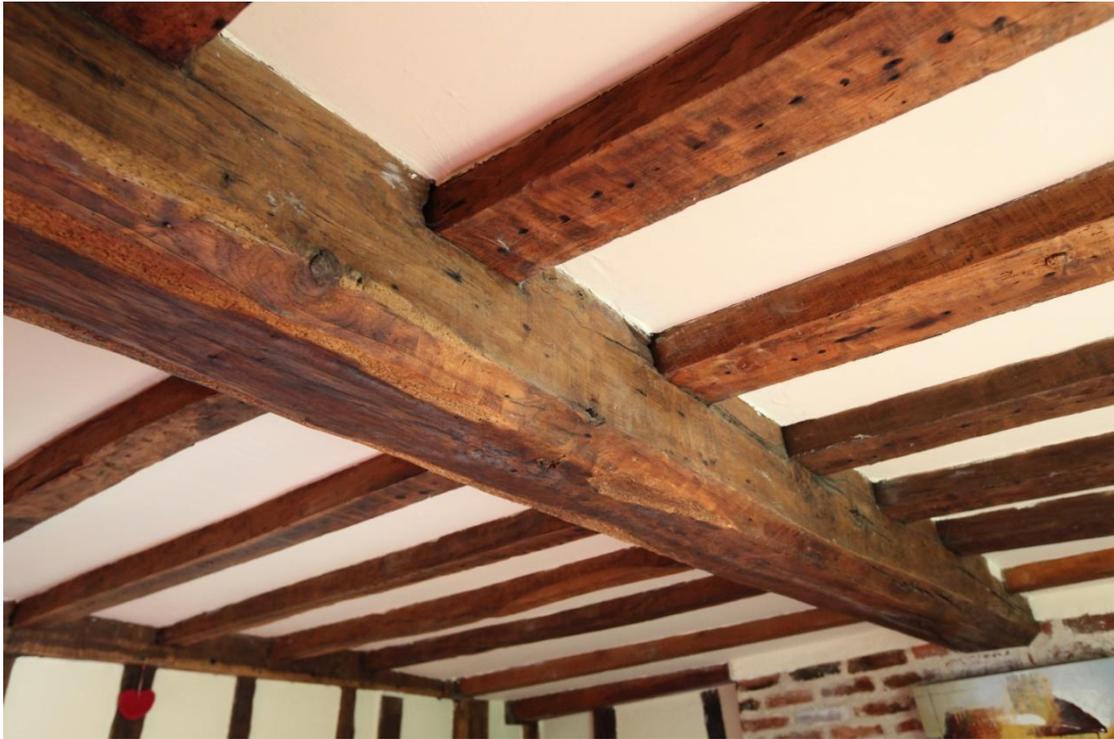
Illus. 13. The ceiling of the sitting room (1) from the north-west showing its unusual combination of narrow, tall-sectioned joists to the left of the axial joist – all tenoned to the mid-rail – and flat-sectioned joists on the right which are lodged on the mid-rail.

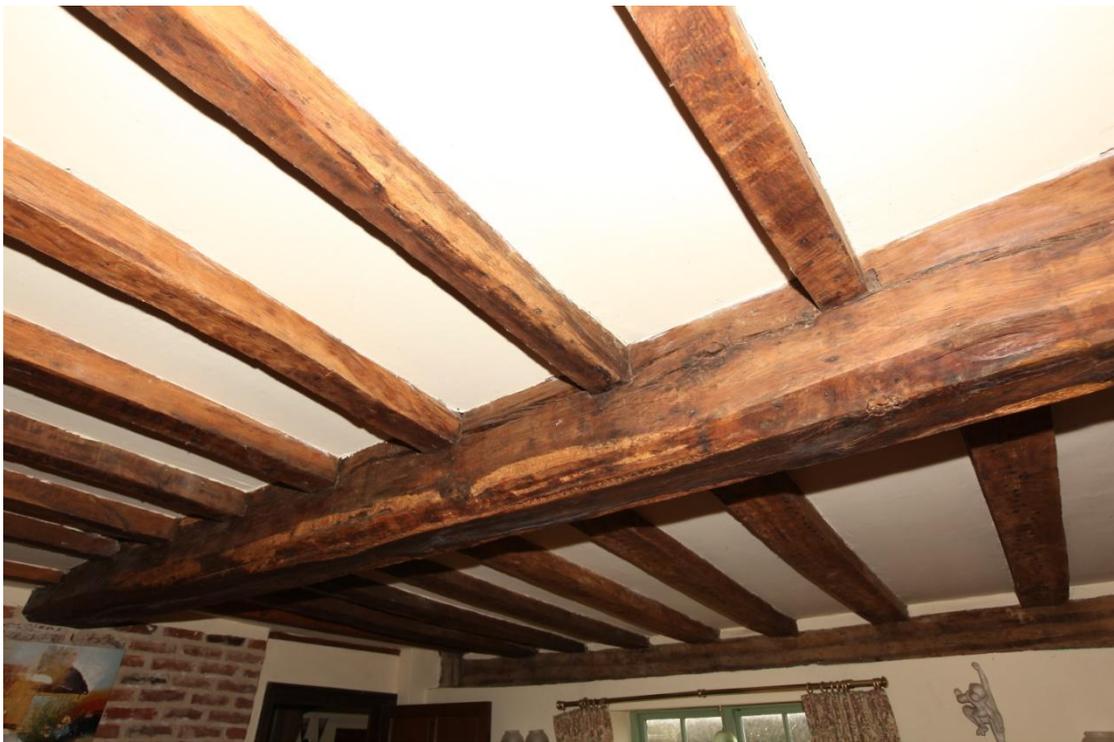
Illus. 14. The opposite side of the axial joist in the sitting room (1) showing the tall-sectioned common joists with no mortices for flat-sectioned predecessors. The mid-rail in the rear lacks joist mortices but is otherwise identical that of the original facade with three pegged stud mortices flanking a central gap for a window. It is highly unusual to find two entirely different forms of carpentry in the same structure.

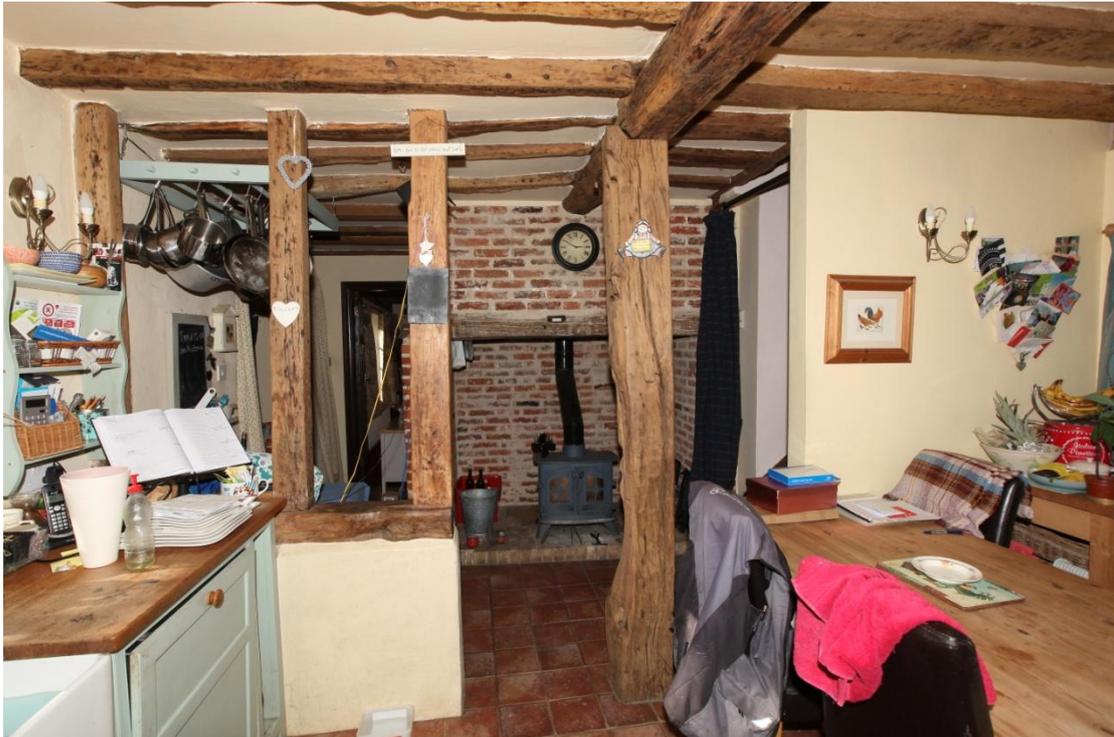
Illus. 15. The kitchen (3) from its south-eastern gable showing the re-used timbers of a partition that was probably inserted in the 1980s to frame the staircase on the right of the fireplace.

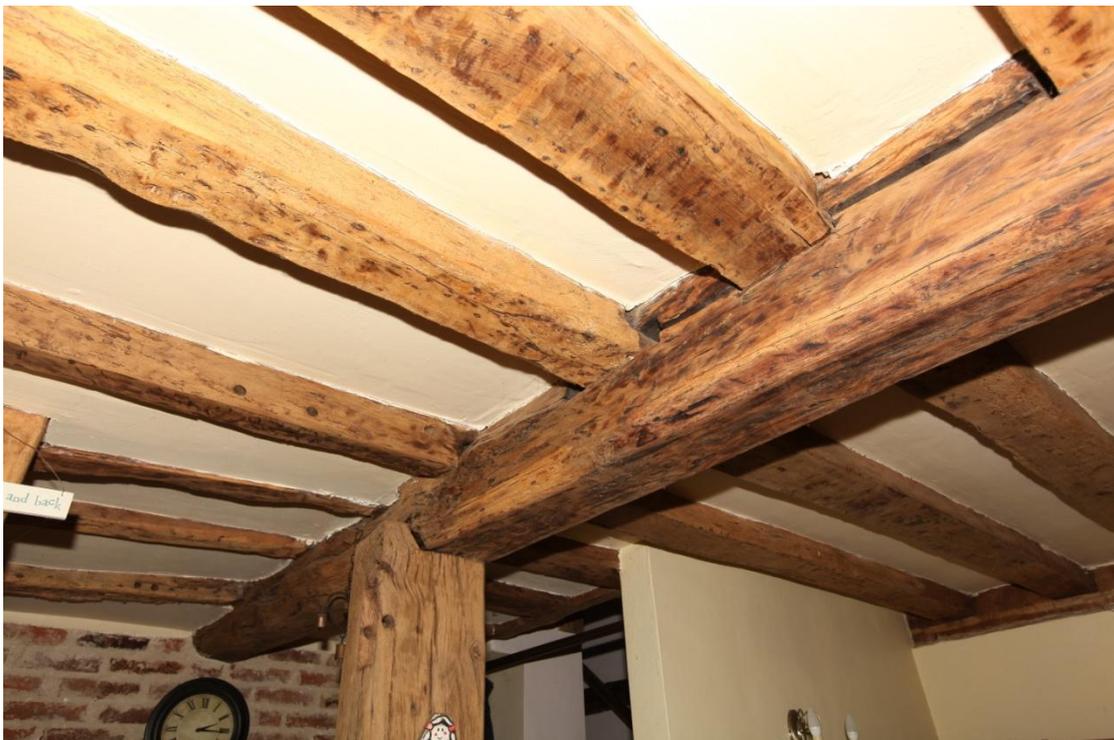
Illus. 16. The ceiling of the kitchen (3) where the joists are also tenoned to the front mid-rail to the north-east and lodged on the rear but consist entirely of flat-sectioned timbers. The four joists to the left in this image have been replaced with re-used timber and may indicate the position of an earlier stair. Exposed framing had ceased to be fashionable by the mid-17th century and these timbers would have been hidden by insulating plaster initially.

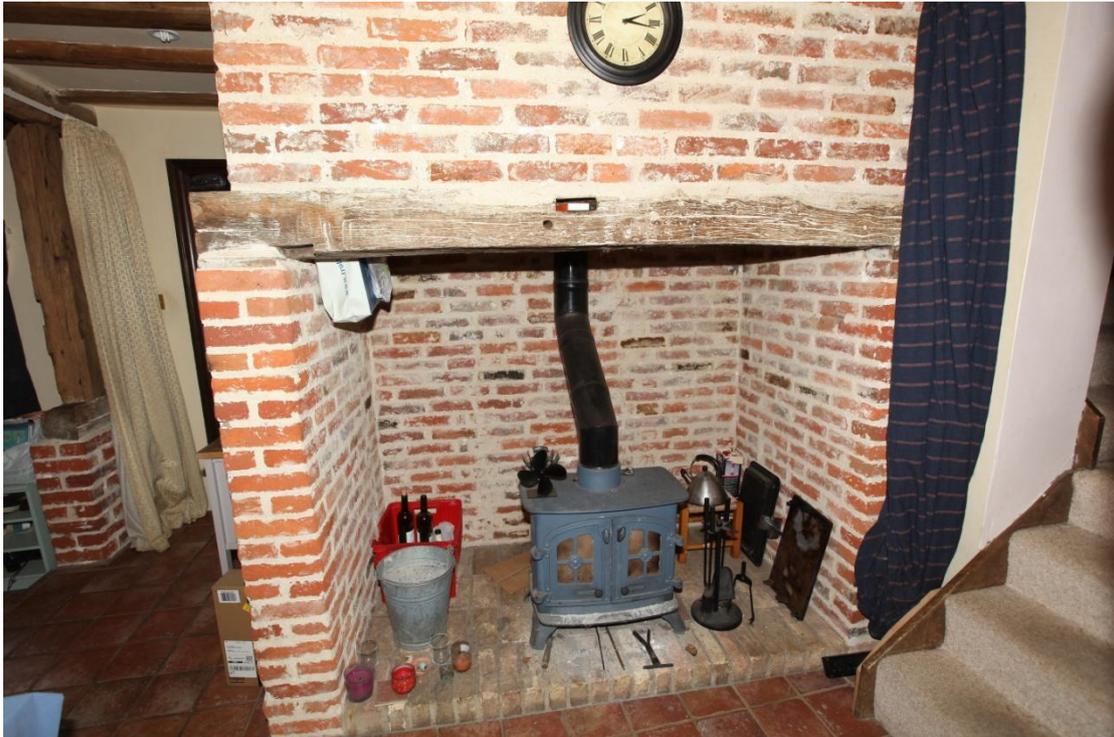
Illus. 17. The fireplace facing the kitchen (3) with the foot of the 1980s staircase on the right and the modern entrance porch to the left. The timber lintel and bricks are re-used, like those of the sitting room (2), and the entire chimney appears to have been rebuilt as part of the 1980s refurbishment. The flue above consists entirely of modern Fletton bricks laid in cement mortar where visible in the roof void.

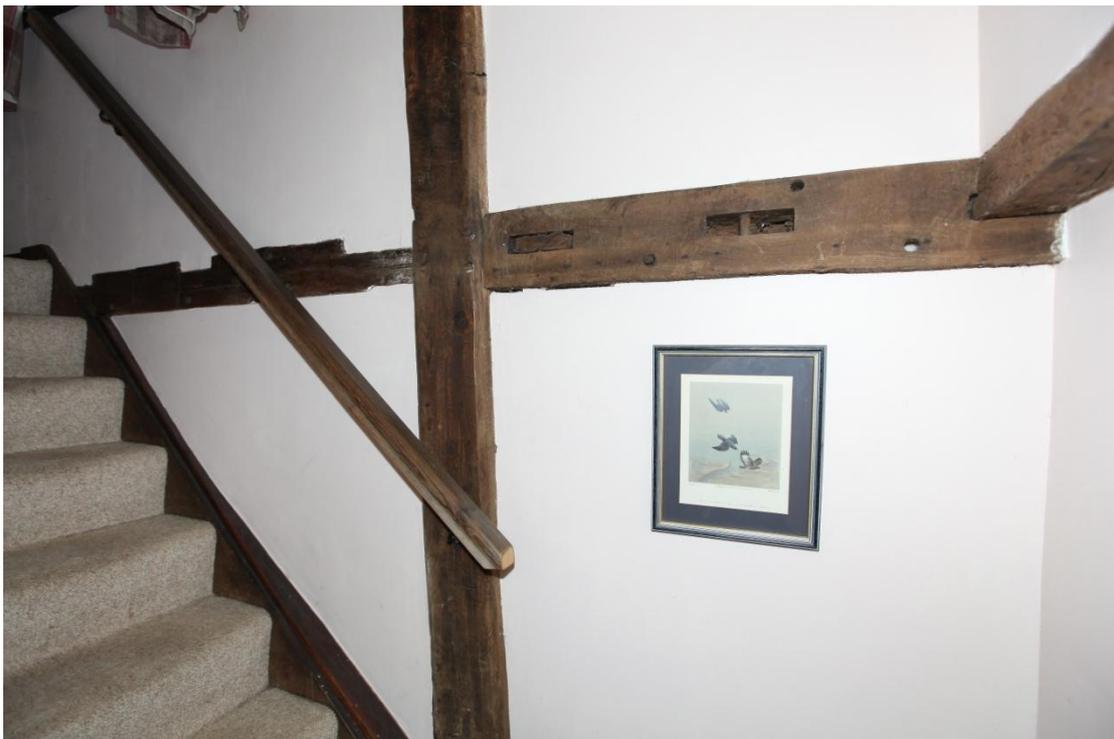
Illus. 18. The exposed framing of the original facade against the modern stair showing mortices for flat-sectioned joists in the mid-rails which are tenoned to the central storey post. These joists were removed to accommodate the stair which probably lay on the other side of the chimney initially.

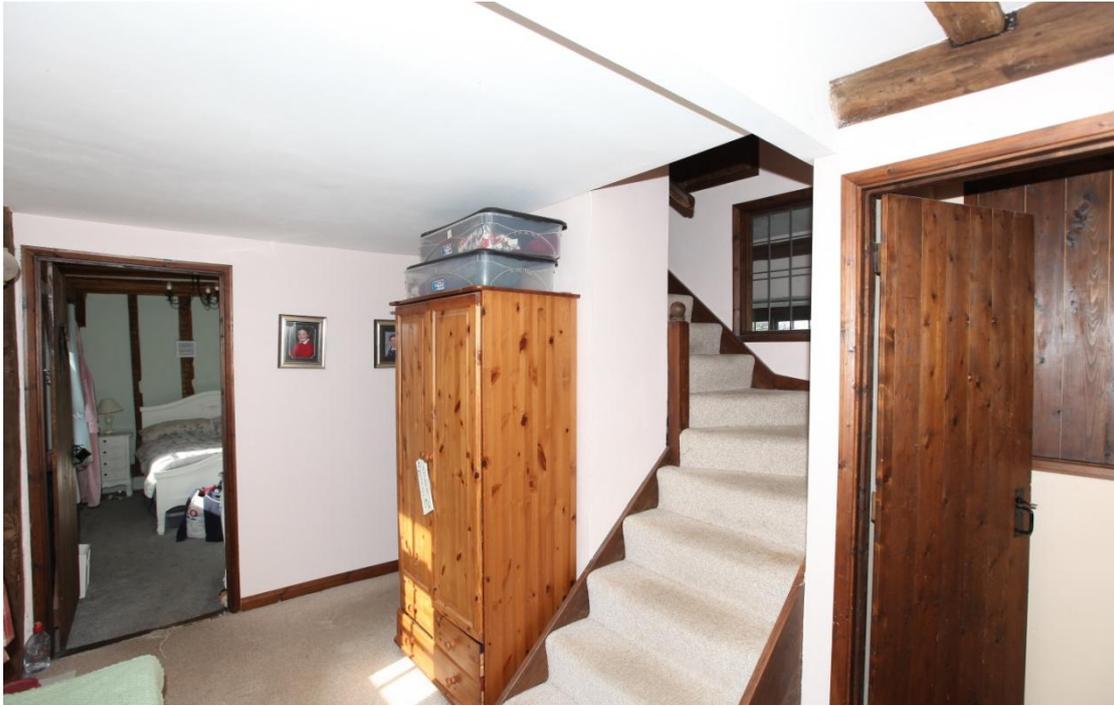
Illus. 19. The stair landing on the first floor as seen from the south-east with the narrow, rebuilt chimney of rendered Fletton brick in the centre. Like the chimney the internal partitions and doors at this level date almost entirely from the extensive refurbishment of the 1980s. The large original chimney in figure 7 would have contained 17th century fireplaces heating the bedrooms rooms on each side.

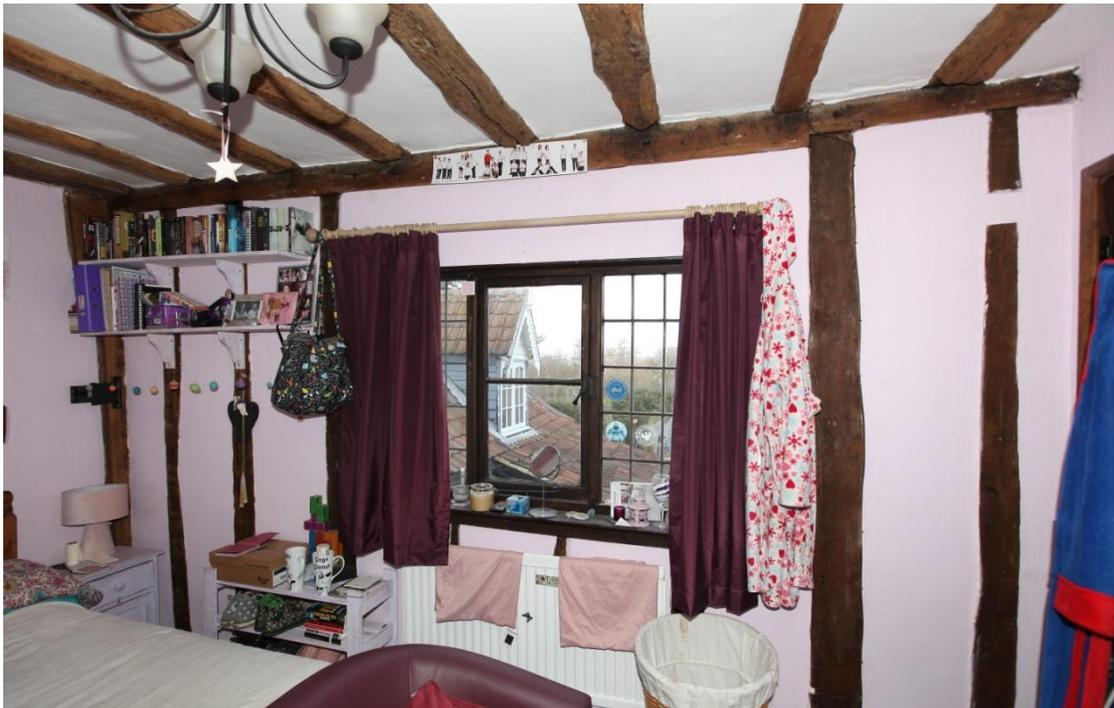
Illus. 20. The early-20th century leaded-light casement window in the original north-eastern facade of the bedroom above the sitting room (2). The ostensibly original ceiling joists on the first floor consist largely of re-used timbers, as do the small areas of exposed wall framing. The rails supporting the joists lie approximately 12 inches below the chamfered roof-plates to create low vertical walls on the attic storey and the base of a jowled corner post is visible to the left.

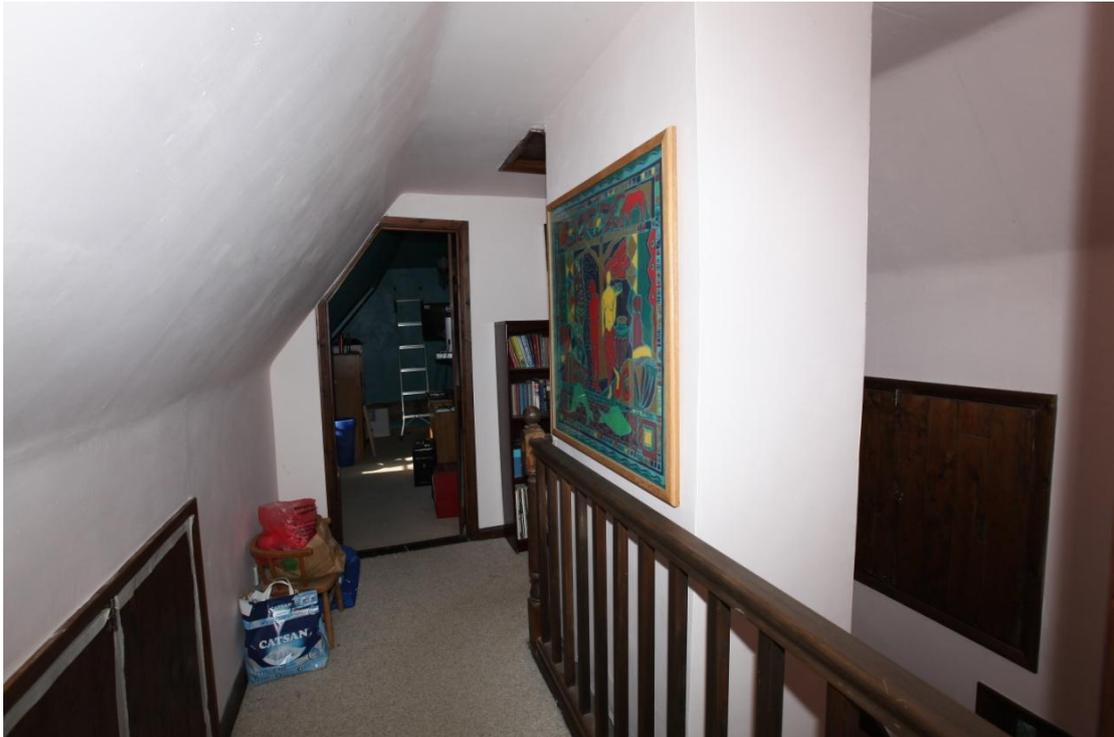
Illus. 21. The central stair landing of the attic storey, as seen from the south-east. The narrow Fletton-brick chimney, partitions and balustrade date only from the 1980s, as do the dormer windows to the south-west (left). The roof structure is hidden by plasterboard but a number of original rafters are visible above the ceiling and retain traces of soot-encrustation having been re-used from a medieval open hall.
