1 Bridges Cottages, Darmsden, Suffolk

Heritage Asset Assessment

March 2021

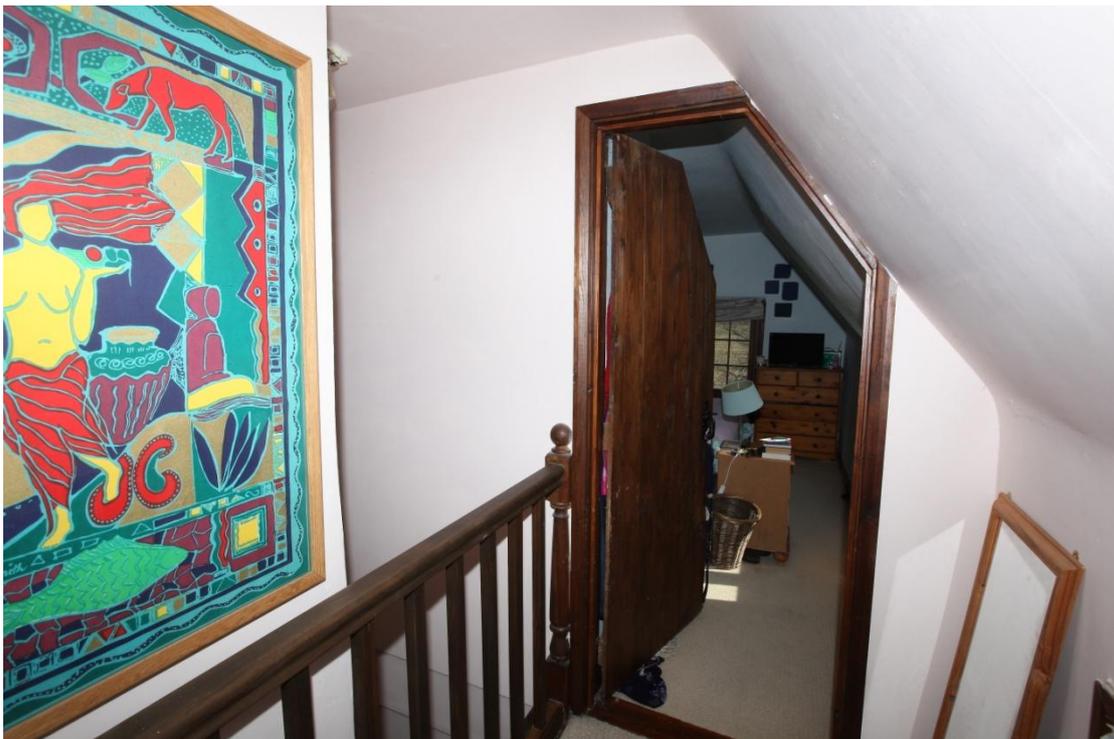
Illus. 22. The attic stair landing looking towards the south-eastern gable showing the late-20th century balustrade and plasterboard partitions. This level of the house was previously lit by dormer windows in the north-eastern facade and has been altered almost beyond recognition.
