Adonis Ecology

A Preliminary Bat Roost Assessment and Nocturnal Bat Survey of 1 Bridges Cottages, Darmsden to support a Planning Application

Project Ref: 1708

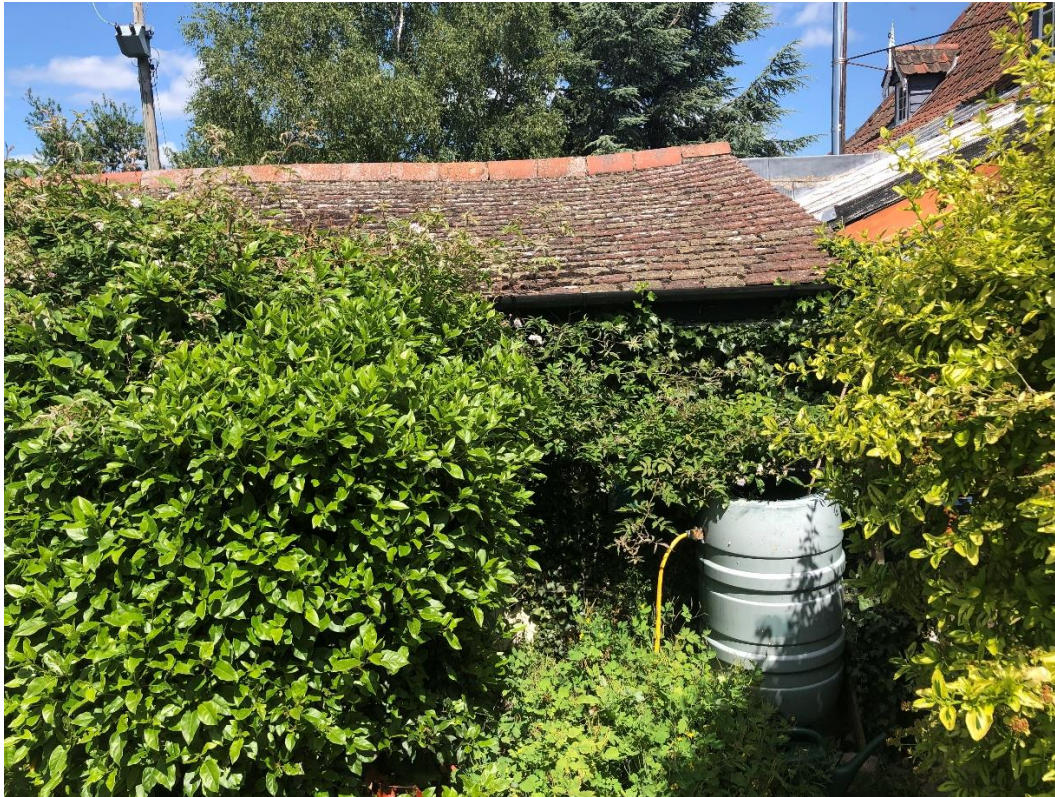
Photograph 1: Building 2 Utility room

3.2.2 These two buildings were adjacent to each other, the utility room (see Photograph 1 in Appendix 2) being internally approximately 3m long and 2.5m high with a rendered ceiling and very light due to a window with no signs of bat activity seen. The building being used as a gym (see Photograph 2 in Appendix 2) was the same internal height 2.5m and around 4m long. The internal roof space was mostly lined with bitumen felt and some plasterboard. A very light space again due to a window with no signs of bats.

3.2.3 From the outside, the building’s roof was tiled and had terracotta ridge tiles. Two lifted tiles were seen during the PRA but examination by torch showed no signs of roosting bats.

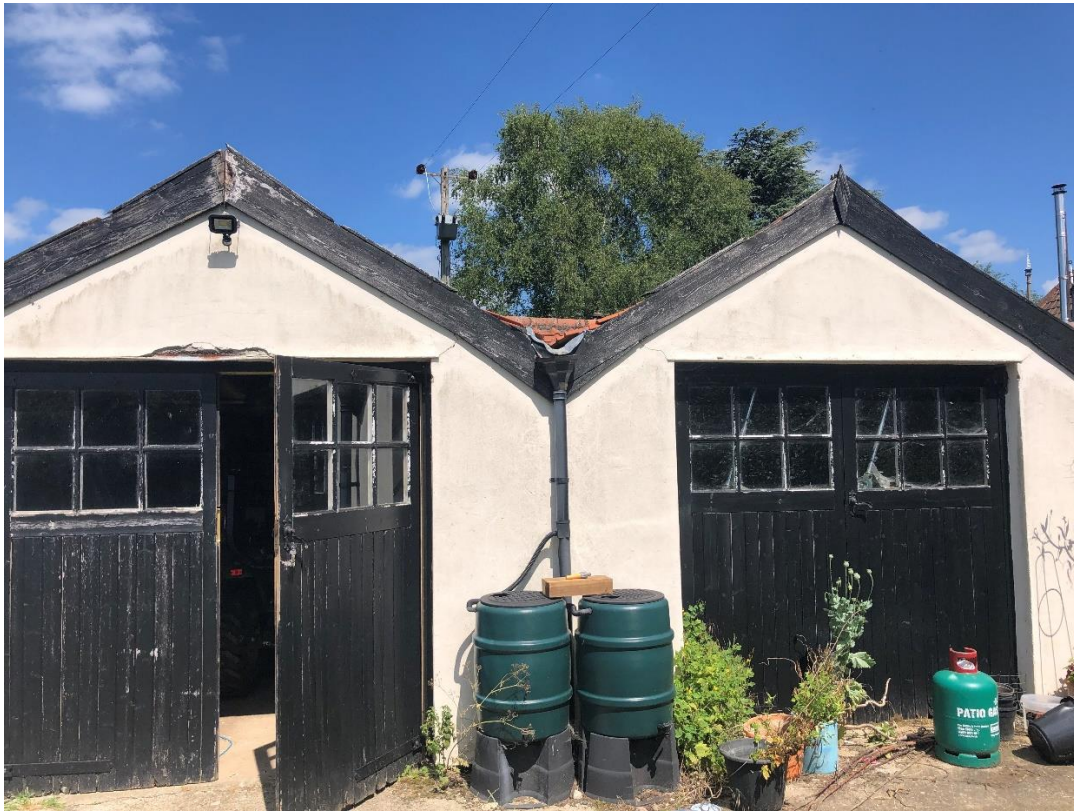
Photograph 3: Building 4 Double garage

- 3.2.4 The double garage was around 3.5m high internally and approximately 6.5m long with a 3m x 3m workshop at the north-western end. The internal roof space was bitumen felt lined with some additional fibreboard on the eastern side of the roof ridge. The internal roof ridge was found to be largely cobwebby. Both garage doors had large glass windows making the internal space very light (see Photograph 3 in Appendix 2). The inside space was used for storage. The occasional mouse dropping was found but no signs on bat activity.
- 3.2.5 Externally there was possible access through gaps in the garage doors and open windows. There were 24 lifted roof tiles seen during the PRA which upon further examination by torch showed no signs of roosting bats, with around six not accessible for examination.
