28 Kirlegate, Meare, Somerset BA6 9TA

Bat Survey - Preliminary Roost Assessment

26th September 2022

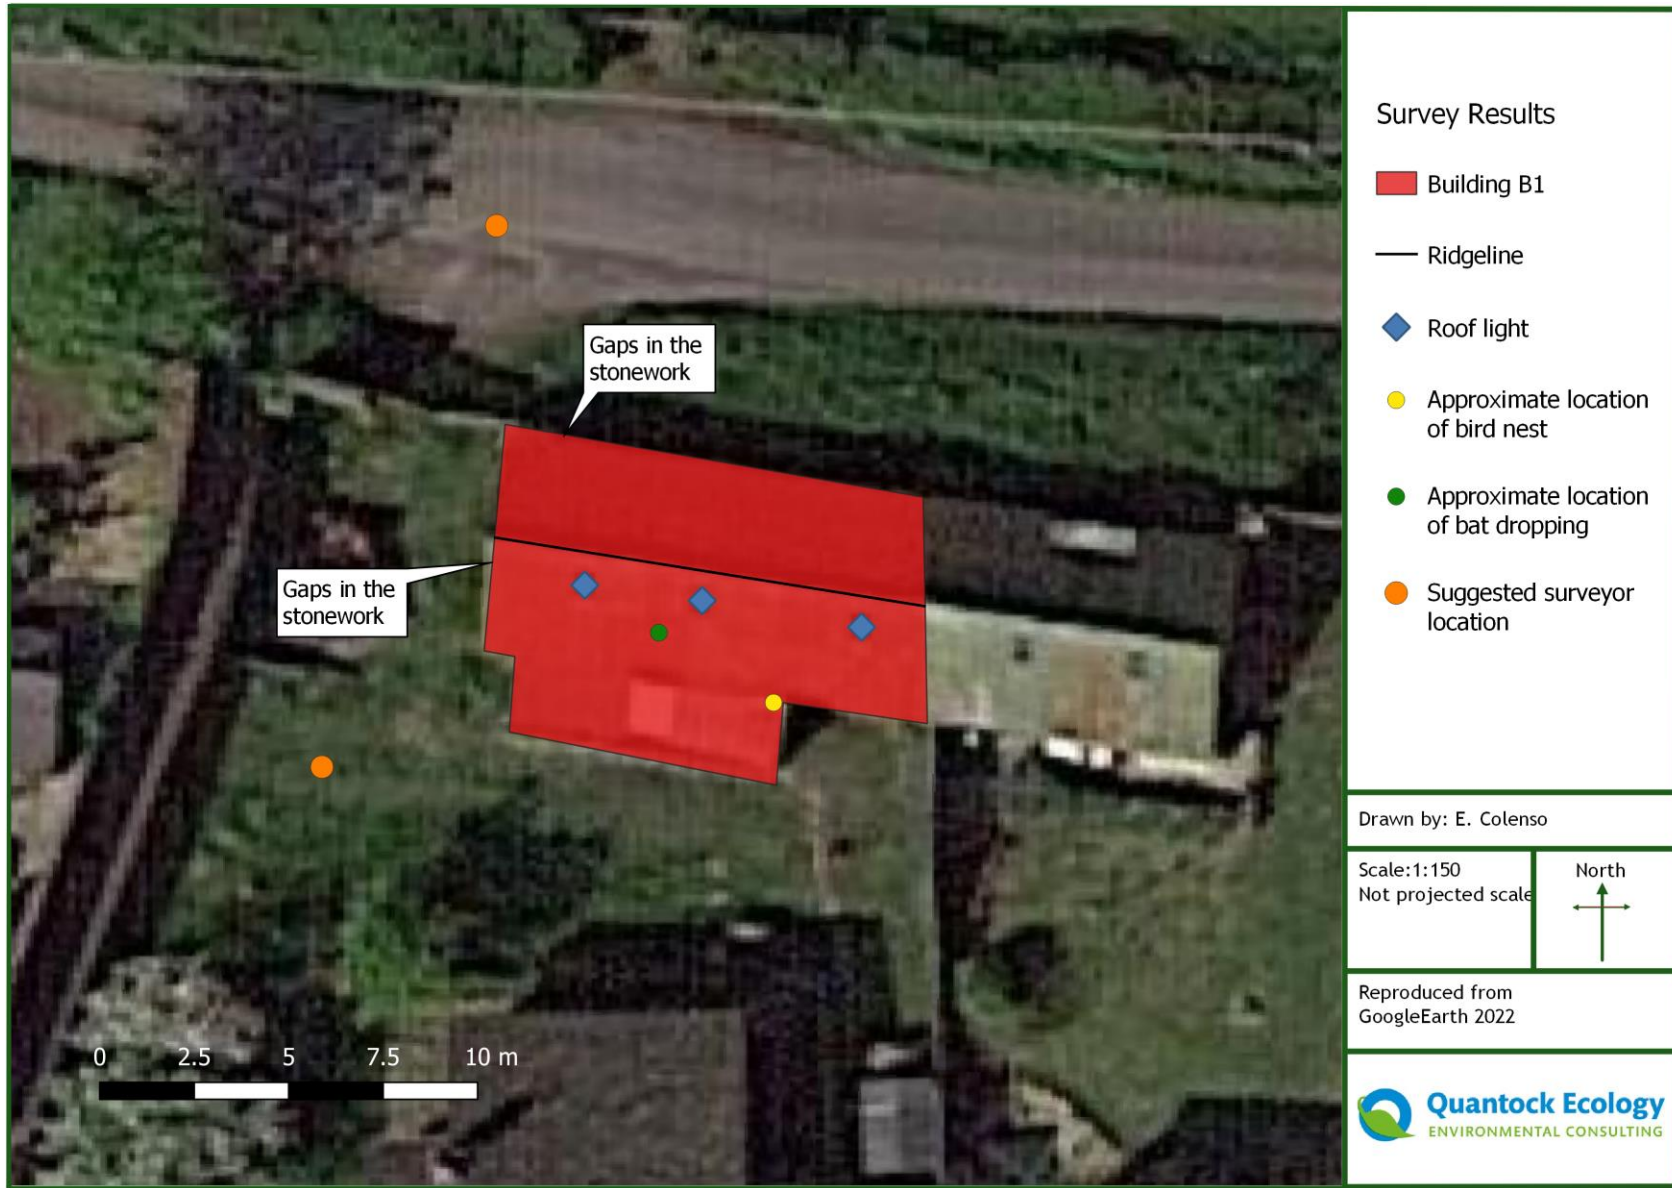
Appendix 1: Survey Plan

The building within the survey area comprised an old stone barn with a small, mono pitched lean-to situated off the southern elevation. The barn was connected to a neighbouring property on its eastern elevation. Each building or structure is referenced, as illustrated in the map in Appendix 1.

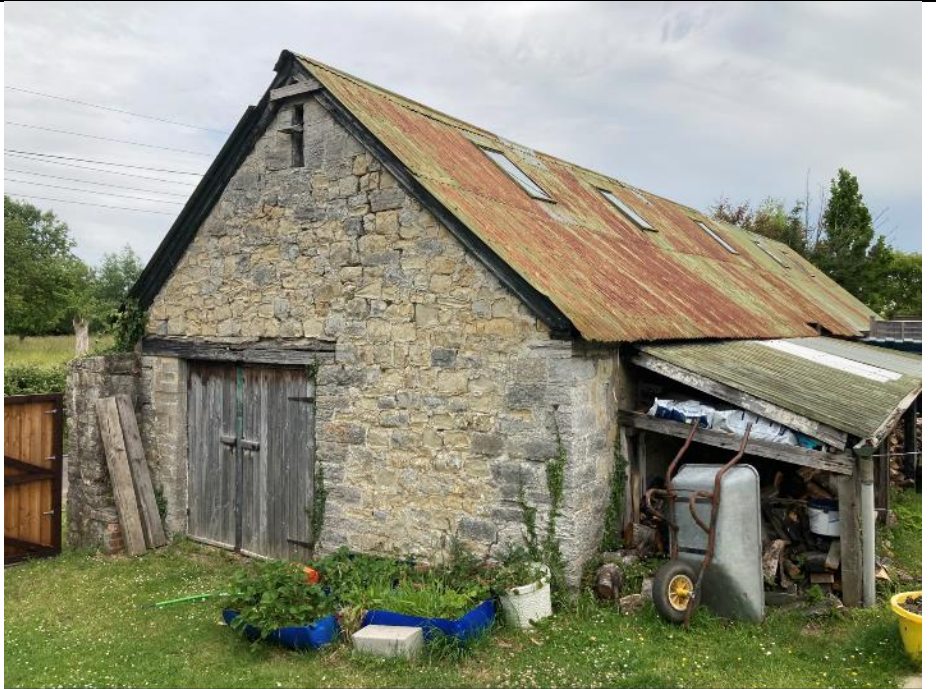
Building B1 comprised a stone barn with a conventionally pitched, corrugated metal roof (see Appendix 3, photo 1). Some gaps were noted under the metal ridgeline due to the corrugated design of the roof sheets, however these were shallow and exposed. Three roof lights were present on the southern roof pitch. These were tightly fitted with no gaps around their frame. The wooden fascia around the building was lifted away from the stone walls, leaving large gaps beneath it (see Appendix 3, photo 2). The gap beneath the fascia on the northern elevation was generally either sealed by a wooden beam or full of cobwebs (see Appendix 3, photo 3). It was assessed that the opening present in the blockwork at the apex of the western gable end led directly into the interior of the building. The remaining stonework on the western gable end had a number of gaps and cracks in the mortar (see Appendix 3, photo 2). A section of missing stonework was also noted at the eastern end of the southern elevation (see Appendix 3, photo 4). The gap created was very open and did not appear to form any deeper crevices upon inspection. The

Photo 1: Showing the southern and western elevation of the building B1 and the small lean-to off the southern elevation.

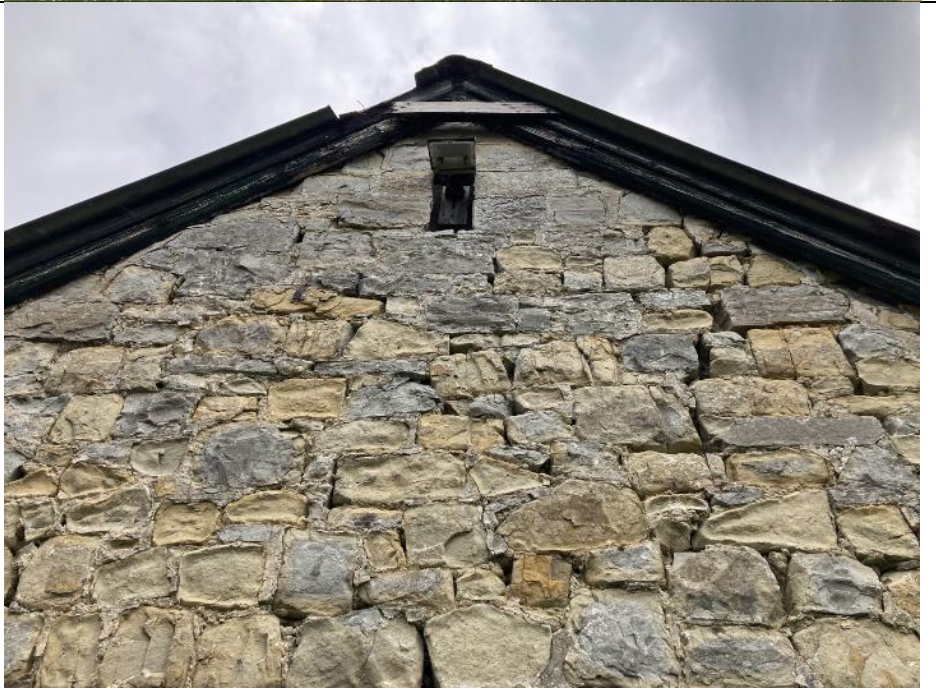
Photo 2: Showing the gaps under the fascia of the western gable end as well as the gap in the stonework at the apex and across the areas of missing mortar.

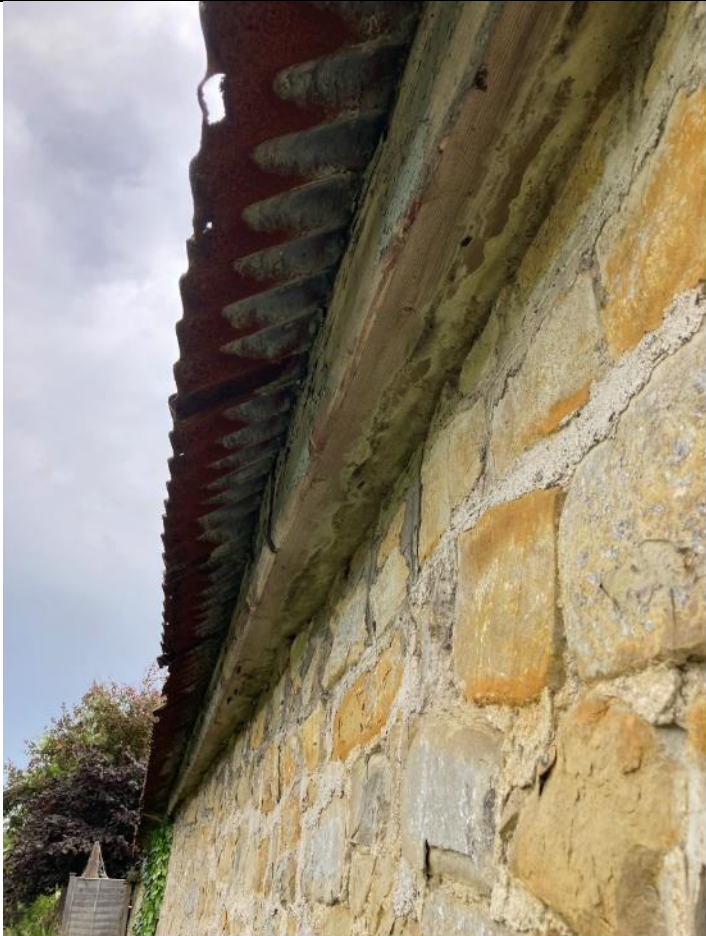
Photo 3: Looking east along the northern fascia.

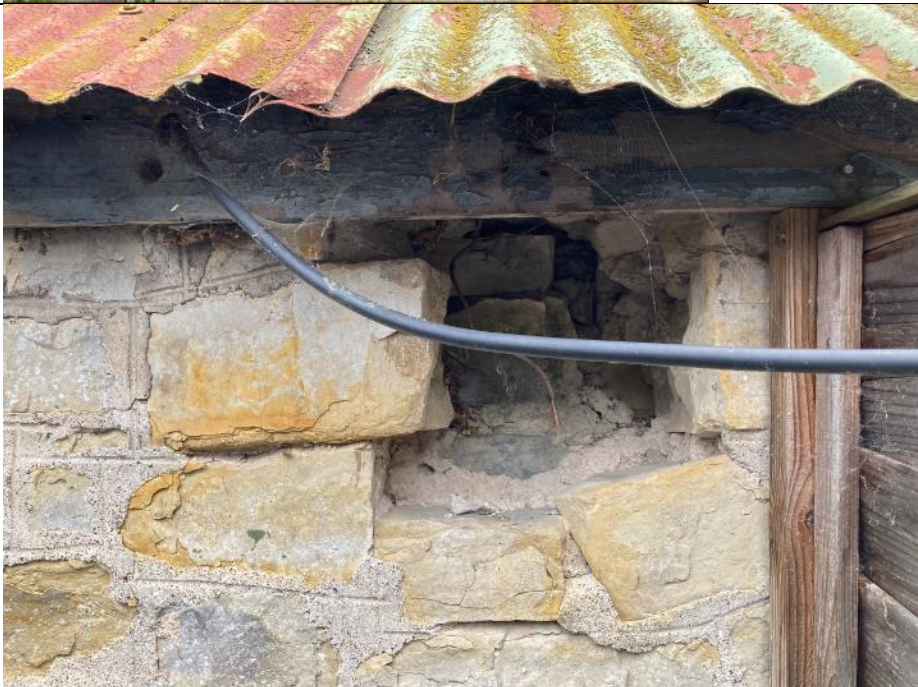
Photo 4: Showing the area of missing stonework at the eastern end of the southern elevation.

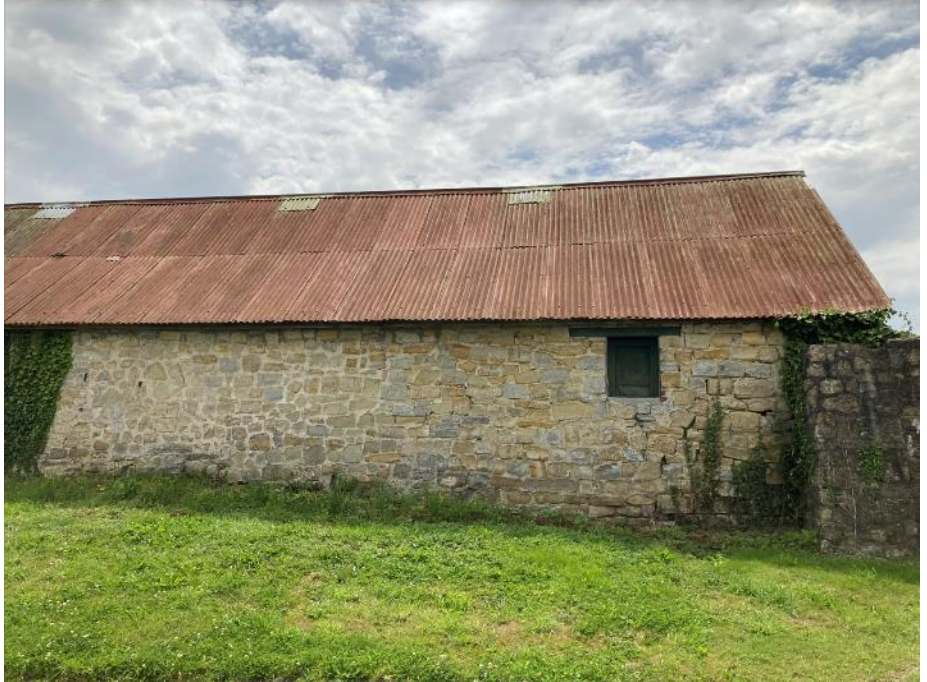
stonework on the northern elevation was generally in good condition however, the western end had some gaps and cracks where the wall had bowed (see Appendix 3, photo 5). The wooden door on the western gable end had some gaps around the lintel however the door itself was well fitted with no large gaps around its frame. The door on the southern elevation was also tightly fitted. The wooden 'window' on the northern elevation had a number of large gaps and cracks around the frame, which either led directly into the interior or into the stonework of the surrounding walls (see Appendix 3, photo 6). A small mono pitched lead to was present off the southern elevation of the main building (see Appendix 3, photo 1). This was ~2m tall at its apex and was in use as a wood store. The roof comprised a mixture of corrugated metal and plastic sheets. The eastern, southern and western elevations of the lean-to were all open. Due to the piles of wood within the building, most of the southern elevation of the main building was obscured.

Photo 5: Showing the northern elevation of B1 with gaps in the stonework at the western end of the wall.

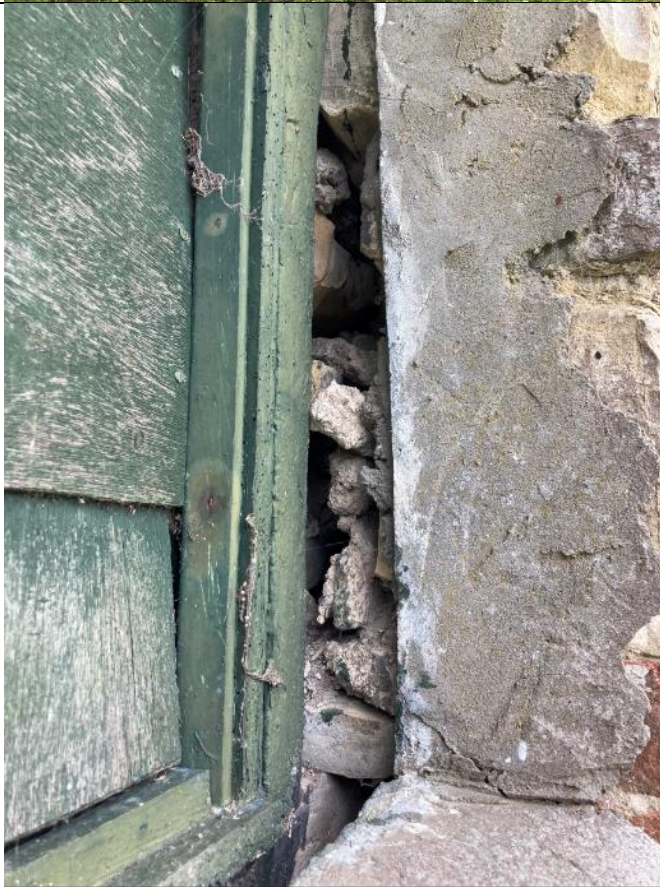
Photo 6: Showing the gaps in the stonework around the wooden window on the northern elevation of B1.

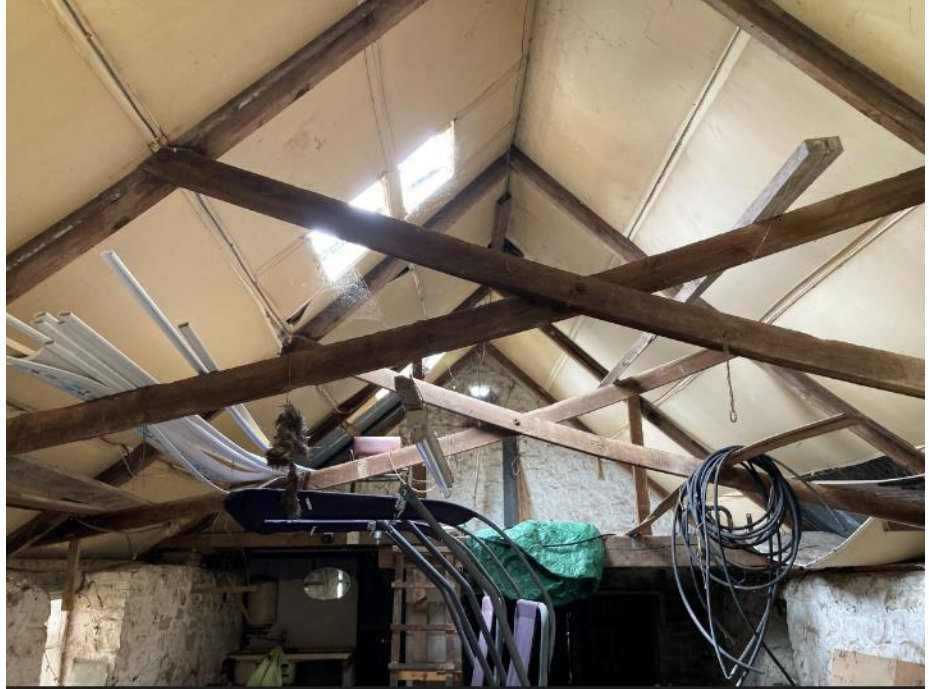
Internally the main building lacked a loft space, leaving the wooden structure exposed (see Appendix 3, photo 7). The roof was partially boarded by plaster board with some sections of corrugated metal left exposed. The space was light due to the southern facing roof lights. The breezeblock wall comprising the eastern elevation was in good condition, however large gaps were present along the wall top where this met the metal roof (see Appendix 3, photo 8). The northern and southern wall tops were exposed and the internal stonework was in good condition with no gaps or cracks. The mezzanine floor at the western end of the building created two small, darker rooms beneath it. These were full of cobwebs at the time of the survey. Access onto the mezzanine was restricted due to safety concerns. Internally the roof of the lean-to was exposed and the space was light and open due to the lack of walls (see Appendix 3, photo 9).

Photo 7: Looking west within the main building showing the internal roof structure.

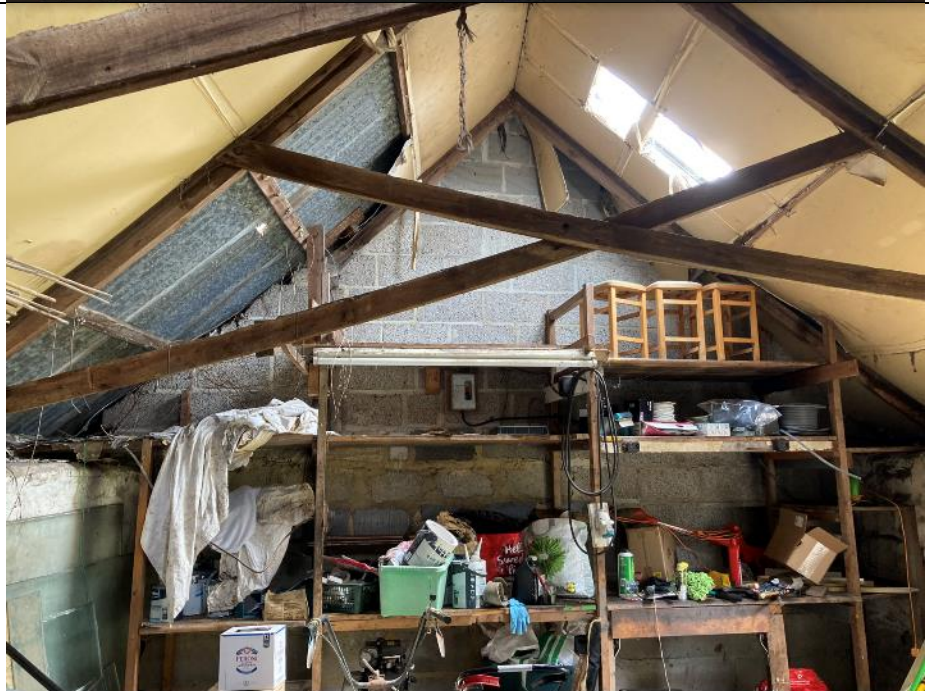
Photo 8: Looking at the eastern gable end showing the gaps along the wall top.

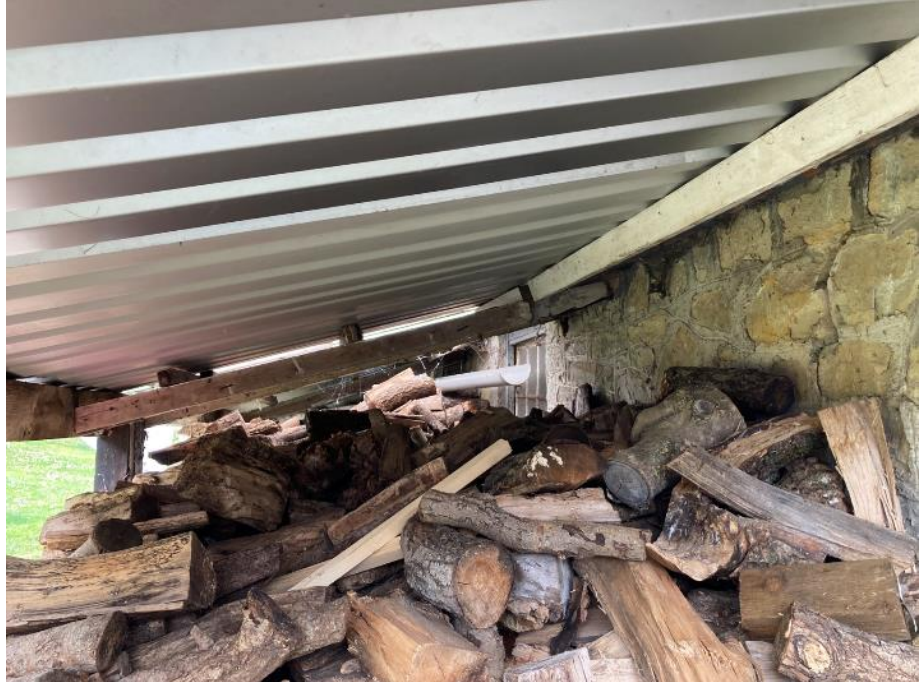
Photo 9: Showing the internal environment within the lean-to extension.

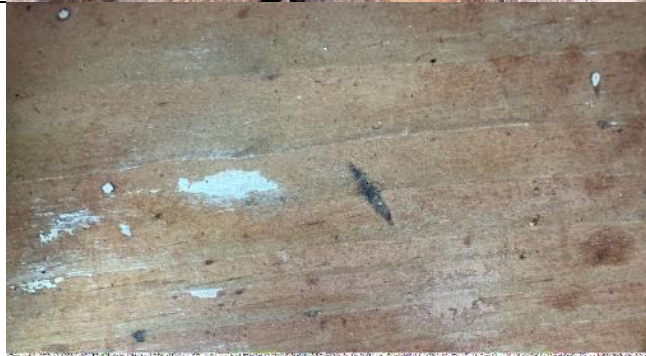
A single, fairly old bat dropping was found within the main building by the southern elevation (see Appendix 3, photo 10). Although full access to the mezzanine floor as not possible at the time of the survey, two small older bat droppings were identified within the debris on the mezzanine floor. No further evidence of bats, such as urine staining or discarded insect wings/casings was noted during the survey.

Photo 10: Showing the single bat dropping found close to the southern elevation within the main building.

Building Ref	Value for / Likelihood of supporting roosting bats	Recommendations
B1 – Existing building	Moderate Habitat Value	Two further surveys comprising a dusk emergence and dawn re-entry survey should be undertaken on the building between May and September, to suggest the presence or likely absence of roosting bats. At least one of the surveys should be undertaken during the optimal survey season (May to August). Two surveyors should be used to provide suitable coverage of all elevations of the structure.
