GROUND CONTAMINATION INVESTIGATION AND ASSESSMENT PHASE 1 and 2

**Manor Farm,
Main Street,
Timberland
LN4 3RX**

L-S&Co Project Number: 65 006
Status of Report: **FINAL**
Date of Issue: November 11th, 2022

Report on: Phase 1 and 2 ground contamination assessment

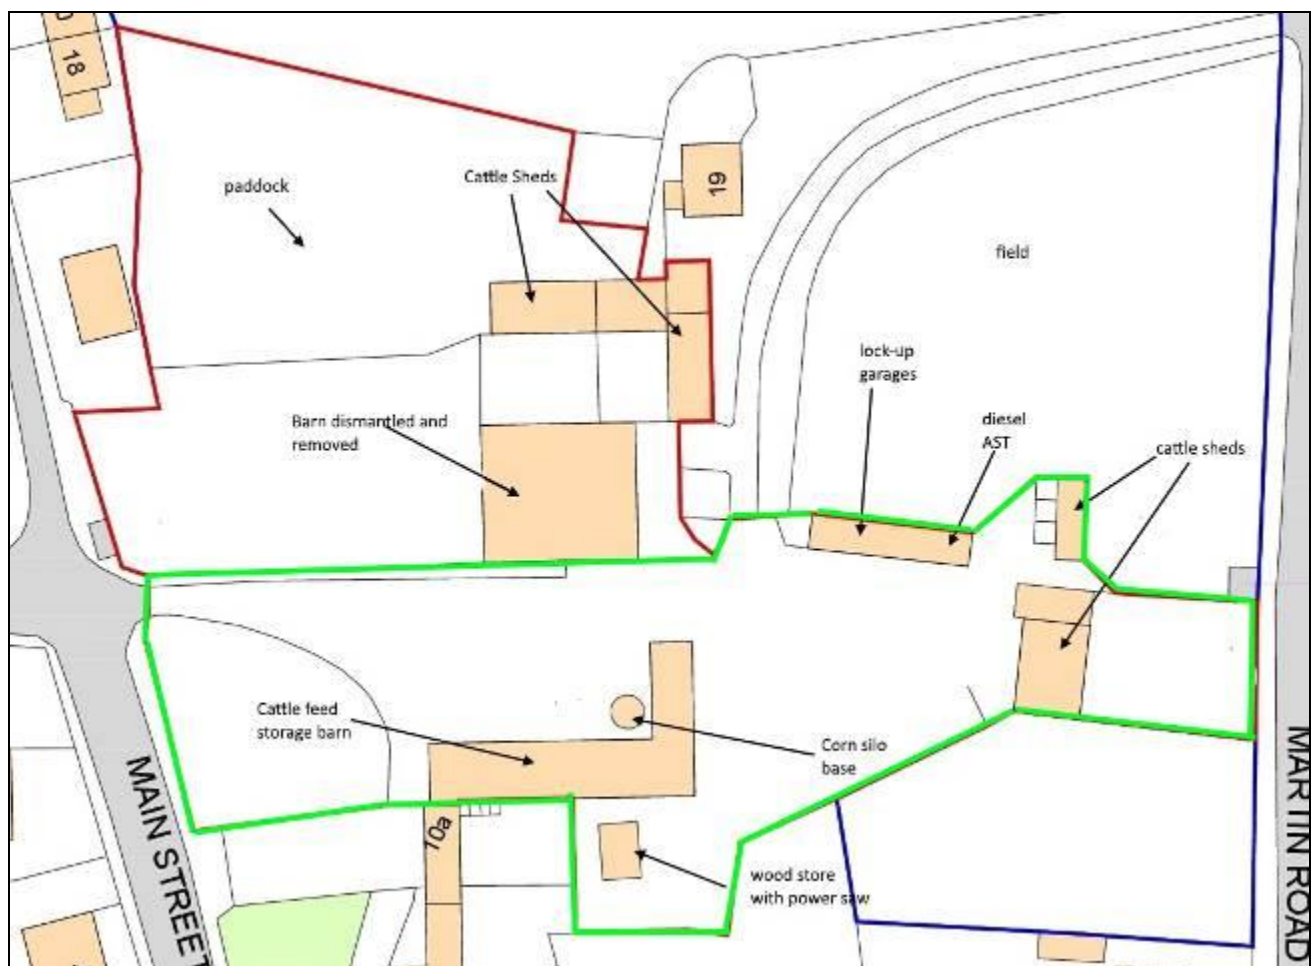
Fig 3 - plan of site (green boundary)

The site is an irregular east-west orientated rectangle, facing for some 60 m on the west side onto Main Street, and the rear of some of the existing houses along that street, and extending east for 120 m or so up to Martin Road, with a large part of the northeast quadrant cut out so that there is narrow access onto Martin Road.

Most of the site is occupied by the original Manor Farm buildings, set out around a central crew-yard of gravelly un-metalled hard ground, with the main access from the main Street.

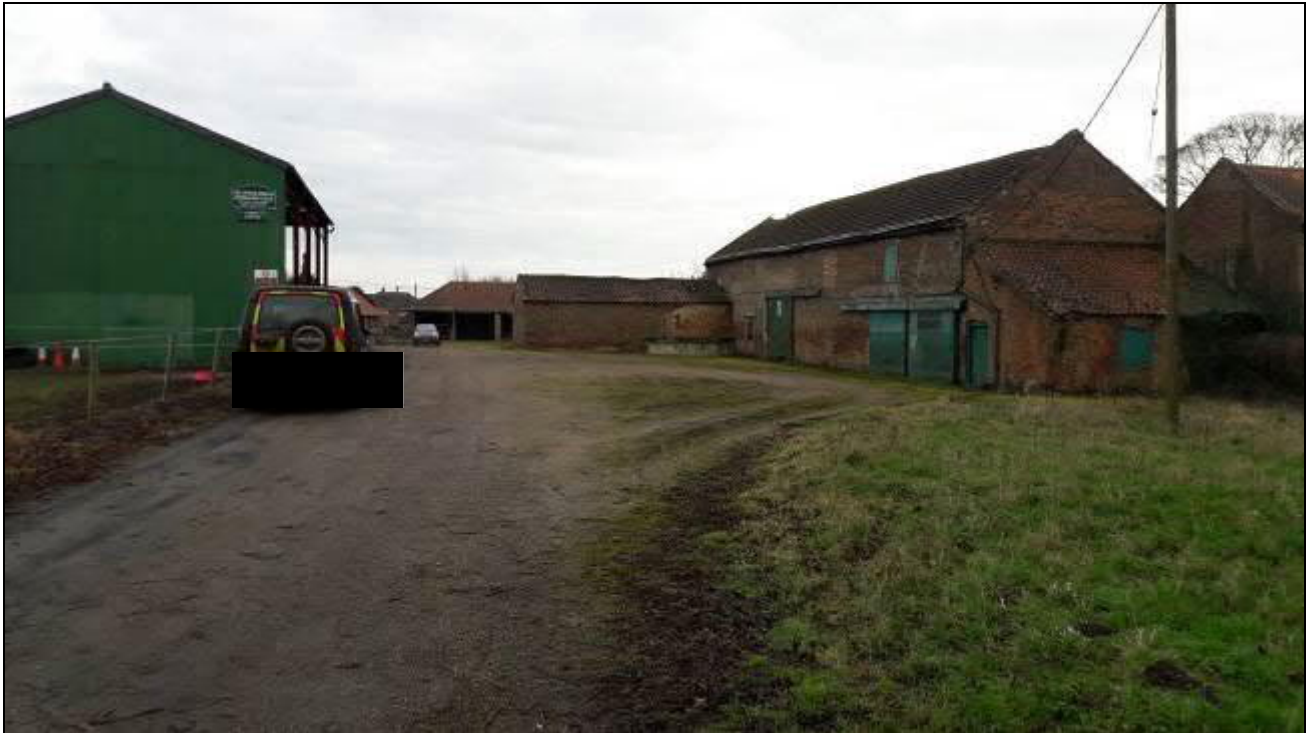
Fig 4 - view to northeast from road across the crew-yard (barn on RHS has been removed)

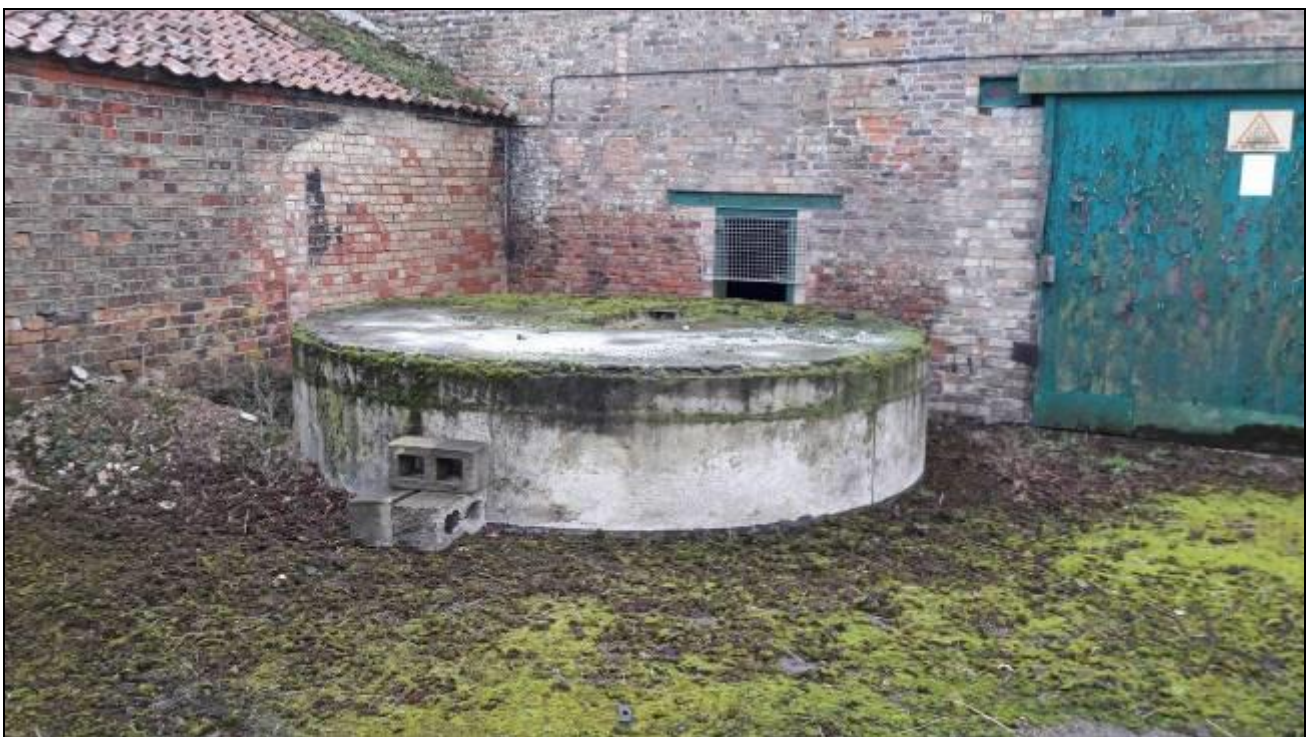
- the main barn was used for storing cattle feed and there is a concrete plinth that was the base of a corn-feed silo;
- to the rear of the main barn (on the south side) was the wood store with an electric power saw;
- opposite the main barn was an open-sided dutch barn, used for straw and hay;
- there are single storey cattle sheds on the north and east sides; and
- a row of lock-up garages, with an unused unbunded diesel AST in one of the garages.

Fig 5 - concrete plinth of the former corn-feed silo

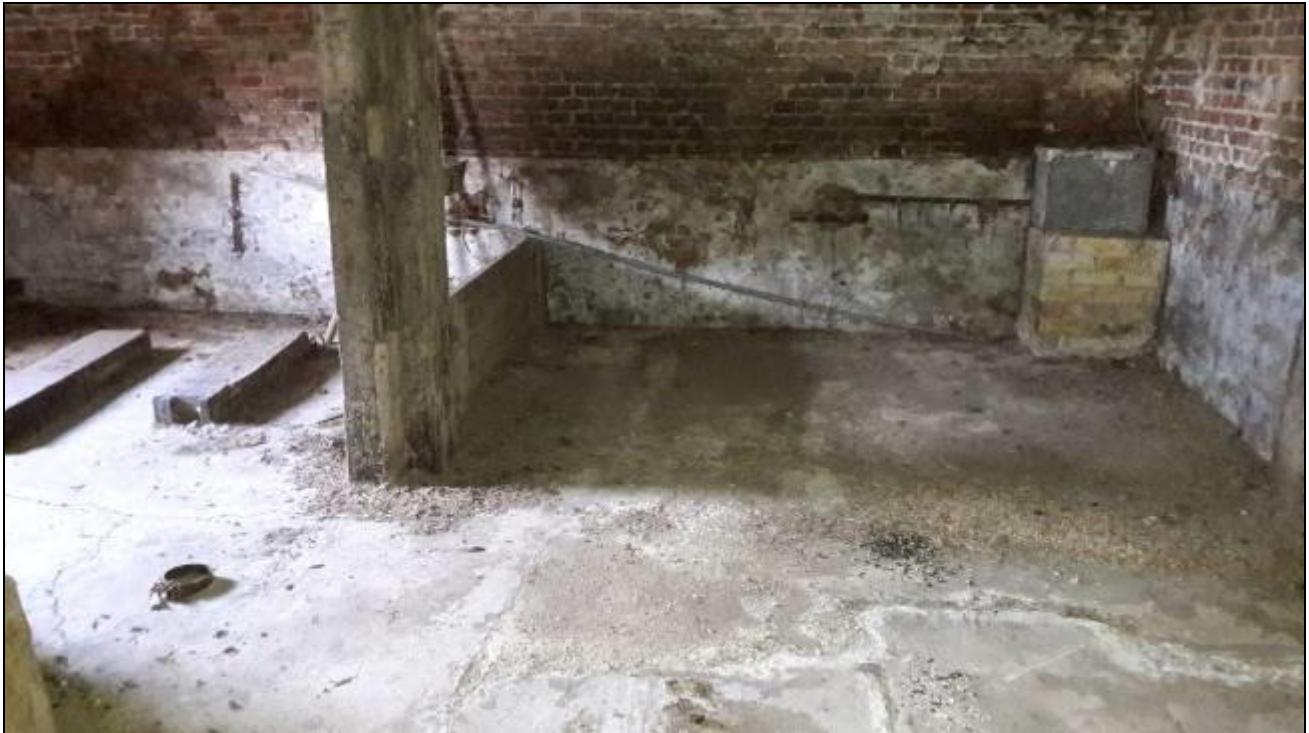
The barns and sheds are all concrete floored and show no staining from fuel spills other than the garage with the diesel AST within.

Fig 6 - interior of the barn showing the solid concrete floor

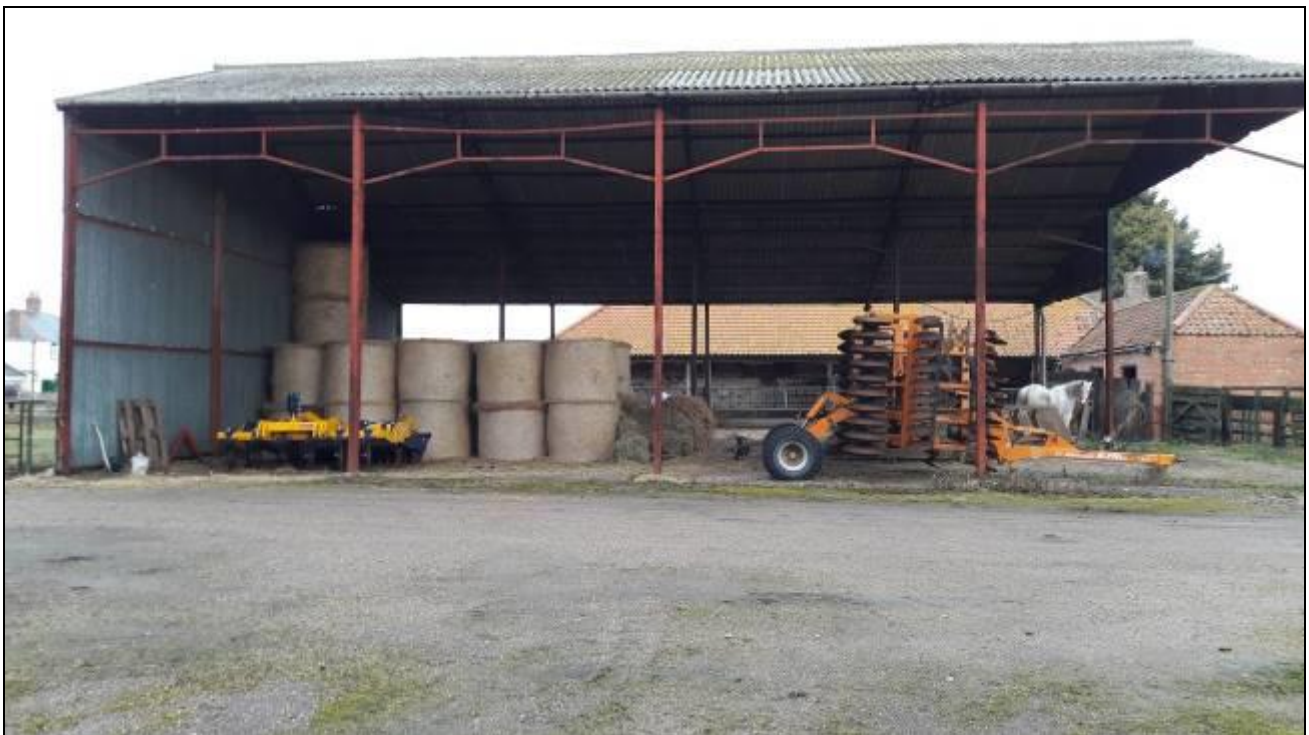
The original buildings are built of red brick with pantiled roofs, and the dutch barn has CBA-panels.

Fig 7 - view to the north of the former dutch barn, showing CBA-panels

- the former diesel AST in the lock-up garages (fig 12); and
- asbestos fibres from CBA roofing and cladding on the dutch barn (fig 7).

It is recommended that the ground be inspected after the dutch barn has been demolished and removed.

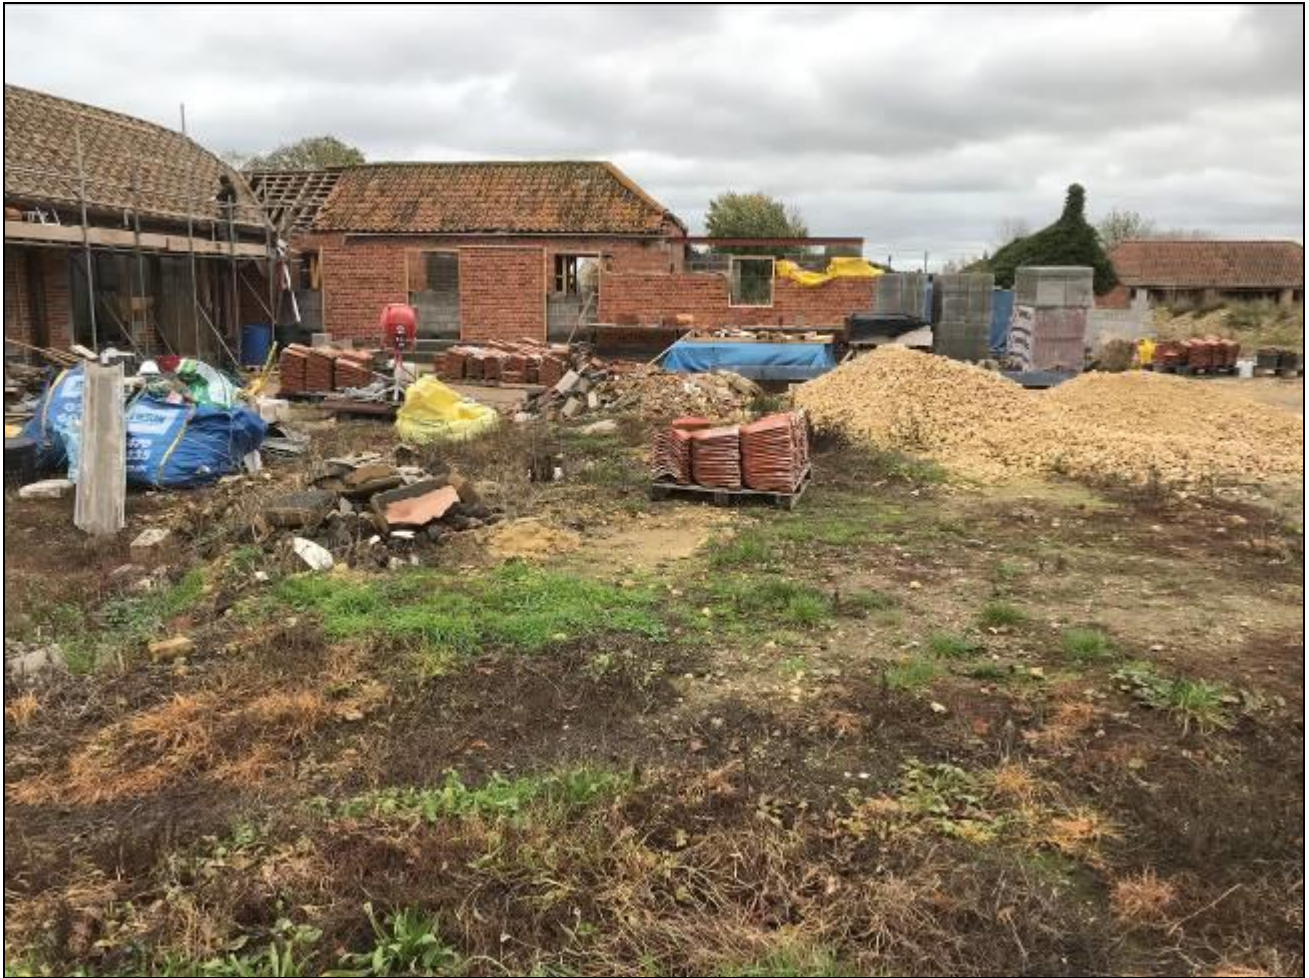
Fig 8 – position of dutch barn after removal

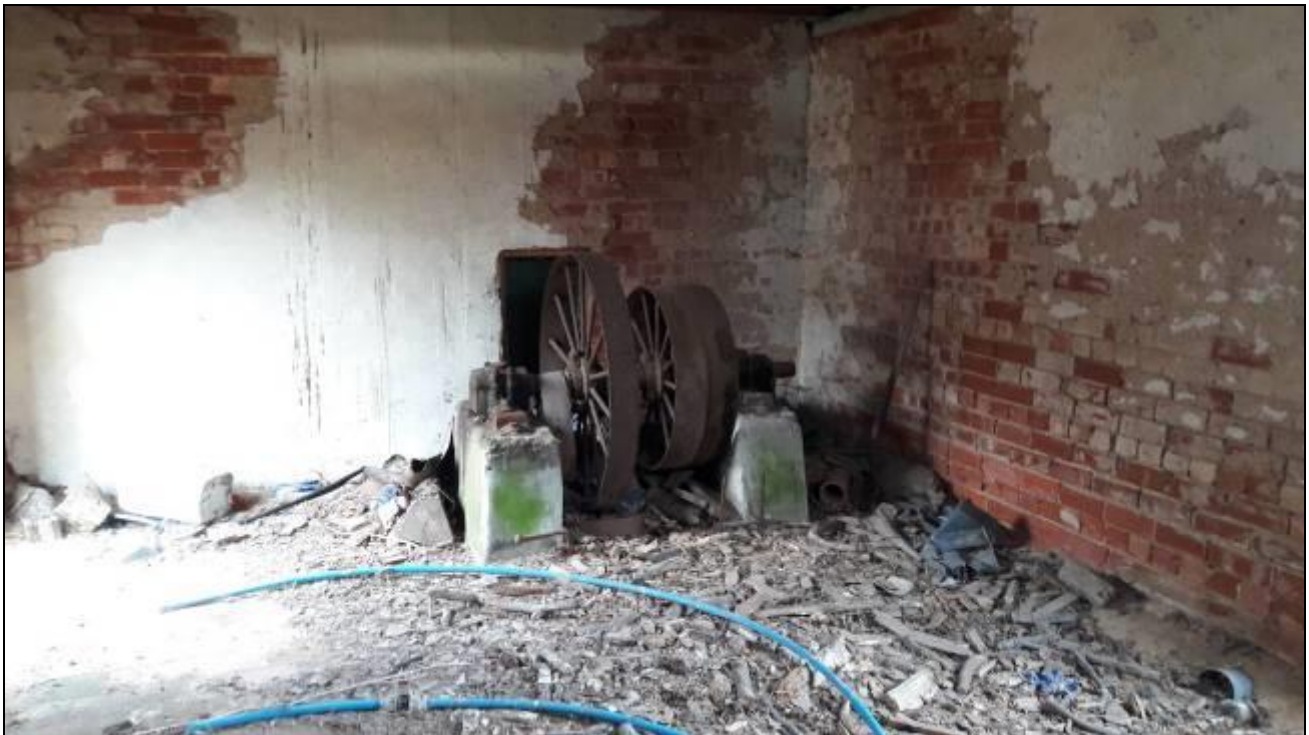
Fig 10 - remains of the electric-powered saw

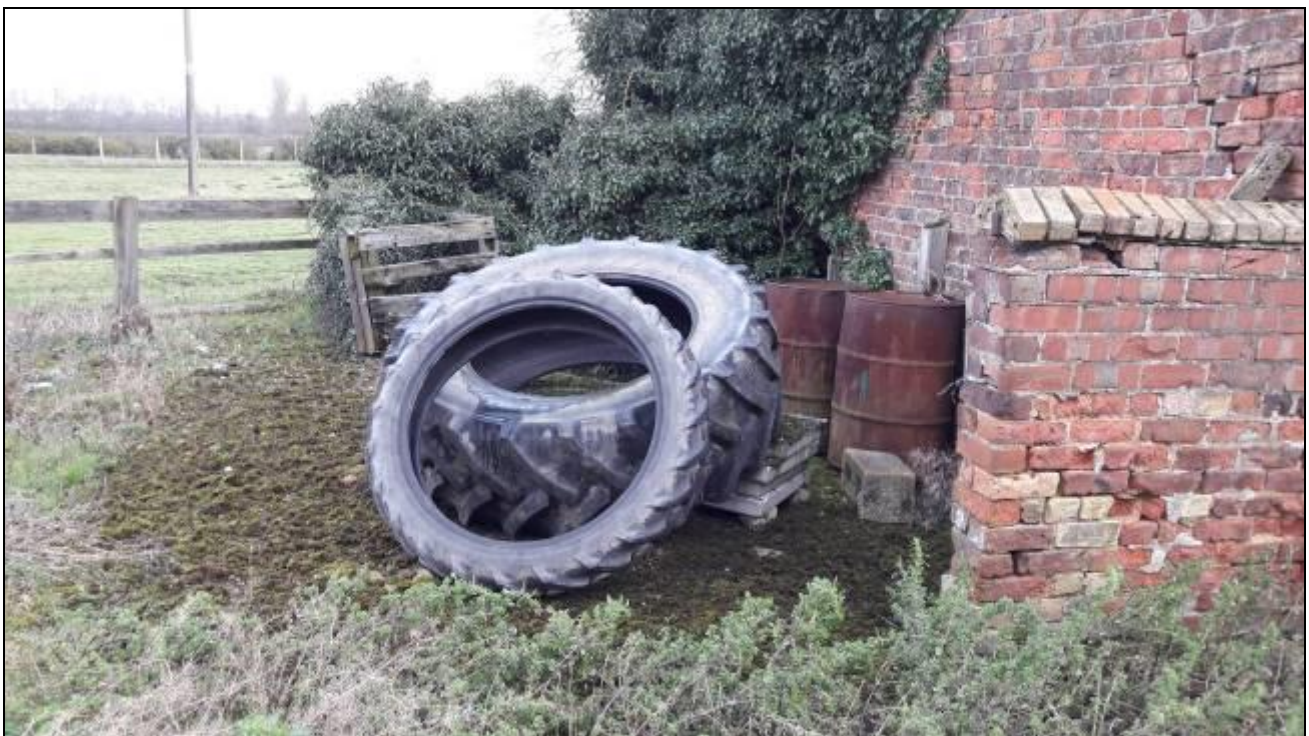
Fig 11 - some old 45-gallon drums and tyres loosely stored

WS9 was in the area of the tyres and rusty oil drums and no contaminated ground was observed.

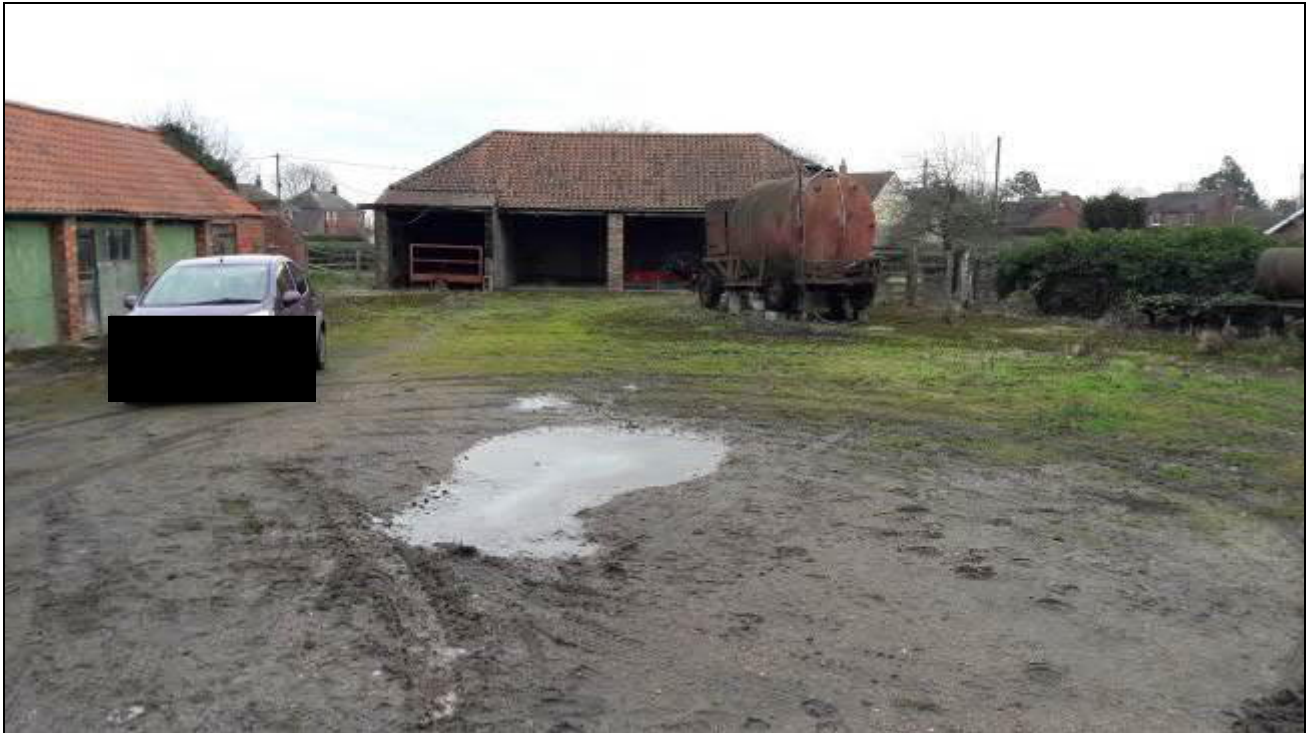
Fig 12 - view to the east of the sheds on the east side

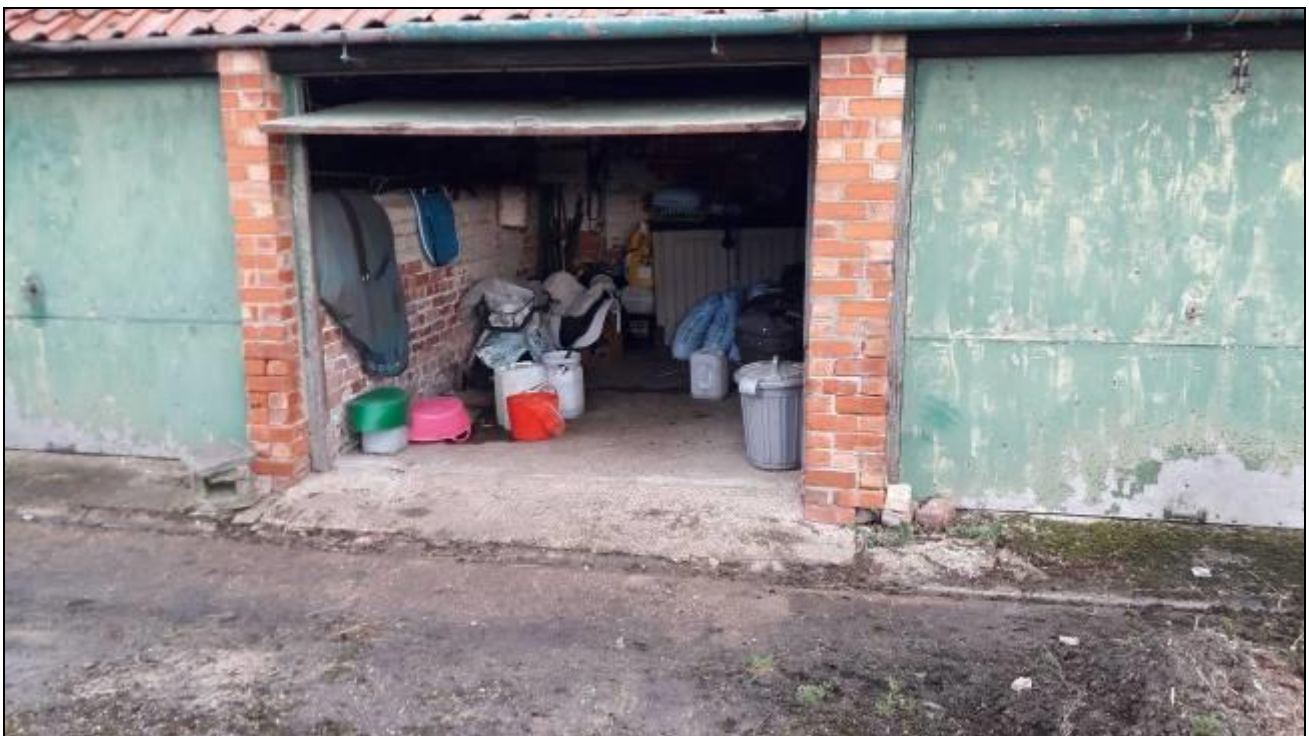
Fig 13 - view to the north of the lock-up garages, with concrete floors

There may be other isolated hot spots of contamination concealed beneath the existing concrete surfaces (*e.g.* fig 13).

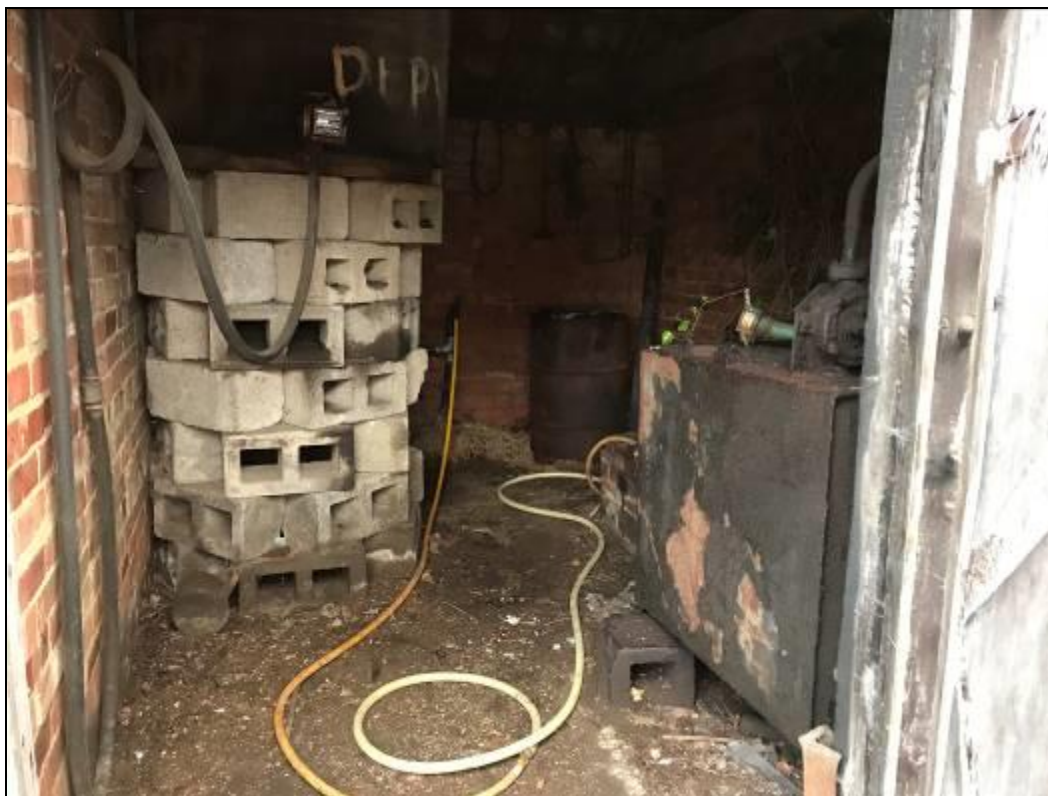
Fig 14 - AST within the lock-up garages

No evidence of any contamination was detected in the samples recovered other than from WS5, when a hydrocarbon odour was detected.

The TPH concentration is centred around the C12 – C21 fraction only, suggesting that fuel is old because all of the lighter components have dispersed and/or degraded to below the level of detection.

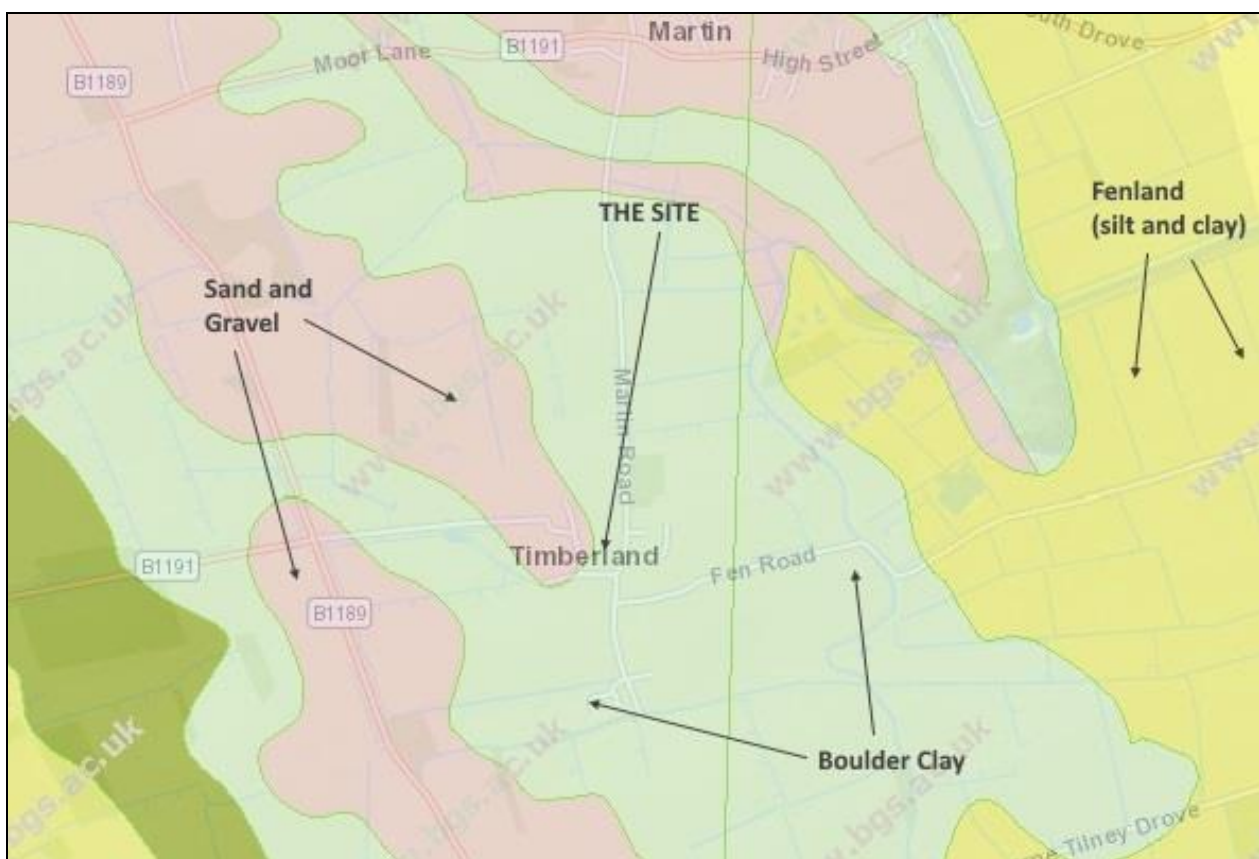
Fig 18 – regional geology

The site comprises of the bedrock Middle Jurassic Oxford Clay (from the Ancholme Clay Group) with Quaternary Glacial Till clay overburden and some Recent Sand and Gravel deposits locally.

Borehole records suggest that the Sand and Gravel is no more than 1.5 m thick and is not water-bearing.

The underlying Boulder Clay extends to 16 m depth, overlying the bedrock Mudstone.

Both the Oxford Clay and the Glacial Till clay are impermeable and are not aquifers.

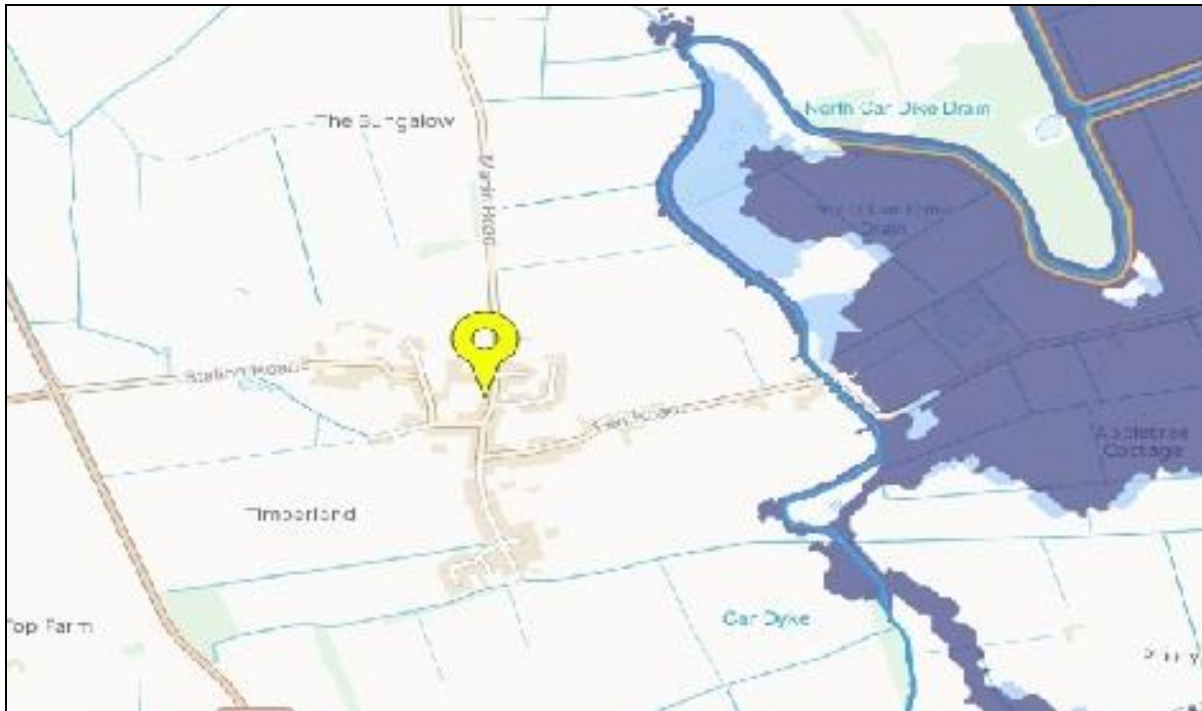
Fig 20 - Flood risk

The rise makes it free from risk of flooding.

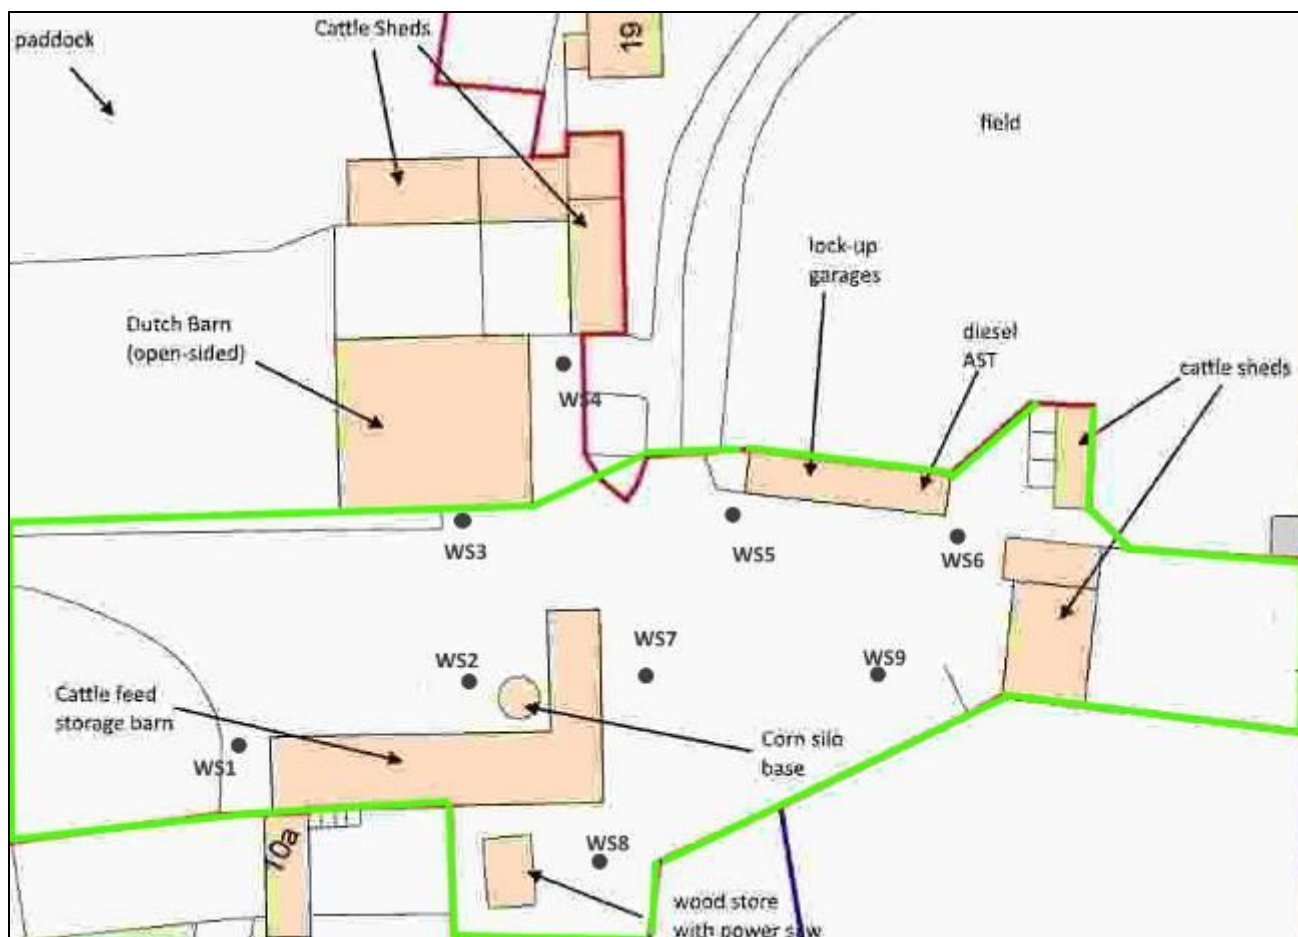
Fig 22 - borehole locations

9 No. 101 mm diameter sleeved bores (WS1 to WS9) were made to 2 m depth across the site using the Dando Terrier operated by Site Investigation Services.

The positions were selected to investigate areas with a high potential to be contaminated and near to the future residences.

The ground encountered was not quite as anticipated, with the Boulder Clay not at the surface, as would be expected from the geological maps, but at 1.2 m - > 2.0 m depth, deeper in the centre of the site, and overlain by a layer of soft sandy Clay with a lens of loose Sand.

The loose Sand was damp, and groundwater was detected in WS2 and WS3 at 0.5 m, and in WS6 at 1 m bgl.
