Bugford Mill, Lapford Ecological Appraisal (Bats & Birds)

Report No: 21/3906.02
Date: August 2022
Client: Richard Stoneman

Devon Wildlife Consultants (DWC) was commissioned by Richard Stoneman to undertake an Ecological Appraisal (Bats & Birds) of a section of a building known as Bugford Mill, located to the north-west of Crediton, Devon.

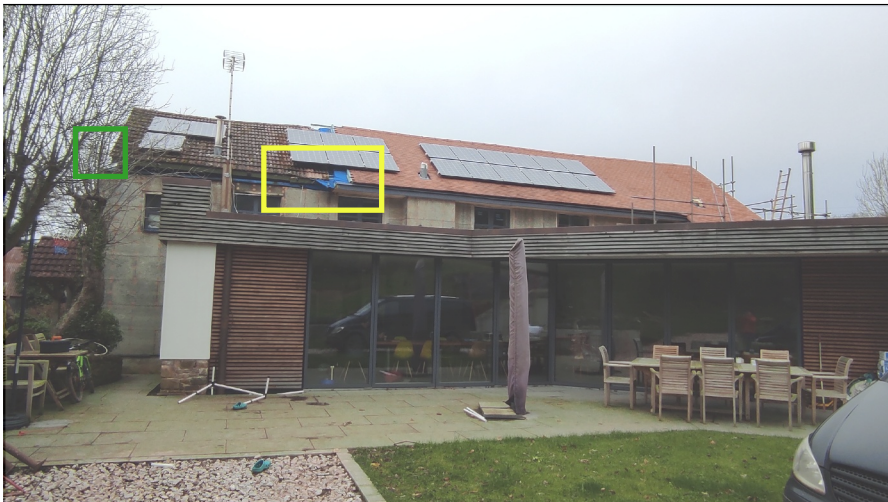
Green rectangle adjacent highlights access point A utilised by 1x common pipistrelle bat.
 Yellow rectangle adjacent highlights access point D utilised by 1x long-eared bat.

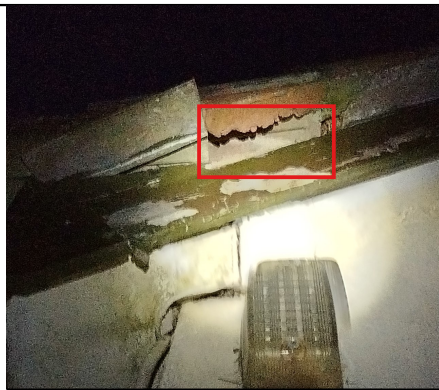
Red rectangle above highlights access point C utilised by 1x long-eared bat.

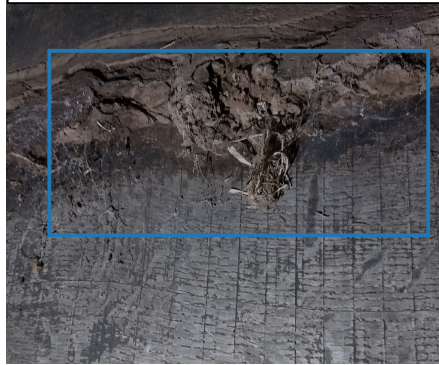
Blue rectangle above highlights access point B utilised by 1x Brandt's bat.

1x Brandt's bat emerged from a gap under the eaves of the northern aspect of the building (access point B).

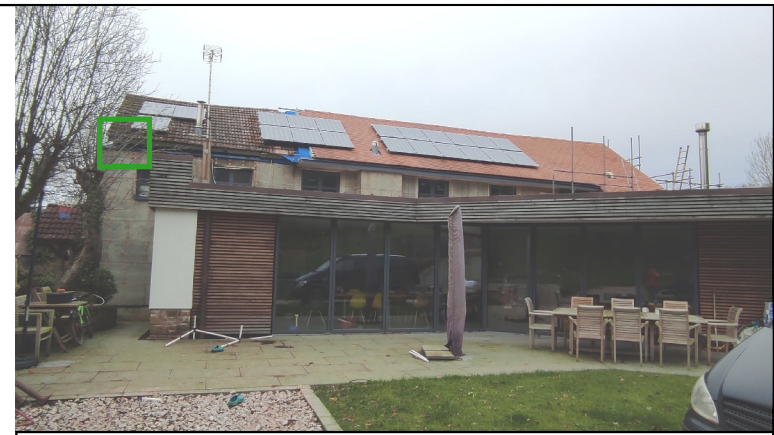
Green rectangle above highlights access point A utilised by 1x common pipistrelle bat.

1x common pipistrelle bat re-entered the building beneath a tile on the north-eastern corner of the building (access point E).

1x common pipistrelle bat re-entered the dense ivy present on the northern aspect of the building (access point F).

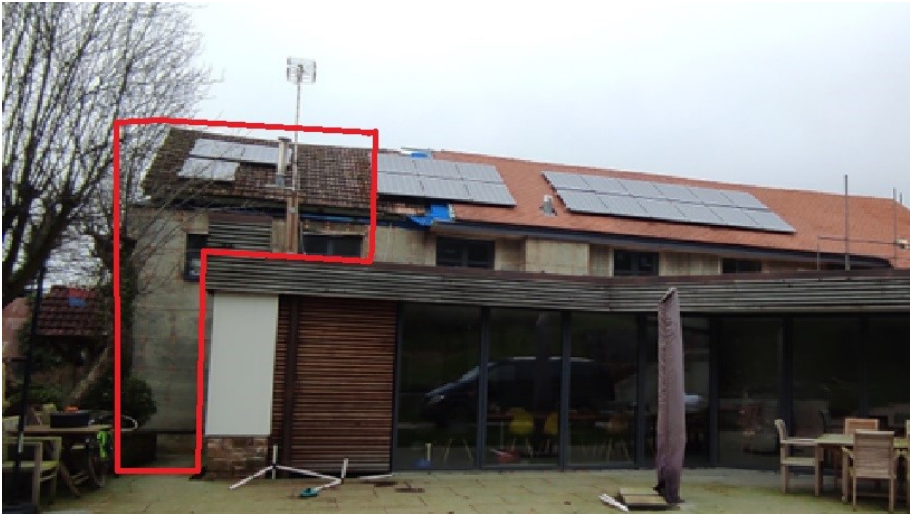
<p>Plate 1. Surveyed section of Bugford Mill (illustrated with a red box)</p>

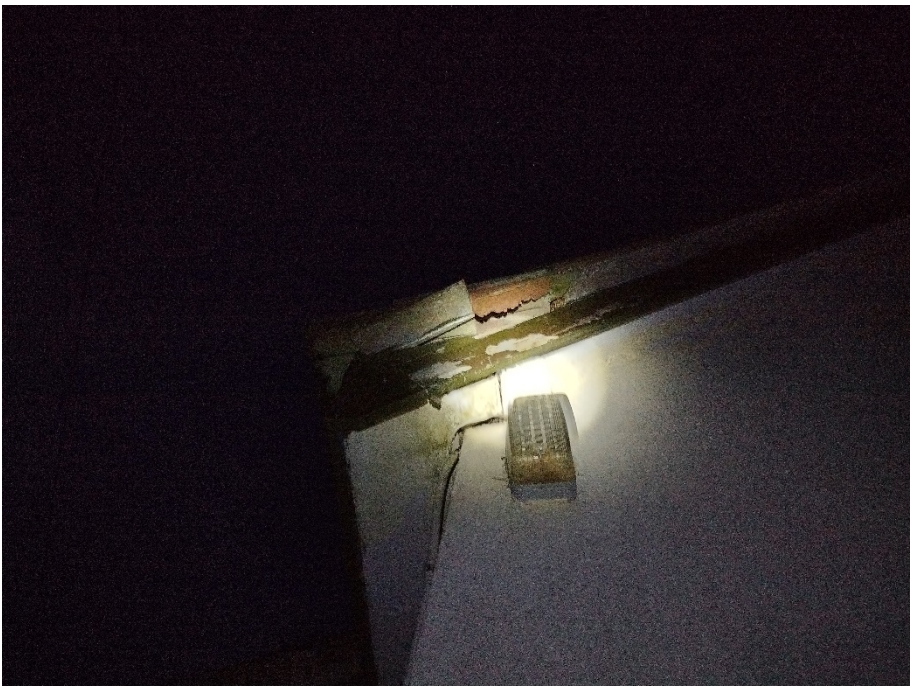
Several access points into the loft space of the building were identified, including under tiles on the roof, under ridge tiles and via rotten timber fascias.

<p>Plate 2. Rotten fascia on the building</p>

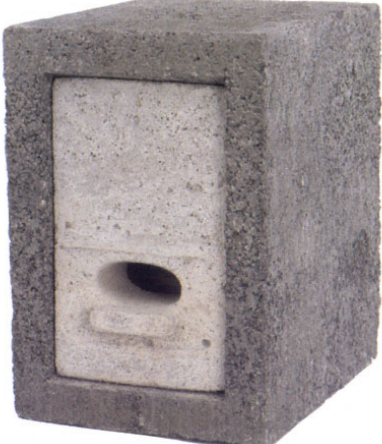
<p>A rectangular, light-colored concrete bat box with a dark, recessed rectangular opening on the front face, centered vertically and horizontally.</p>	<p>Schwegler N27 Bat Box (pictured)</p> <p>Position: Within external walls with a southerly aspect, beneath eaves or approximately 3m or higher from ground level.</p>

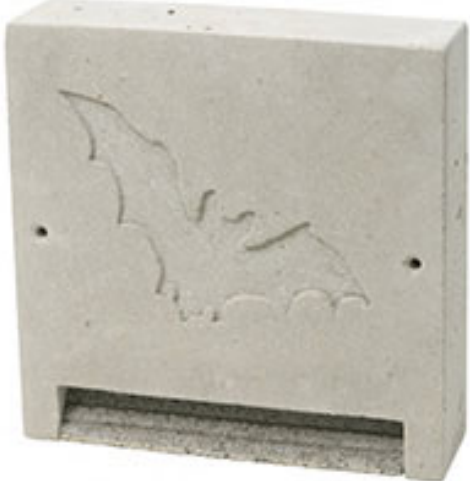
<p>A rectangular, light-colored concrete panel featuring a raised, embossed bat silhouette in the center. There are two small circular holes on either side of the bat's wings. A horizontal slot is visible at the bottom edge.</p>	<p>Schwegler 1FE Bat Access Panel with Optional Back Panel (pictured)</p> <p>Position: Within or on external walls with a southerly aspect, beneath eaves or approximately 3m or higher from ground level.</p> <p>Additional Information: Installation of access panel alone would allow bats to access into a building, potentially into a cavity wall spaces or loft spaces. No maintenance required</p> <p>By fitting the optional back panel the Schwegler 1FE becomes a self contained bat roosting unit at the dimensions shown above.</p>

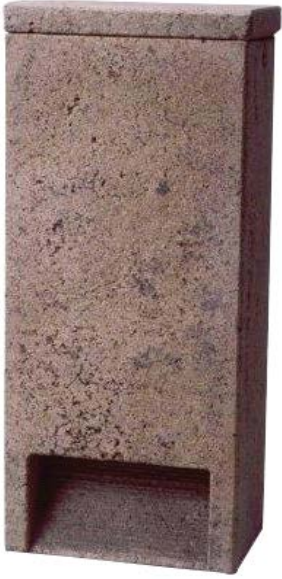
<p>Schwegler 2FR Bat Tube (pictured)</p> <p>Position: Within or on external walls with a southerly aspect, beneath eaves or approximately 3m or higher from ground level.</p> <p>Additional information: Can be painted or rendered. No maintenance required. The top can be removed to allow access to cavity walls, or optional holes in the sides mean that several units can be installed together to form a larger roost.</p>
 	<p>Permanent provision within structure of the building</p> <p>It is possible to create more traditional access into the roof space and suitable crevices within a building, for example through raised ridge tiles or slates, or gaps behind the soffit boxes e.g. Tudor Roof tiles (pictured)</p> <p>http://www.tudorrooftiles.co.uk/bat.html</p>
