Report : Bat Survey:
House at Little Rock,
Rock Farm, Llanllwchaiarn SY16 3BH

Reference : GCR/2781/22.1

Date : 3 October 2022

Purpose : To inform the proposed extension of the House

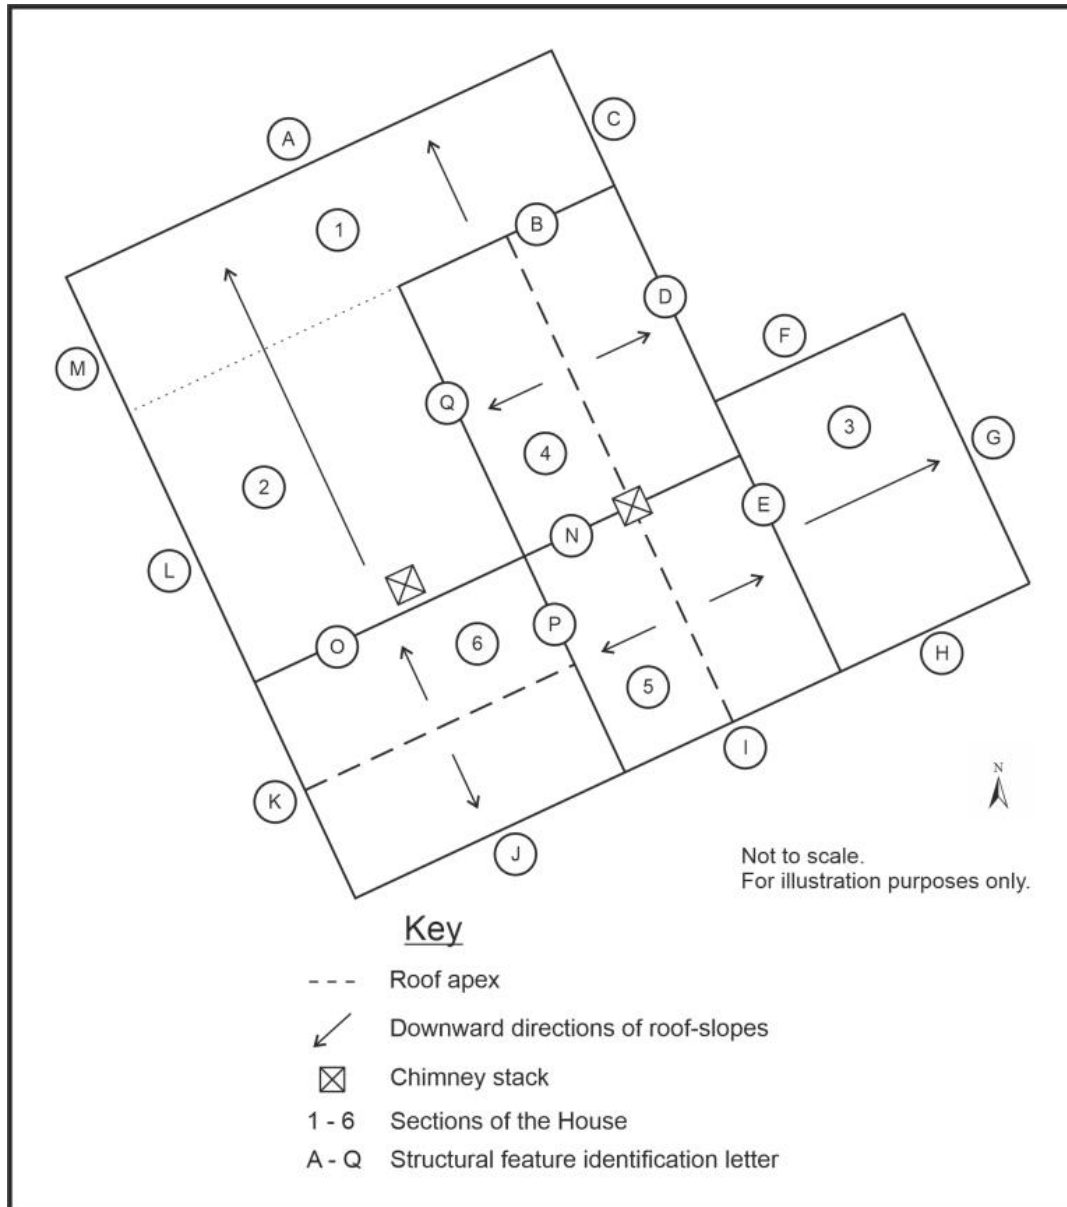
The House is a single- and two-storey structure, part rendered brick and concrete-block with six distinct structural roof structures; Sections 1 – 6.

For ease of reference the relevant structural features of the House have been labelled A – Q and are described separately.

A diagram of the structural outlay of the House showing the locations of Sections 1 – 6 and features A - Q is shown below:

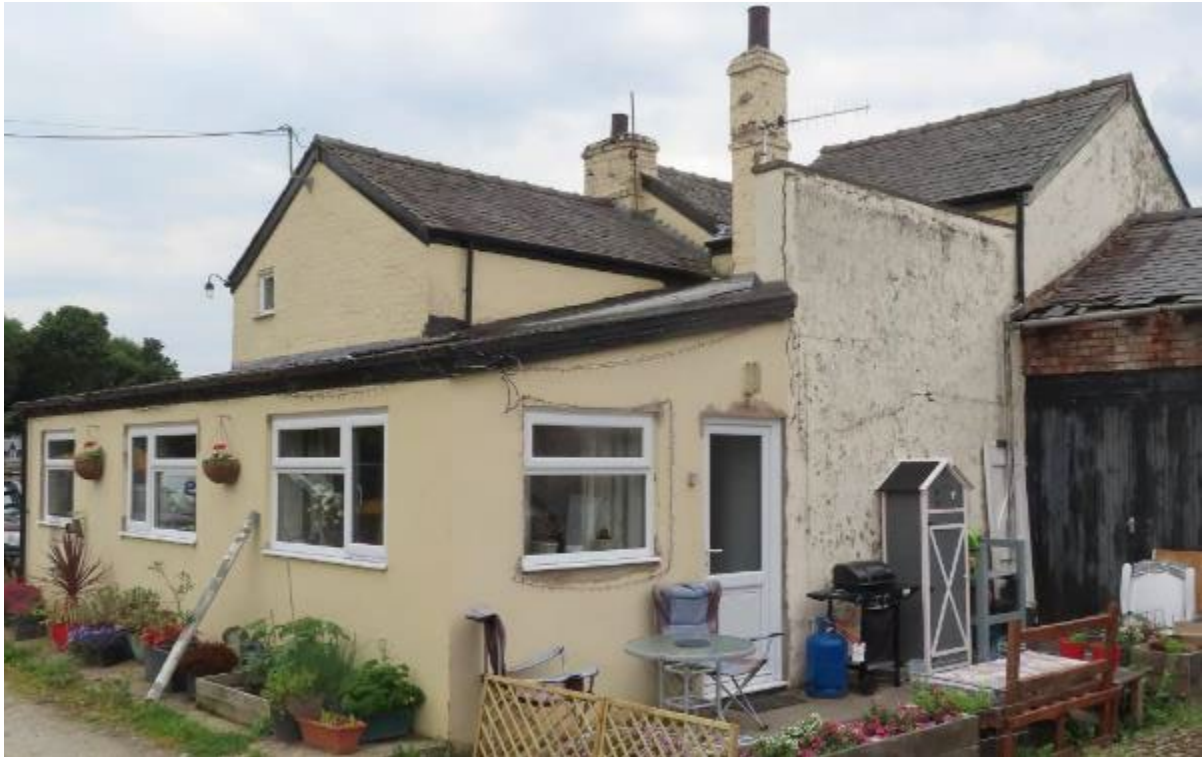
Photograph 1. Exterior.

Left: part of the Northwest elevation.
Right: part of the Southwest elevation.

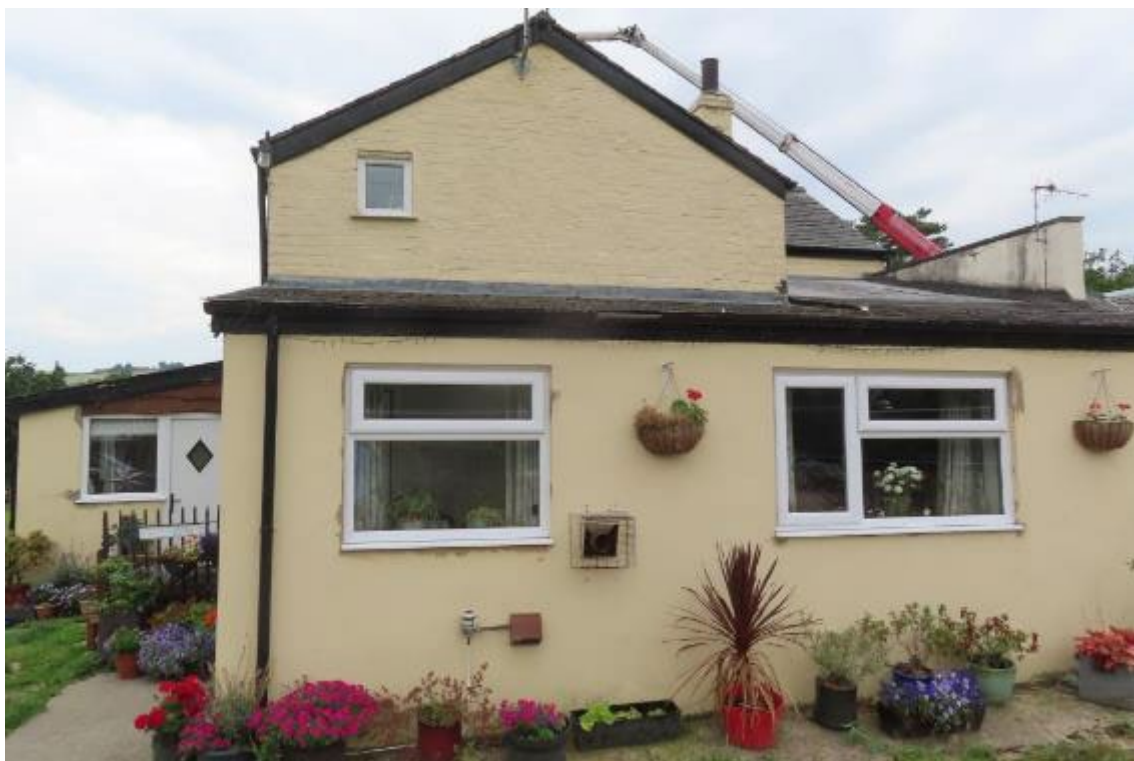
Photograph 2. Exterior.

Part of the Northwest elevation.

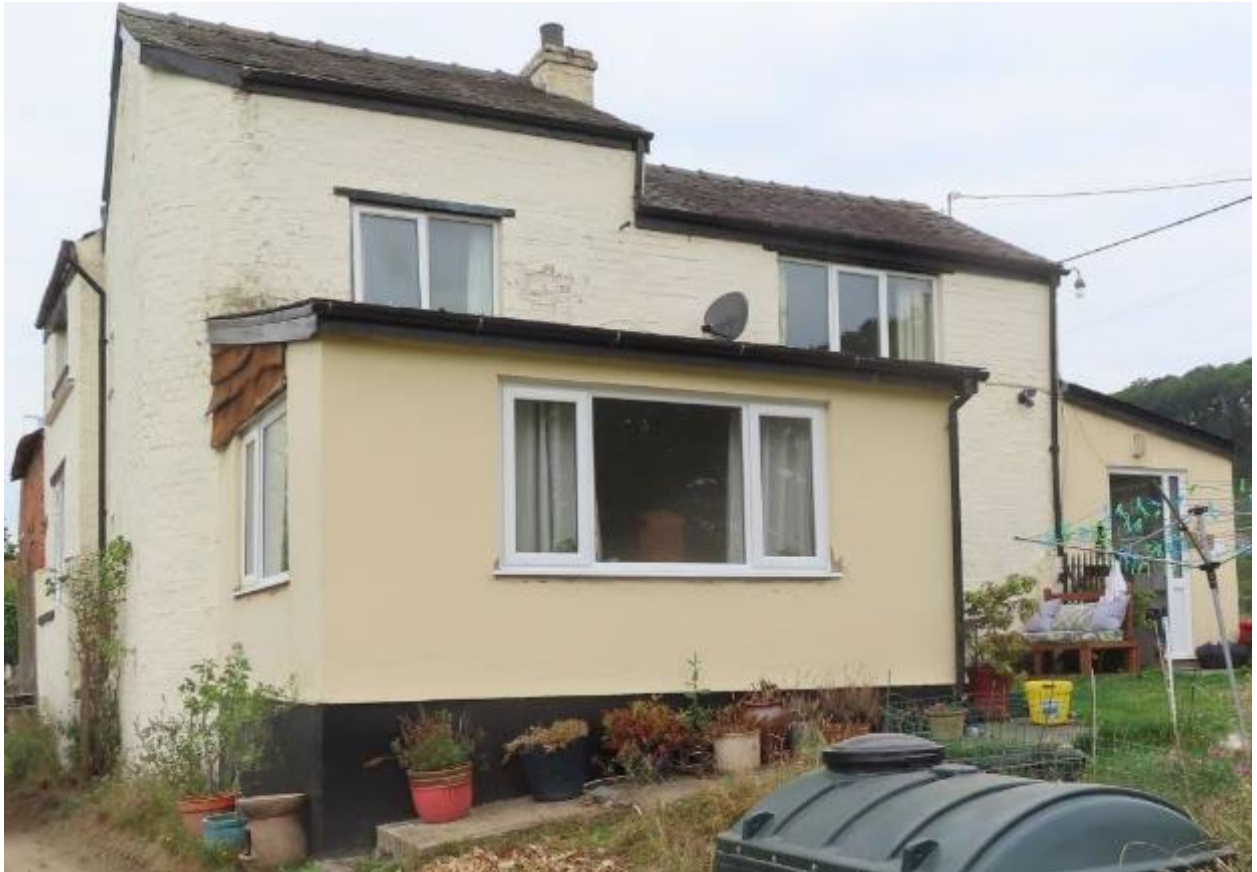
Photograph 3. Exterior.
Far left: part of the Southeast elevation.
Centre and right: Northeast elevation.

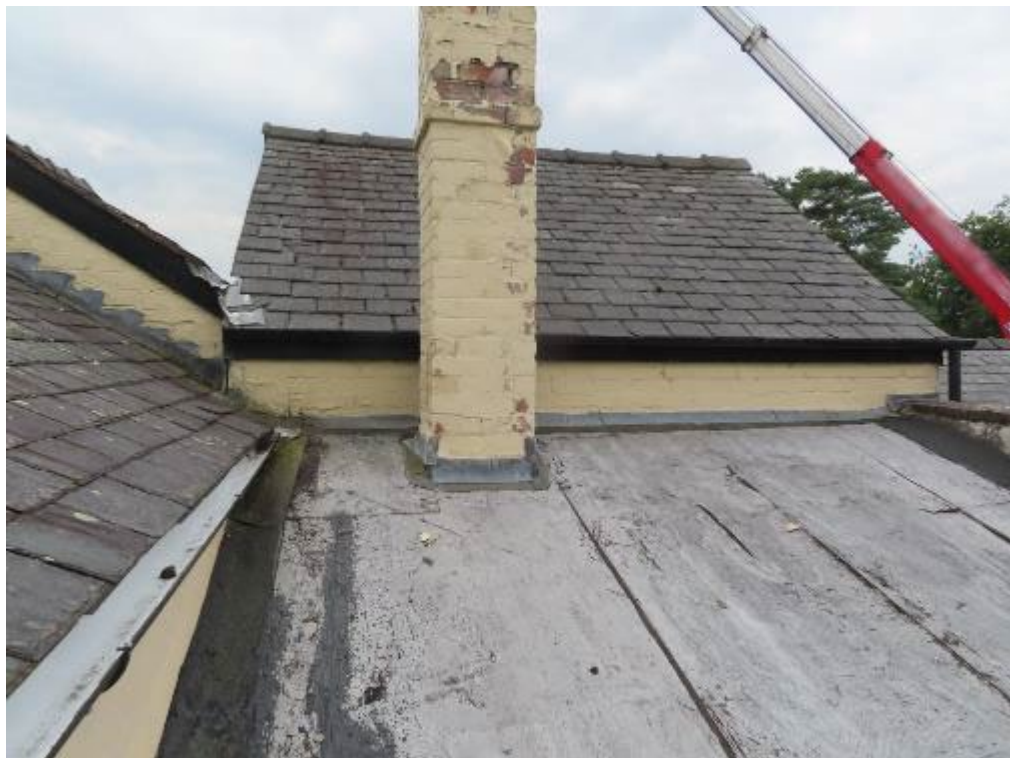
Photograph 4. Exterior.
Lower left: part of the Section 4 Southwest elevation roof-slope.
Upper left: part of the Section 5 Northwest elevation gable.
Lower centre and right: part of the Section 2 roof structure.
Upper centre and right: Northwest elevation of Section 6.

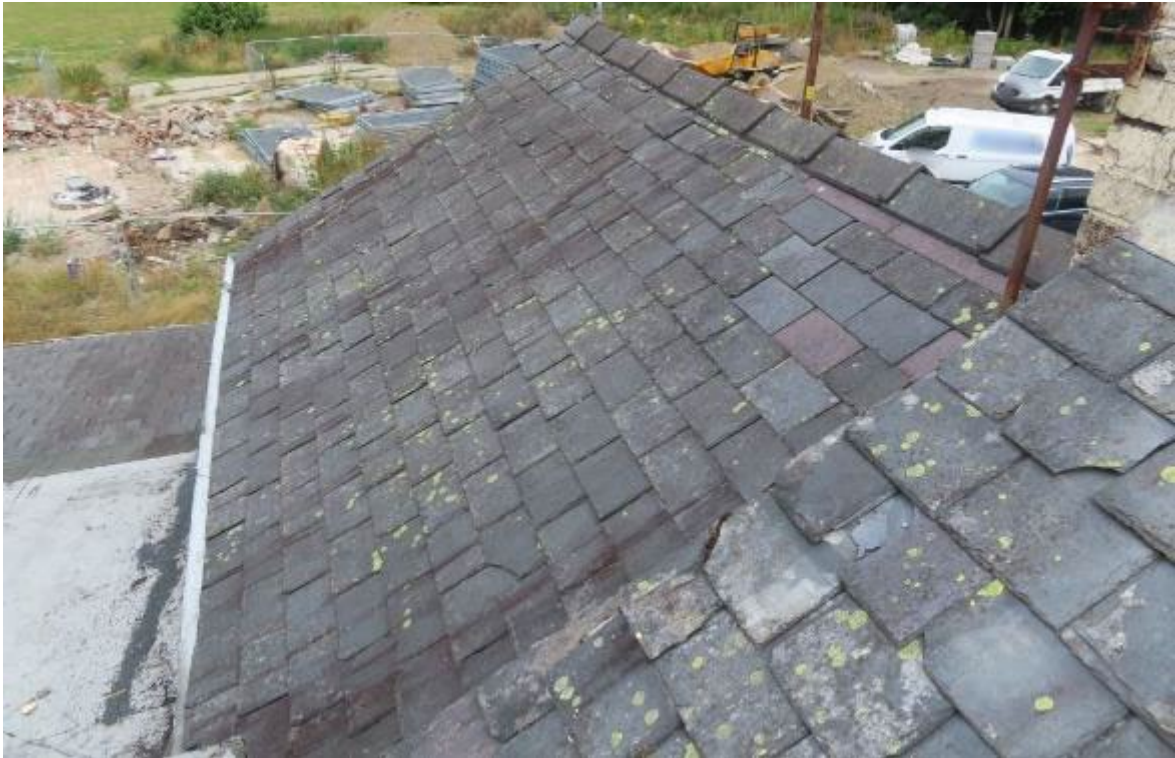
Photograph 5. Exterior.

Lower left: part of the Section 2 roof structure.
Mid-ground left: part of the Section 1 roof structure.
Centre: part of the Section 4 Southwest elevation roof-slope.
Lower right: part of the Section 5 Southwest elevation roof structure.

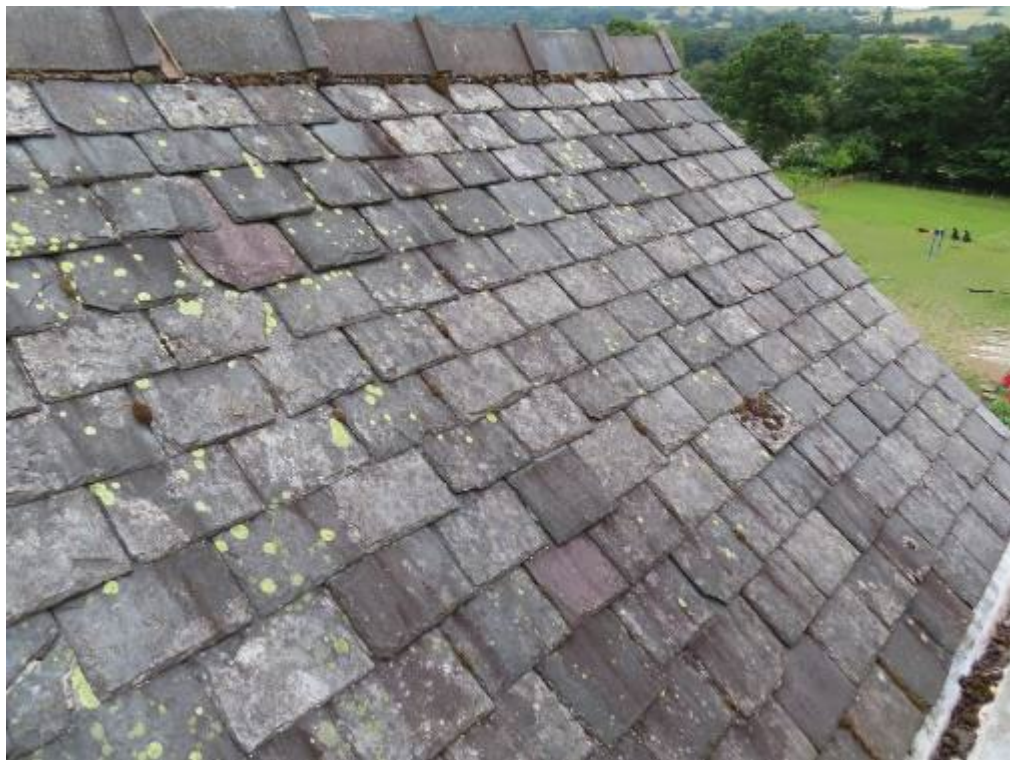
Photograph 6. Exterior.

View of part of the Section 6 Northwest elevation roof-slope.

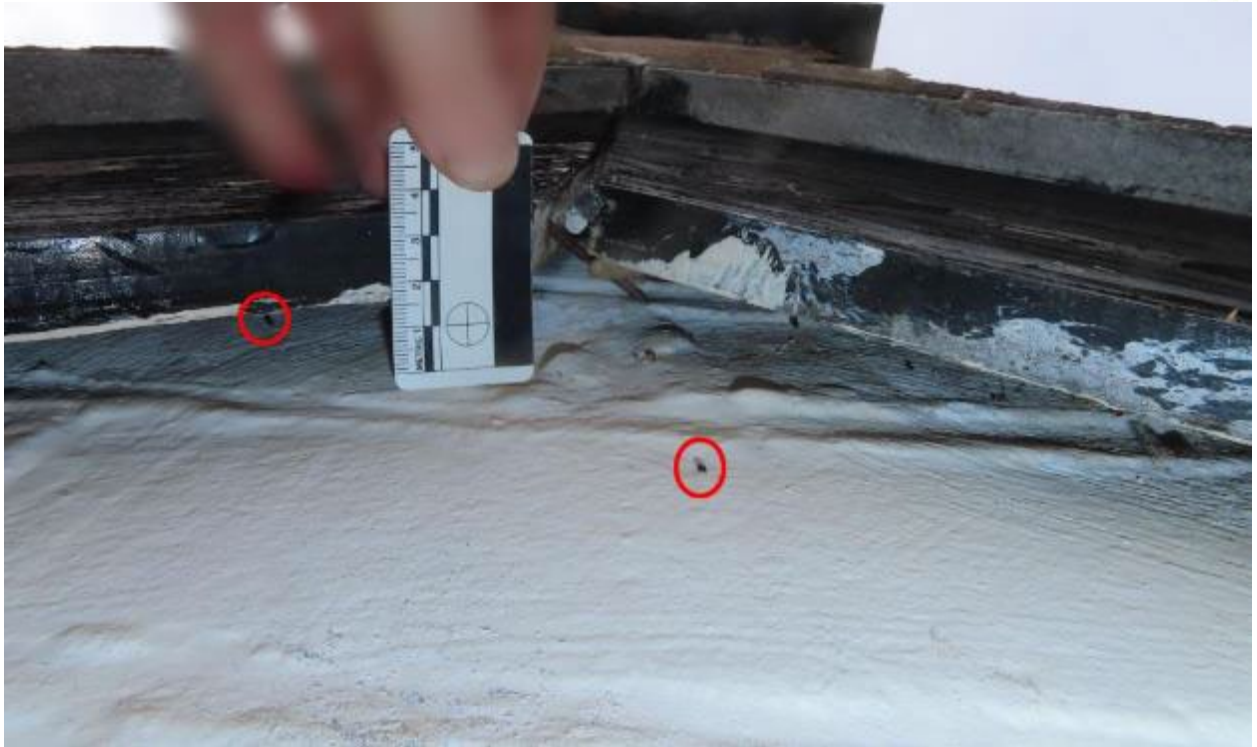
Photograph 7. Exterior.

Two fresh, year 2022, bat droppings were found on the northeast gable wall of the northeast-to-southwest apex roof structure; one within a gap between the northwest roof-slope barge board and the exterior wall surface.

It was considered likely that the gap between the northwest roof-slope barge board and the exterior wall surface of the northeast-to-southwest apex roof structure (Section 6) is used as a bat roost. However, no holes that bats may potentially use to gain access to/from the barge board gaps and the (Section 6) roof-slope batten voids were found.

View of part of part of the Section 6 Northeast elevation gable apex, showing the location of the identified bat roost and two Soprano pipistrelle bat droppings (circled in red) stuck to the wall surface.

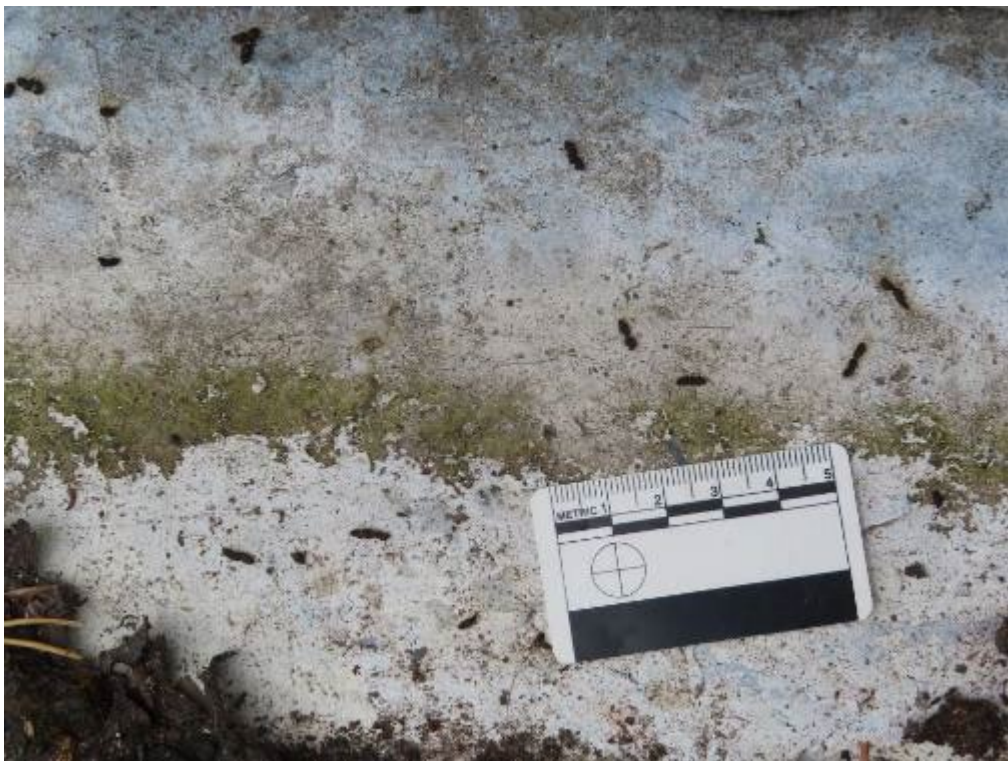
Photograph 8. Exterior.

A group of 12 fresh, year 2022, bat droppings was found on a lead gutter between the northeast gable of the northeast-to-southwest apex roof structure (Section 6) and the southwest roof-slope of the southeast, southeast-to-northwest roof structure (Section 5) (see Feature P).

View of part of the group of Soprano pipistrelle bat droppings found within the gutter between the Section 5 Southwest elevation roof-slope and the Section 6 Northeast elevation gable.

The droppings were immediately beneath the Section 6 Northeast elevation gable apex (as shown in Photograph 7).
