**CEDARBROOK  
OLD HALL DRIVE  
WIDMERPOOL NOTTINGHAMSHIRE  
NG12 5PZ**

**PROTECTED SPECIES SURVEY (BATS) PRA  
SURVEY REPORT**

**(November 2022)**

**REPORT REF: 22109 - PHA**

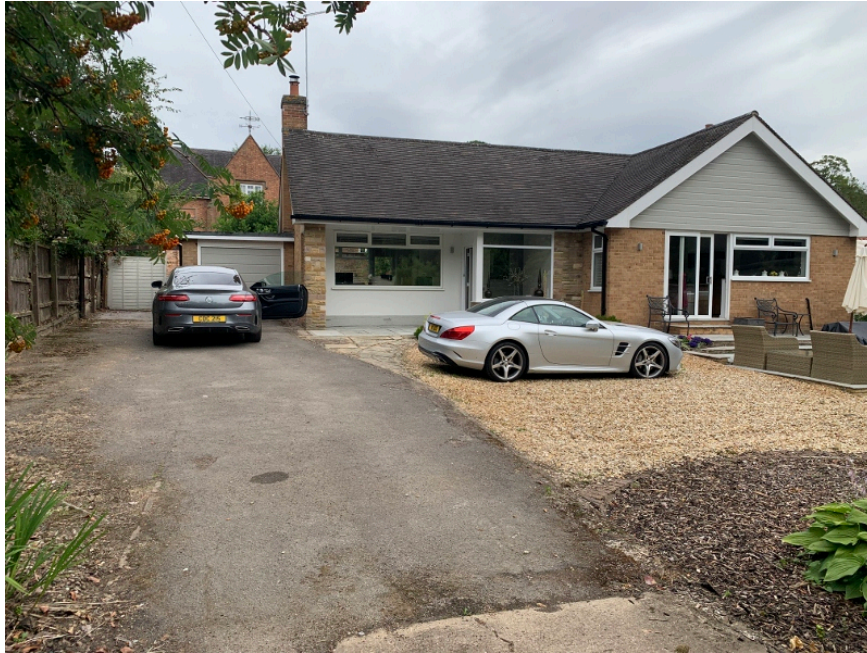
Photograph of front elevation with attached flat roof garage.

The building comprises of traditional masonry cavity wall construction with facing brickwork and render. The roof comprises of a double pitched roof comprising of traditional rafters and ceiling

joists supported on purlins and braces taken down to load-bearing walls. The rafters are overlaid with a modern breathable roof membrane overlaid with battens and a clay tile roof covering. There is a large gable feature within the front elevation. This is clad with a painted boarding and is well sealed. Eaves comprise of tightly sealed UPVC fascia's and soffits with UPVC gutters and downpipes. Windows and doors comprise of double glazed UPVC casement windows and double glazed UPVC doors.

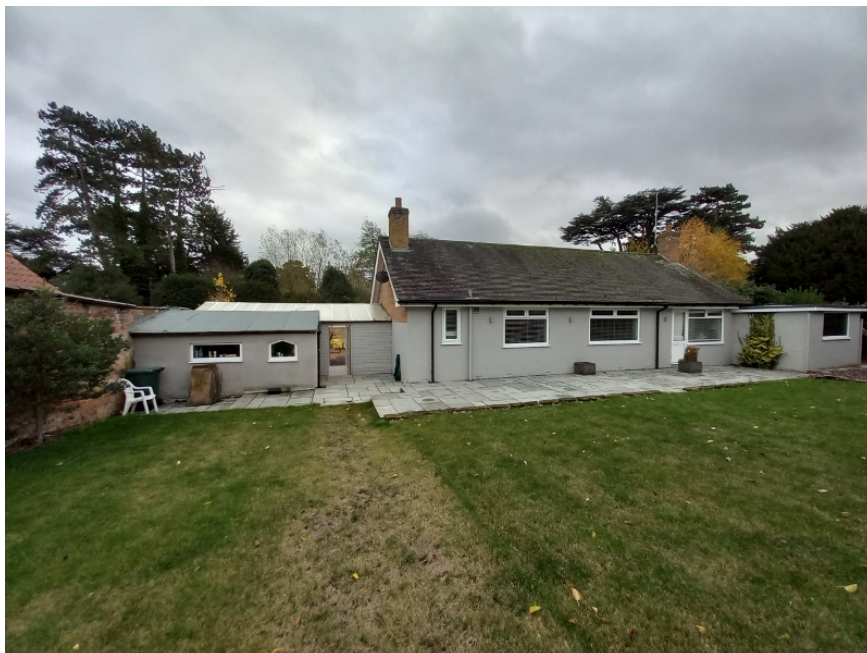
Photograph of rear elevation.

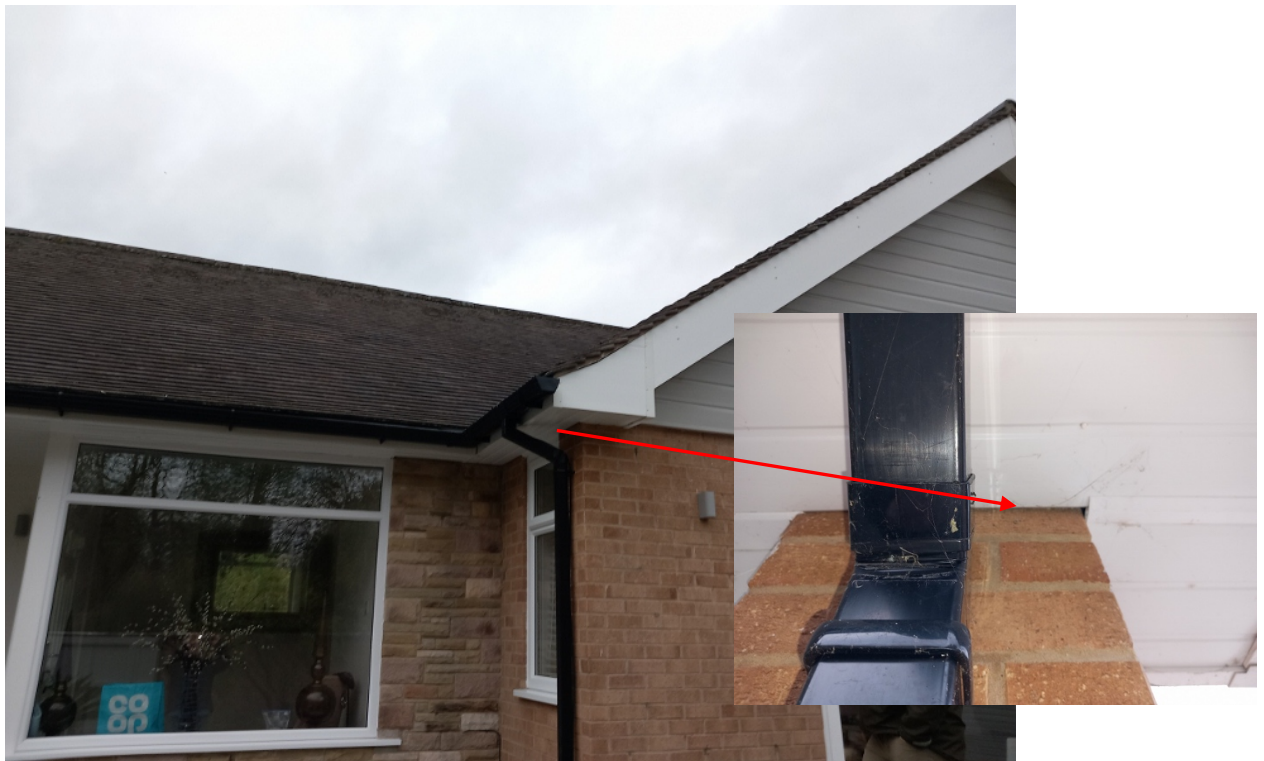
- 3.2 There is a single storey garage attached to the western end of the bungalow and comprises of rendered single brick walls with a traditional timber flat roof overlaid with a felt roof covering with UPVC fascia's , gutters and downpipes. The garage was once an open car port and a painted aluminium up and over garage door has been added in later years sealing access to the building.
- 3.3 Externally all buildings are well sealed. With the exception of a single open joint within the eaves of the front gable there are no gaps, missing joints or raised areas of flashings within the external envelope of the building. Gaps previously identified within the B. J. Collins report dated March 2019 have subsequently been sealed. The remaining open joint within the front gable corner is clean and free of debris.

- 4.4 **Phase 1** – November to January 2022. Access is required to the rear of the property to allow for the construction of the new dwelling. This will require the demolition of the flat roof garage at the western end of the dwelling. No evidence or features have been recorded present within this structure and therefore the work will not be constrained by the requirement for a European Protected Species Licence.

- 4.5 On removal of the garage any exposed structure including, open joints, caps, cracks, cavities and the like will be immediately sealed to prevent access to bats and birds.

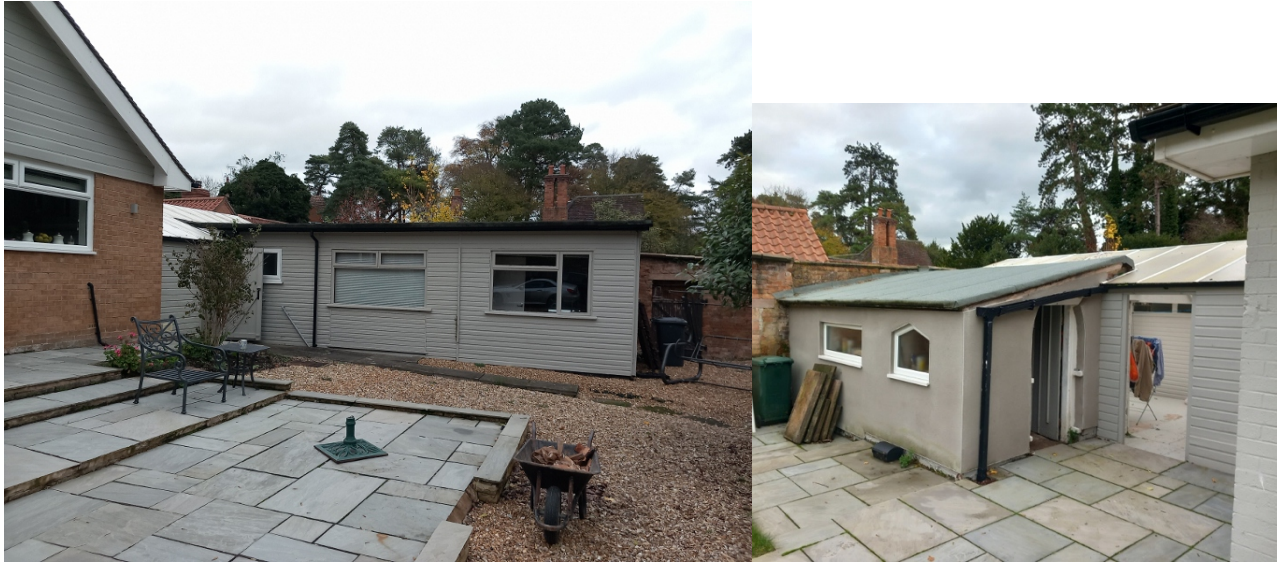
- 3.4 Attached to the eastern end of the bungalow there is a timber conservatory with a timber frame and timber clad annex building and store.

Photographs of annex building at eastern end of bungalow.

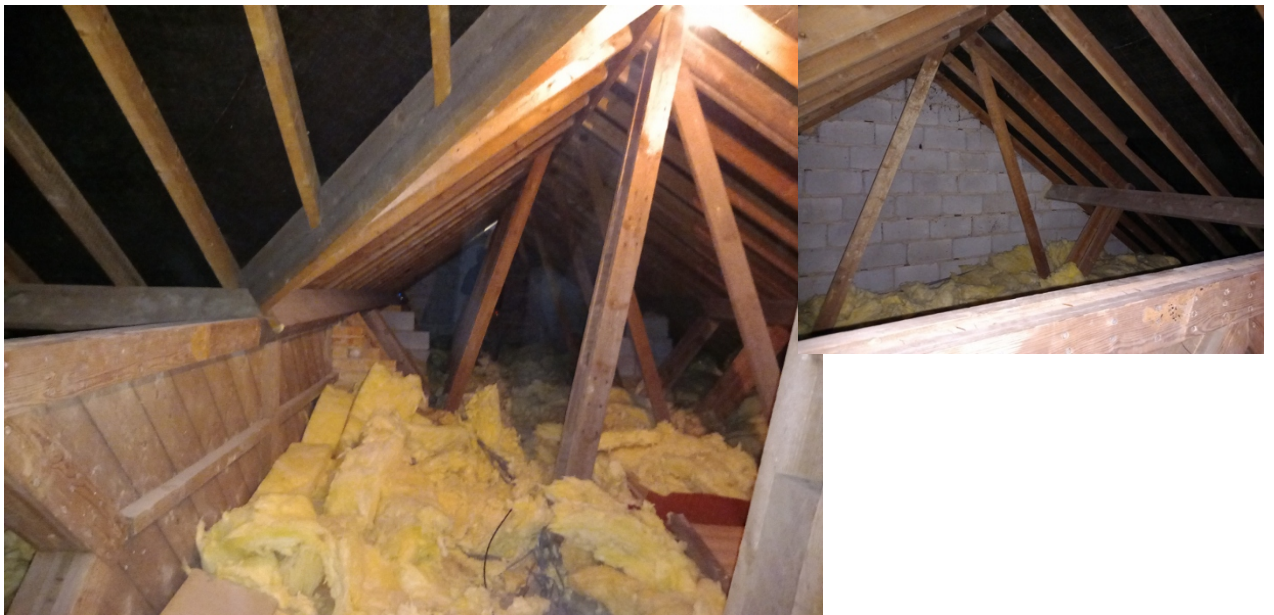
- 3.5 Internally the main loft space of the bungalow comprises of traditional rafters and ceiling joists with insulation at ceiling level. The rafters are overlaid with a modern breathable roof membrane indicating that the covering has been replaced. The roof space is well sealed and there are no light gaps penetrating the roof space. There are large amounts of debris and spiders webs within the loft.
- 3.6 No droppings or feeding remains were found present within the roof space.

Photograph of loft space within the roof of the bungalow.

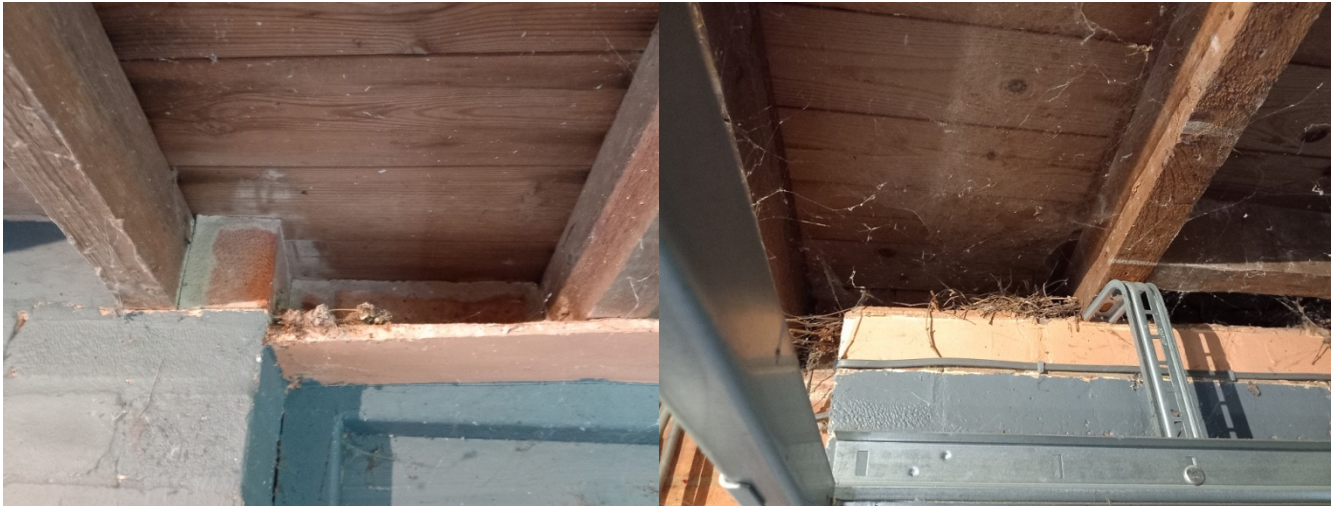
- 3.7 The garage roof comprises of timber flat roof joists overlaid with boarding and roofing felt. The roof is well sealed and there are no gaps or access to the exterior of the building. There are old birds nest present between the rafters.
- 3.8 There are no loft spaces within the annex building along the east of the bungalow and ceilings comprise of roof boarding overlaid with flat roof membrane. There is a suspended ceiling within the annex at the front however, the roof is well sealed directly above this.

Photographs of old swallow nest (left) and black bird nest (right) within garage.
