# Trial Pit Log

# Trial Pit Photos

Manor Farm, Carburton

P21-00134

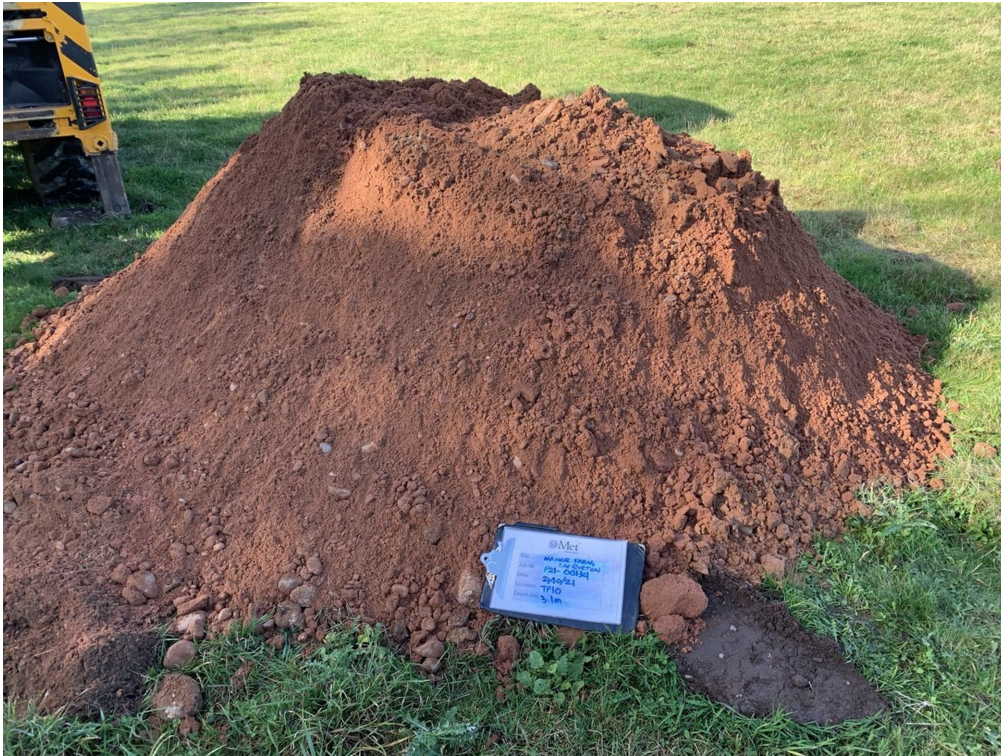
Photograph 31: TP10. Arisings.

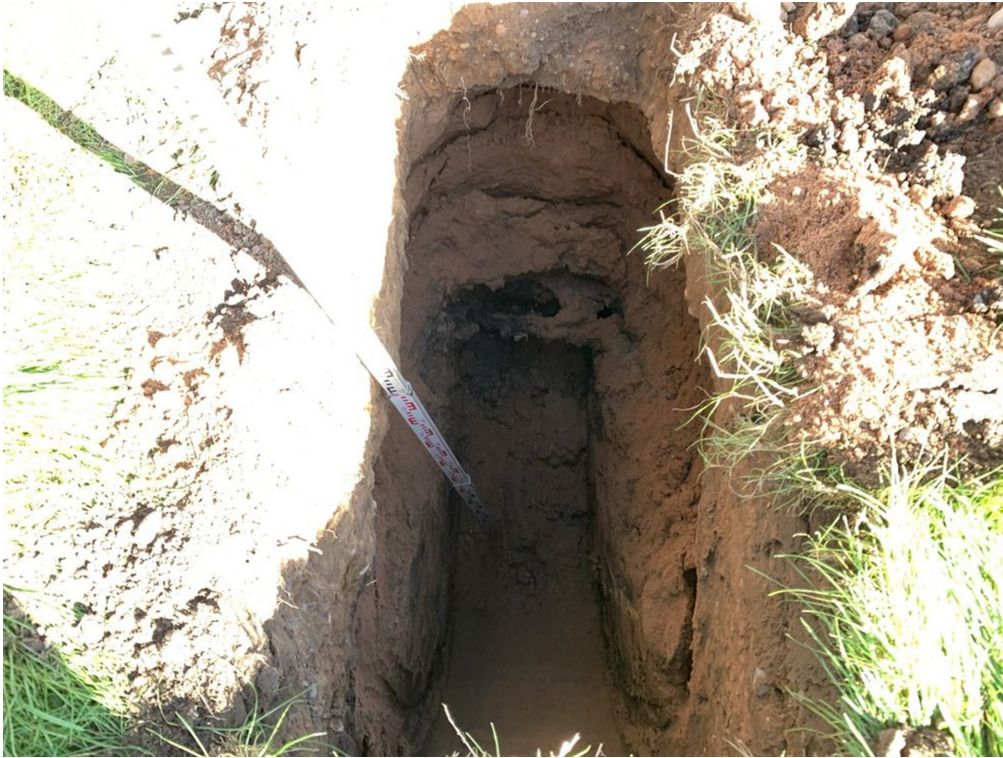
Photograph 32: TP11. Trial Pit.

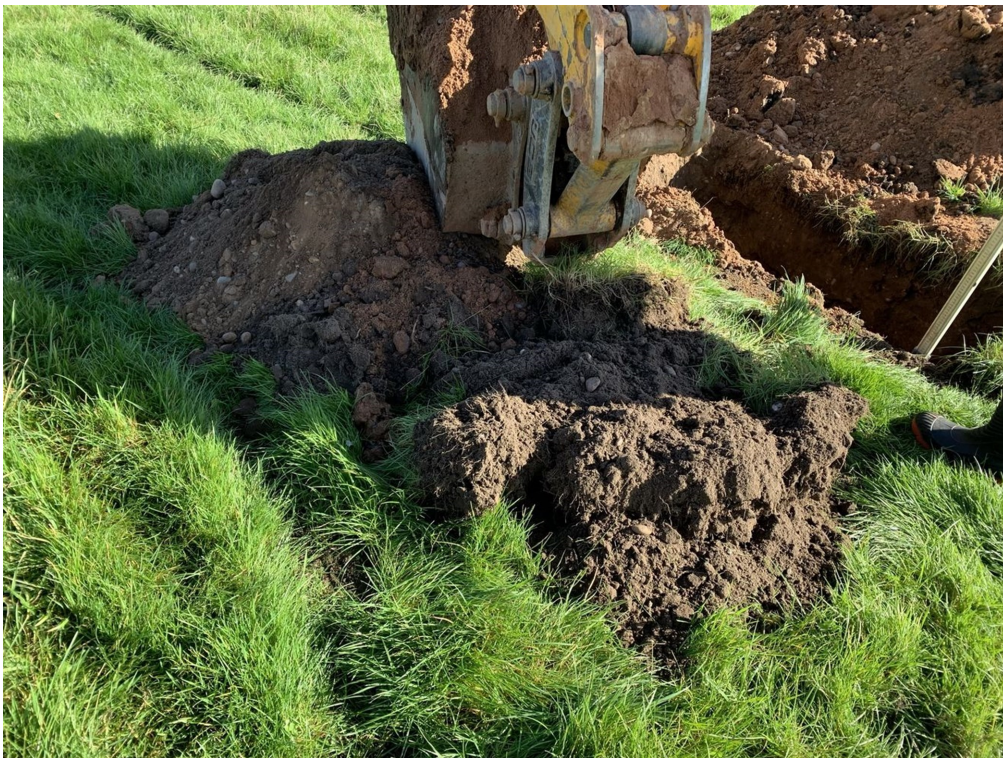
Water Strike	Samples & In Situ Testing			Depth (m)	Level (m)	Legend	Stratum Description
	Depth	Type	Results				
				0.30	35.54		Grass overlying medium brown silty gravelly SAND (TOPSOIL) with frequent rootlets. Sand is fine. Gravel is subangular to rounded fine to coarse of mixed lithologies including occasional brick.

Photograph 33: TP11. Topsoil Arisings.

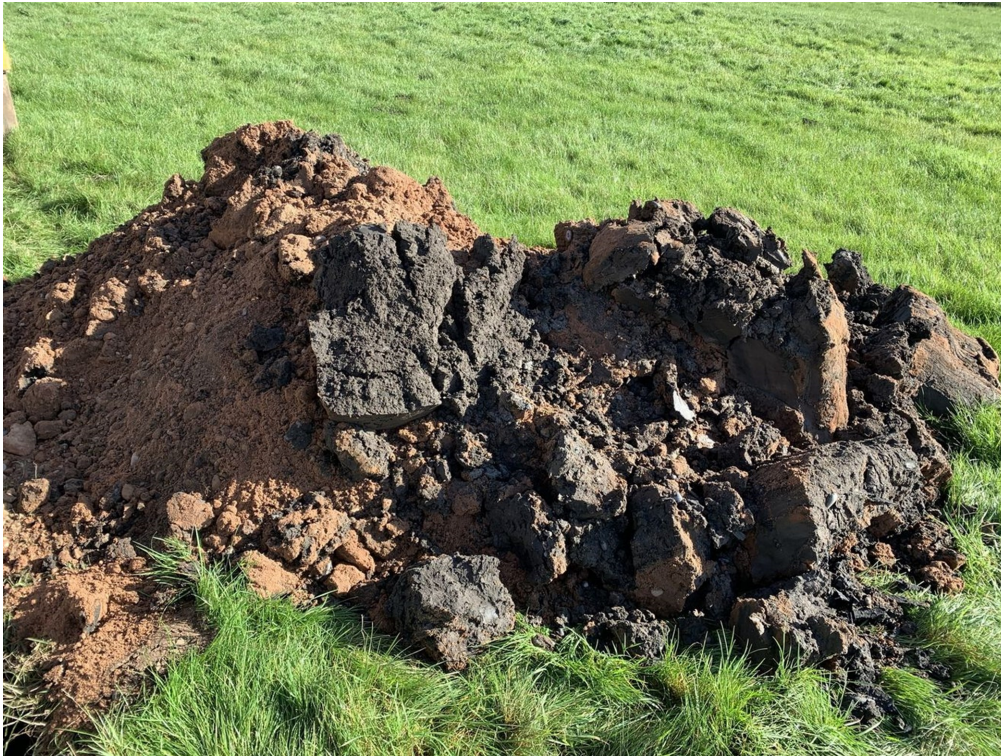
0.65	35.19		Light brown gravelly SAND (SUBSOIL) with moderate to high cobble content. Sand is fine. Gravel is subrounded to rounded fine to coarse of mixed lithologies. Cobbles are subrounded to rounded of mixed lithologies up to 90mm across.

1.50	34.34		Reworked: Orange gravelly SAND with high cobble content. Sand is fine to medium. Gravel is subrounded to rounded fine to coarse of mixed lithologies. Cobbles are subrounded to rounded of mixed lithologies up to 110mm across.

2.00	33.84		MADE GROUND: Black/ dark brown peaty silty gravelly SAND with medium cobble content/ Sand is fine. Gravel is subangular to rounded fine to coarse of mixed lithologies including brick. Cobbles are subrounded to rounded of mixed lithologies up to 110mm across. Frequent fragments of ceramic, glass, wood, animal bone and plant root noted. Strong organic odour noted. Hit potential service at 1.8mbgl in east of trial pit, some sitting water noted.
							End of Pit at 2.00m

Photograph 34: TP11. Arisings.

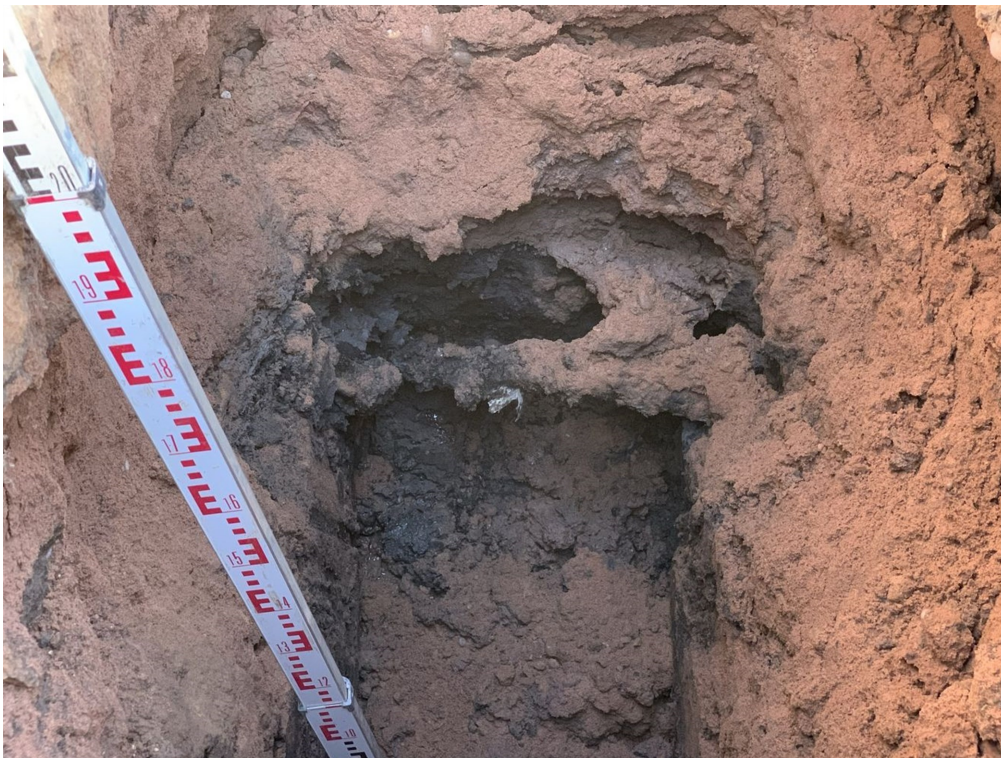
Remarks: Ground observed to be generally loose during excavation by JCB. Terminated due to potential service. Sample taken from unknown material, laboratory testing confirmed material to be weathered wood.

Photograph 35: TP11. Potential service. Sample taken from unknown material, laboratory testing confirmed material to be weathered wood..

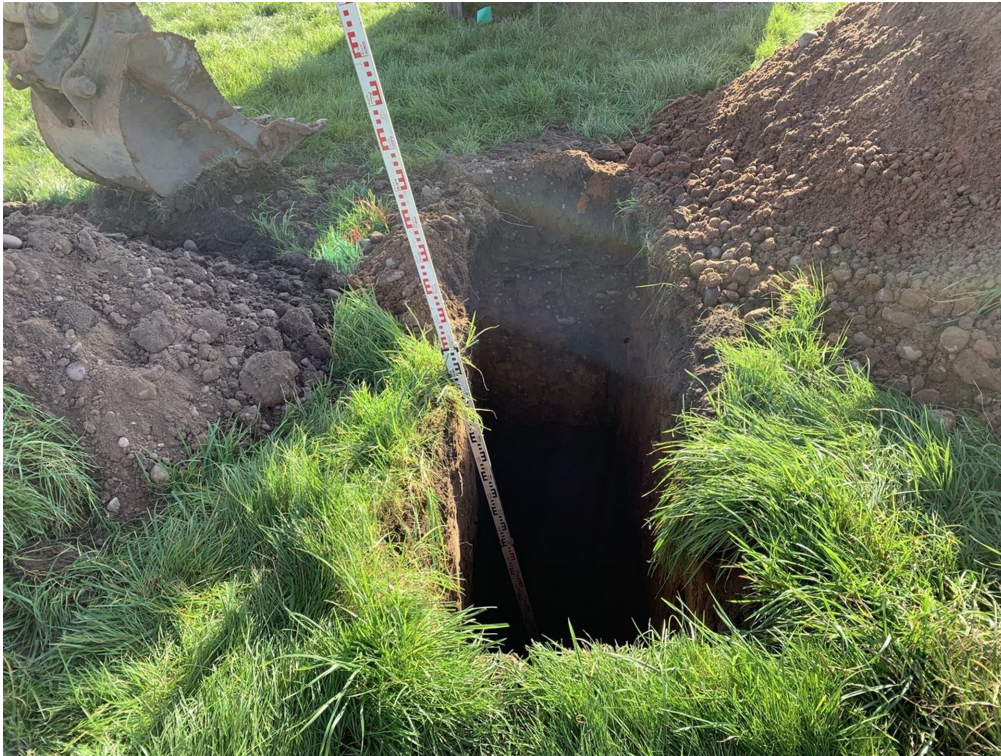
Remarks: Ground observed to be generally loose during excavation by JCB. Terminated due to water strikes noted at 2.6mbgl and 2.8mbgl. Damp sand noted from 1.9mbgl, wet sand noted from 2.2mbgl.

Photograph 36: TP12. Trial Pit.

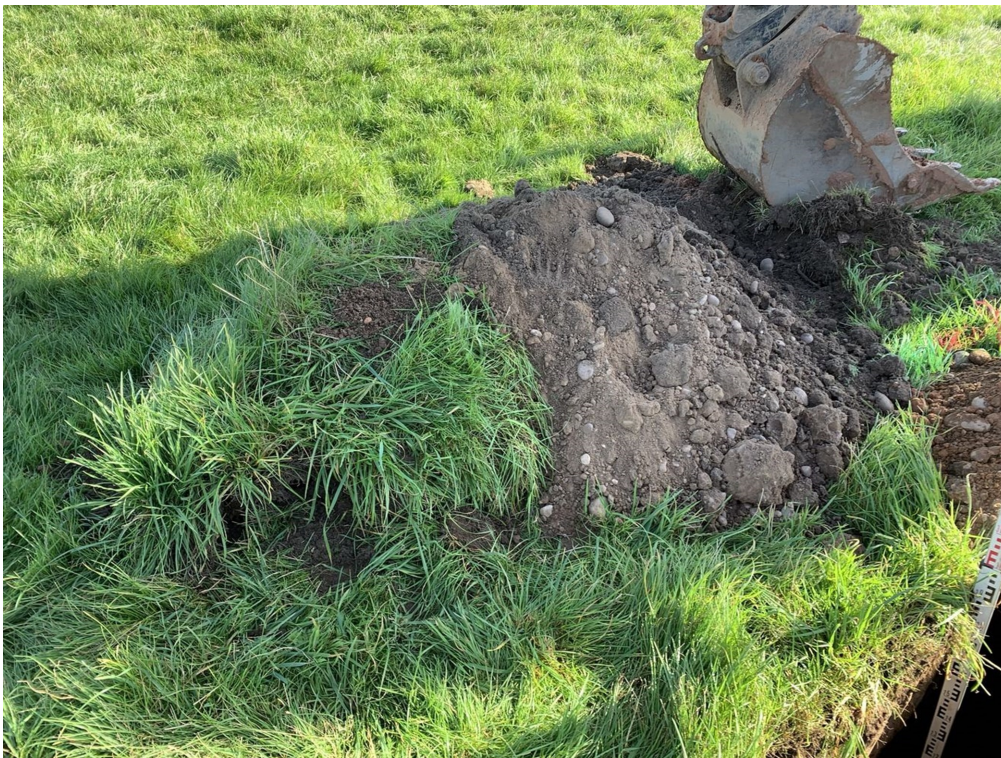
Water Strike	Samples & In Situ Testing			Depth (m)	Level (m)	Legend	Stratum Description
	Depth	Type	Results				
				0.20	36.72		Grass overlying medium brown silty SAND (TOPSOIL) with frequent rootlets. Sand is fine.

Photograph 37: TP12. Topsoil Arisings.

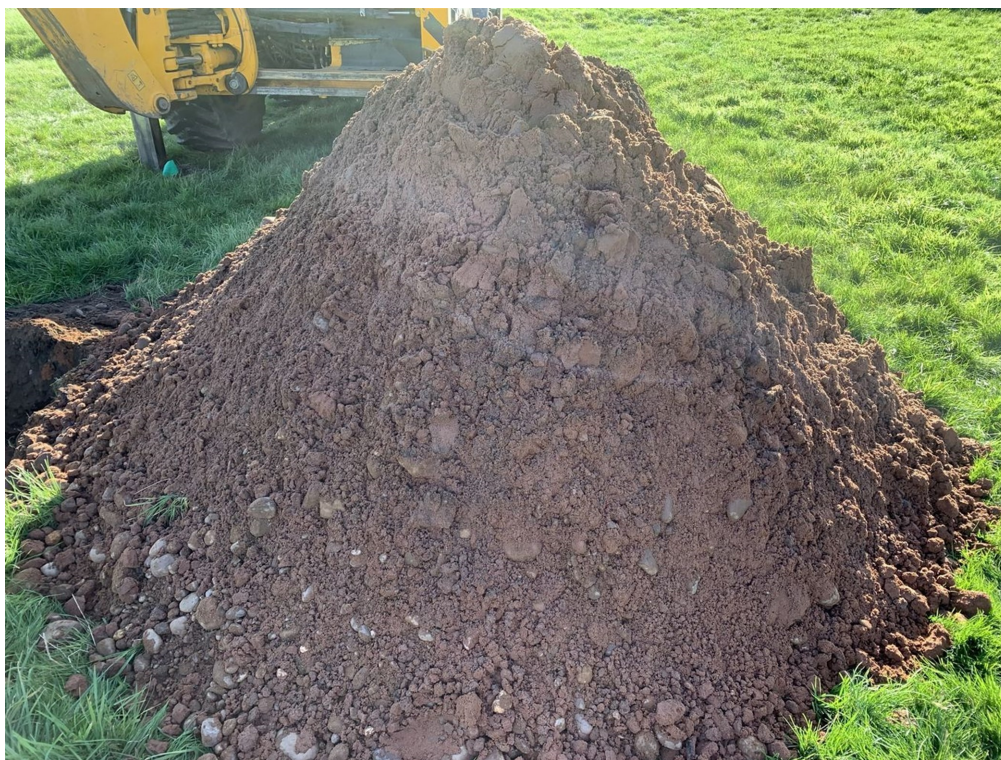
0.70	36.22		Light brown gravelly SAND (SUBSOIL) with moderate cobble content. Sand is fine. Gravel is subangular to rounded fine to coarse of mixed lithologies. Cobbles are subrounded to rounded to rounded of mixed lithologies up to 80mm across.

1.90	35.02		Orangish light brown gravelly SAND with very high cobble content. Sand is fine to medium. Gravel is subrounded to rounded fine to coarse of mixed lithologies. Cobbles are subrounded to rounded of mixed lithologies up to 100mm across.

2.20	34.72		Damp reddish orange brown gravelly SAND with very high cobble content. Sand is fine to medium. Gravel is subrounded to rounded fine to coarse of mixed lithologies. Cobbles are subrounded to rounded of mixed lithologies up to 100mm across.

2.90	34.02		Wet reddish orange brown fine grained SAND. Sand becoming denser from approximately 2.6mbgl. Water strikes noted at 2.6mbgl in south of trial pit and 2.8mbgl in north of trial pit.
							End of Pit at 2.90m

Photograph 38: TP12. Arisings.
