Appendix V

Coring Logs

CBR Testing Results

Date 22-October-2021 Contract Manor Farm, Carburton

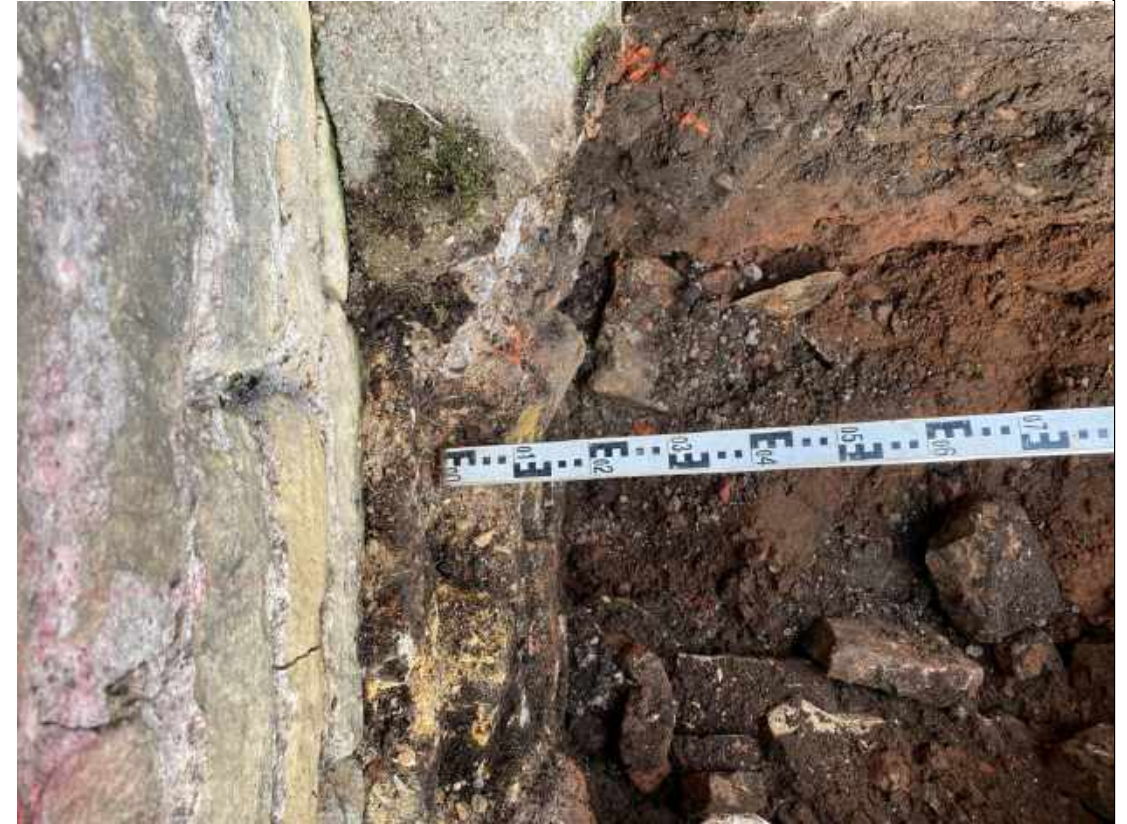
Photograph 32 – Foundation Pit 08 step

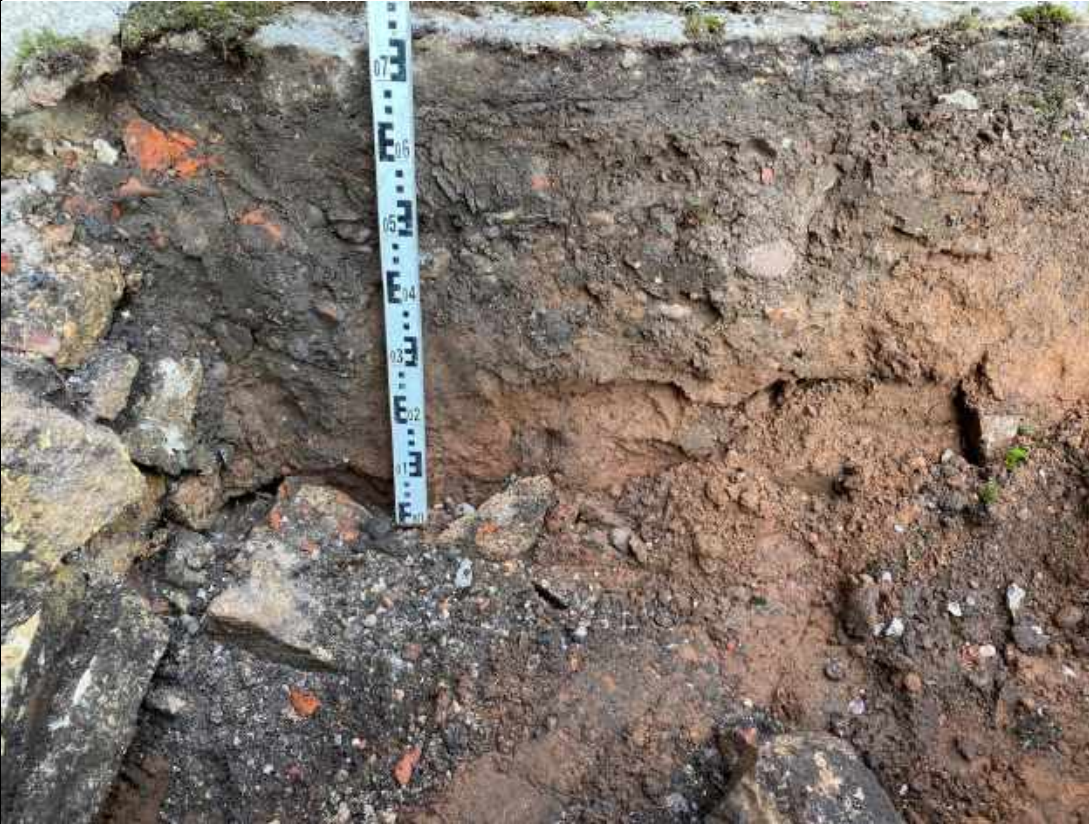
Photograph 33 – Foundation Pit 08 soil horizons

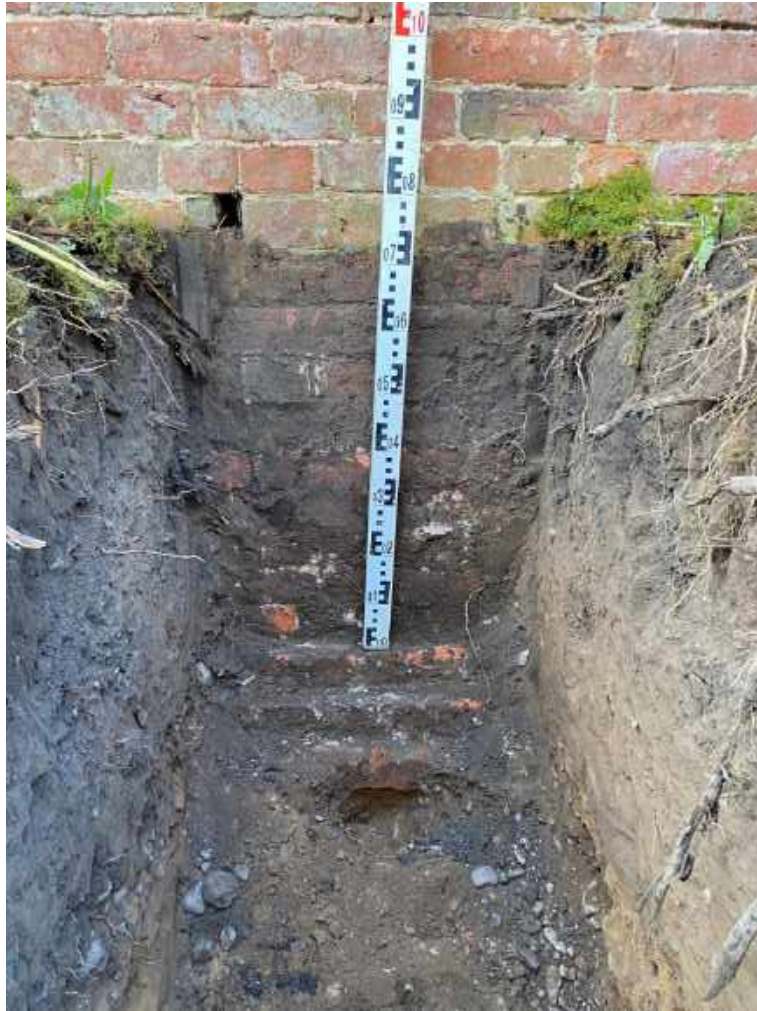
Photograph 35 – Foundation Pit 09 step

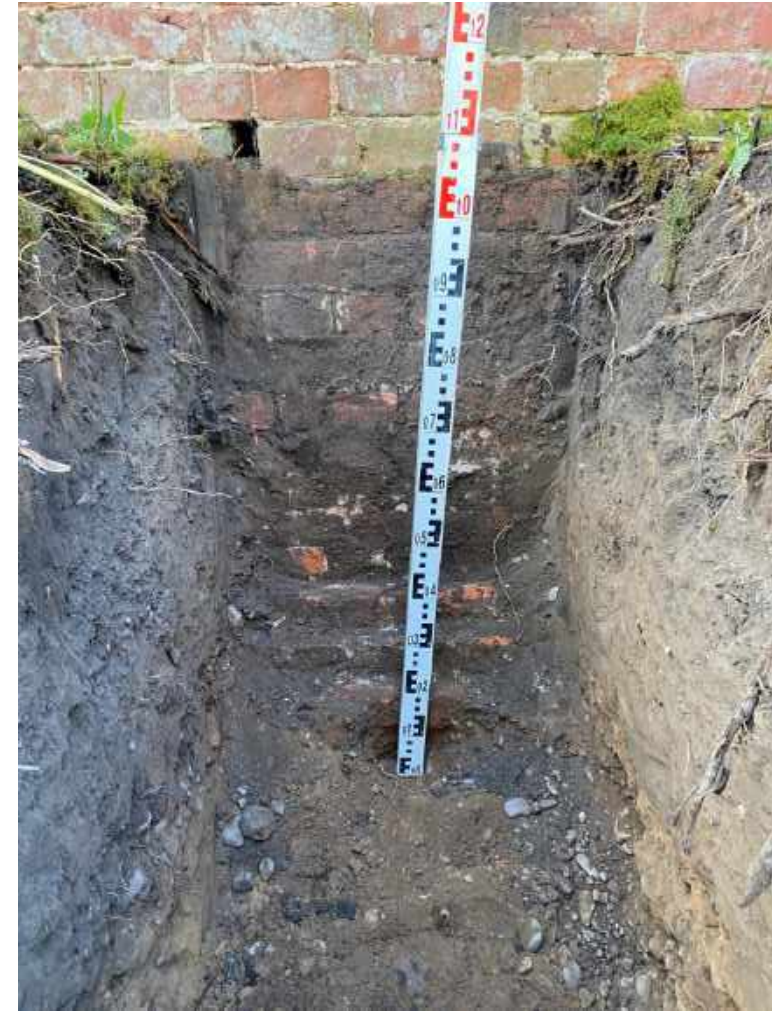
Photograph 36 – Foundation Pit 09 base of foundations

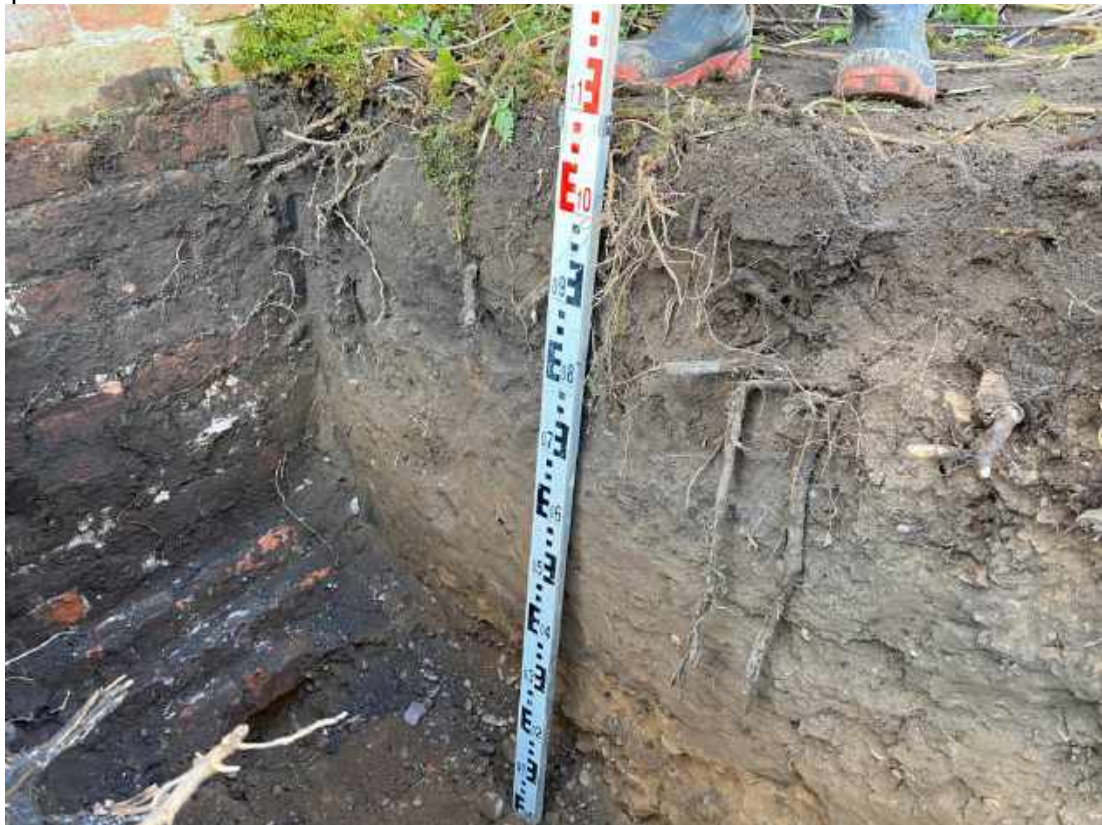
Photograph 37 – Foundation Pit 09 soil horizons

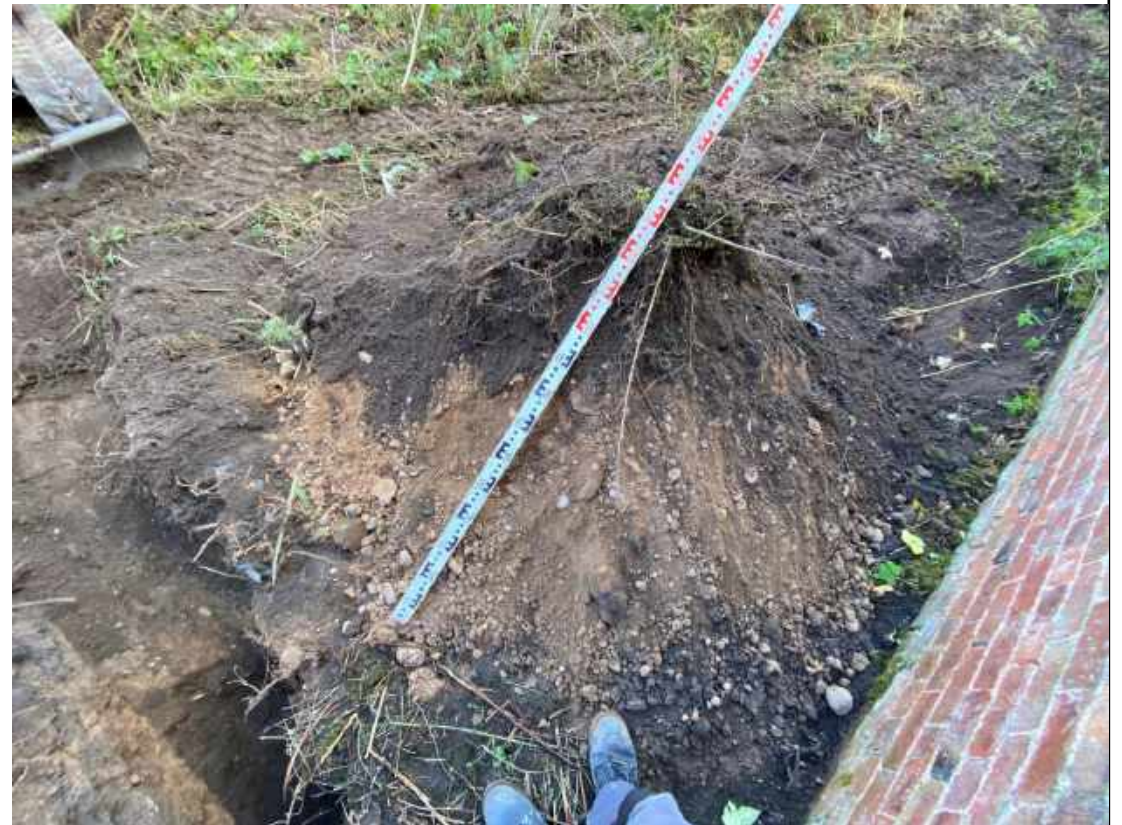
Photograph 38 – Foundation Pit 09 soil arisings

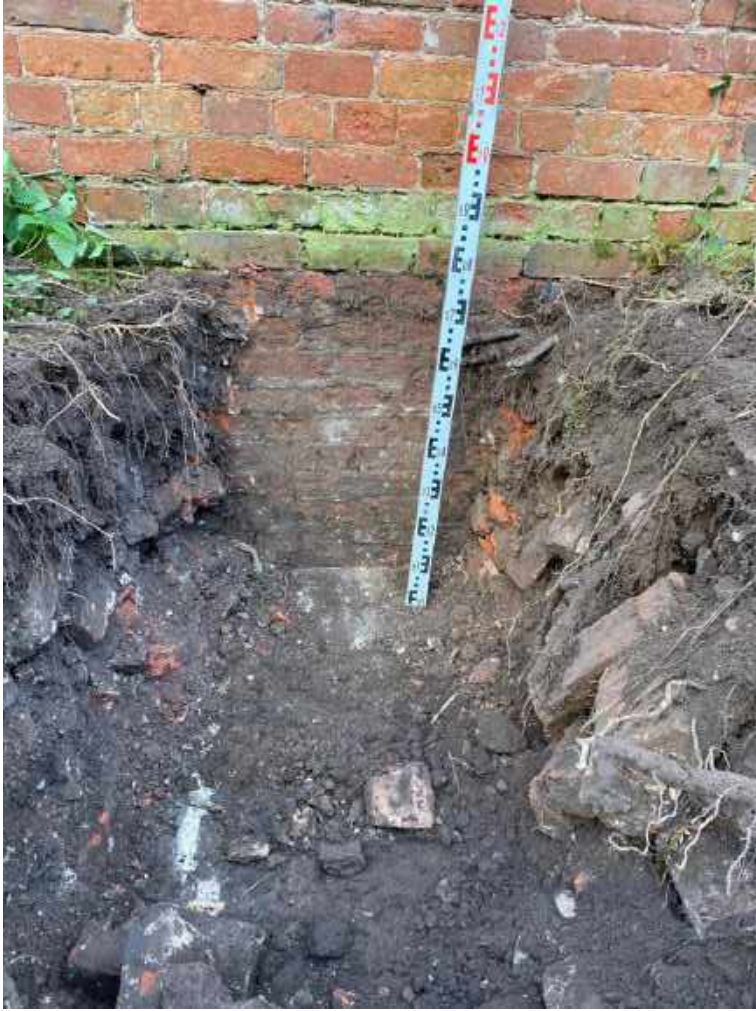
Photograph 39 – Foundation Pit 10 prior to slab being broken out

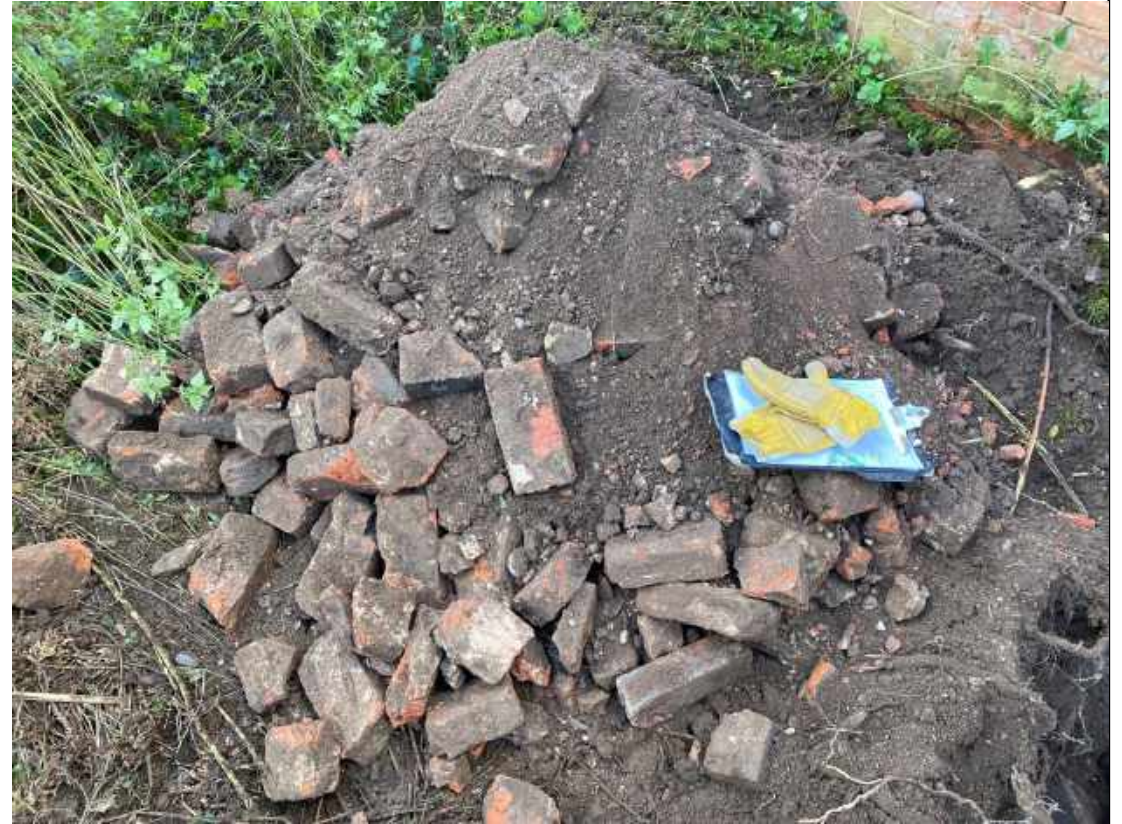
Photograph 40 – Foundation Pit 10 soil arisings

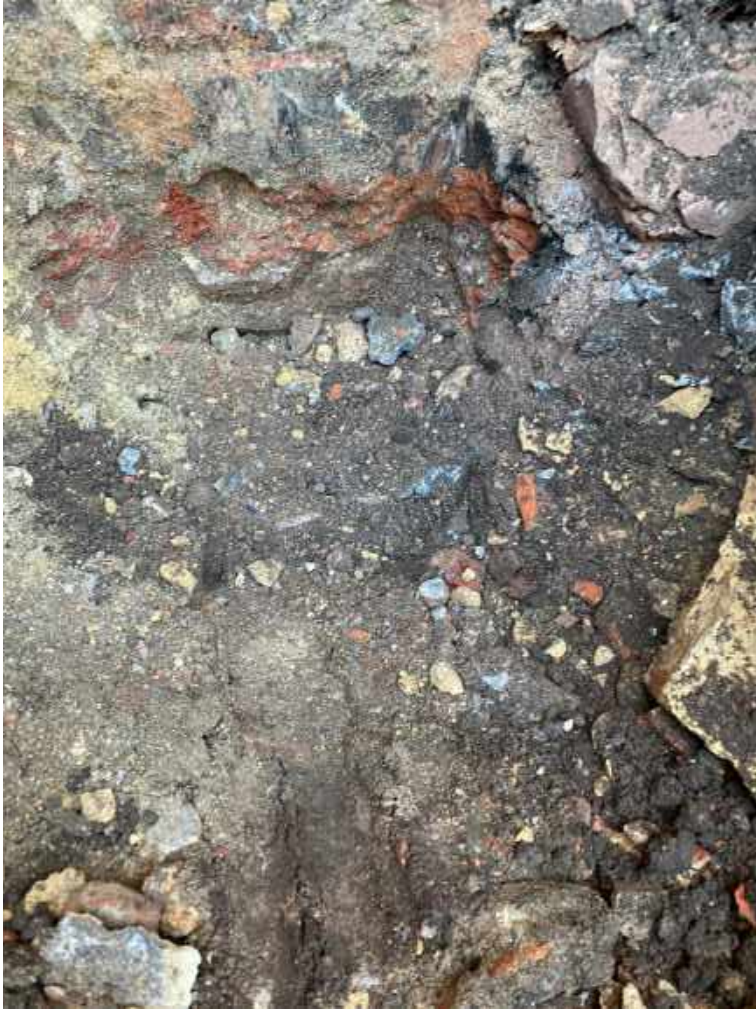
Photograph 41 – Foundation Pit 10 base of pit after slab broken out

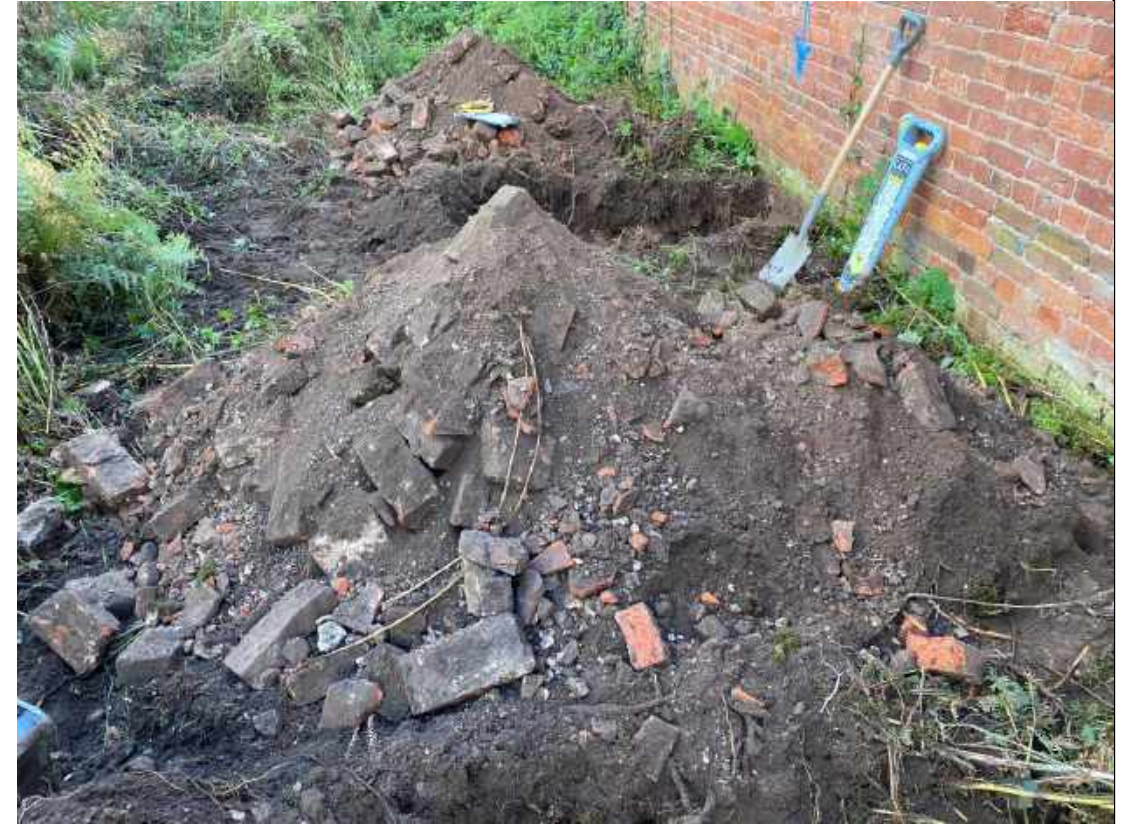
Photograph 44 – Foundation Pit 11 arisings

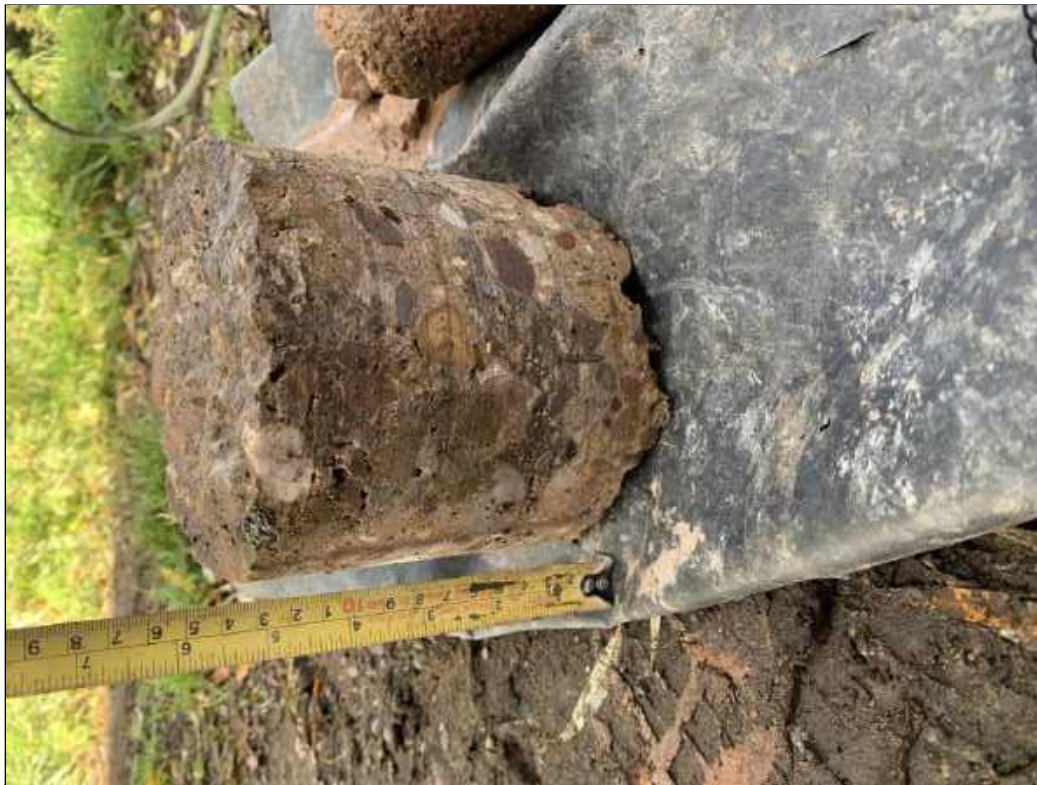
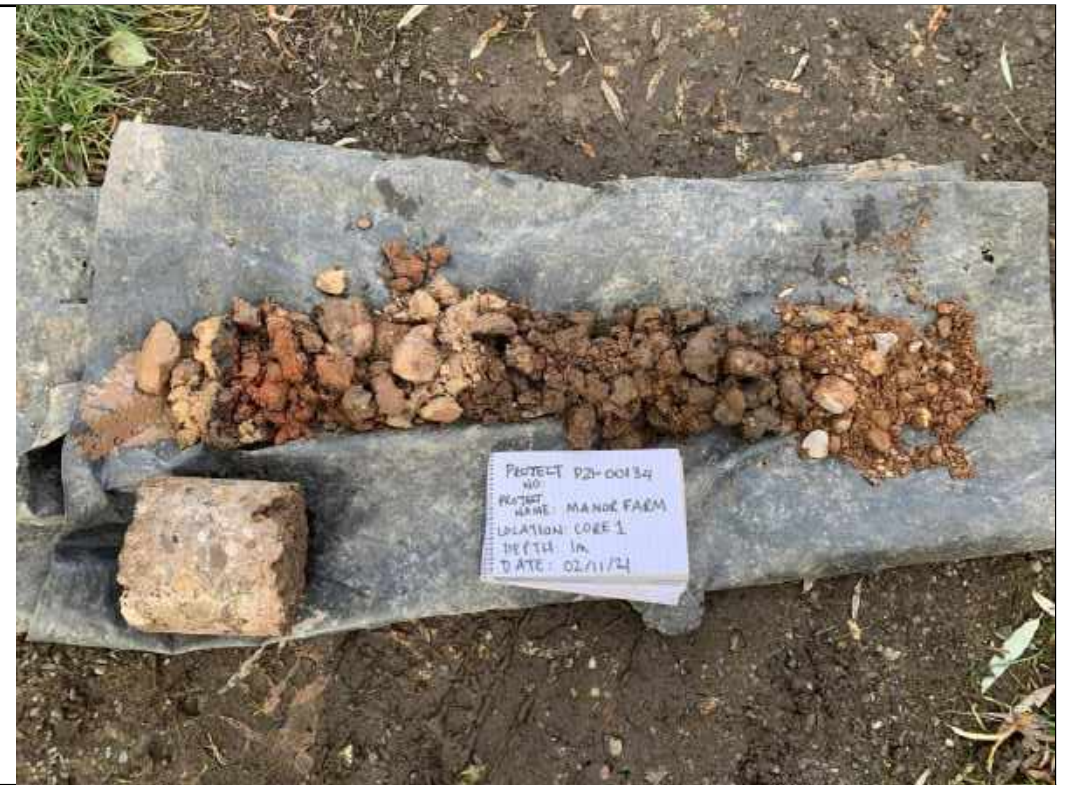
Core Location – CORE 1

Thickness of Tarmac: None identified. Thickness of Concrete: 13cm. Thickness of Sub-Base: 87cm.

0-13cm -	Concrete. Subrounded to rounded fine to coarse gravels of mixed lithologies within a concrete matrix. No rebar.
Made Ground 13-80cm -	Multi-coloured (black/brown/red/cream) very gravelly sand with moderate cobble content. Sand is fine. Gravel is subangular to rounded fine to coarse of mixed lithologies. Cobbles are subangular to subrounded of mixed lithologies up to 70mm across. Brick noted at 0.3mbgl.
Natural 80-100cm -	Orangish light brown very gravelly sand. Sand is fine to medium. Gravel is subrounded to rounded fine to coarse of mixed lithologies.

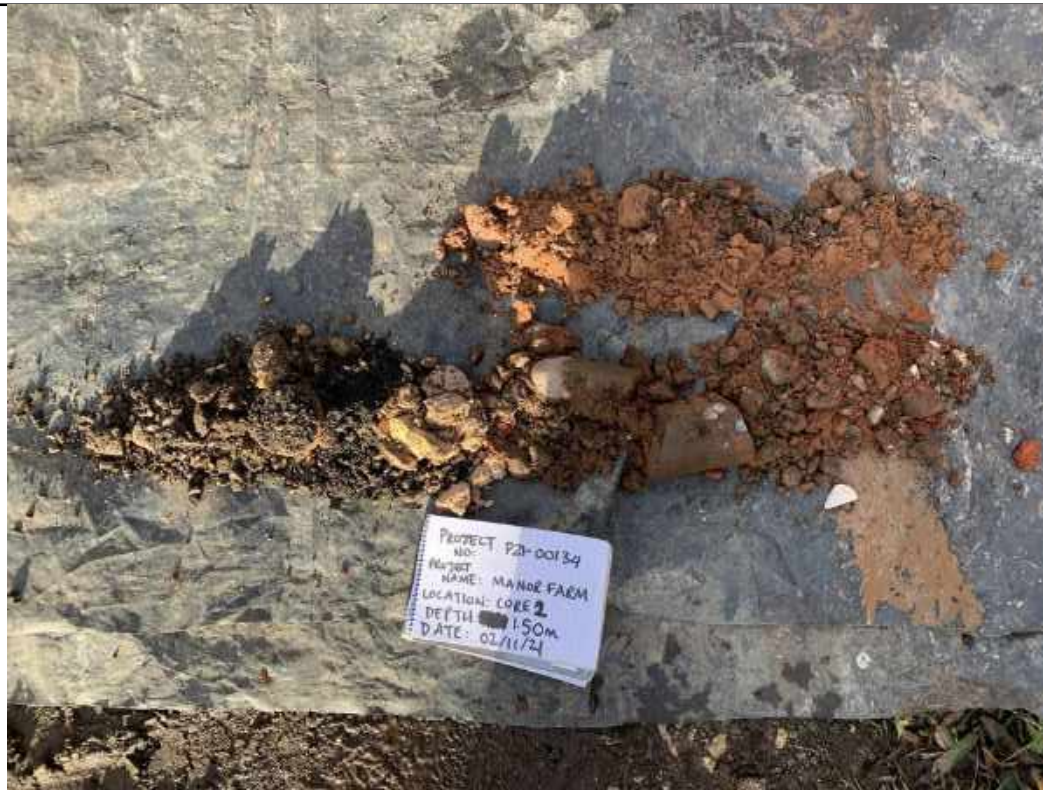
Core Location – CORE 2

Thickness of Tarmac: None identified. Thickness of Concrete: None identified. Thickness of Sub-Base: 150cm.

Made Ground 0-7cm -	Dark brown very gravelly sand with subangular brick cobble noted. Sand is fine to medium. Gravel is angular to subangular fine to coarse of mixed lithologies including brick.
Made Ground 7-15cm -	Loose black angular to subangular fine to coarse tarmac gravels.
Made Ground 15-40cm -	Loose white angular to subangular fine to coarse sandstone gravels.
Made Ground 40-100cm -	Loose reddish brown very gravelly sand with brick cobble noted. Sand is fine. Gravel is angular to rounded of mixed lithologies including brick.
Natural 100-150cm -	Reddish orange gravelly sand with low cobble content. Sand is fine. Gravel is subrounded to rounded fine to coarse of mixed lithologies. Cobbles are subrounded to rounded of mixed lithologies up to 65mm across.

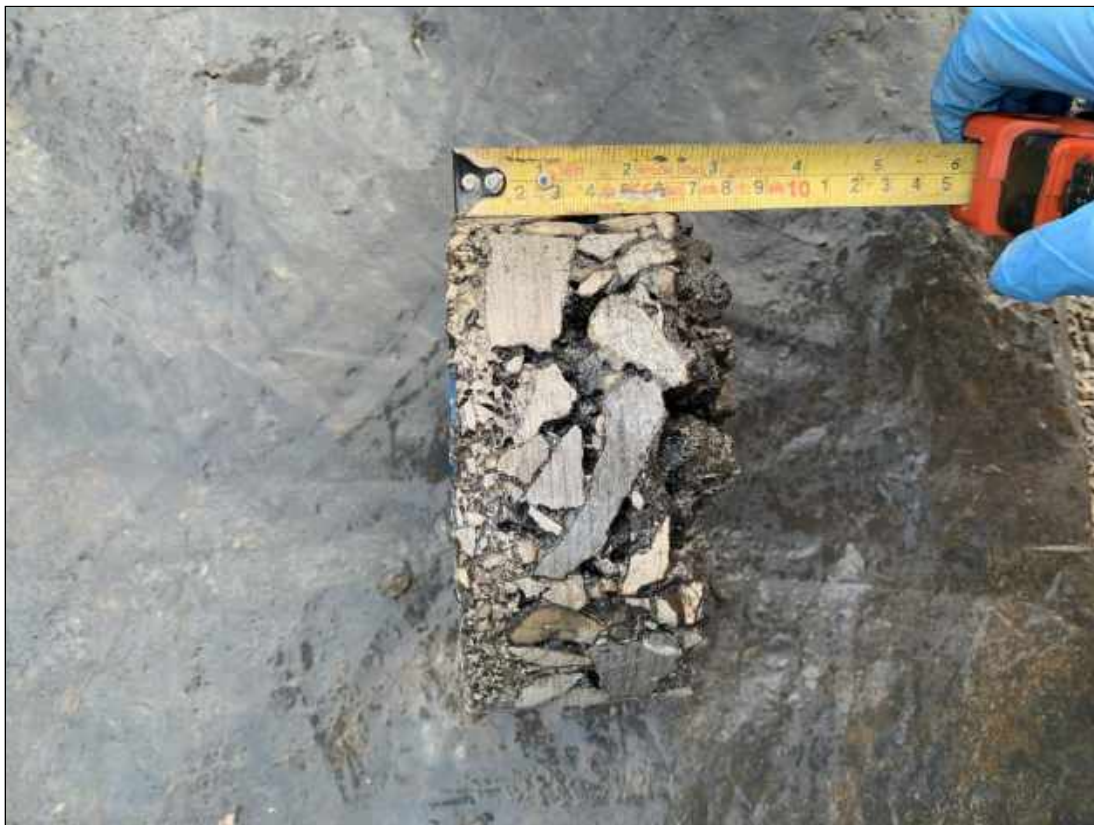
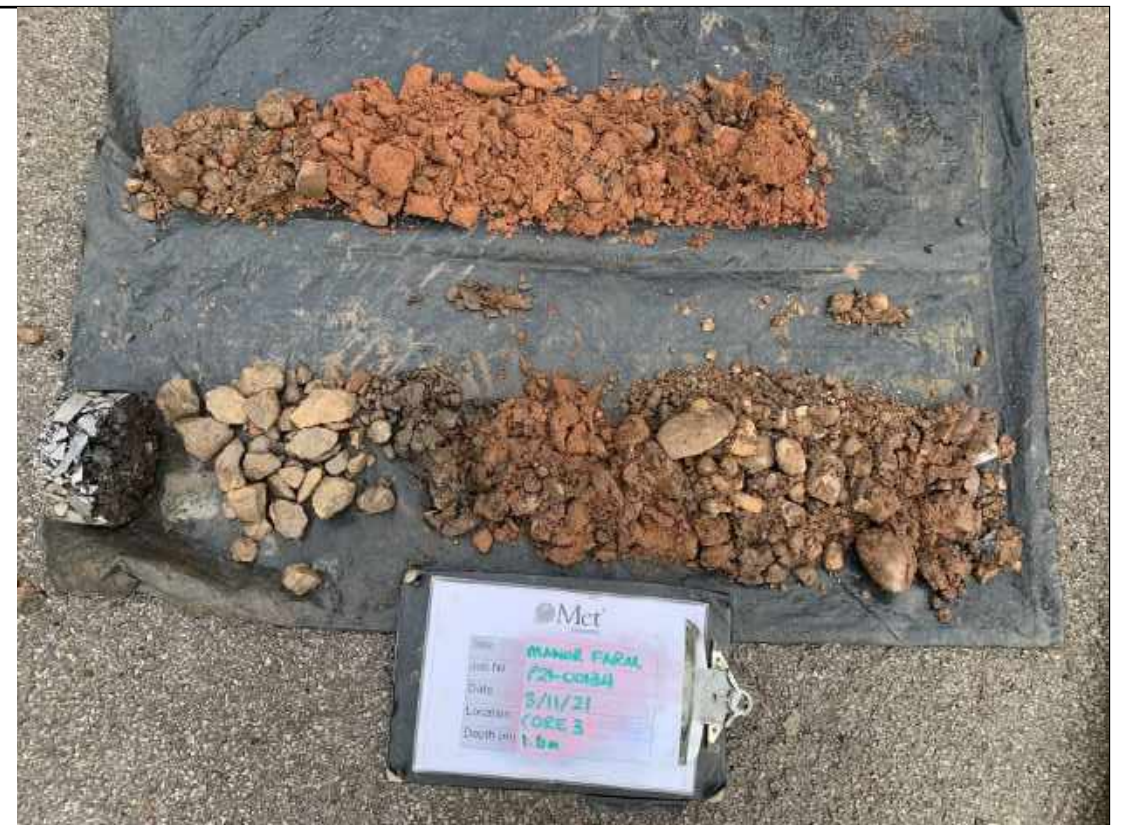
Core Location – CORE 3

Thickness of Tarmac: 6cm. Thickness of Concrete: None identified. Thickness of Sub-Base: 154cm.

0-6cm -	Tarmac. 0-1cm is angular to subangular fine tarmac gravels, 1-6cm is angular to subangular fine to coarse tarmac gravels.
Fill	6-20cm -	Cream/yellow subangular cobbles of sandstone and some brick up to 70mm across.
Made Ground	20-30cm -	Grey subangular to rounded fine to coarse gravels of mixed lithologies.
Made Ground	30-60cm -	Reddish brown gravelly sand. Sand is fine. Gravel is subangular to rounded of mixed lithologies including coal and brick.
Reworked	60-110cm -	Reddish brown very gravelly sand with high cobble content. Sand is fine. Gravel is angular to rounded of mixed lithologies including some brick. Cobbles are subrounded to rounded of mixed lithologies up to 85mm across.
Natural	110-160cm -	Reddish orange slightly gravelly sand with medium cobble content. Sand is fine. Gravel is subrounded to rounded fine to coarse of mixed lithologies. Cobbles are subrounded to rounded of mixed lithologies up to 90mm across.

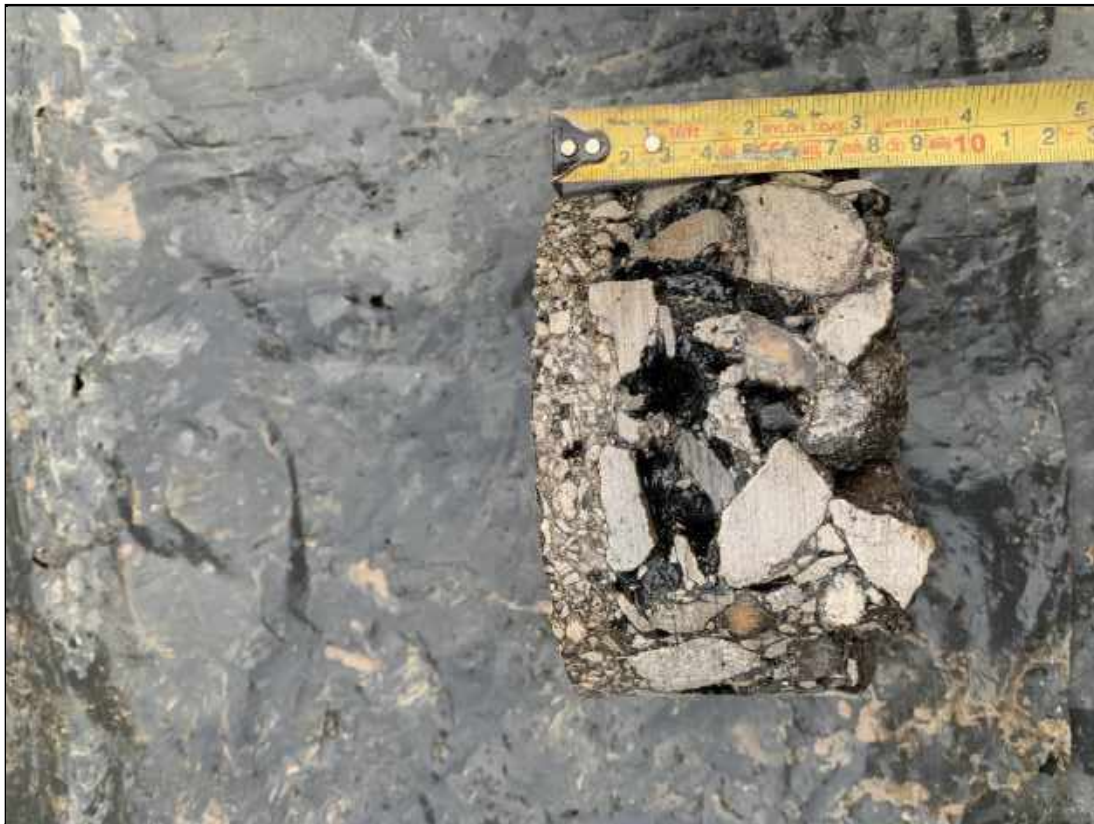
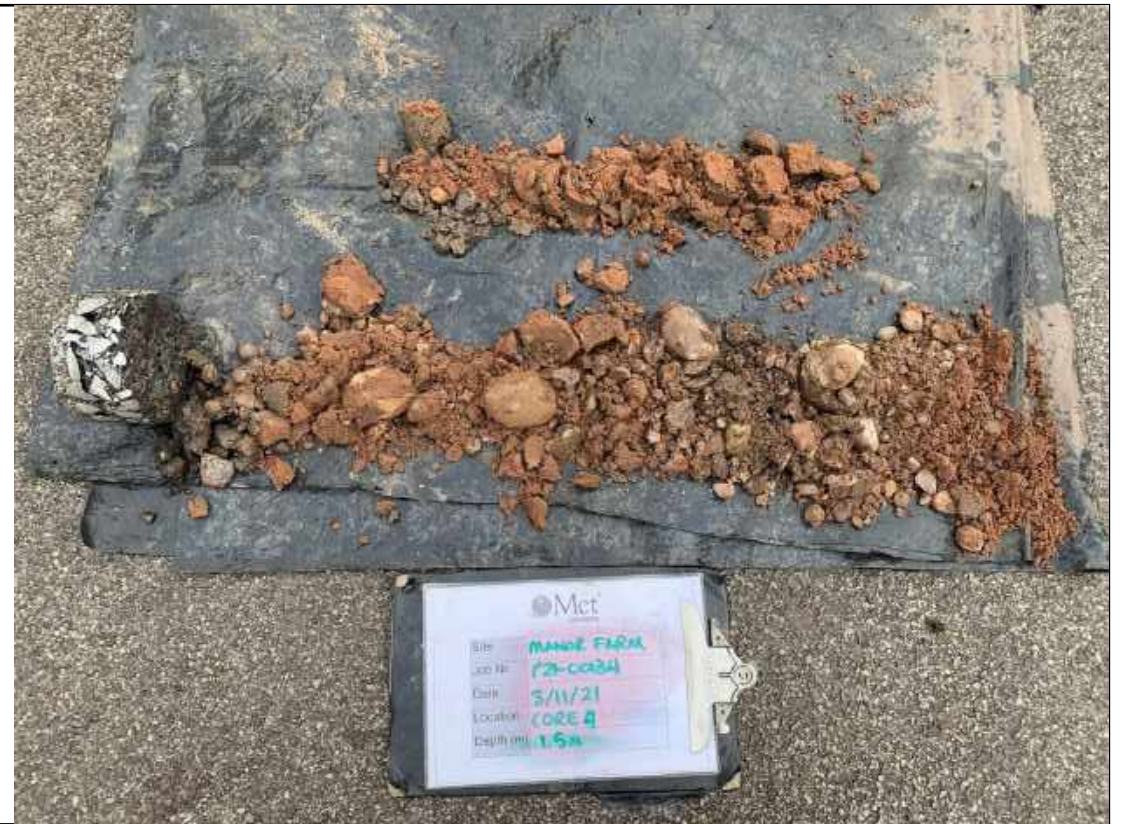
Core Location – CORE 4

Thickness of Tarmac: 8cm. Thickness of Concrete: None identified. Thickness of Sub-Base: 142cm.

0-8cm -	Tarmac. 0-1.5cm is angular to subangular fine tarmac gravels, 1.5-8cm is angular to subangular fine to coarse tarmac gravels.
Made Ground 8-70cm -	Reddish orange gravelly sand with moderate to high cobble content. Sand is fine. Gravel is subangular to rounded fine to coarse of mixed lithologies including sandstone and brick. Cobbles are angular to rounded of mixed lithologies up to 80mm across. Ceramic tile noted at 0.1mbgl.
Made Ground 70-90cm -	Medium brown gravelly sand with moderate cobble content. Sand is fine. Gravel is angular to rounded fine to coarse of mixed lithologies including brick and coal. Cobbles are rounded of mixed lithologies up to 75mm across.
Natural 90-150cm -	Reddish orange fine grained sand.

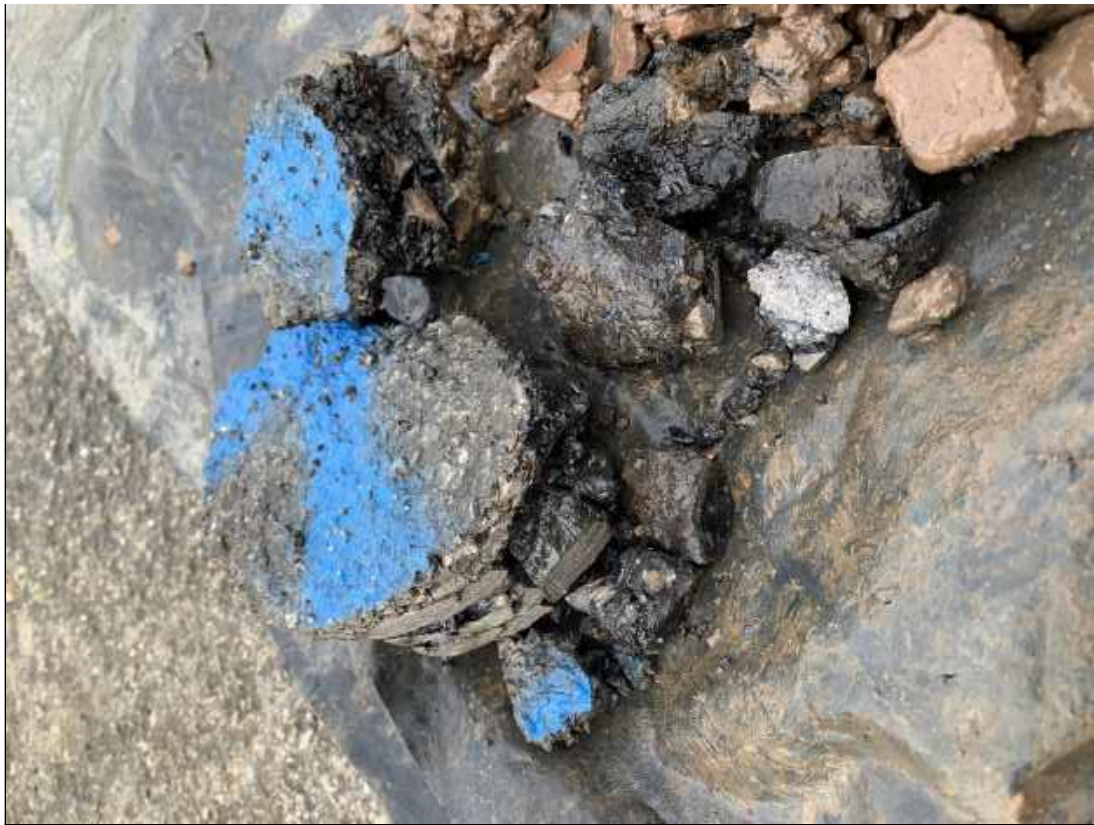
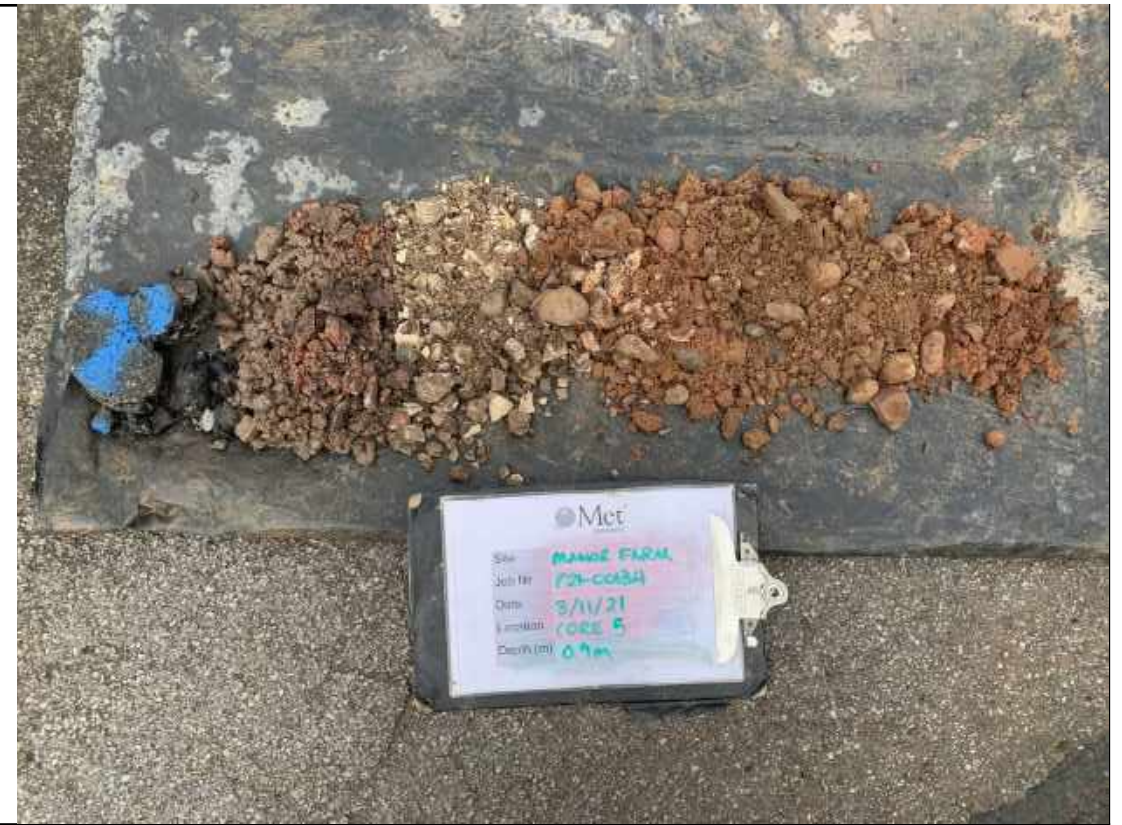
Core Location – CORE 5

Thickness of Tarmac: 7cm. Thickness of Concrete: None identified. Thickness of Sub-Base: 83cm.

0-7cm -	Weak tarmac, recovered with breakages. 0-1cm is subangular to angular fine tarmac gravels, 1-7cm is subangular to angular fine to coarse tarmac gravels.
Made Ground 7-15cm -	Multicoloured (black/red/brown) ashy sandy gravel. Sand is fine to medium. Gravel is angular to subangular fine to coarse of mixed lithologies including sandstone, brick and some coal.
Made Ground 15-25cm -	Light brown sandy gravel. Sand is fine. Gravel is angular to subangular fine to coarse of mixed lithologies including brick.
Made Ground 25-80cm -	Reddish brown gravelly sand. Sand is fine. Gravel is subangular to rounded fine to coarse of mixed lithologies including brick.
Natural 80-90cm -	Reddish brown gravelly sand. Sand is fine. Gravel is subrounded to rounded fine to coarse of mixed lithologies.

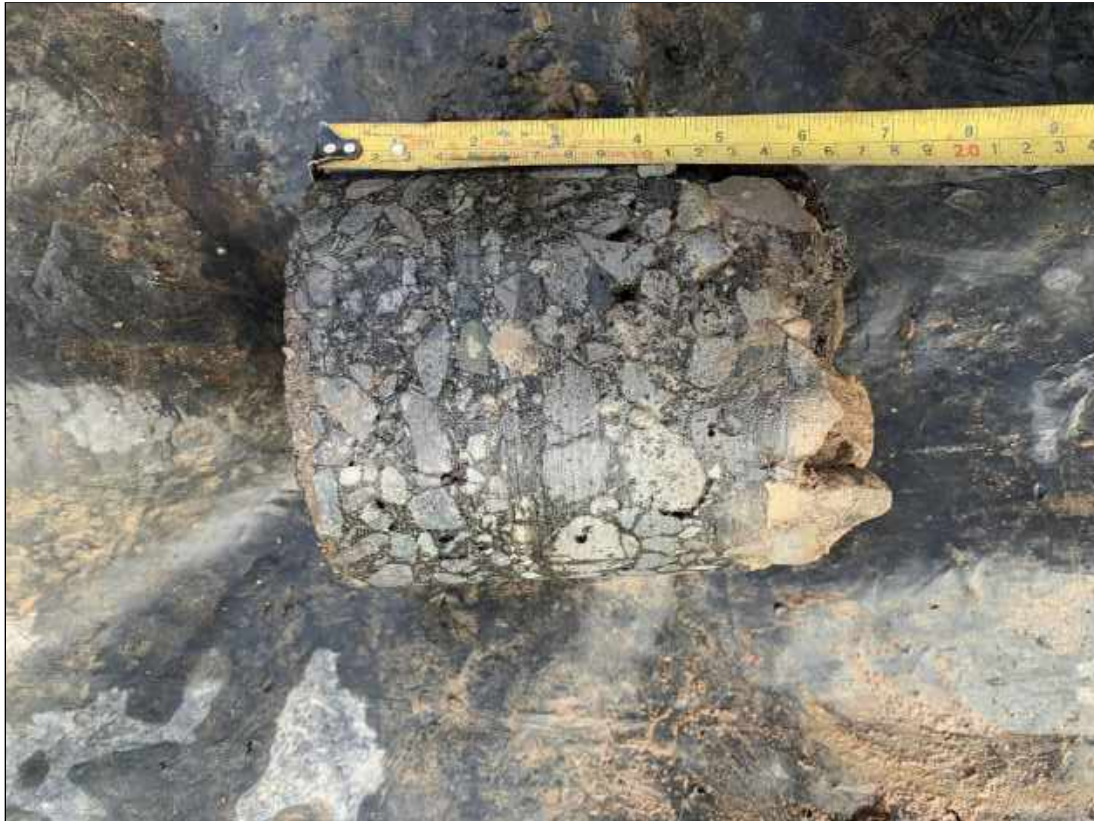
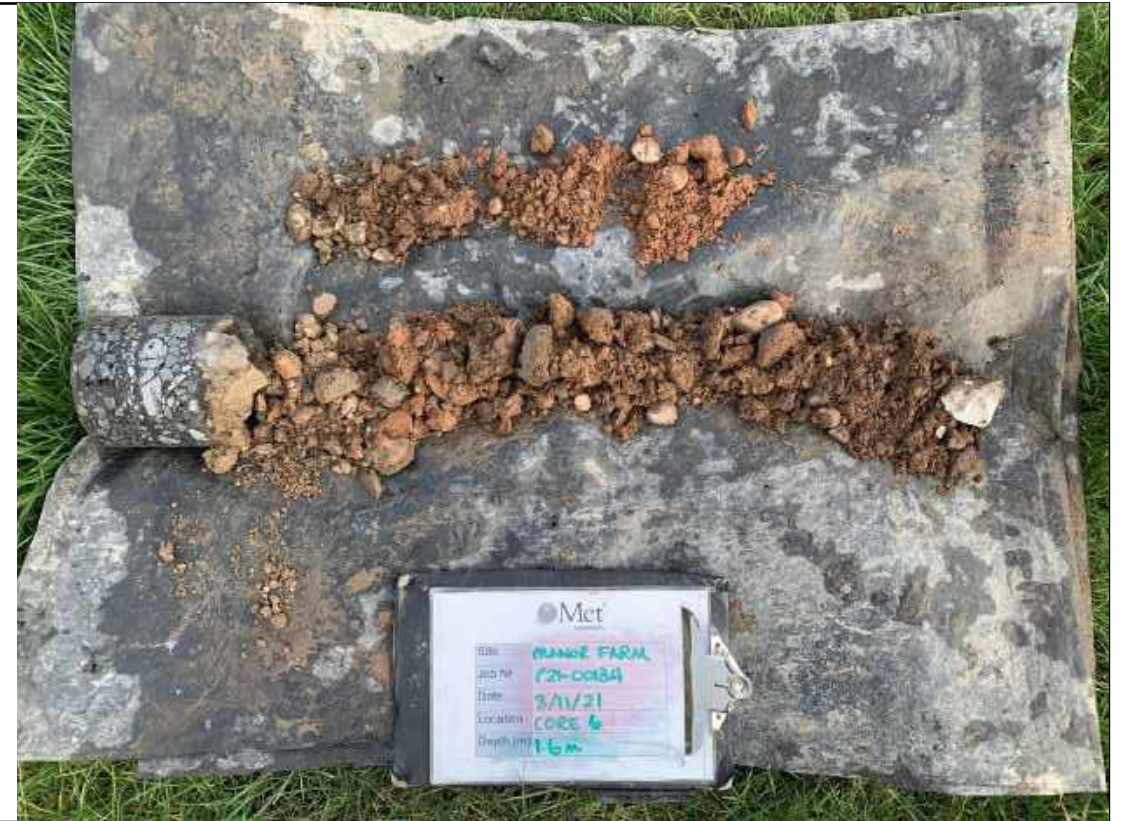
Core Location – CORE 6

Thickness of Tarmac: 15cm. Thickness of Concrete: None identified. Thickness of Sub-Base: 145cm.

0-15cm -	Tarmac. 0-7cm is angular to subangular fine to medium tarmac gravels, 7-15cm is angular to subangular fine to coarse tarmac gravels.
Made Ground 15-20cm -	Light brown sandy gravel. Sand is fine. Gravel is angular to subangular fine to coarse of mixed lithologies including sandstone and brick.
Reworked 20-120cm -	Reddish brown gravelly sand with moderate cobble content. Sand is fine. Gravel is angular to rounded fine to coarse of mixed lithologies including some brick and coal. Cobbles are subrounded to rounded of mixed lithologies up to 70mm across.
Natural 120-160cm -	Reddish orange gravelly sand. Sand is fine. Gravel is subrounded to rounded fine to coarse of mixed lithologies.

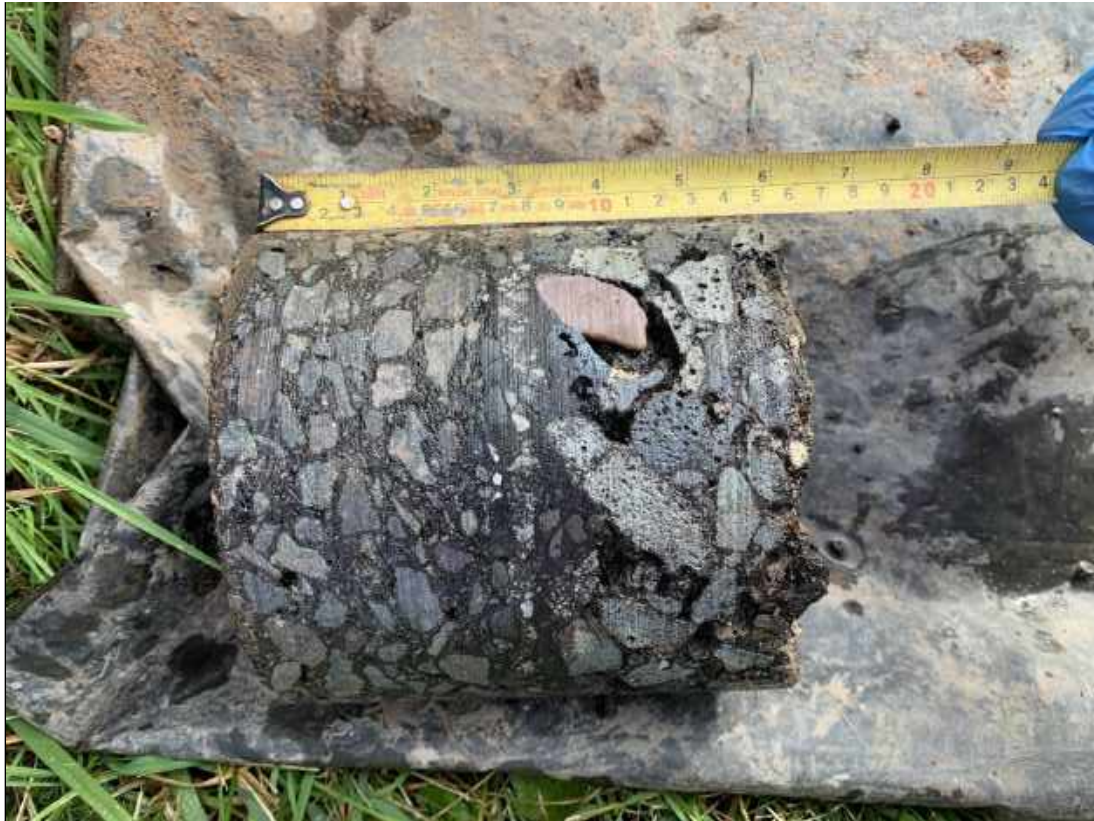
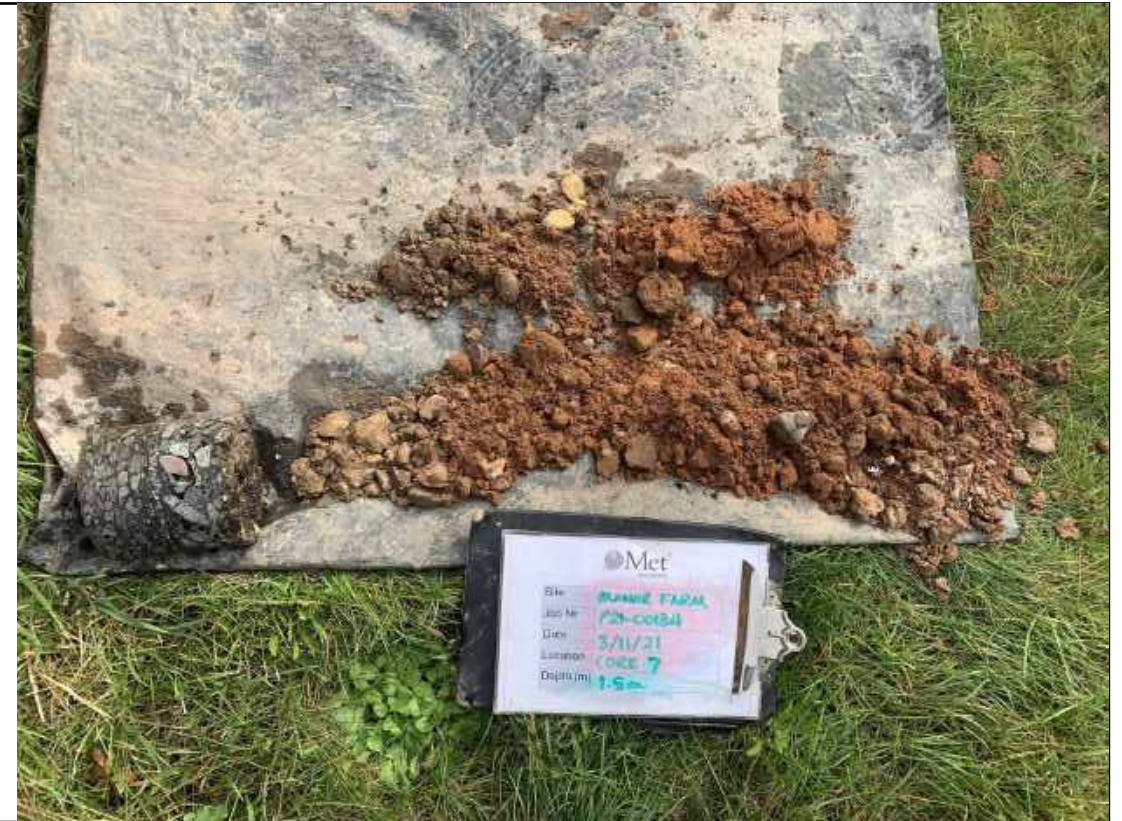
Core Location – CORE 7

Thickness of Tarmac: 14cm. Thickness of Concrete: None identified. Thickness of Sub-Base: 136cm.

0-14cm -	Tarmac. 0-8cm is angular to subangular fine to medium tarmac gravels, 8-14cm is angular to subangular fine to coarse tarmac gravels.
Fill	14-20cm -	Cream very sandy gravel. Sand is fine. Gravel is angular to rounded fine to coarse of mixed lithologies including sandstone and some brick.
Reworked	20-120cm -	Reddish orange gravelly sand. Sand is fine. Gravel is subrounded to rounded fine to coarse of mixed lithologies including some coal and potential brick.
Natural	120-150cm -	Reddish orange fine grained sand.
