Appendix V

Coring Logs

CBR Testing Results

Date 22-October-2021 Contract Manor Farm, Carburton

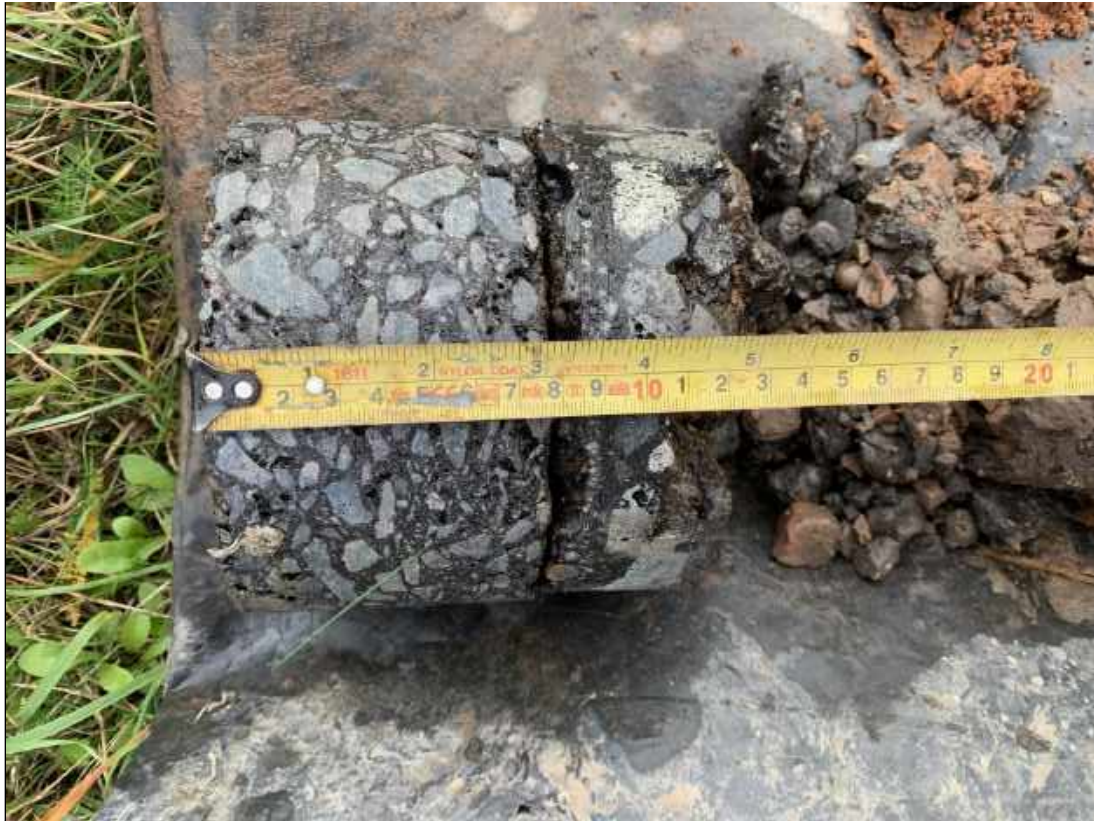
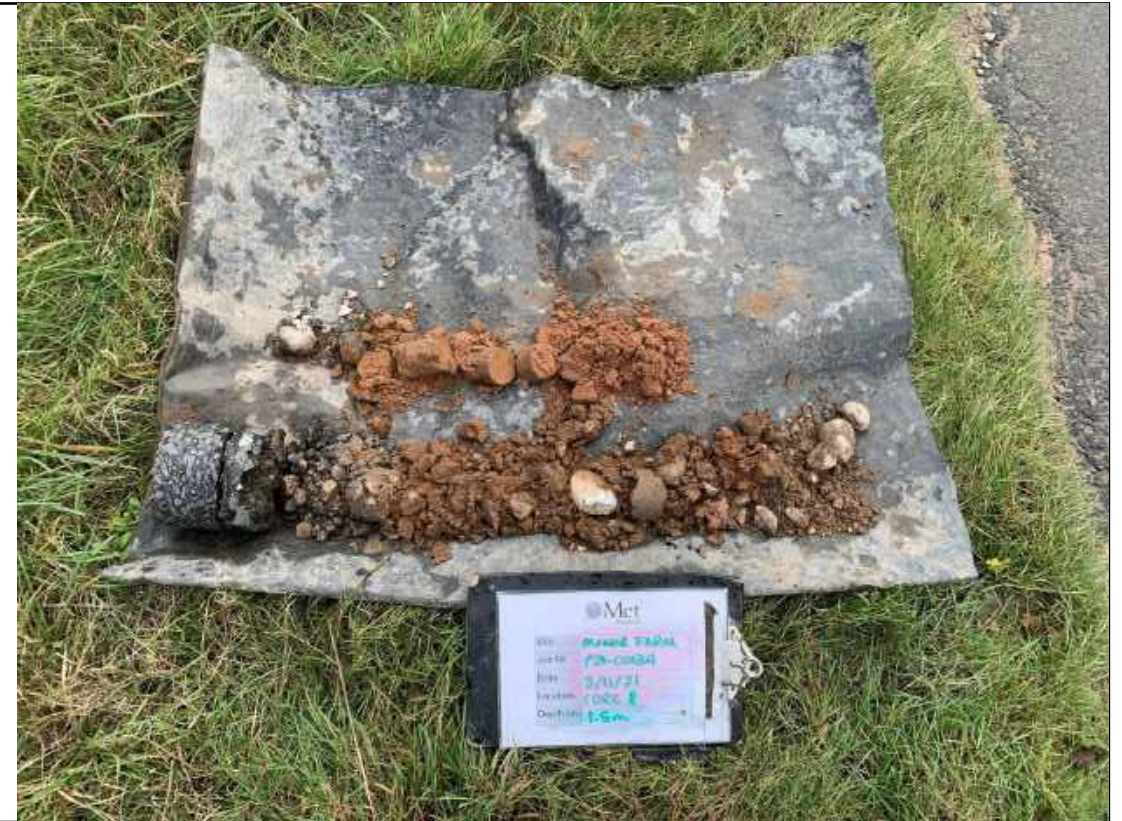
Core Location – CORE 8

Thickness of Tarmac: 15cm. Thickness of Concrete: None identified. Thickness of Sub-Base: 135cm.

0-15cm -	Tarmac. 0-7.5cm is angular to subangular fine to coarse tarmac gravels, 7.5-13cm, is angular to subangular fine to coarse tarmac gravels, 13-15cm is weak tarmac recovered as broken angular to subangular fine to coarse tarmac gravels.
Reworked	15-110cm -	Reddish brown, brown between 0.9-1.1mbgl, gravelly sand with moderate cobble content. Sand is fine. Gravel is angular to rounded of mixed lithologies including potential brick and some coal. Cobbles are subrounded to rounded of mixed lithologies up to 80mm across.
Natural	110-150cm -	Reddish orange fine grained sand.

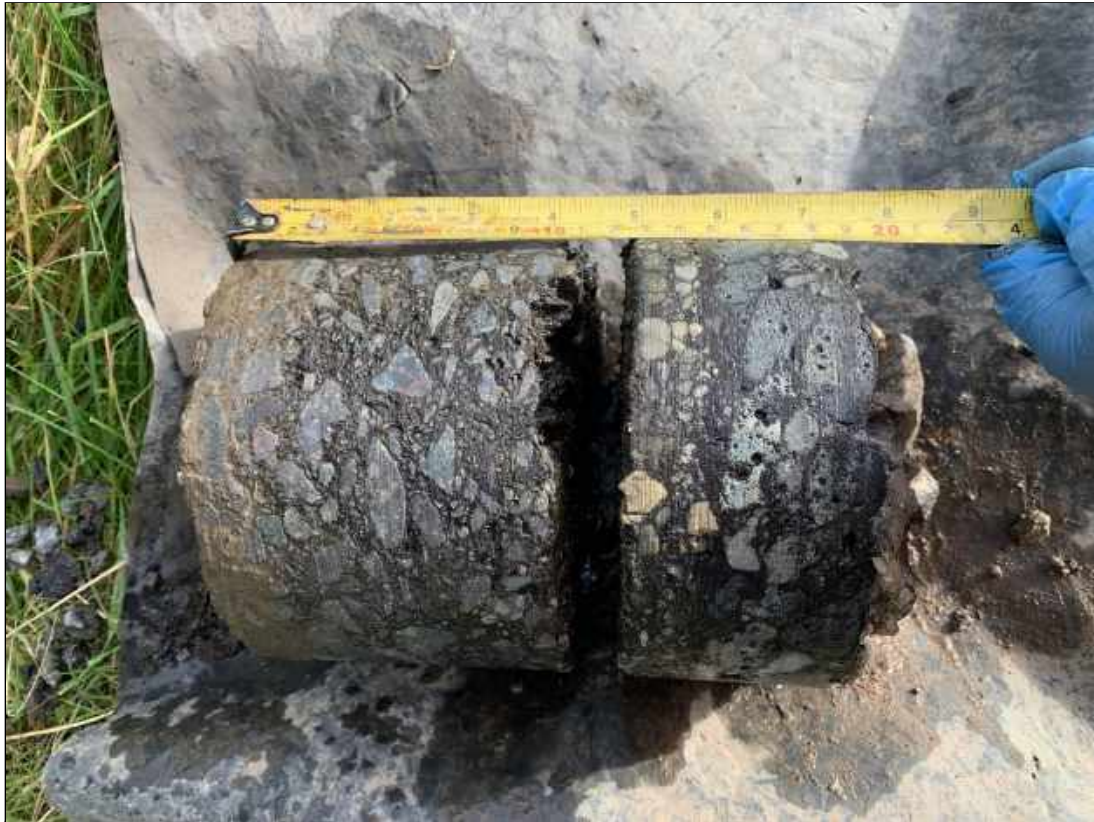
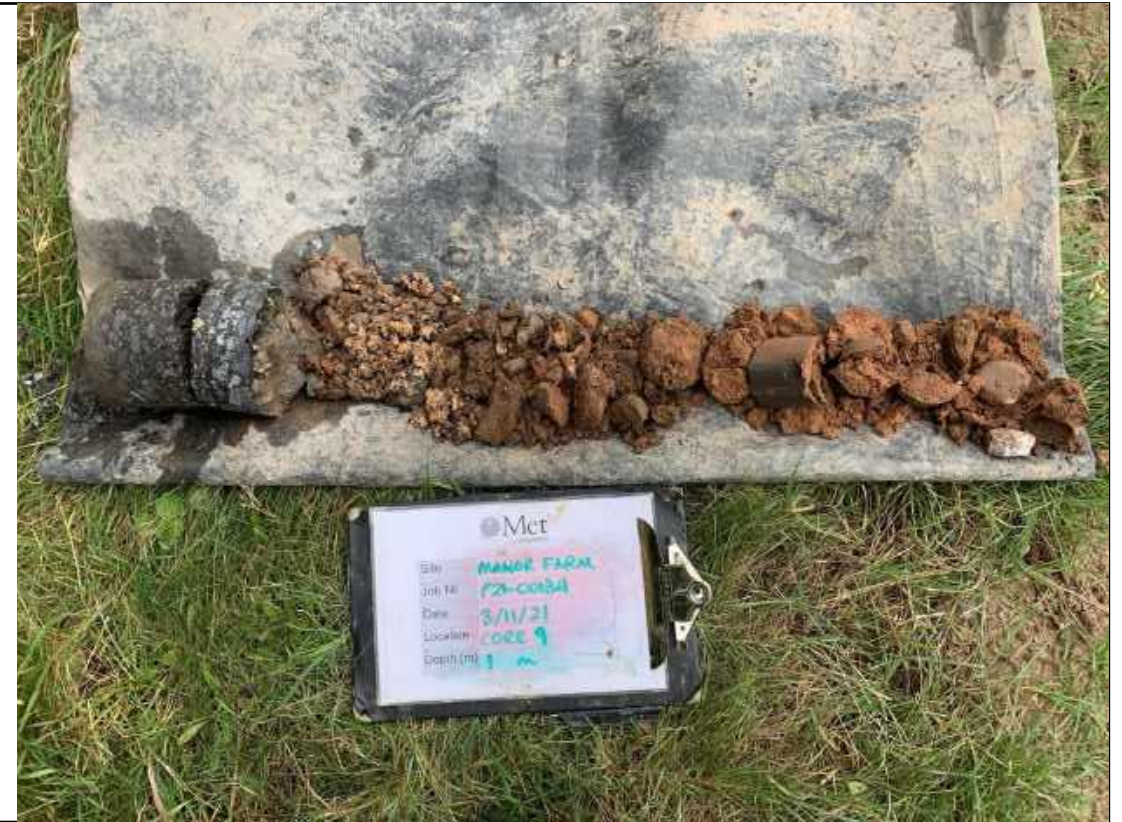
Core Location – CORE 9

Thickness of Tarmac: 21cm. Thickness of Concrete: None identified. Thickness of Sub-Base: 79cm.

0-21cm -	Tarmac. Angular to subangular fine to coarse tarmac gravels, recovered as broken angular to subangular fine to coarse tarmac gravels at base.
Made Ground 21-35cm -	Multicoloured (red/cream/brown) slightly clayey gravelly sand. Sand is fine to coarse. Gravel is angular to subangular fine to coarse of mixed lithologies including brick and coal.
Made Ground 35-60cm -	Medium brown gravelly sand. Sand is fine. Gravel is angular to subangular fine to coarse of brick and coal.
Natural 60-100cm -	Red slightly gravelly sand. Sand is fine. Gravel is rounded fine to coarse of mixed lithologies.

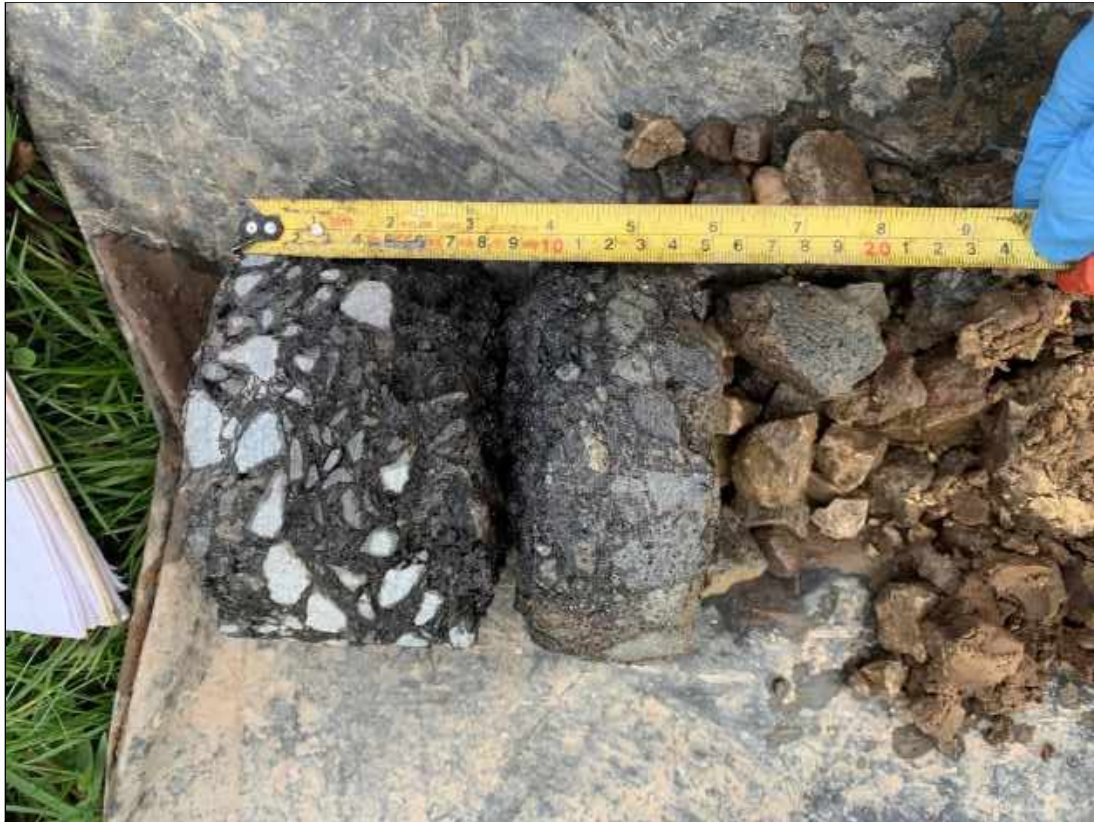
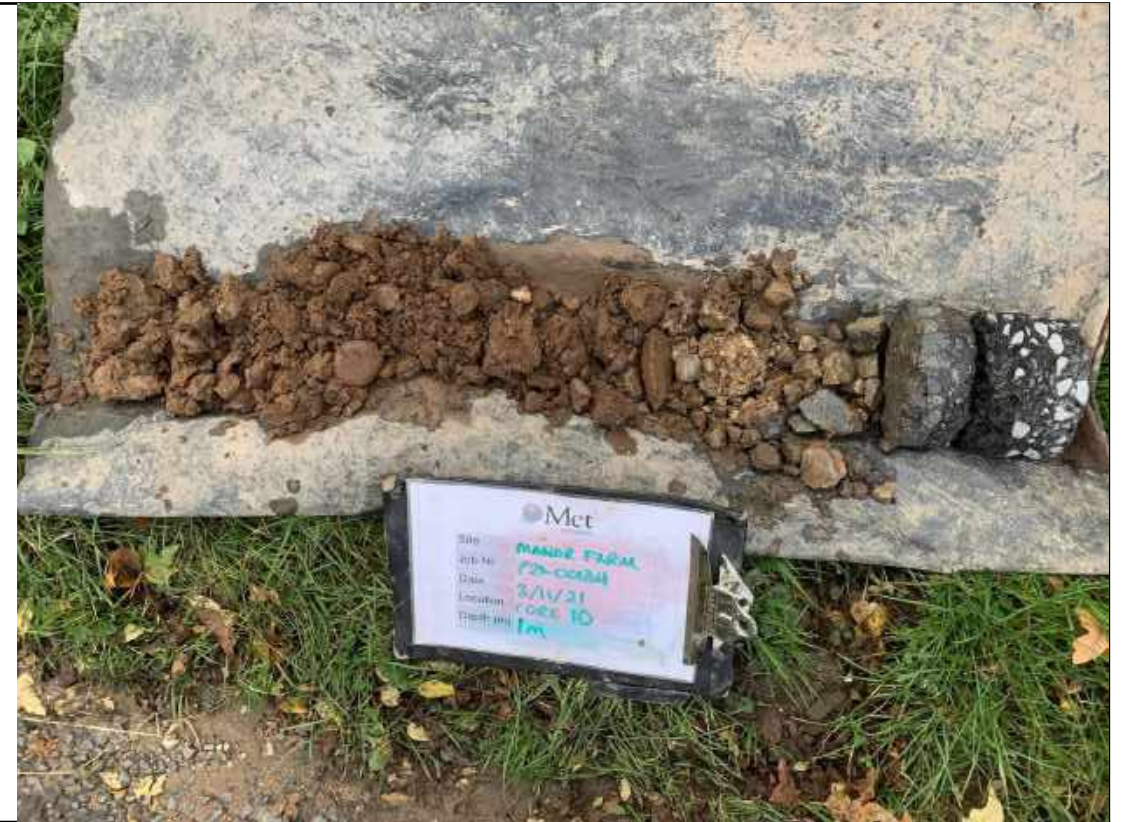
Core Location – CORE 10

Thickness of Tarmac: 15cm. Thickness of Concrete: None identified. Thickness of Sub-Base: 85cm.

0-15cm -	Tarmac. 0-9cm is angular to subangular fine to coarse tarmac gravels, 9-15cm is weak angular to subangular fine to coarse tarmac gravels.
Fill	15-20cm -	Cream and grey angular to subangular coarse gravels of mixed lithologies.
Reworked	20-25cm -	Cream/light brown sandy gravel. Sand is fine. Gravel is subangular to rounded fine to coarse of mixed lithologies including brick.
Natural	25-100cm -	Light brown gravelly sand with moderate cobble content. Sand is fine. Gravel is subrounded to rounded fine to coarse of mixed lithologies including flecks of coal. Cobbles are subrounded to rounded of mixed lithologies up to 85mm across.

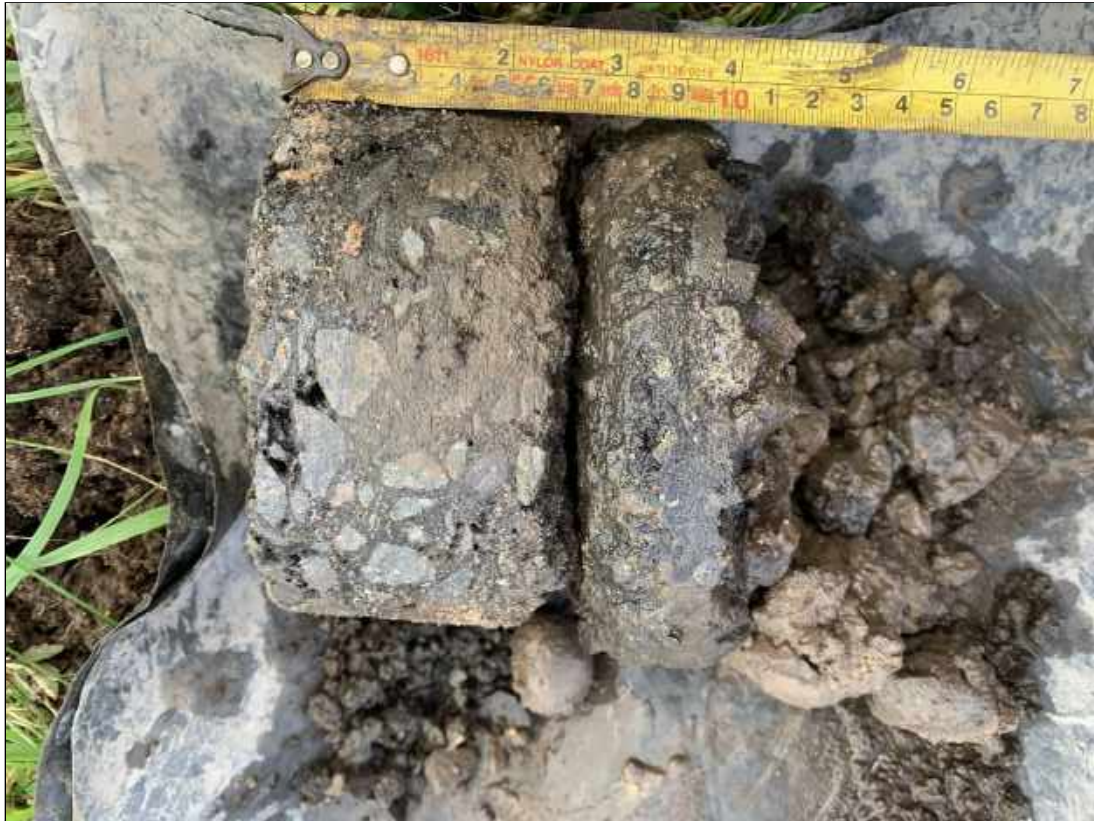
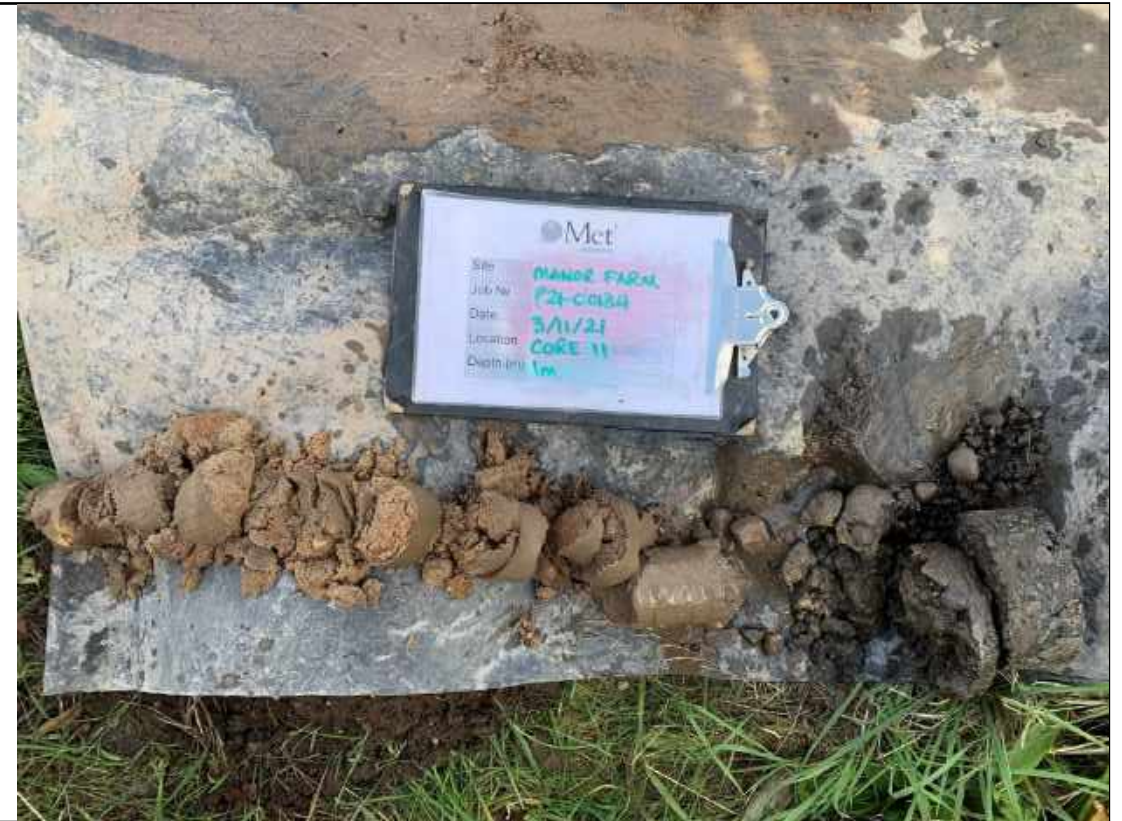
Core Location – CORE 11

Thickness of Tarmac: 15cm. Thickness of Concrete: None identified. Thickness of Sub-Base: 85cm.

0-15cm -	Tarmac. 0-6.5cm is angular to subangular fine to coarse tarmac gravels, 6.5-11cm is angular to subangular fine to medium tarmac gravels, 11-15cm is weak tarmac recovered as broken angular to subangular fine to coarse tarmac gravels.
Fill	15-25cm -	Cream slightly gravelly sand. Sand is fine. Gravel is subangular fine to coarse of sandstone.
Natural	25-55cm -	Reddish brown gravelly sand. Sand is fine. Gravel is subrounded to rounded fine to coarse of mixed lithologies.
Natural	55-100cm -	Orangish light brown fine to coarse sand.

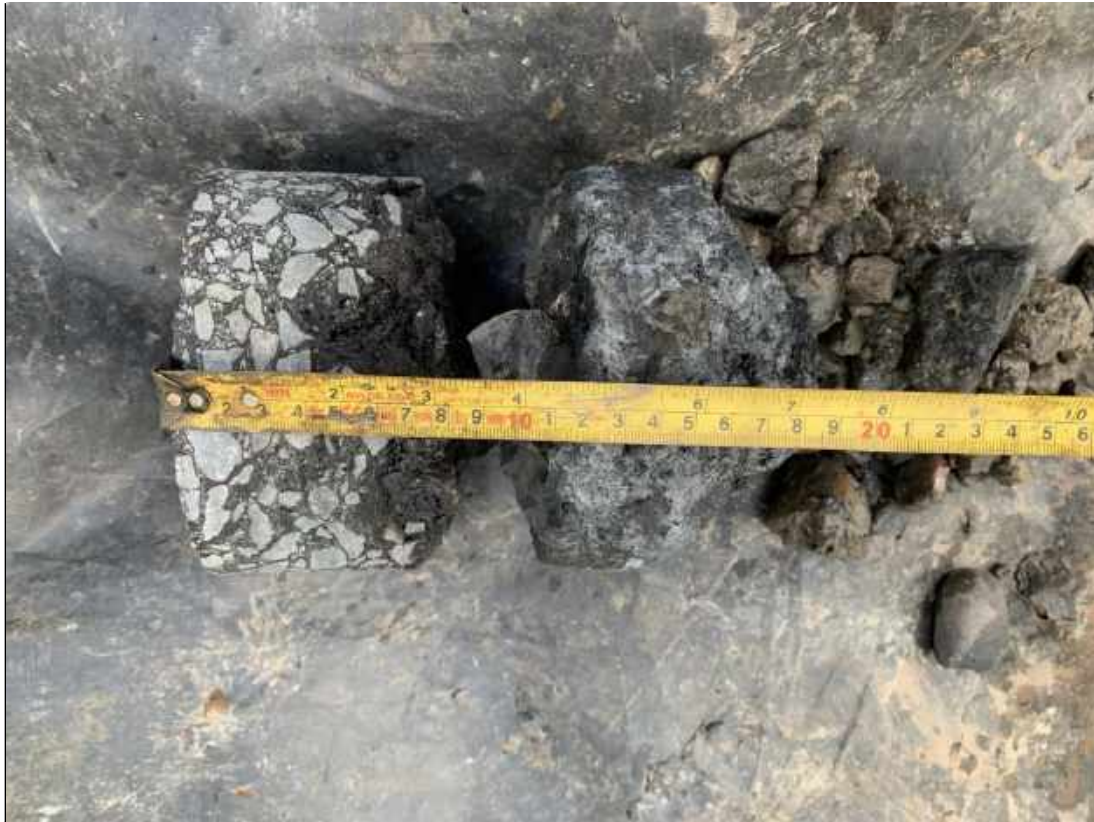
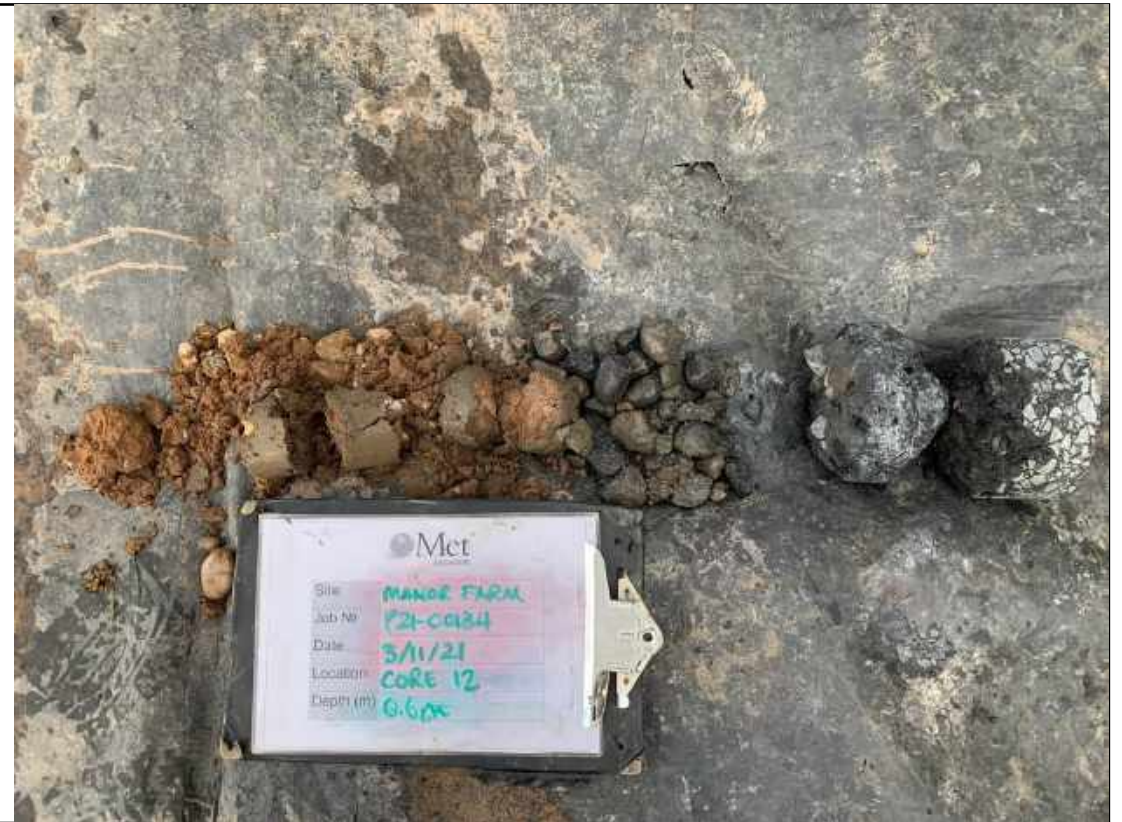
Core Location – CORE 12

Thickness of Tarmac: 20cm. Thickness of Concrete: None identified. Thickness of Sub-Base: 40cm.

0-20cm -	Tarmac. 0-8cm is angular to subangular fine to medium gravels, 8-20cm is degraded tarmac with very strong bitumen odour noted and loose angular to subangular fine to coarse tarmac gravels at base.
Fill	20-27cm -	Grey subrounded to rounded medium to coarse gravels.
Natural	27-60cm -	Reddish brown gravelly sand with moderate cobble content. Sand is fine. Gravel is subrounded to rounded fine to coarse of mixed lithologies. Cobbles are subrounded to rounded of mixed lithologies up to 65mm across.

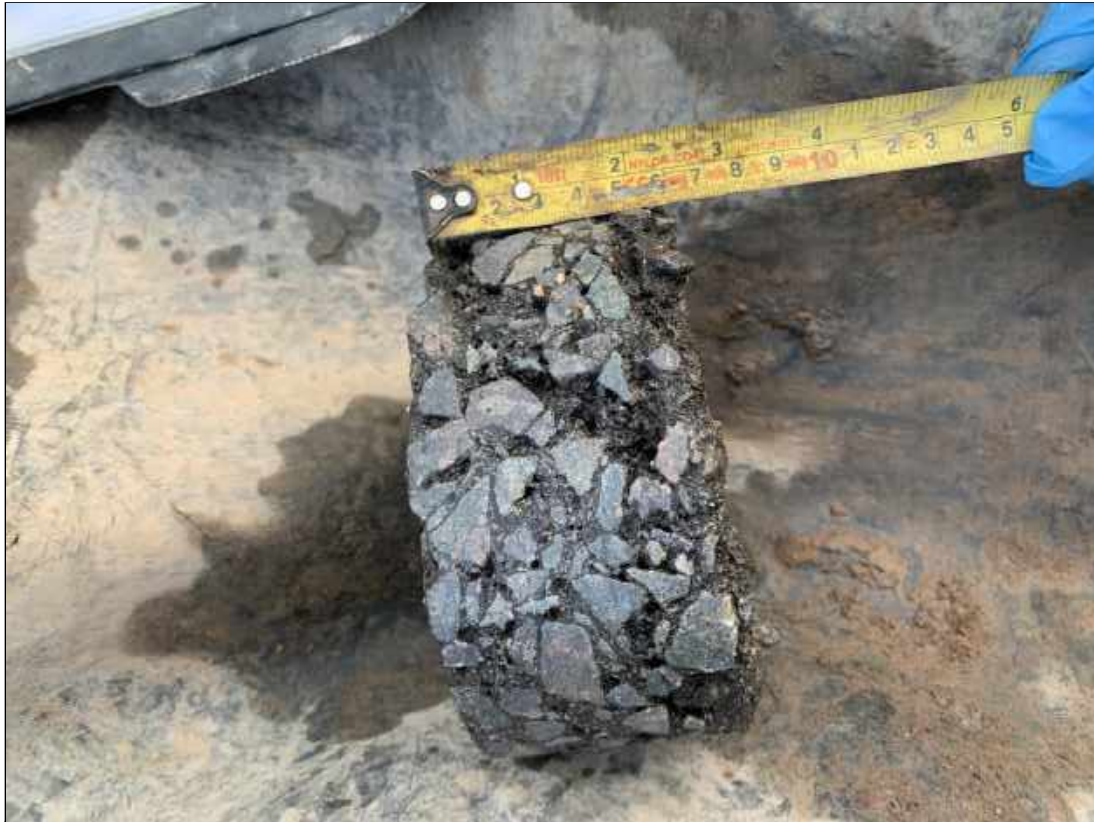
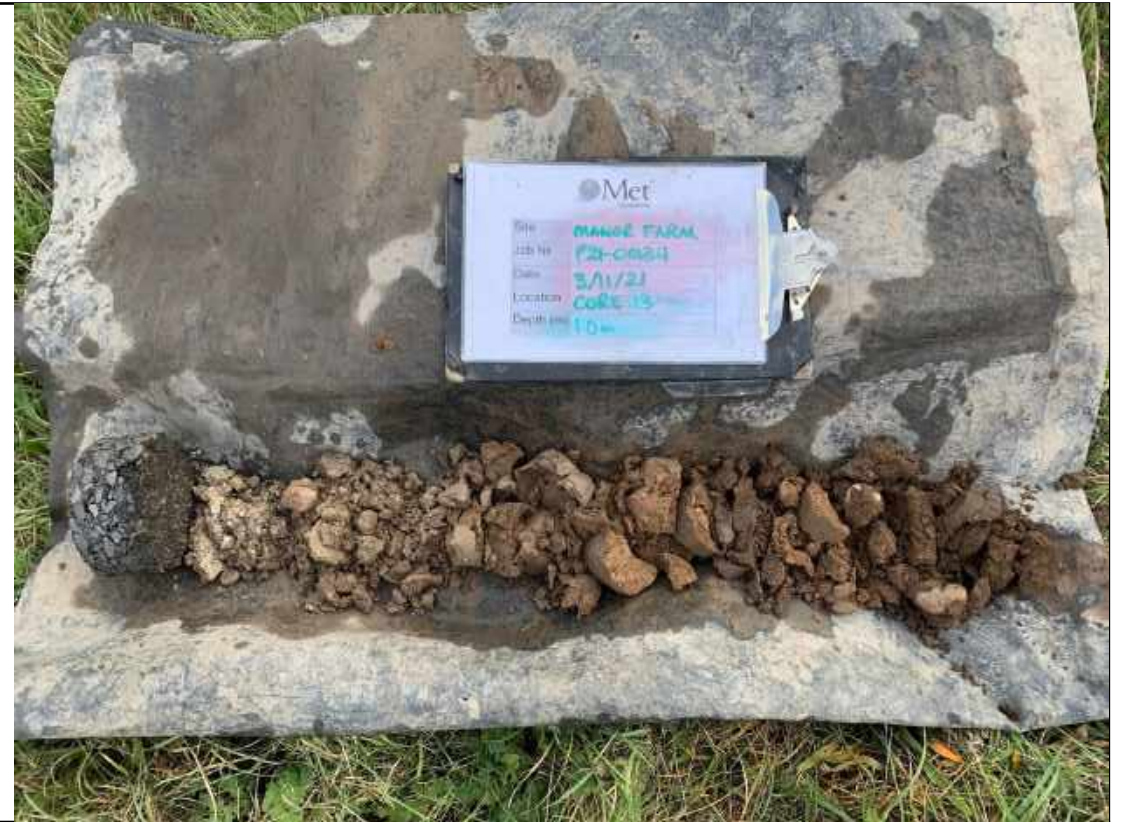
Core Location – CORE 13

Thickness of Tarmac: 6cm. Thickness of Concrete: None identified. Thickness of Sub-Base: 94cm.

0-6cm -	Tarmac. Subangular to angular fine to coarse tarmac gravels.
Fill	6-17.5cm -	Cream becoming brown very sandy gravel. Sand is fine. Gravel is angular to subangular fine to coarse of limestone.
Natural	17.5-100cm -	Reddish brown gravelly sand with low cobble content. Sand is fine. Gravel is subrounded to rounded fine to coarse of mixed lithologies with flecks of coal. Cobbles are subrounded to rounded of mixed lithologies up to 65mm across.

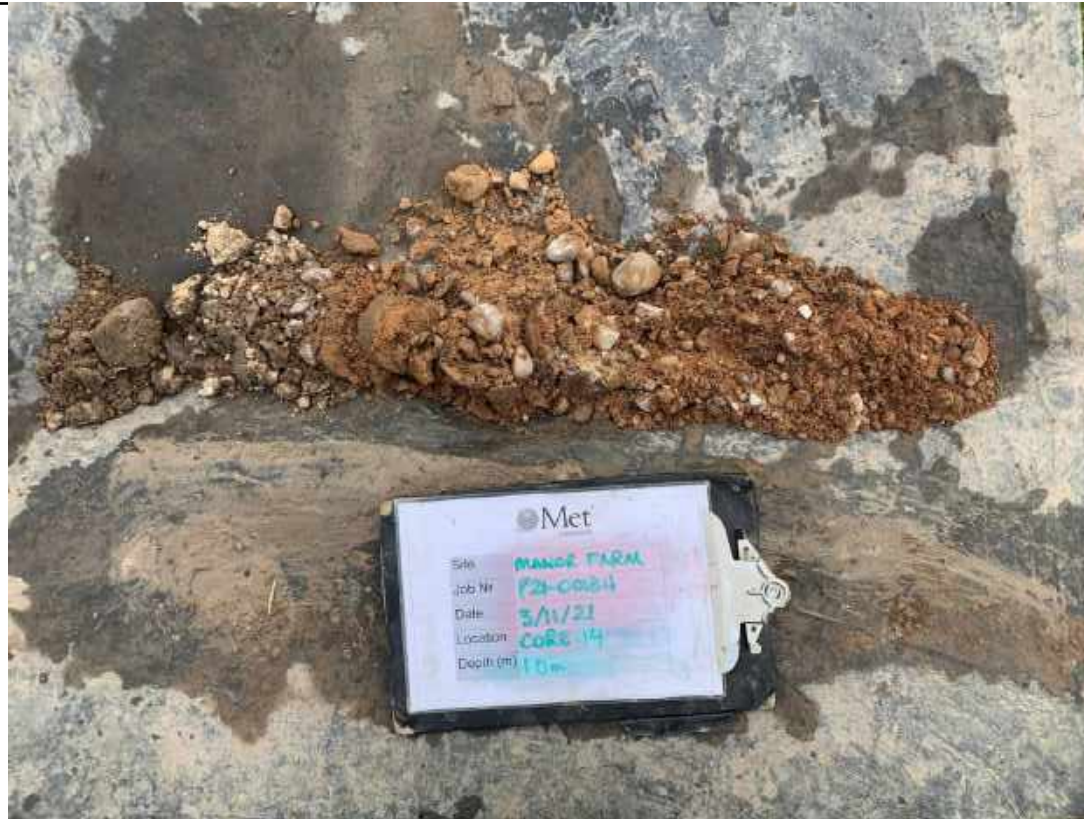
Core Location – CORE 14

Thickness of Tarmac: None Identified. Thickness of Concrete: None identified. Thickness of Sub-Base: 100cm.

Made Ground 0-23cm -	Grey/light brown very sandy gravel. Sand is fine. Gravel is angular to subangular fine to coarse of mixed lithologies including some brick.
Natural 23-100cm -	Reddish orange gravelly sand with high cobble content. Sand is fine to medium. Gravel is subrounded to rounded fine to coarse of mixed lithologies. Cobbles are subrounded to rounded of mixed lithologies up to 75mm across.

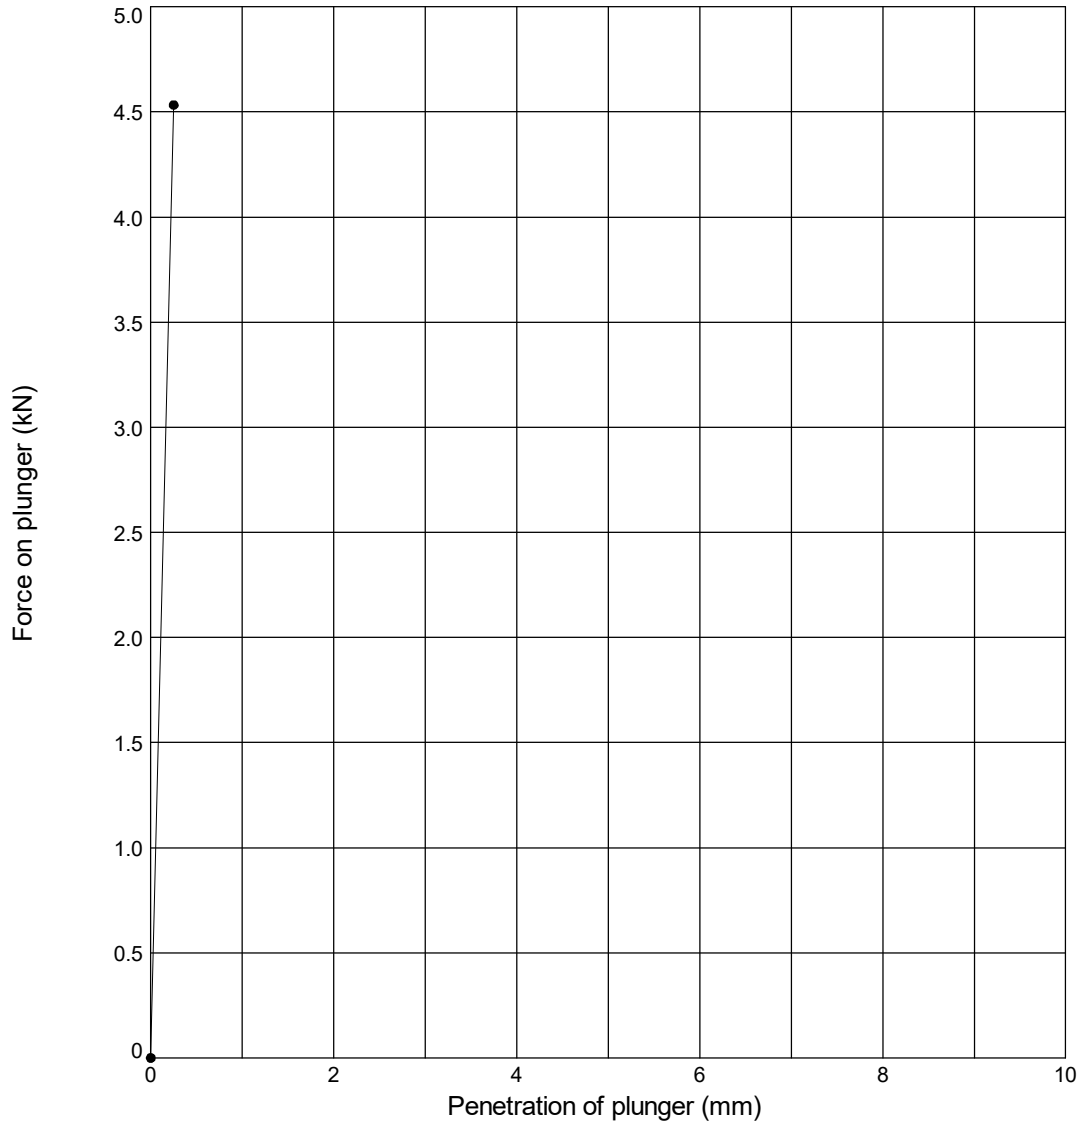
Position Ref: **CBR01** Depth (m): **0.00** Date: **20/10/21**

Test Details	Test Conditions	Test Results
Kentledge : Toyota Hilux Surcharge (kg) : 4.52 Surcharge Pressure (kPa) : 1	Weather : Light rain Temperature (°C) : 11	CBR Value (%) : > 39 Moisture Content (%) : NA
Sample Description	Test Notes	
TARMAC	Estimated particles >20 mm (%) : 0 Size and position of particles >20mm in relation to the plunger : Unknown

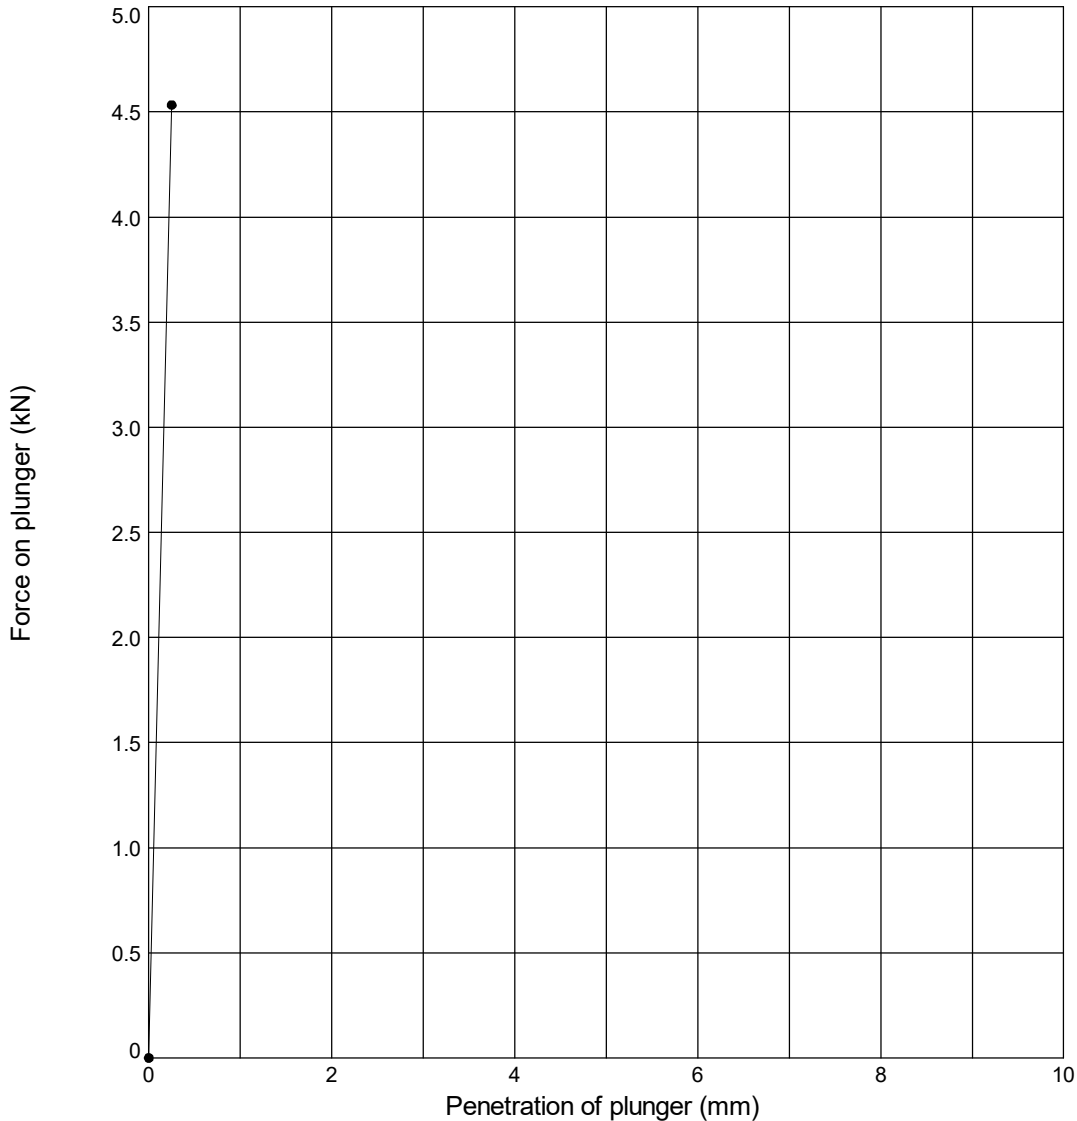
Position Ref: **CBR02** Depth (m): **0.00** Date: **20/10/21**

Test Details	Test Conditions	Test Results
Kentledge : Toyota Hilux Surcharge (kg) : 4.52 Surcharge Pressure (kPa) : 1	Weather : Rain Temperature (°C) : 11	CBR Value (%) : > 39 Moisture Content (%) : NA
Sample Description	Test Notes	
TARMAC	Estimated particles >20 mm (%) : 0 Size and position of particles >20mm in relation to the plunger : Unknown

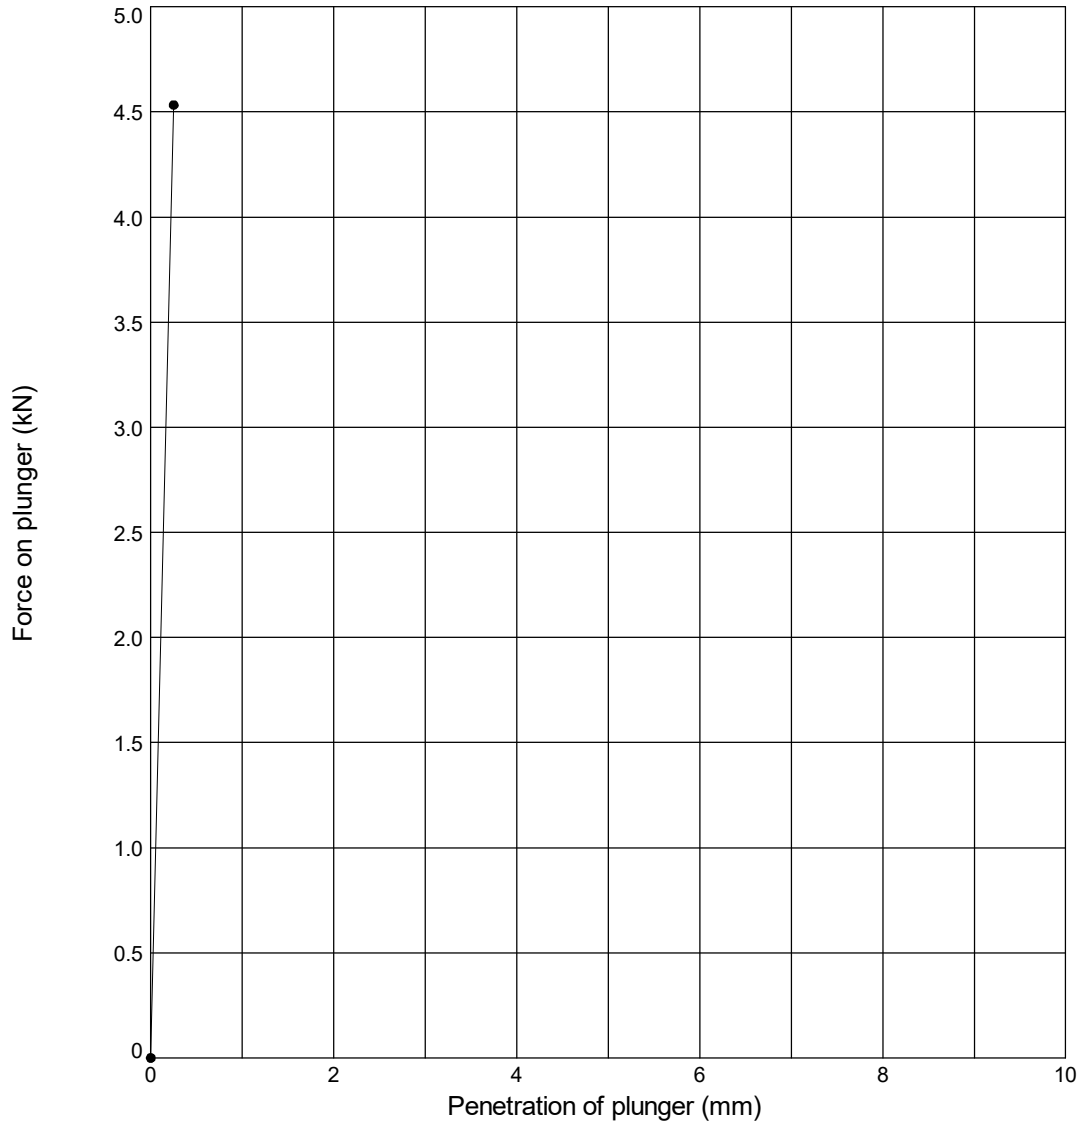
Position Ref: **CBR03** Depth (m): **0.00** Date: **20/10/21**

Test Details	Test Conditions	Test Results
Kentledge : Toyota Hilux Surcharge (kg) : 4.52 Surcharge Pressure (kPa) : 1	Weather : Fine Temperature (°C) : 12	CBR Value (%) : > 39 Moisture Content (%) : NA
Sample Description	Test Notes	
TARMAC	Estimated particles >20 mm (%) : 0 Size and position of particles >20mm in relation to the plunger : Unknown

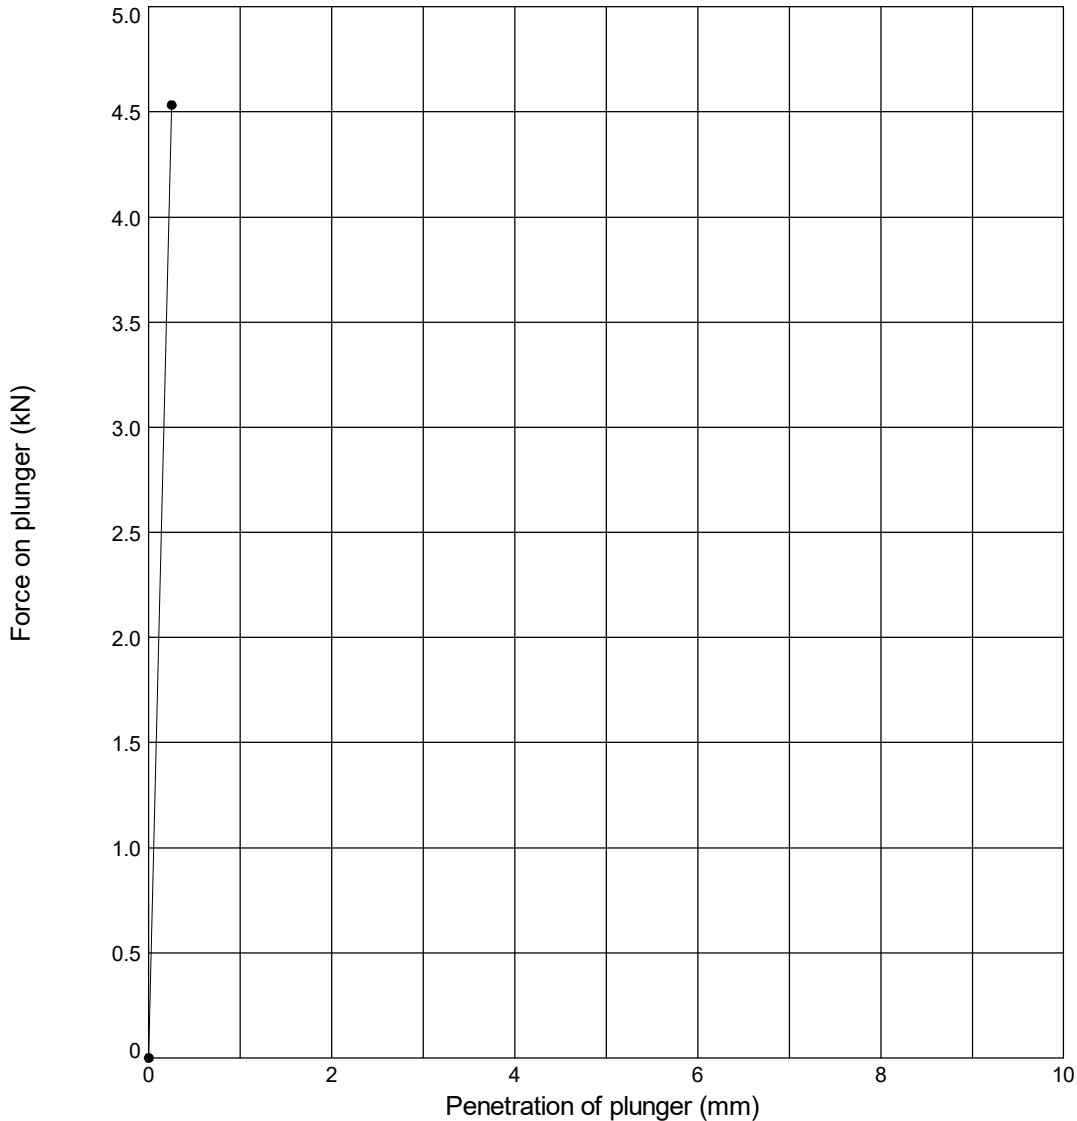
Position Ref: **CBR04** Depth (m): **0.00** Date: **20/10/21**

Test Details	Test Conditions	Test Results
Kentledge : Toyota Hilux Surcharge (kg) : 4.52 Surcharge Pressure (kPa) : 1	Weather : Fine Temperature (°C) : 13	CBR Value (%) : > 39 Moisture Content (%) : 6.8
Sample Description	Test Notes	
Light grey slightly sandy GRAVEL	Estimated particles >20 mm (%) : 3 Size and position of particles >20mm in relation to the plunger : Unknown

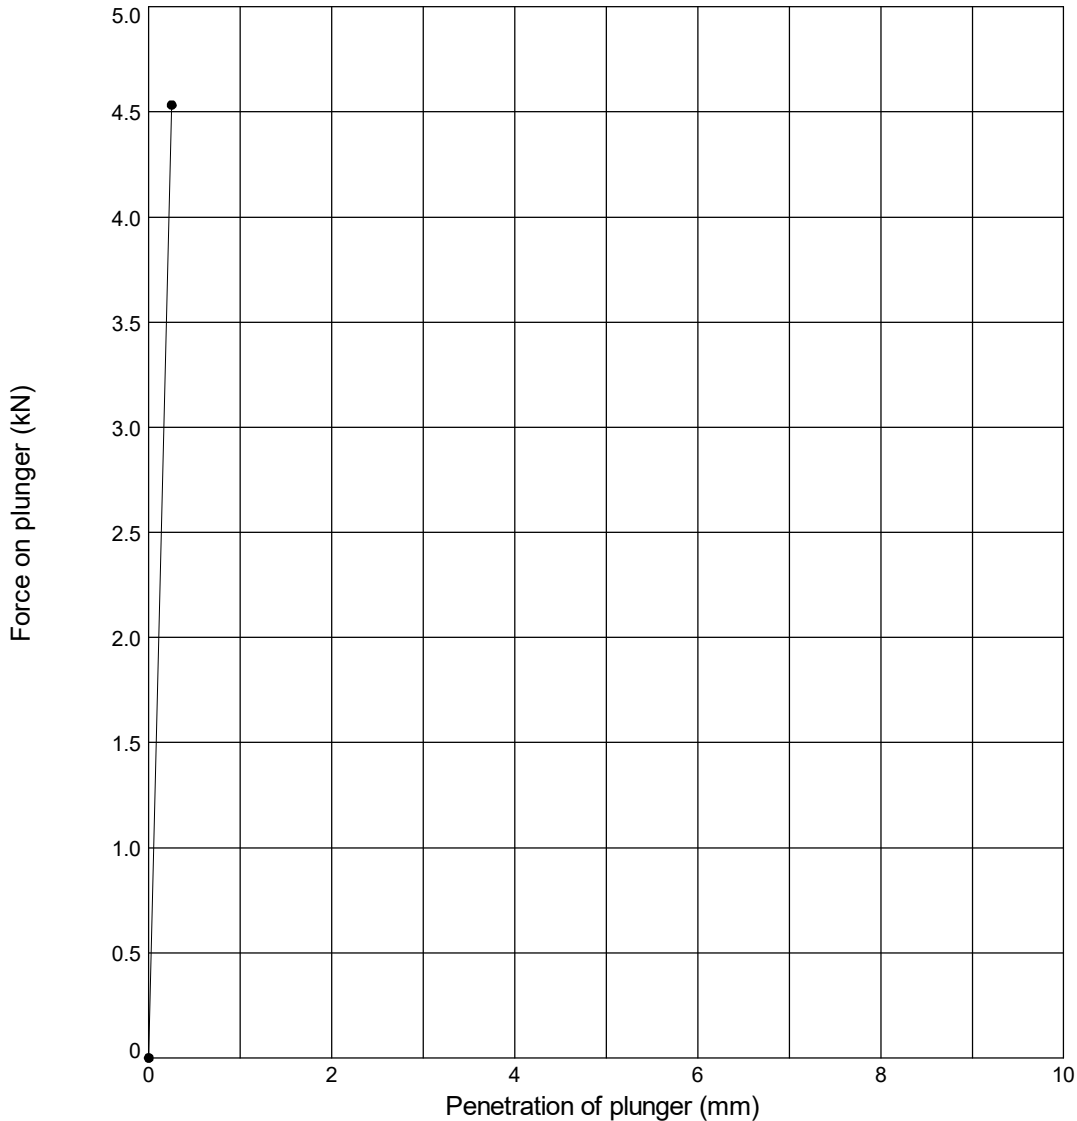
Position Ref: **CBR05** Depth (m): **0.00** Date: **20/10/21**

Test Details	Test Conditions	Test Results
Kentledge : Toyota Hilux Surcharge (kg) : 4.52 Surcharge Pressure (kPa) : 1	Weather : Fine Temperature (°C) : 13	CBR Value (%) : > 39 Moisture Content (%) 4.03
Sample Description	Test Notes	
Light brown sandy GRAVEL	Estimated particles >20 mm (%) : 0 Size and position of particles >20mm in relation to the plunger : Unknown

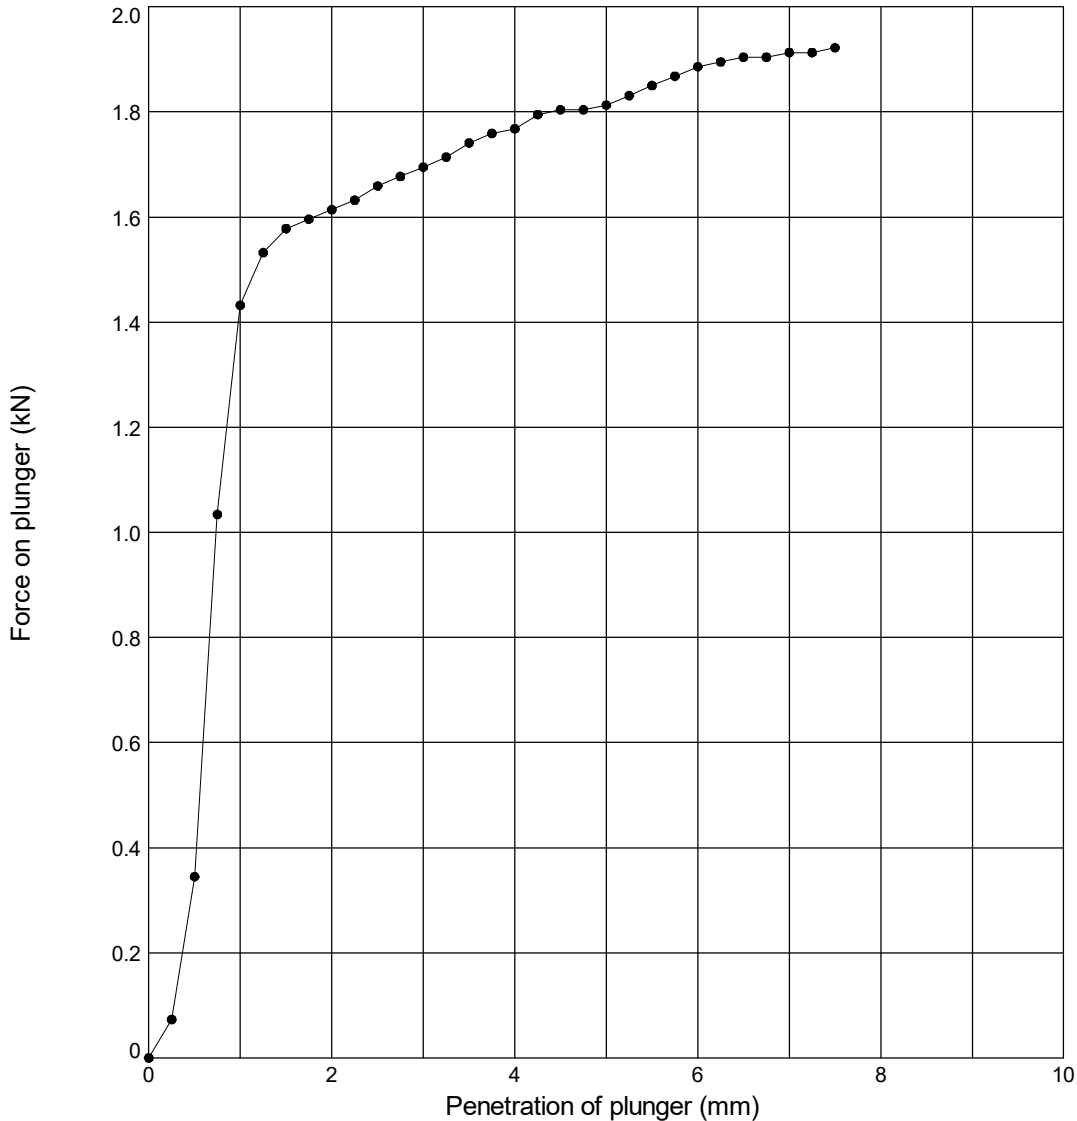
Position Ref: **CBR06** Depth (m): **0.00** Date: **20/10/21**

Test Details	Test Conditions	Test Results
Kentledge : Toyota Hilux Surcharge (kg) : 4.52 Surcharge Pressure (kPa) : 1	Weather : Fine Temperature (°C) : 14	CBR Value (%) : 13 Moisture Content (%) : 11
Sample Description	Test Notes	
Light brown very sandy GRAVEL	Estimated particles >20 mm (%) : 3 Size and position of particles >20mm in relation to the plunger : Unknown

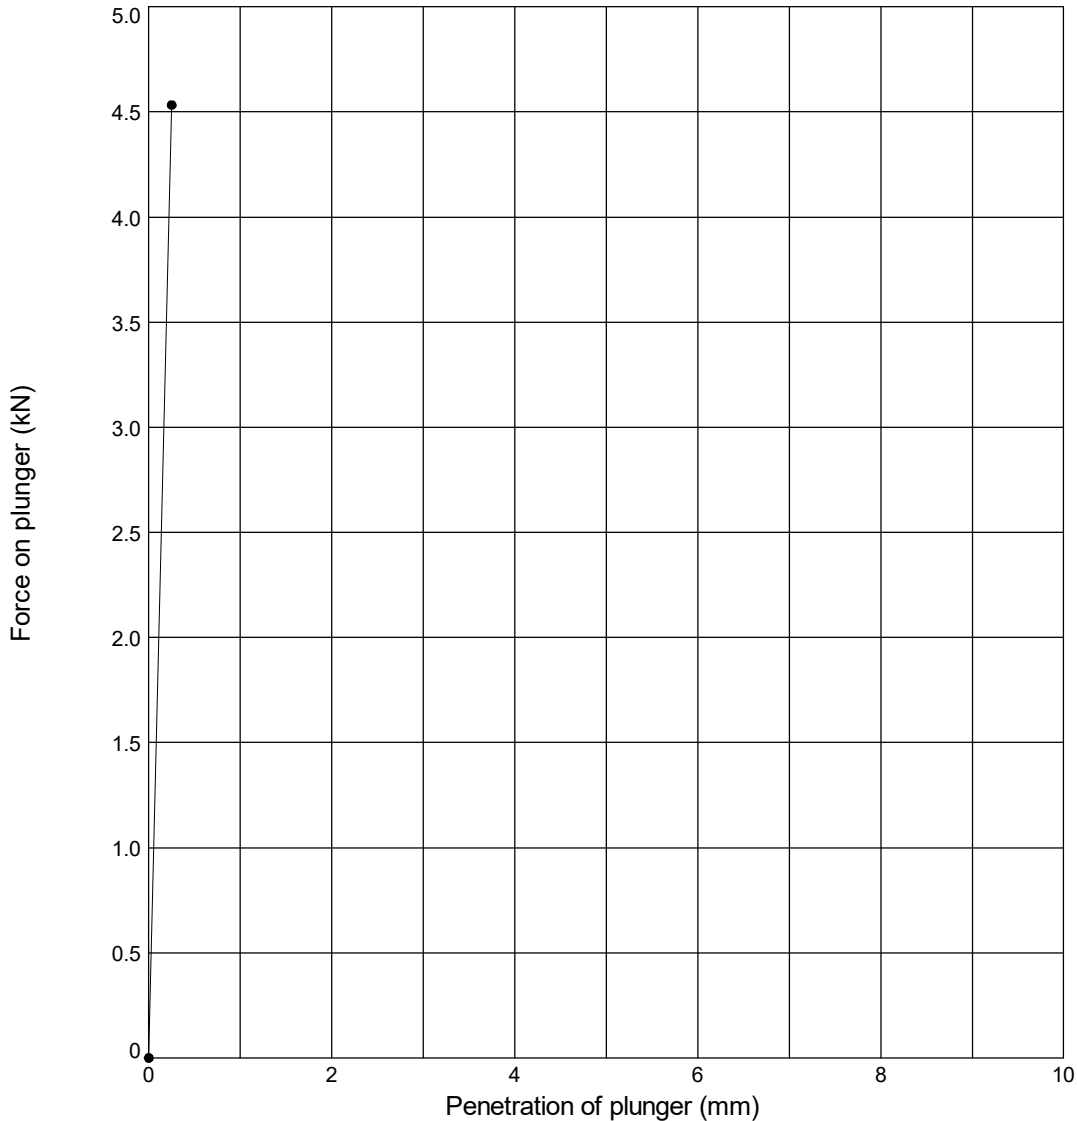
Position Ref: **CBR07** Depth (m): **0.00** Date: **20/10/21**

Test Details	Test Conditions	Test Results
Kettleage : Toyota Hilux Surcharge (kg) : 4.52 Surcharge Pressure (kPa) : 1	Weather : Fine Temperature (°C) : 13	CBR Value (%) : > 39 Moisture Content (%) : 11
Sample Description	Test Notes	
Light grey sandy GRAVEL	Estimated particles >20 mm (%) : 3 Size and position of particles >20mm in relation to the plunger : Unknown
