Appendix V

Coring Logs

CBR Testing Results

Date 22-October-2021 Contract Manor Farm, Carburton

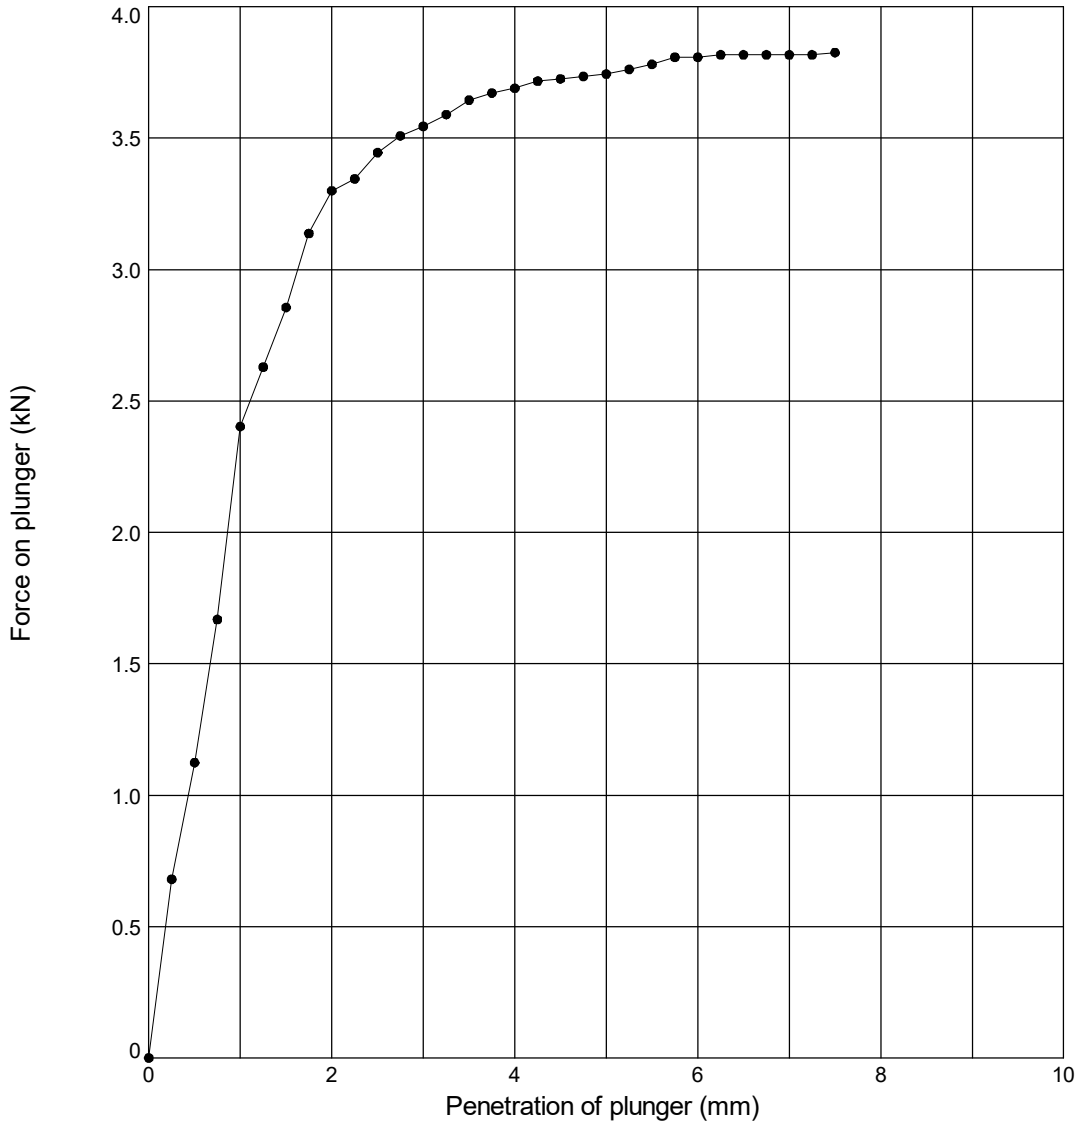
Position Ref: **CBR08** Depth (m): **0.00** Date: **20/10/21**

Test Details	Test Conditions	Test Results
Kentledge : Toyota Hilux Surcharge (kg) : 4.52 Surcharge Pressure (kPa) : 1	Weather : Fine Temperature (°C) : 15	CBR Value (%) : 26 Moisture Content (%) : 8.2
Sample Description	Test Notes	
Light grey sandy GRAVEL	Estimated particles >20 mm (%) : 3 Size and position of particles >20mm in relation to the plunger : Unknown

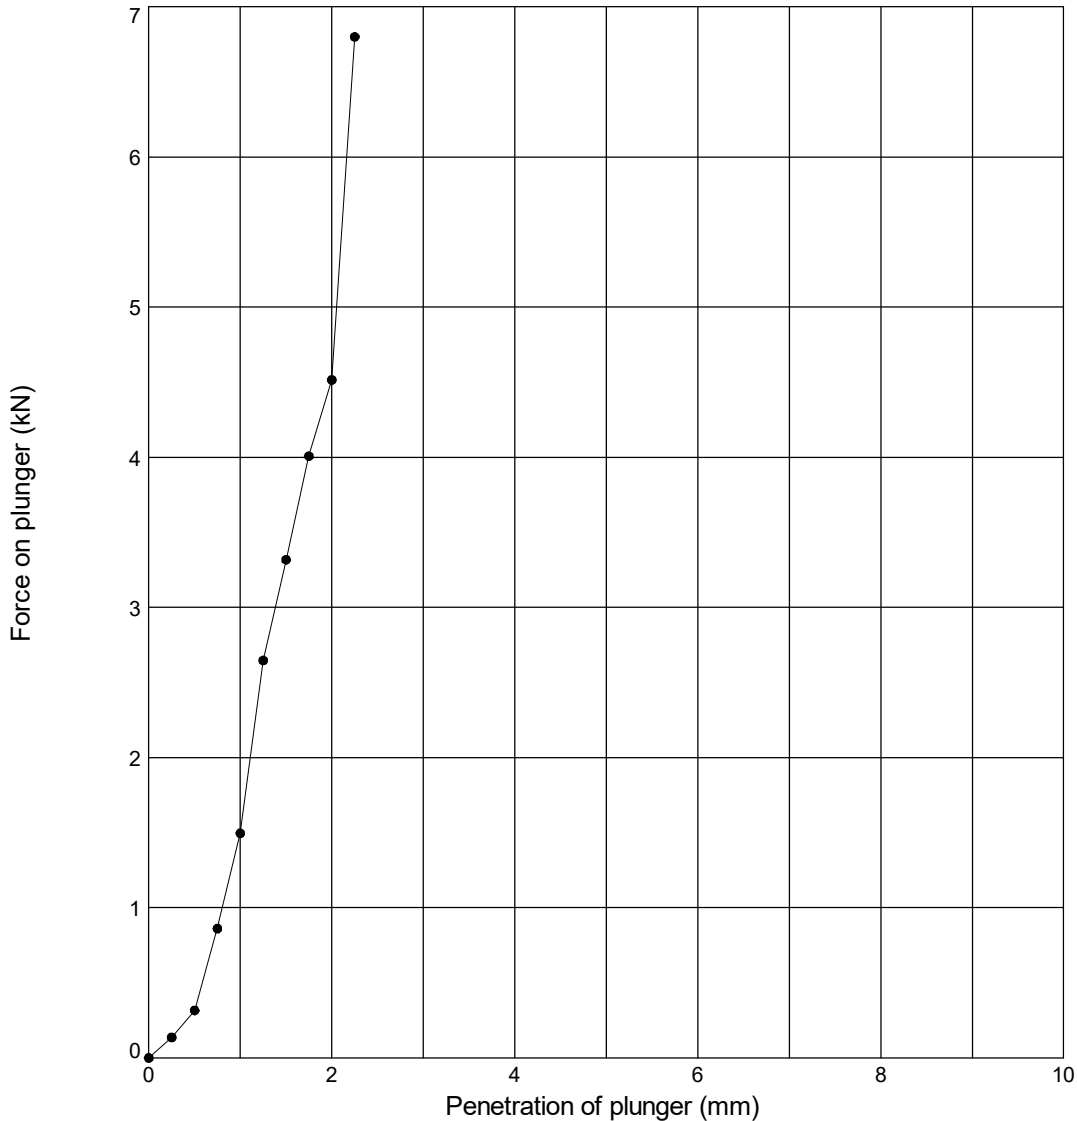
Position Ref: **CBR09** Depth (m): **0.00** Date: **20/10/21**

Test Details	Test Conditions	Test Results
Kentledge : Toyota Hilux Surcharge (kg) : 4.52 Surcharge Pressure (kPa) : 1	Weather : Fine Temperature (°C) : 13	CBR Value (%) : > 39 Moisture Content (%) : 8.3
Sample Description	Test Notes	
Light grey brown sandy GRAVEL	Estimated particles >20 mm (%) : 3 Size and position of particles >20mm in relation to the plunger : Unknown

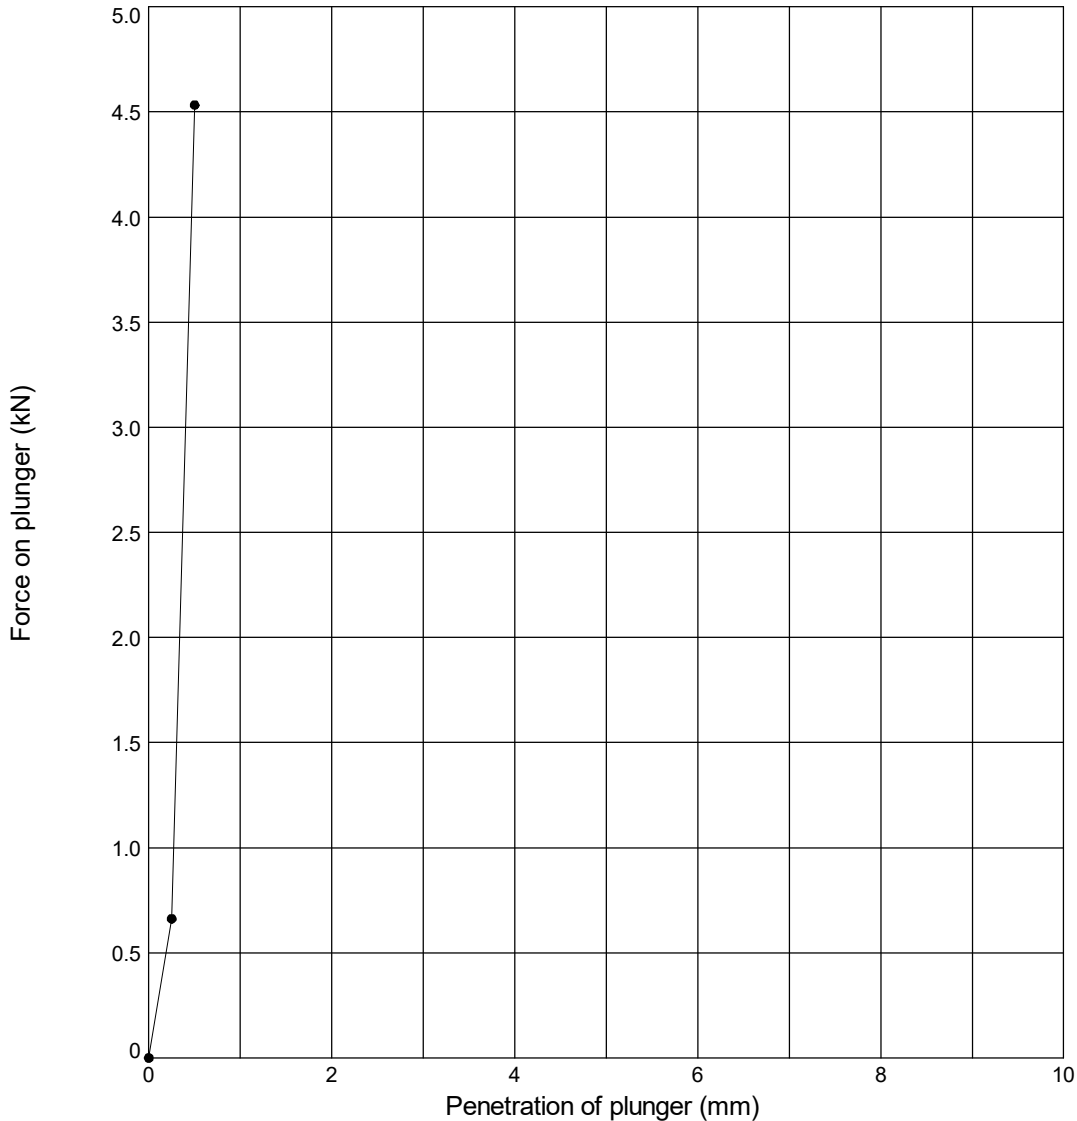
Position Ref: **CBR10** Depth (m): **0.00** Date: **21/10/21**

Test Details	Test Conditions	Test Results
Kentledge : Toyota Hilux Surcharge (kg) : 4.52 Surcharge Pressure (kPa) : 1	Weather : Fine Temperature (°C) : 8	CBR Value (%) : > 39 Moisture Content (%) : 13.80
Sample Description	Test Notes	
Light greyish brown sandy GRAVEL	Estimated particles >20 mm (%) : 5 Size and position of particles >20mm in relation to the plunger : Unknown

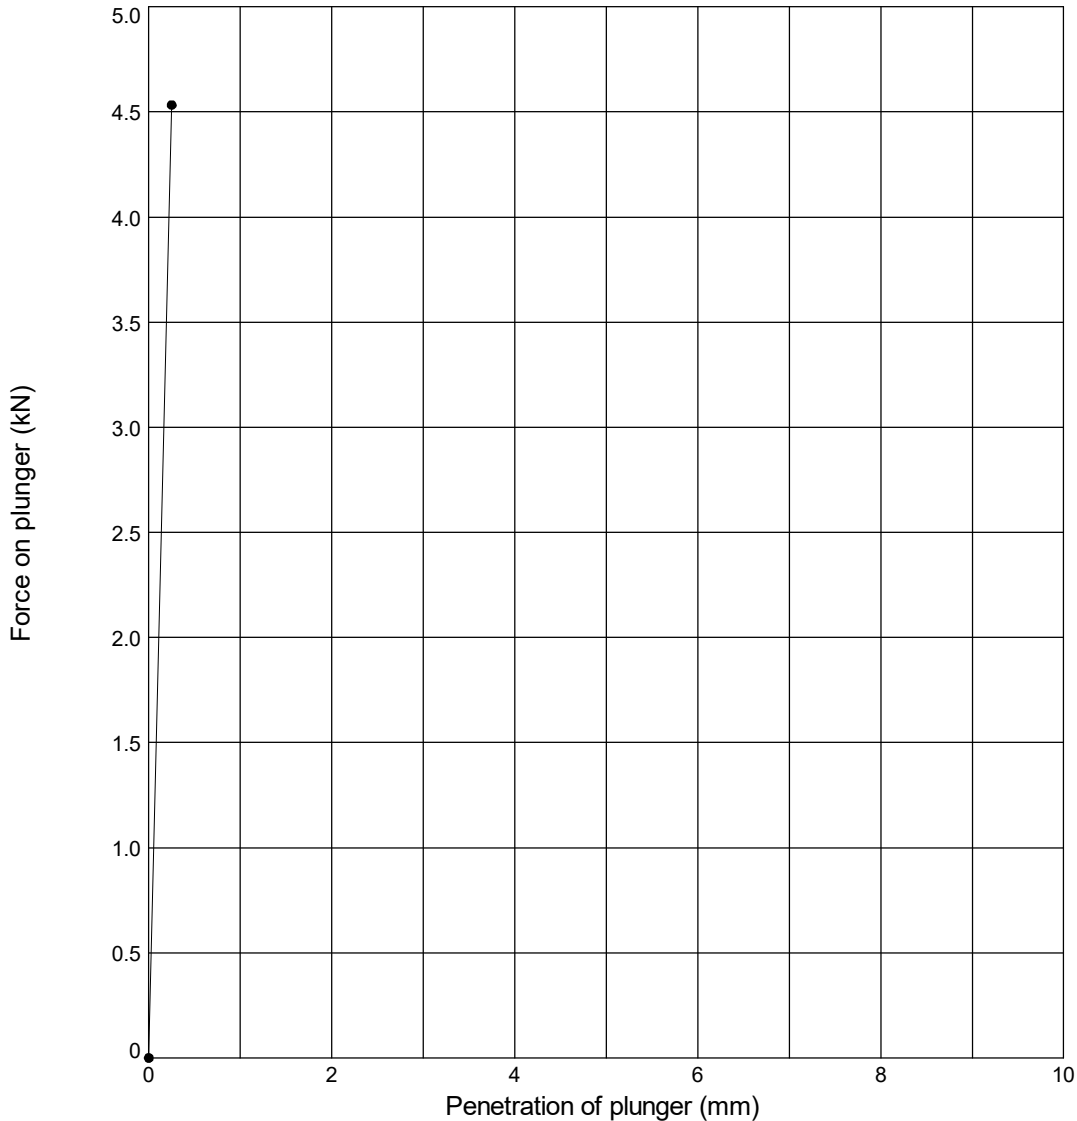
Position Ref: **CBR11** Depth (m): **0.00** Date: **21/10/21**

Test Details	Test Conditions	Test Results
Kentledge : Toyota Hilux Surcharge (kg) : 4.52 Surcharge Pressure (kPa) : 1	Weather : Fine Temperature (°C) : 8	CBR Value (%) : > 39 Moisture Content (%) : 7.4
Sample Description	Test Notes	
Light brown very sandy GRAVEL	Estimated particles >20 mm (%) : 10 Size and position of particles >20mm in relation to the plunger : Unknown

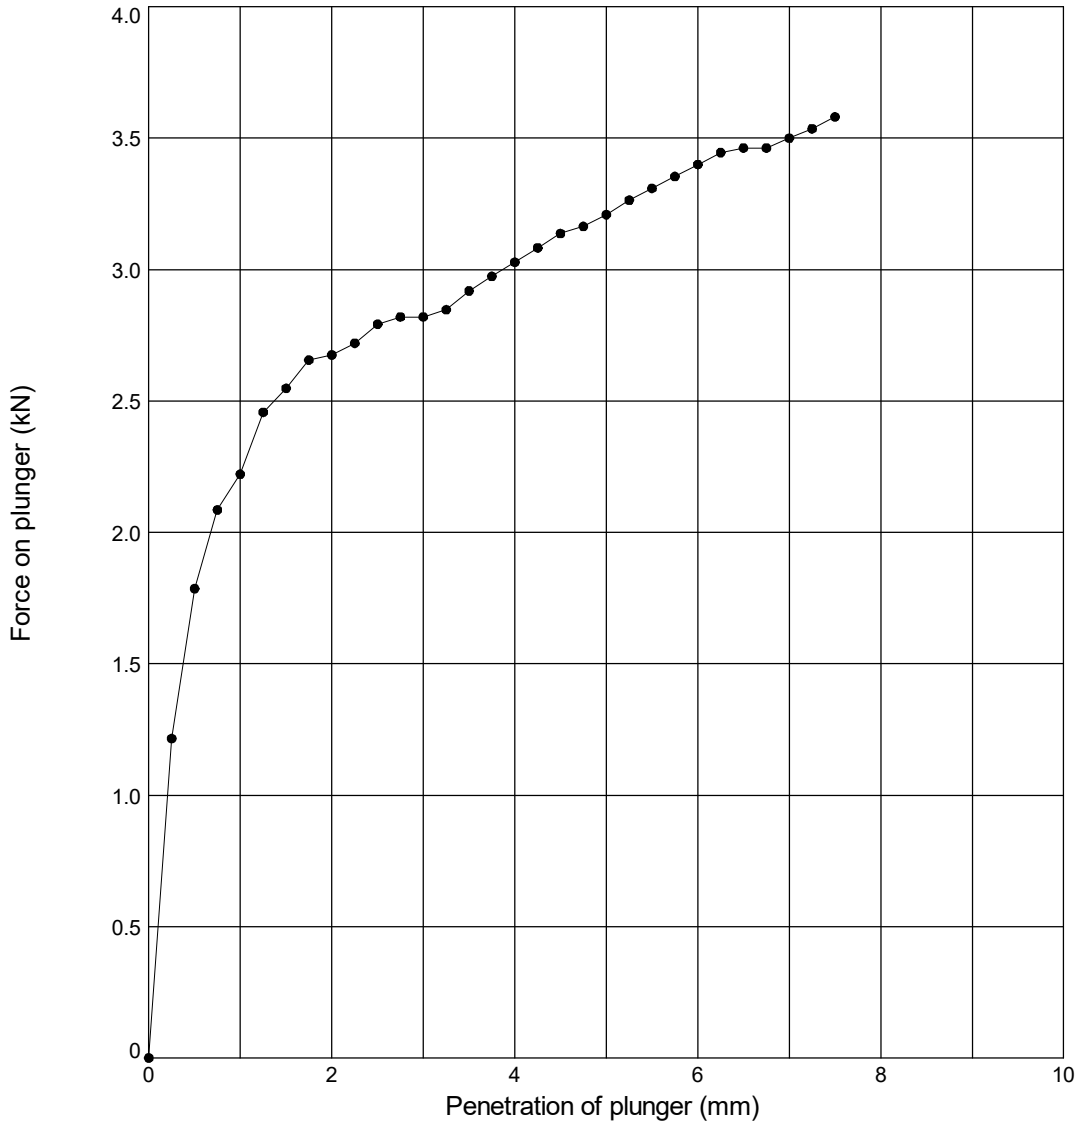
Position Ref: **CBR12** Depth (m): **0.00** Date: **21/10/21**

Test Details	Test Conditions	Test Results
Kentledge : Toyota Hilux Surcharge (kg) : 4.52 Surcharge Pressure (kPa) : 1	Weather : Fine Temperature (°C) : 8	CBR Value (%) : 21 Moisture Content (%) : 8.2
Sample Description	Test Notes	
Light brown sandy GRAVEL	Estimated particles >20 mm (%) : 4 Size and position of particles >20mm in relation to the plunger : Unknown

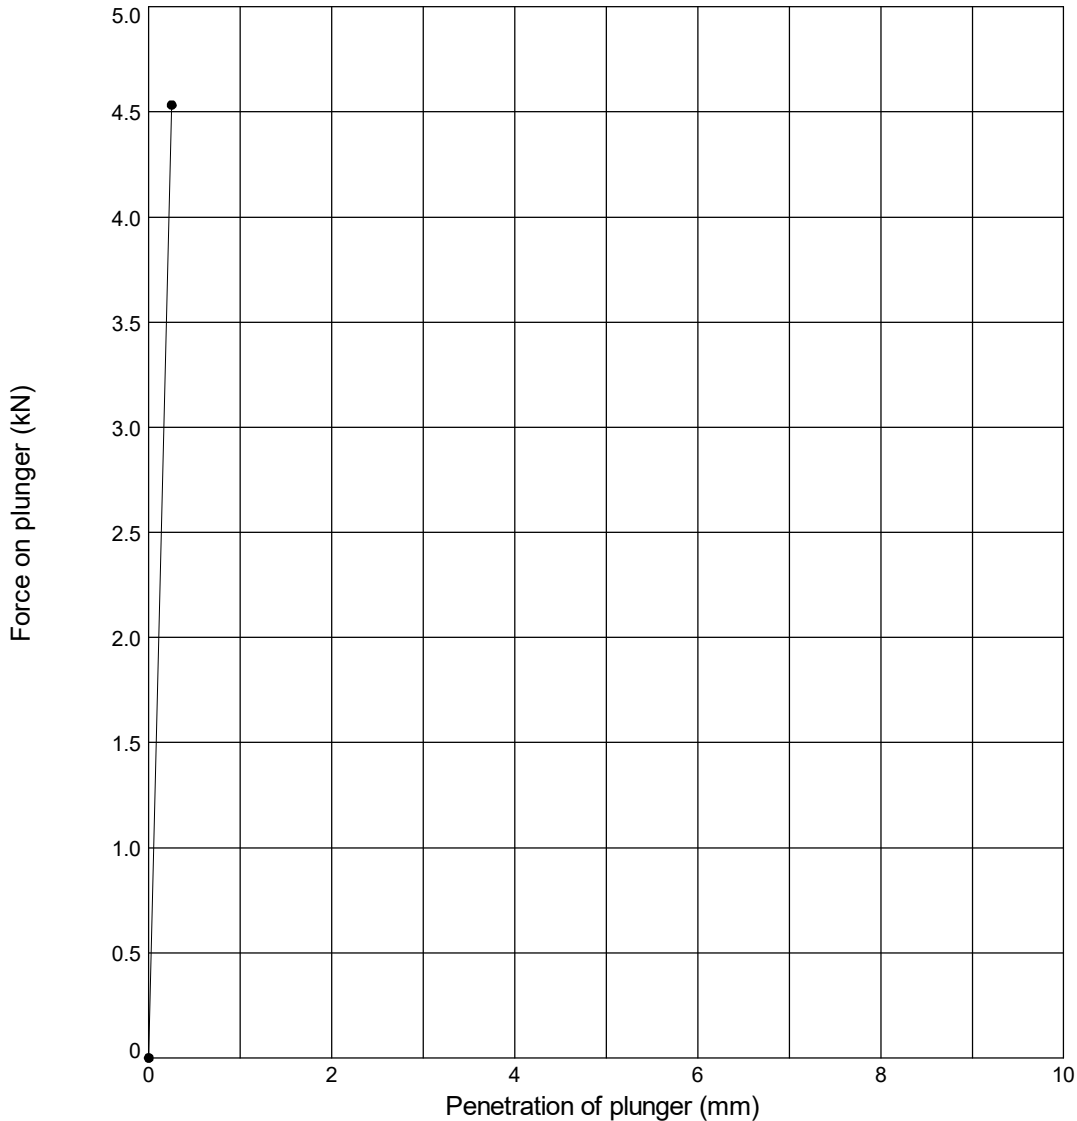
Position Ref: **CBR13** Depth (m): **0.00** Date: **21/10/21**

Test Details	Test Conditions	Test Results
Kentledge : Toyota Hilux Surcharge (kg) : 4.52 Surcharge Pressure (kPa) : 1	Weather : Fine Temperature (°C) : 8	CBR Value (%) : > 39 Moisture Content (%) : NA
Sample Description	Test Notes	
TARMAC	Estimated particles >20 mm (%) : 0 Size and position of particles >20mm in relation to the plunger : Unknown

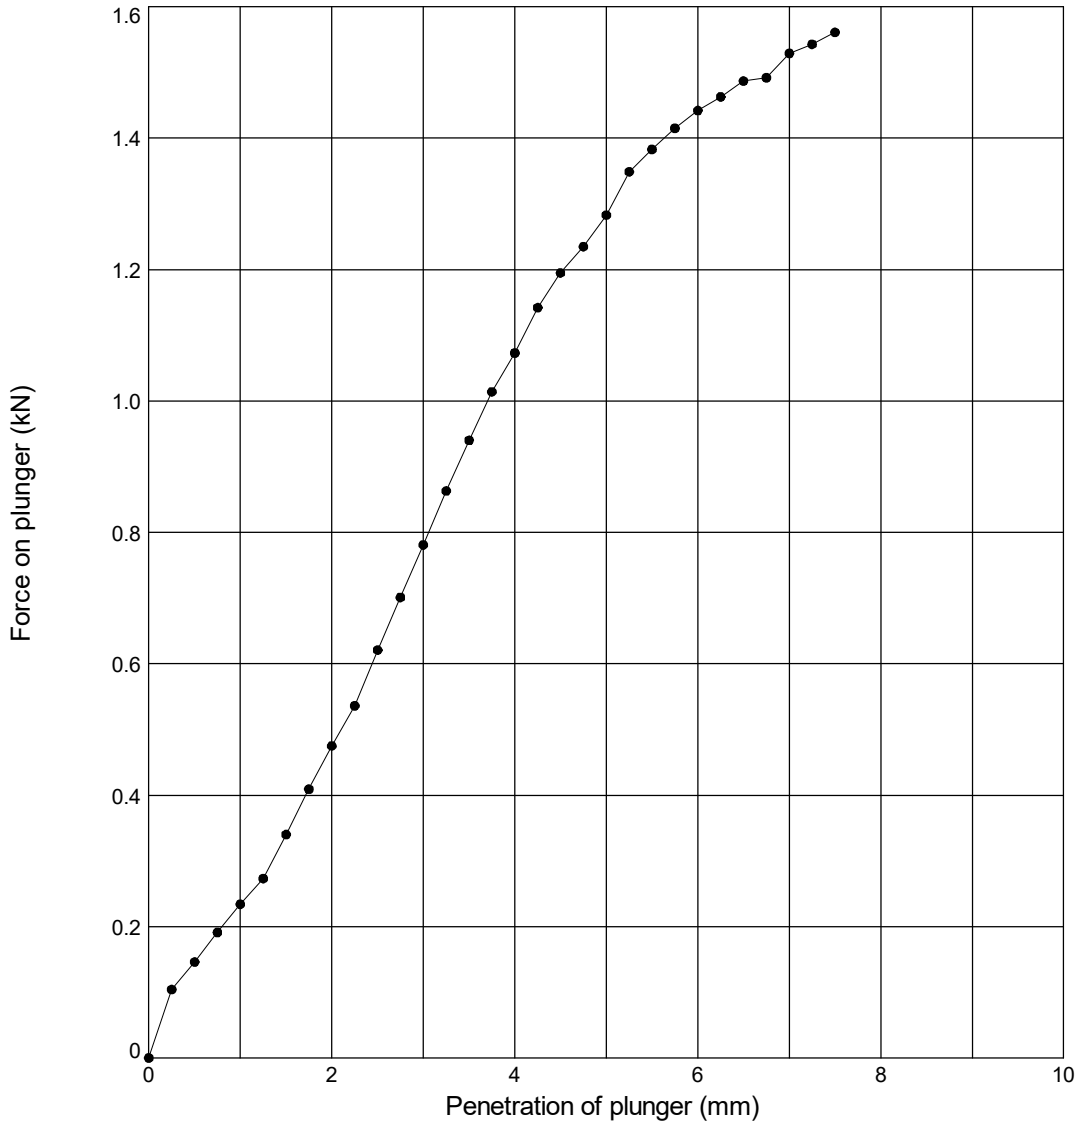
Position Ref: **CBR14** Depth (m): **0.45** Date: **21/10/21**

Test Details	Test Conditions	Test Results
Kentledge : Toyota Hilux Surcharge (kg) : 4.52 Surcharge Pressure (kPa) : 1	Weather : Fine Temperature (°C) : 11	CBR Value (%) : 6.4 Moisture Content (%) : 10
Sample Description	Test Notes	
Light grey brown gravelly SAND	Estimated particles >20 mm (%) : 0 Size and position of particles >20mm in relation to the plunger : Unknown

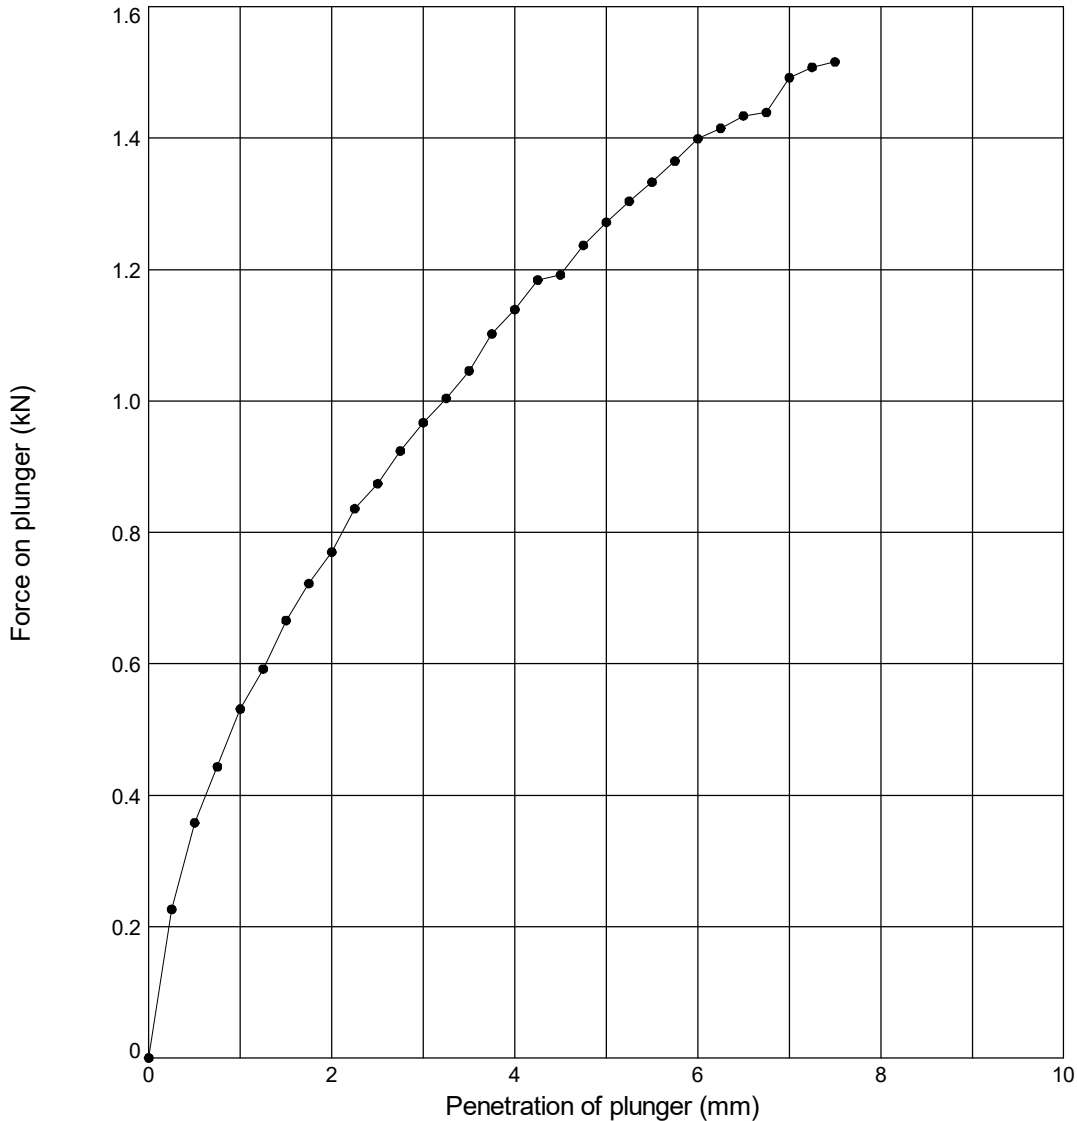
Position Ref: **CBR15** Depth (m): **0.45** Date: **22/10/21**

Test Details	Test Conditions	Test Results
Kentledge : Toyota Hilux Surcharge (kg) : 4.52 Surcharge Pressure (kPa) : 1	Weather : Fine Temperature (°C) : 12	CBR Value (%) : 6.6 Moisture Content (%) : 9.4
Sample Description	Test Notes	
Light brown gravelly SAND	Estimated particles >20 mm (%) : 1 Size and position of particles >20mm in relation to the plunger : Unknown

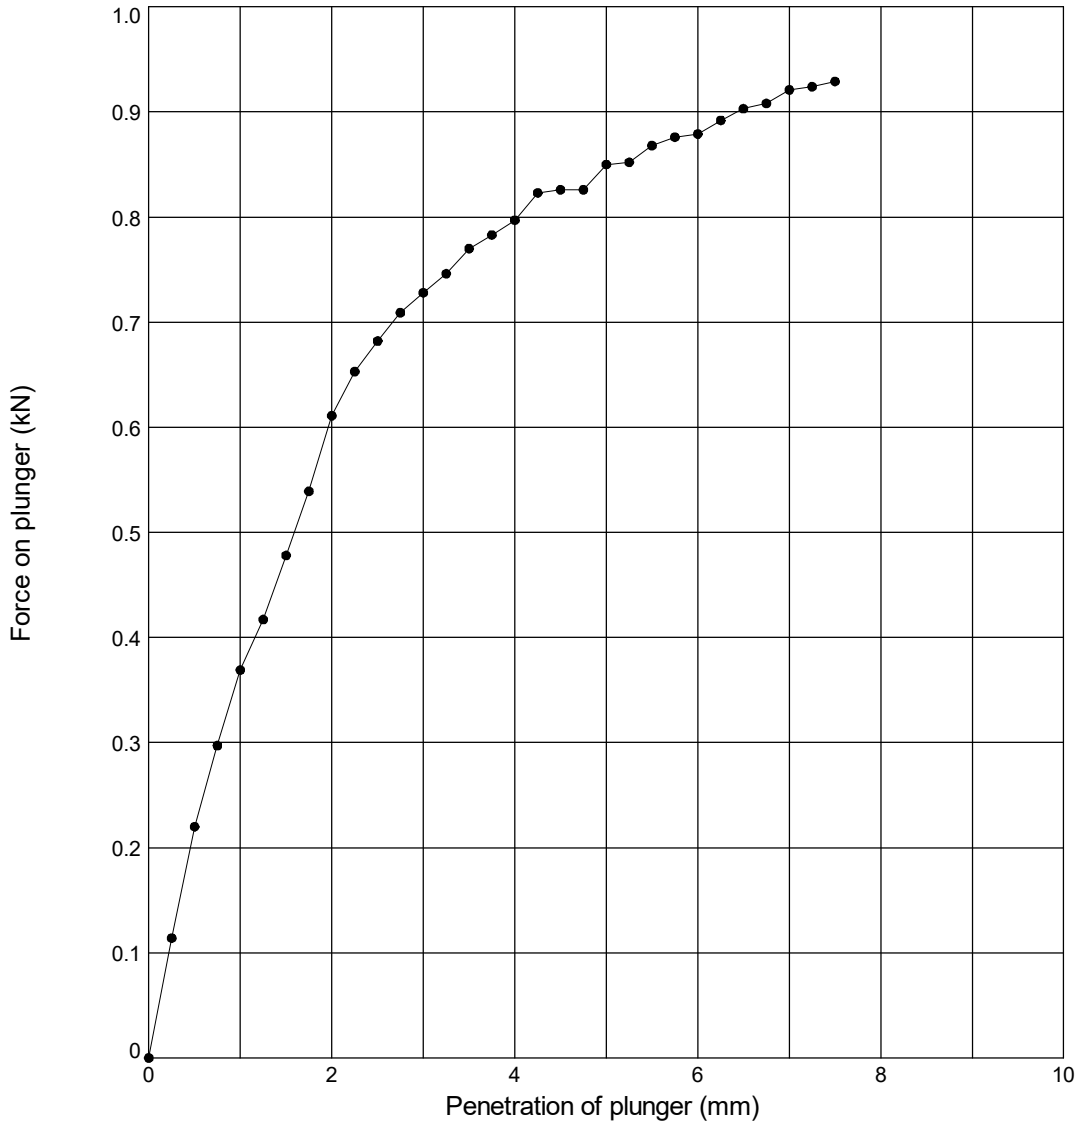
Position Ref: **CBR16** Depth (m): **0.45** Date: **22/10/21**

Test Details	Test Conditions	Test Results
Kentledge : Toyota Hilux Surcharge (kg) : 4.52 Surcharge Pressure (kPa) : 1	Weather : Fine Temperature (°C) : 12	CBR Value (%) : 5.2 Moisture Content (%) : 14
Sample Description	Test Notes	
Light brown slightly gravelly SAND	Estimated particles >20 mm (%) : 1 Size and position of particles >20mm in relation to the plunger : Unknown

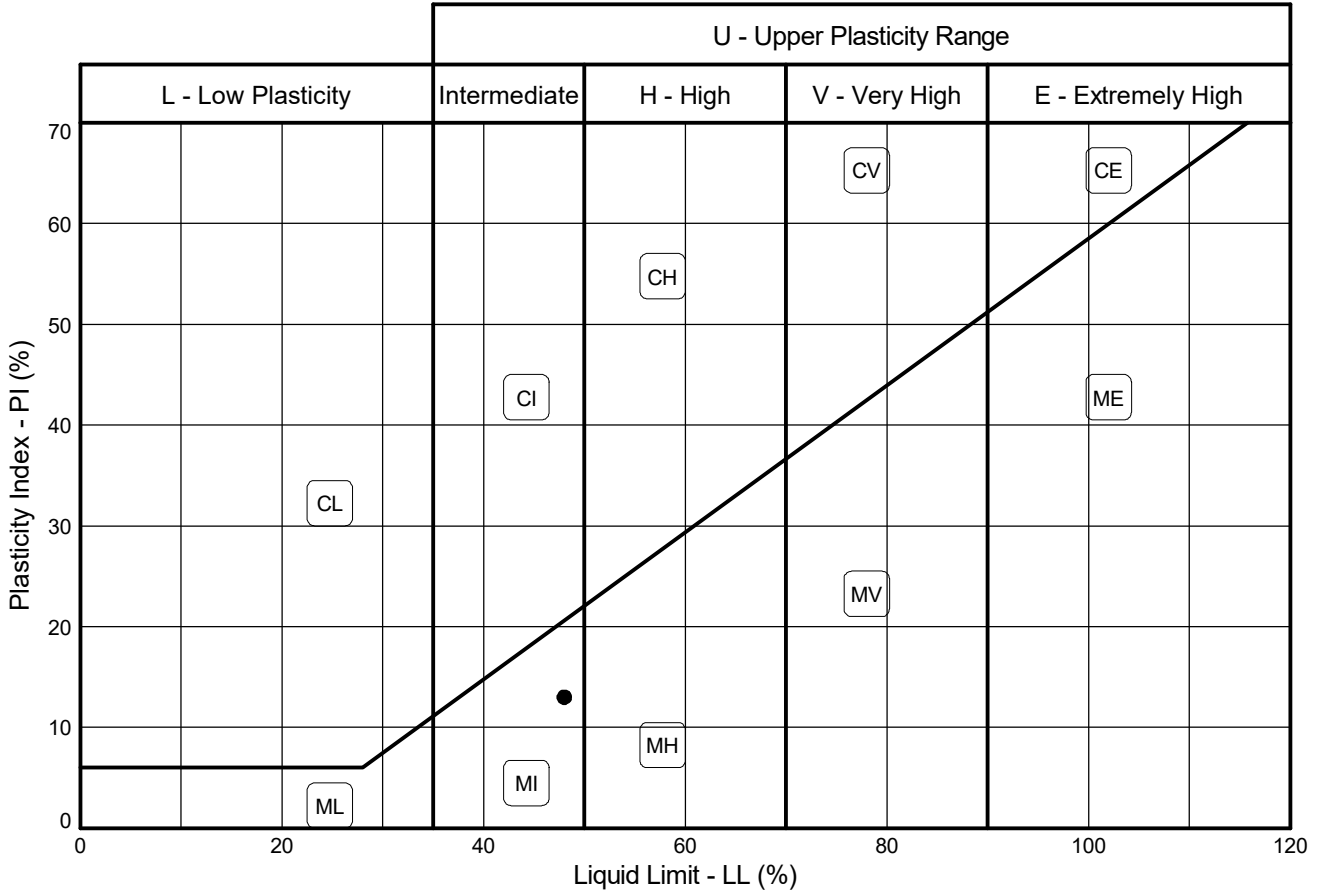
Sample Identification			BS Test Method #	Preparation Method +	MC %	LL %	PL %	PI %	<425µm %	Lab location	Notes
Exploratory Position ID	Sample	Depth (m)									
●	TP11	21/11658/19D	3.2/4.3/5.3/5.4	4.2.4	81	48	35	13	91	T	
	TP13	21/11658/23D	3.2/4.3/5.3/5.4	4.2.4	18	NP	NP	NP	68	T

Tested in accordance with the following clauses of BS1377-2:1990.
 3.2 - Moisture Content
 4.3 - Cone Penetrometer Method
 4.4 - One Point Cone Penetrometer Method
 4.6 - One Point Casagrande Method
 5.3 - Plastic Limit Method
 5.4 - Plasticity Index

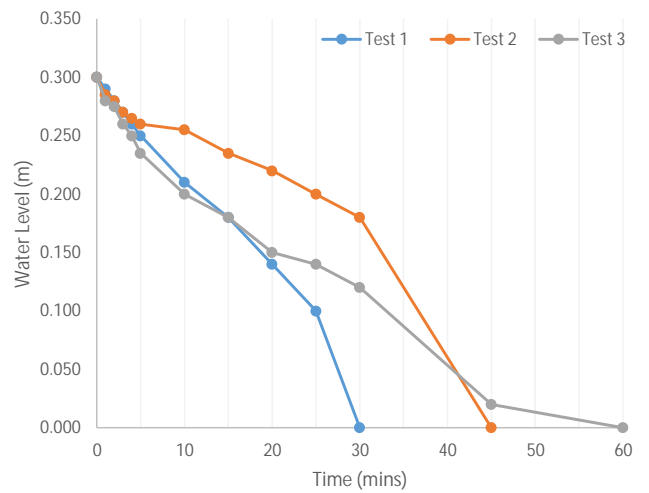
Test 1		Test 2		Test 3	
Mins	WL (m)	Mins	WL (m)	Mins	WL (m)
0	0.300	0	0.300	0	0.300
1	0.290	1	0.285	1	0.280
2	0.280	2	0.280	2	0.275
3	0.270	3	0.270	3	0.260
4	0.260	4	0.265	4	0.250
5	0.250	5	0.260	5	0.235
10	0.210	10	0.255	10	0.200
15	0.180	15	0.235	15	0.180
20	0.140	20	0.220	20	0.150
25	0.100	25	0.200	25	0.140
30	0.000	30	0.180	30	0.120
45		45	0.000	45	0.020
60		60		60	0.000
75		75		75	
90		90		90	
105		105		105	
120		120		120

Test 1	Test 2	Test 3
Start Water Depth (m)	0.300	0.300	0.300
Start time (mins)	0	0	0
Finish Water depth (mbgl)	0.000	0.000	0.000
Finish time (mins)	30	45	60
Effective Area at 50% (m ²)	1.665	1.665	1.665
Effective time (mins)	20	25	35
Effective Volume (m ³)	0.1485	0.1485	0.1485
Permeability Coefficient " f "	7.43E-05	5.95E-05	4.25E-05

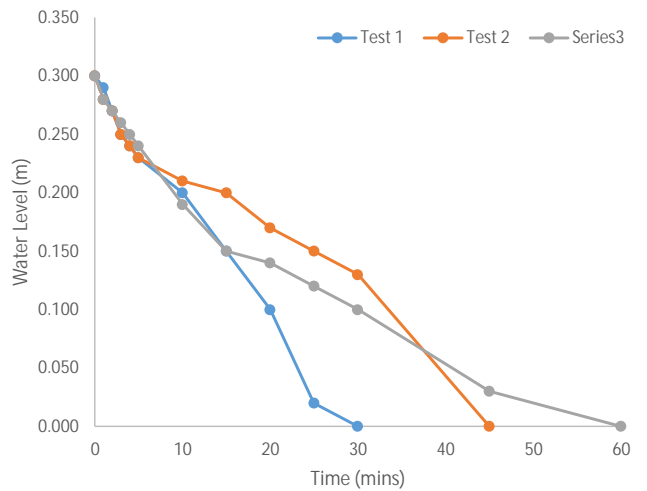
Test 1		Test 2		Test 2	
Mins	WL (m)	Mins	WL (m)	Mins	WL (m)
0	0.300	0	0.300	0	0.300
1	0.290	1	0.280	1	0.280
2	0.270	2	0.270	2	0.270
3	0.250	3	0.250	3	0.260
4	0.240	4	0.240	4	0.250
5	0.230	5	0.230	5	0.240
10	0.200	10	0.210	10	0.190
15	0.150	15	0.200	15	0.150
20	0.100	20	0.170	20	0.140
25	0.020	25	0.150	25	0.120
30	0.000	30	0.130	30	0.100
45		45	0.000	45	0.030
60		60		60	0.000
75		75		75	
90		90		90

Test 1	Test 2	Test 2
Start Water Depth (m)	0.300	0.300	0.300
Start time (mins)	0	0	0
Finish Water depth (mbgl)	0.000	0.000	0.000
Finish time (mins)	30	45	45
Effective Area at 50% (m ²)	1.89	1.89	1.89
Effective time (mins)	15	35	50
Effective Volume (m ³)	0.171	0.171	0.171
Permeability Coefficient " f "	1.01E-04	4.31E-05	3.02E-05
