Bat Survey Report

Hambleton House

9 Newmarket Road

19th February 2021
Project Ref: 17423

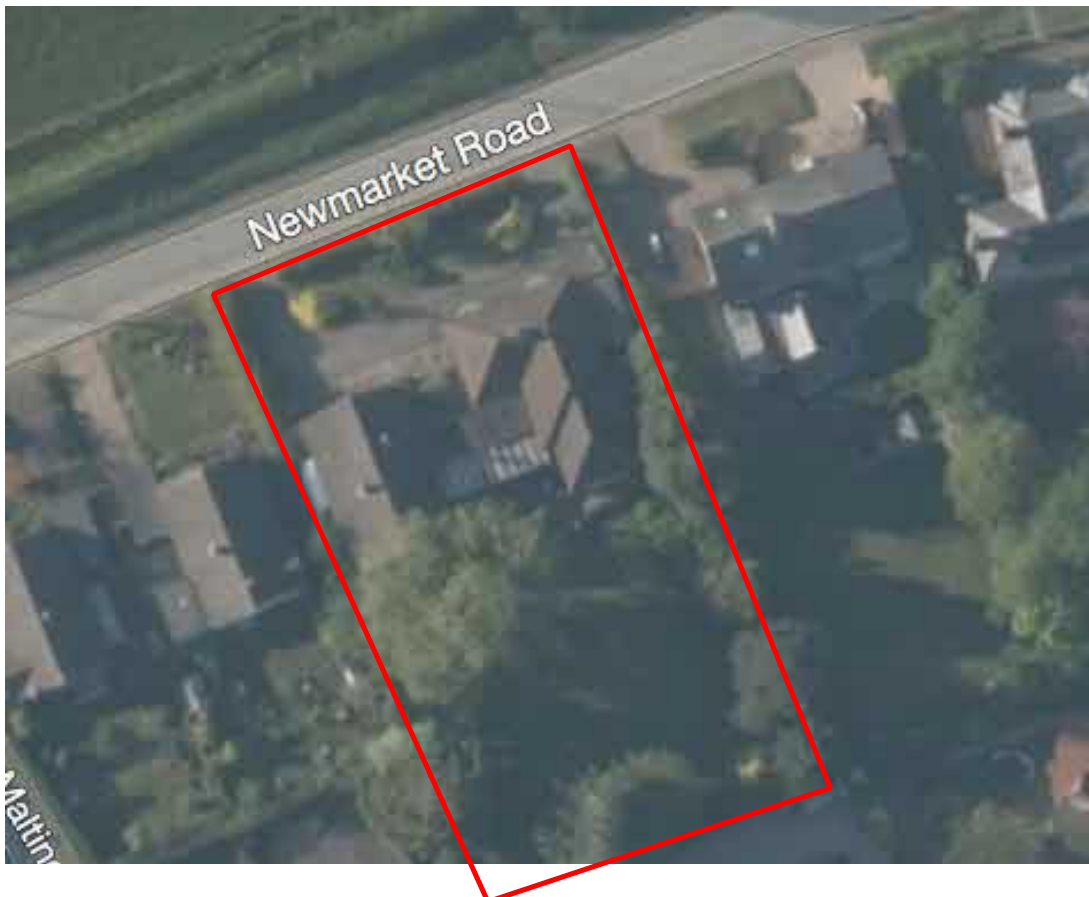
Figure 2.1 Aerial image of site.

- 2.1.3. The existing building comprises of 2 single storey sections, with pitched tiled roofs linked by a flat roofed section.
- 2.1.4. The western section has a single pitch concrete tiled roof which has gable ends to the front and rear elevations.

- 2.1.5. The eastern section has a pitched concrete tiled roof with several ridges and hipped gables.

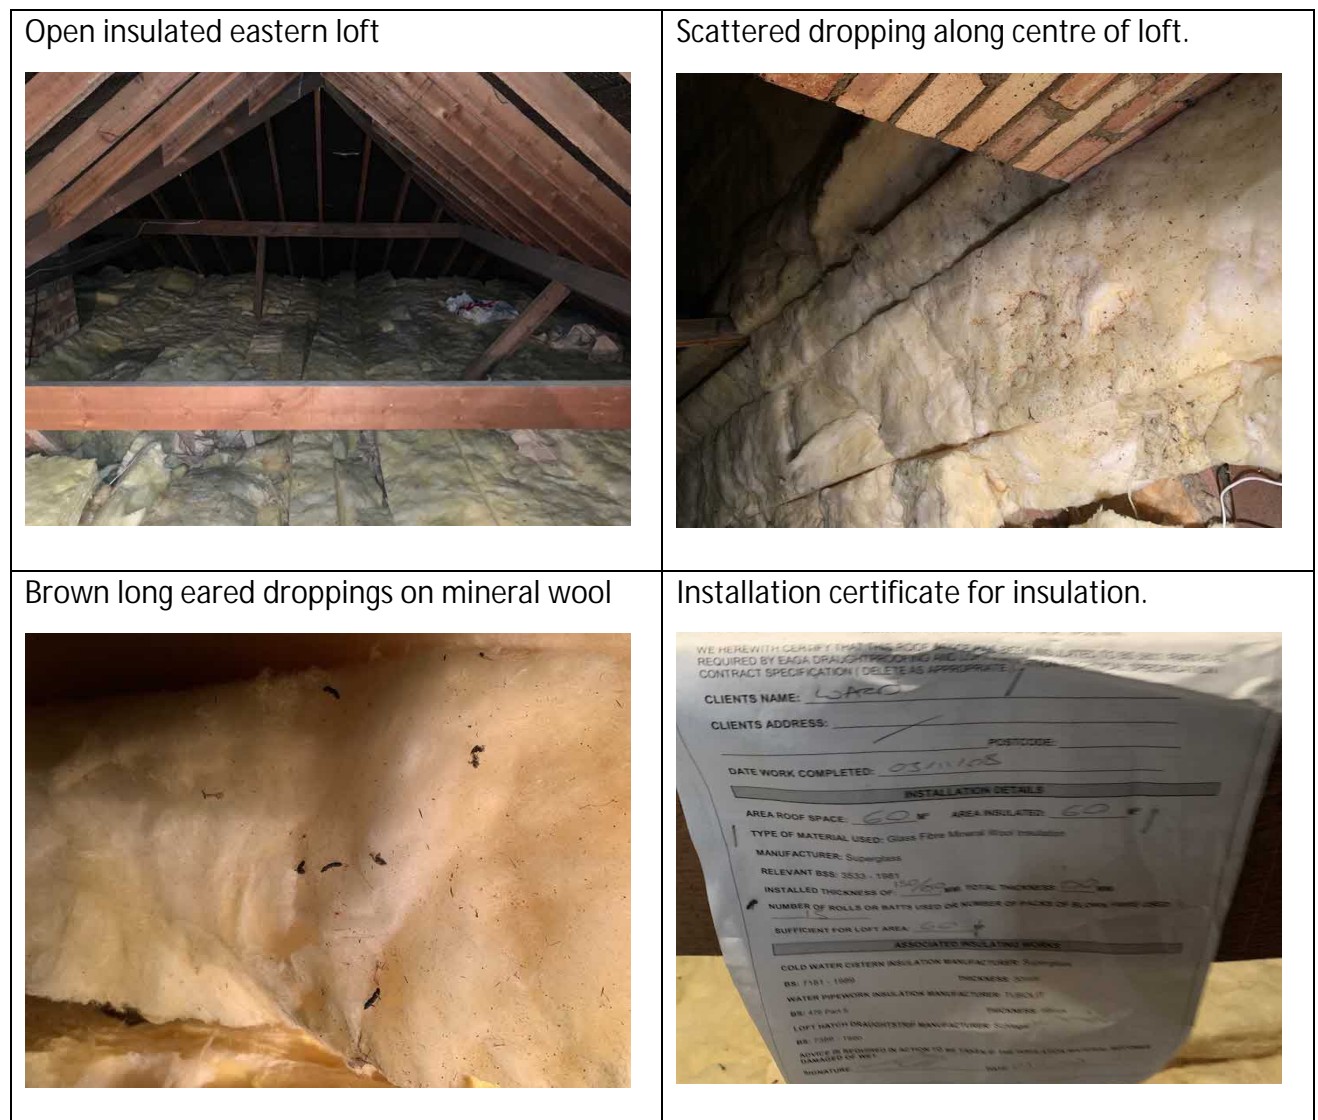
Figure 4.3 Internal survey photographs of eastern loft section.

- 4.2.16. The eastern loft is lined with bituminous felt which is generally in good order with a few tears which may afford bat access.
- 4.2.17. It is covered with mineral insulation extending to the eaves. It appears from the installation ticket this was topped up in 2008, so any evidence is accumulated since that date.
- 4.2.18. There is a scattering of a small number (approximately 50) of droppings both small fine particle and medium rough textured droppings characteristic of common pipistrelle and brown long eared respectively.

4.2.19. These are scattered throughout the loft on top of the mineral insulation, although generally beneath the ridge beams of the various loft areas, which may indicate this is the roosting location along the ridge, often preferred by brown long eared bats.

4.2.20. The new mineral wool insulation was lifted in several locations and no significant amounts of dropping were seen beneath.

4.2.21. The number and distribution of droppings does not present a significant number or concentration to indicate the roost is used by large numbers such as a maternity roost. It is more suggestive of a roost used by an individual or small number of individuals, circa 50 droppings over a 12-year period.
