Ecological Impact Assessment and Bat Survey

GARDEN COTTAGE, WEST THIRSTON, NORTHUMBERLAND

SUMMER 2022

Ruth Hadden, BSc. MCIEEM
Ryal Soil and Ecology
Ryal
Northumberland

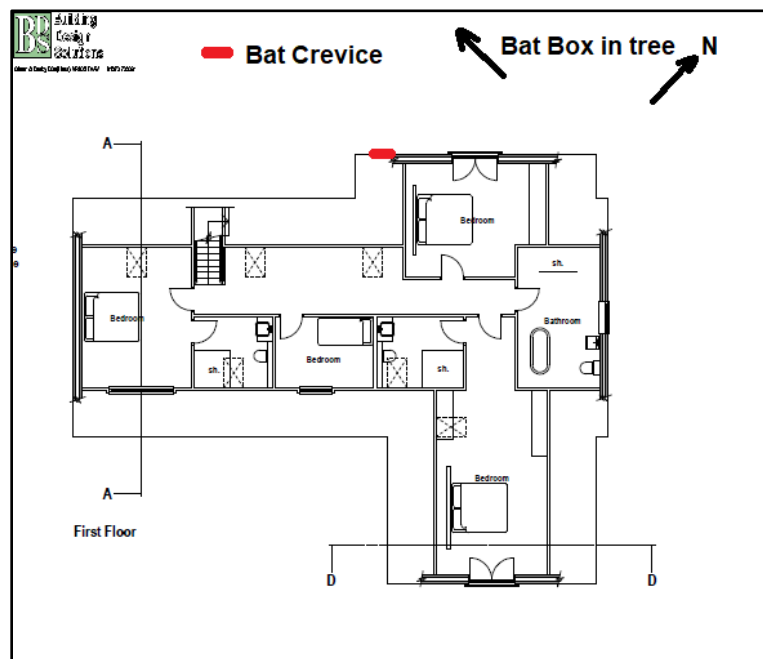
Figure 1. Ecological Mitigation Plan

- Mitigation will be in the form of a bat crevice in the extended building and a bat box will be provided.
- No nesting birds were noted around the area of works. Any nesting bird species though will be allowed access to the nest until the young have fledged.

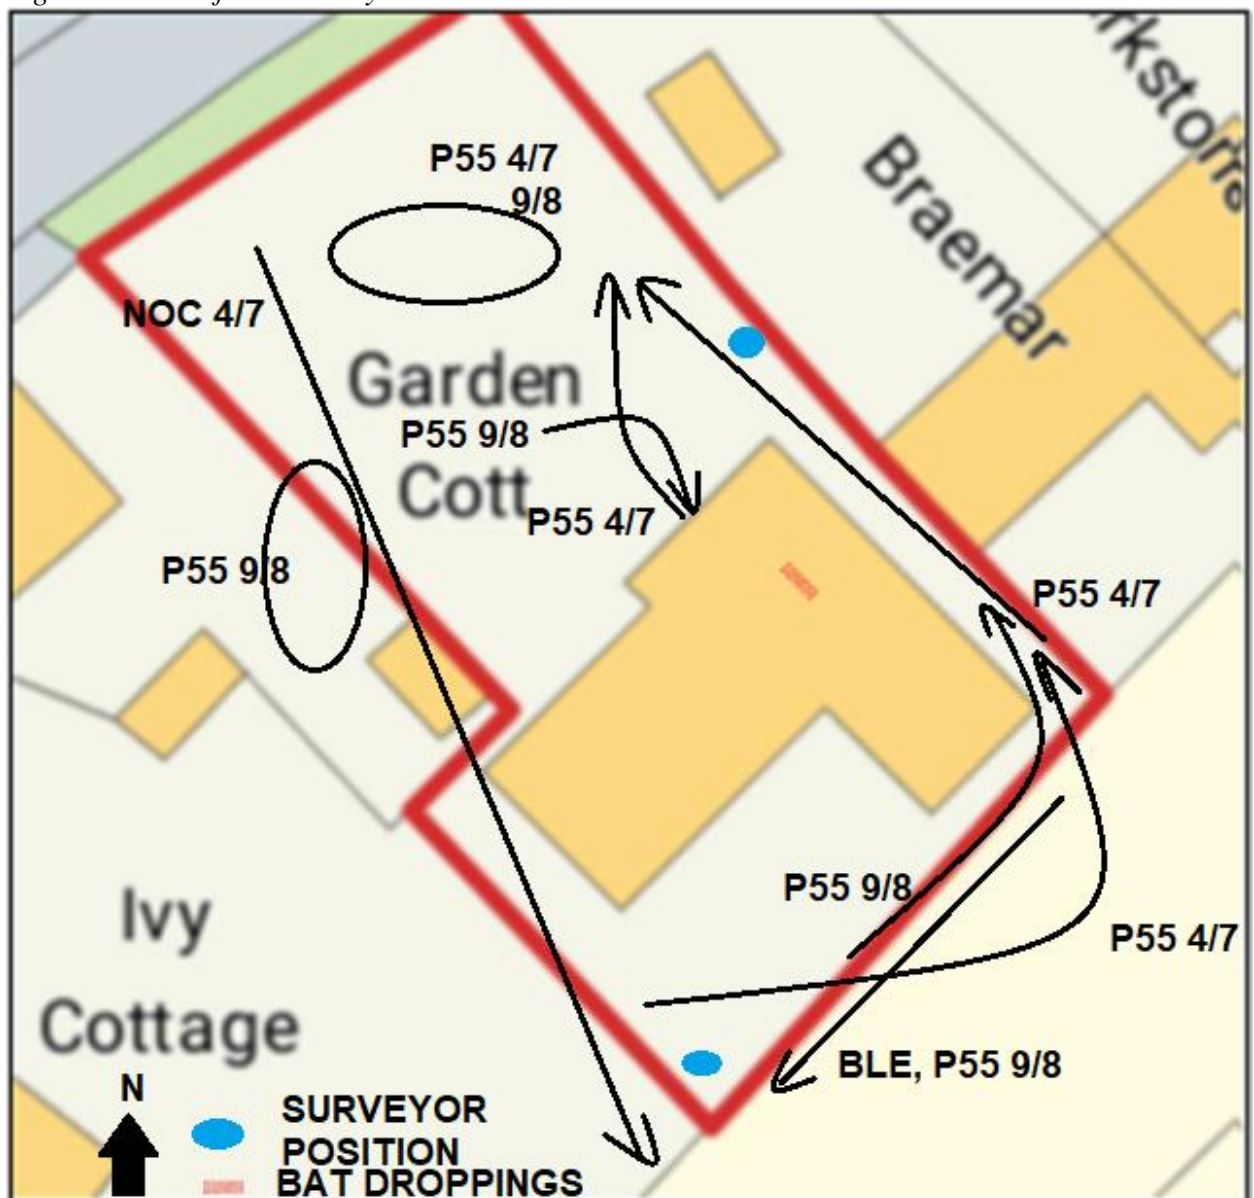
Figure 4. Plan of Bat activity

The emergence survey confirmed bat emergence from the property of two Pipistrelle 55kHz bats and after sunset small numbers of Pipistrelle 55kHz bats were foraging over the site with Noctule bats also heard or seen during the survey. The dawn survey identified re-entry into the building of two Pipistrelle 55kHz bats and commuting activity of Pipistrelle 45kHz, Noctule and Brown long-eared bats. Please see Appendix 2 for further details.

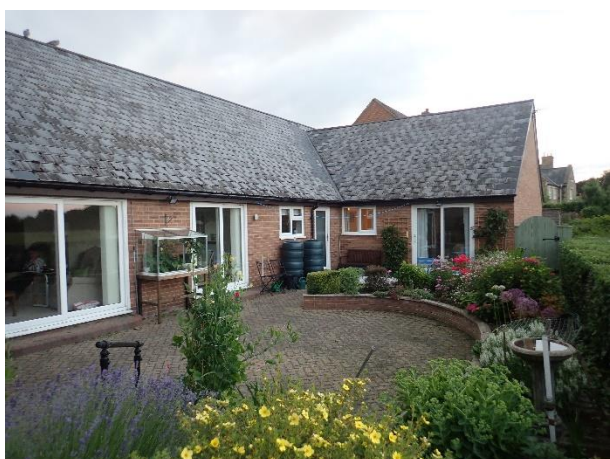
Soffits well sealed

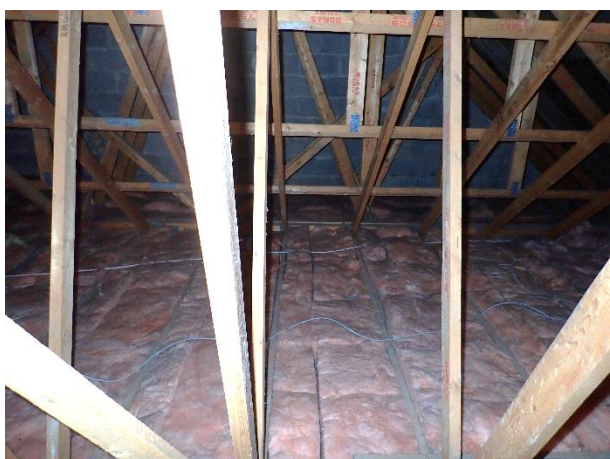
Trussed roof with insulation

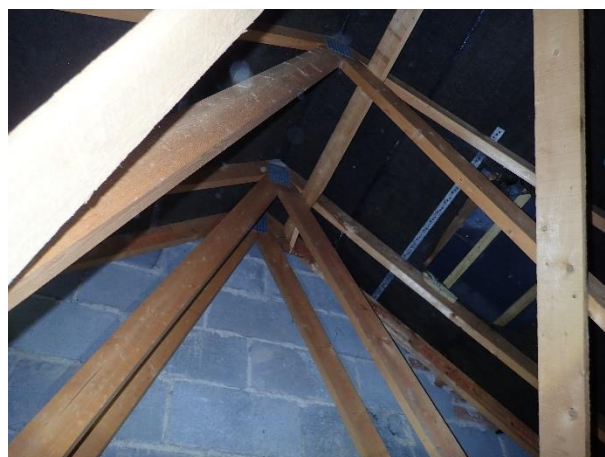
No ridge board

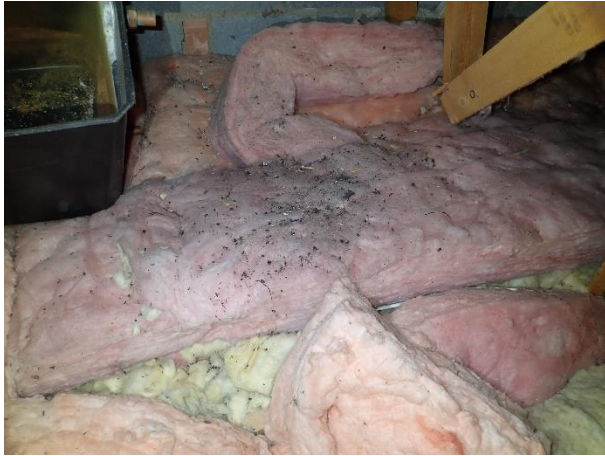
Insulation otherwise clean

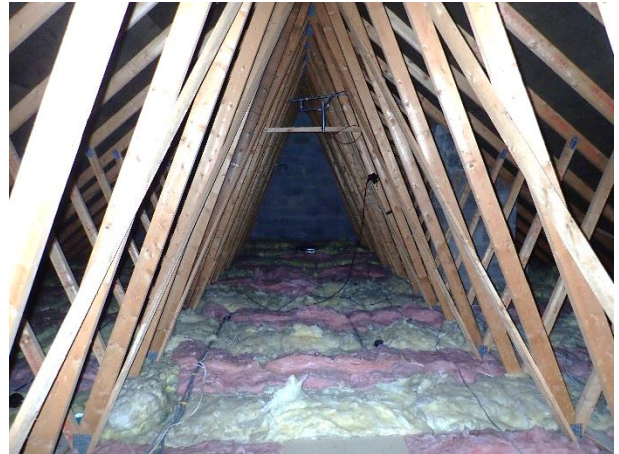
Inspection results of the exterior revealed that the single storey building affected by the proposals is stone built on the northwest aspect and is brick on the gables and southeast aspects. No crevices in the masonry are present and the soffits are well sealed, however crevices appear to be present at the gables. The trussed, pitched roof, which is resin tiled, had a bitumen sarking present. There were small bat droppings, consistent with Pipistrelle species, present at the north end of the loft, the insulation was otherwise clean allowing

Area of bat droppings

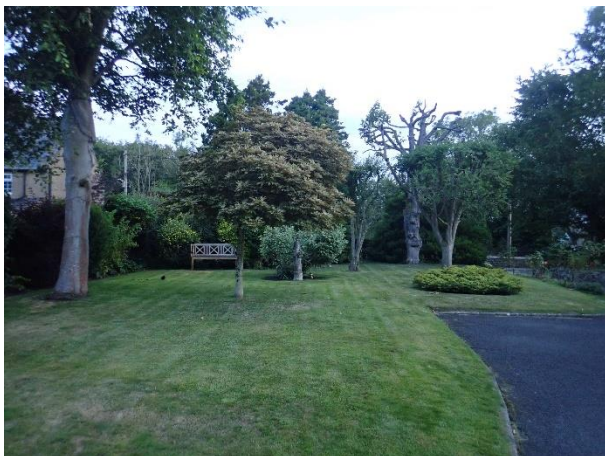
Garden area, amenity grass that will be lost due to extending the parking area

An area of amenity grass will be lost, see photograph above, however no trees will be felled.

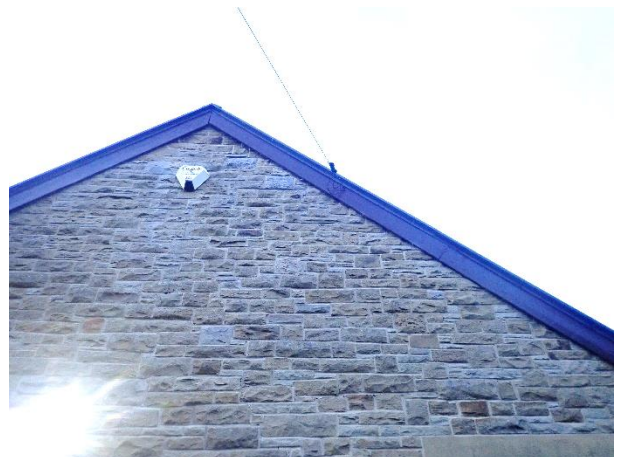
Northwest gable were bats exited and re-entered.

An external crevice will be retained as at present on the northwest gable walltop of the building. This will be in the form of an access gap measuring 20mm by 15mm created between the slates/tiles and the gable wall top through the mortar fillet into a larger crevice on the wall top below the slates/tiles, resembling a 'flattened bottle' measuring c.100 x c.200 x 20mm. This provides a small space that acts as a suitable bat roost for the occasional bat. Please see Appendix 3 for detail and plan at Fig. 6 for locations.

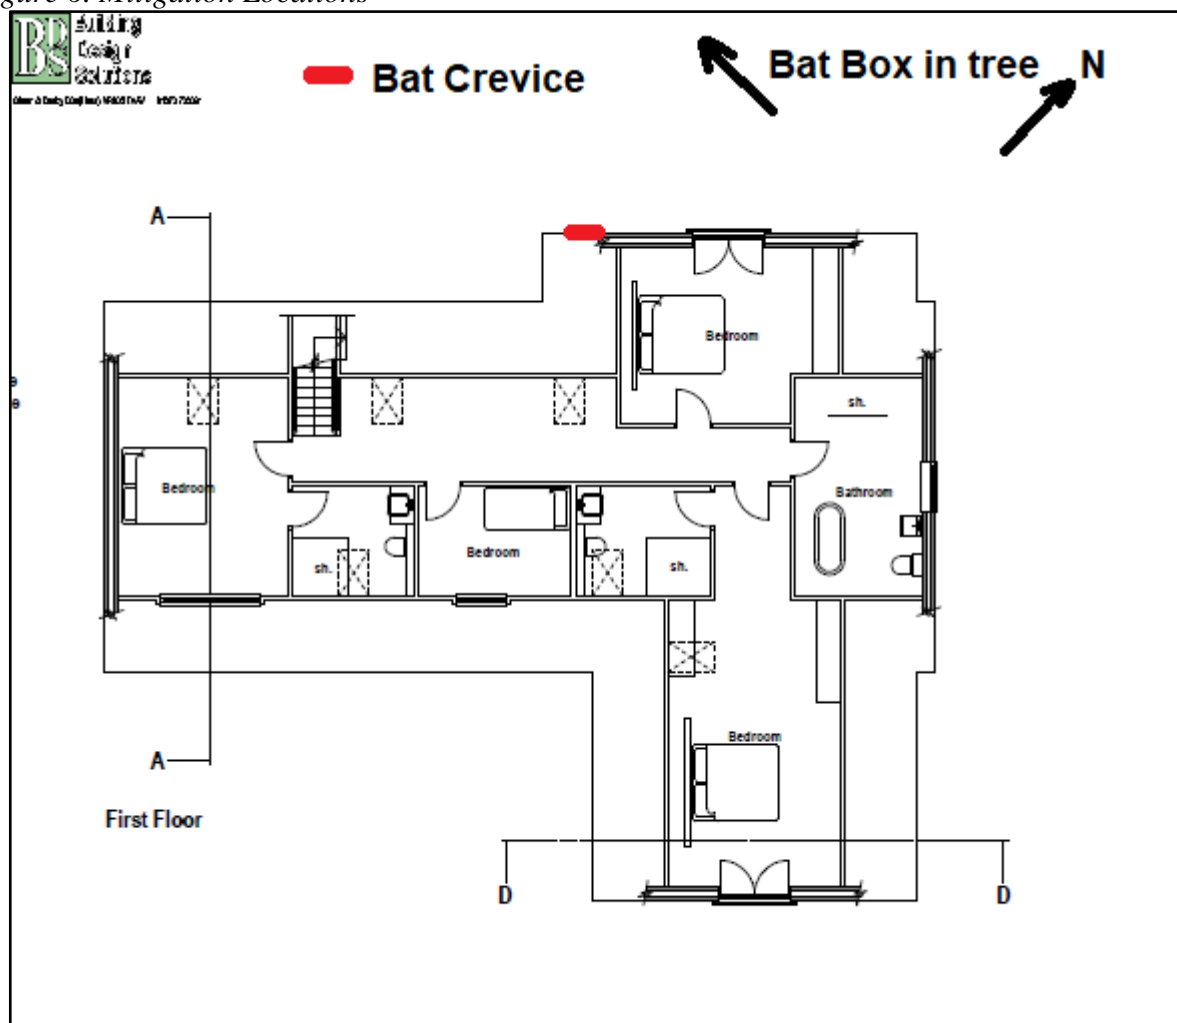
Figure 6. Mitigation Locations

Location	Mitigation Type
Extended building	Bat access will be retained at the eaves at the south eaves corner wall top.
Tree	A Low Profile WoodStone bat box will be positioned facing to the northeast at a height of 3+m

A Low Profile WoodStone bat box will be positioned on a tree to the west, facing to the northeast at a height of 3+m and will be maintained for five years.

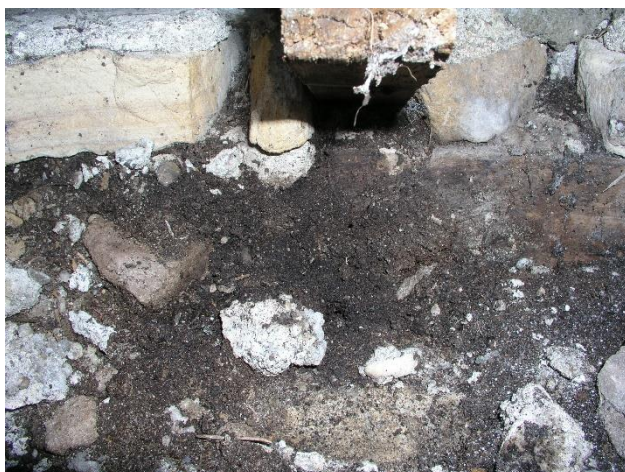
Photo showing disintegrated bat droppings beneath coping stones. If examined carefully, in the black dust exoskeletons of insects can be seen shining.

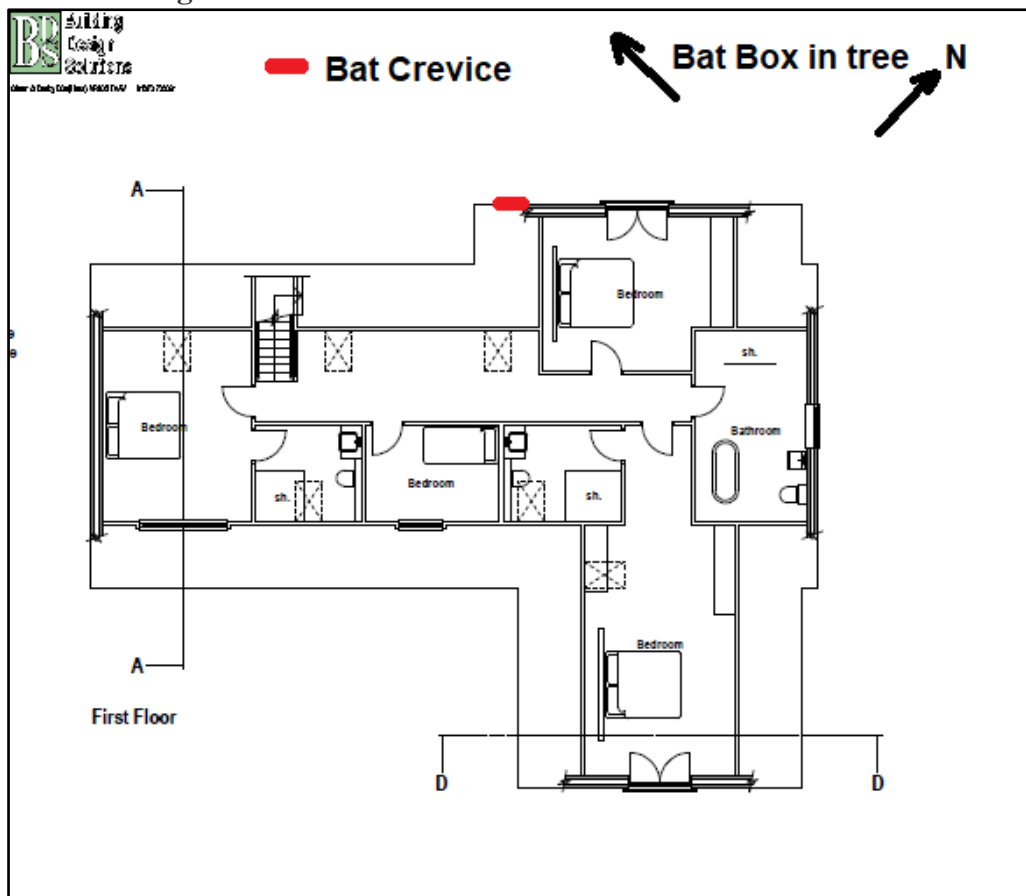
Location of Bat Mitigation

A Low Profile WoodStone bat box will be positioned on a tree to the west facing to the northeast at a height of 3+m and will be maintained for five years.

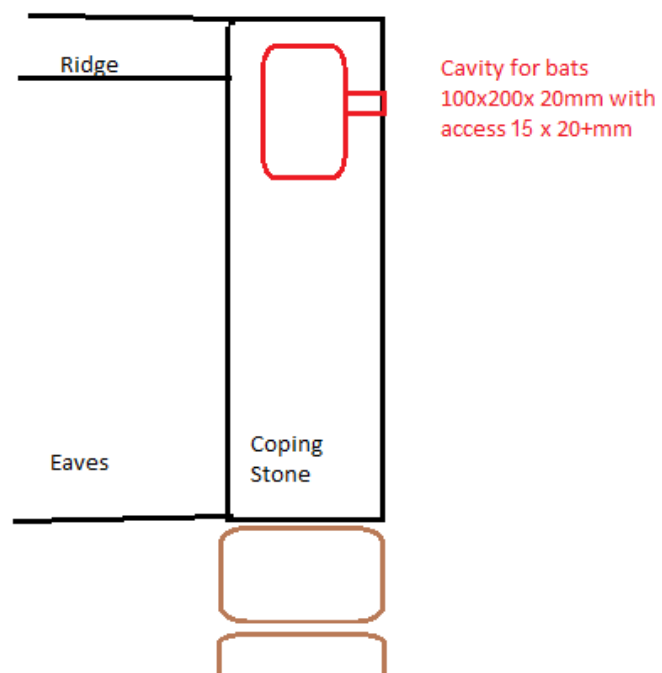
Gable wall crevice
