# Flemings Hall Barn

## STAGE I/ TIER I Geo-Environmental Desk Study Report

Report: NE22/009/SIT1  
31/08/2022  
Rev. 00

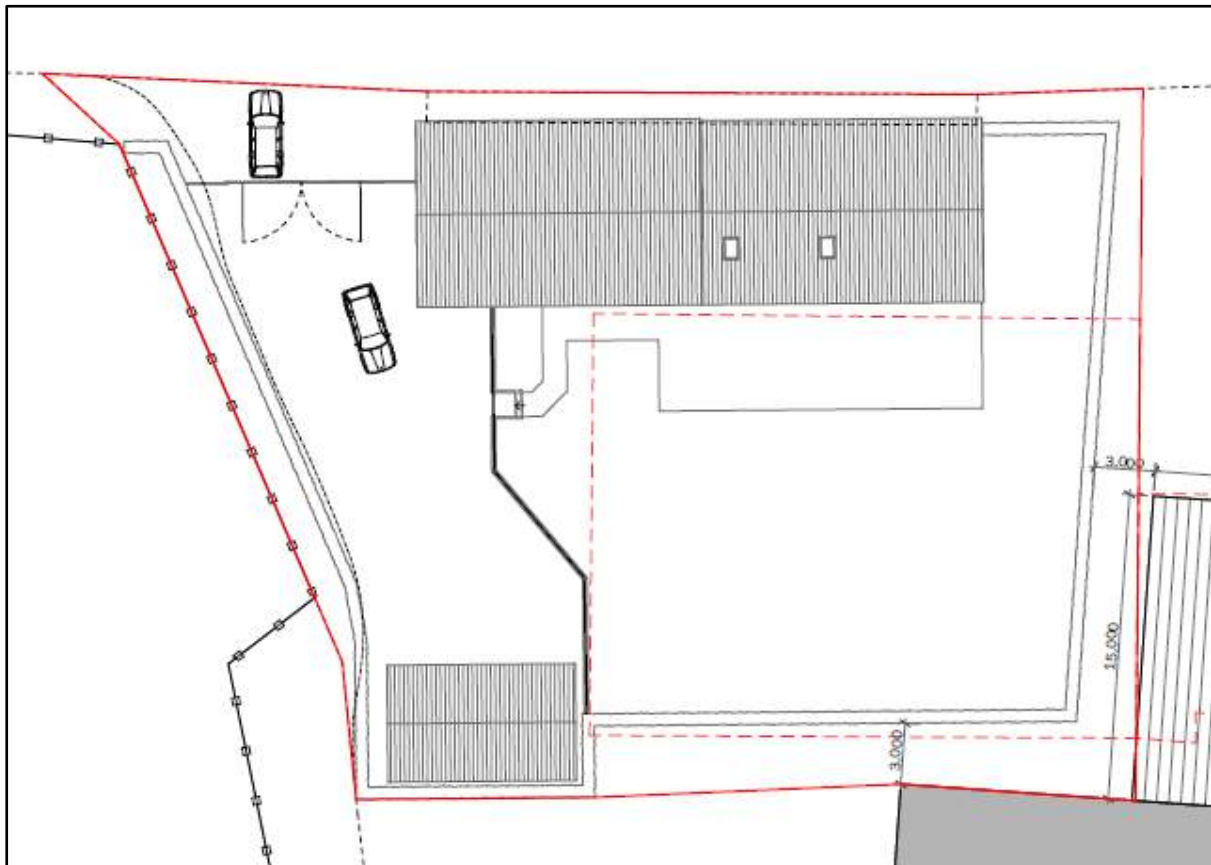
Figure 1: Proposed Site Plan (extract)

1.4.1 We understand development proposals comprise the demolition of an existing agricultural barn and the conversion of another existing barn into residential accommodation. The works will include the construction of a new garage building as well as associated car parking and gardens. An extract of the development proposal is shown in **Figure 1** below.
