FIGURE 4: PROPOSED RESTORATION

Project Northern Extension Dimmock's Cote Quarry Wicken	
Drawing Title Restoration Plan	Date Revised October 2019
Drawing number CP/FF/DCN/05 Rev e	Scale 1:1000 at A1

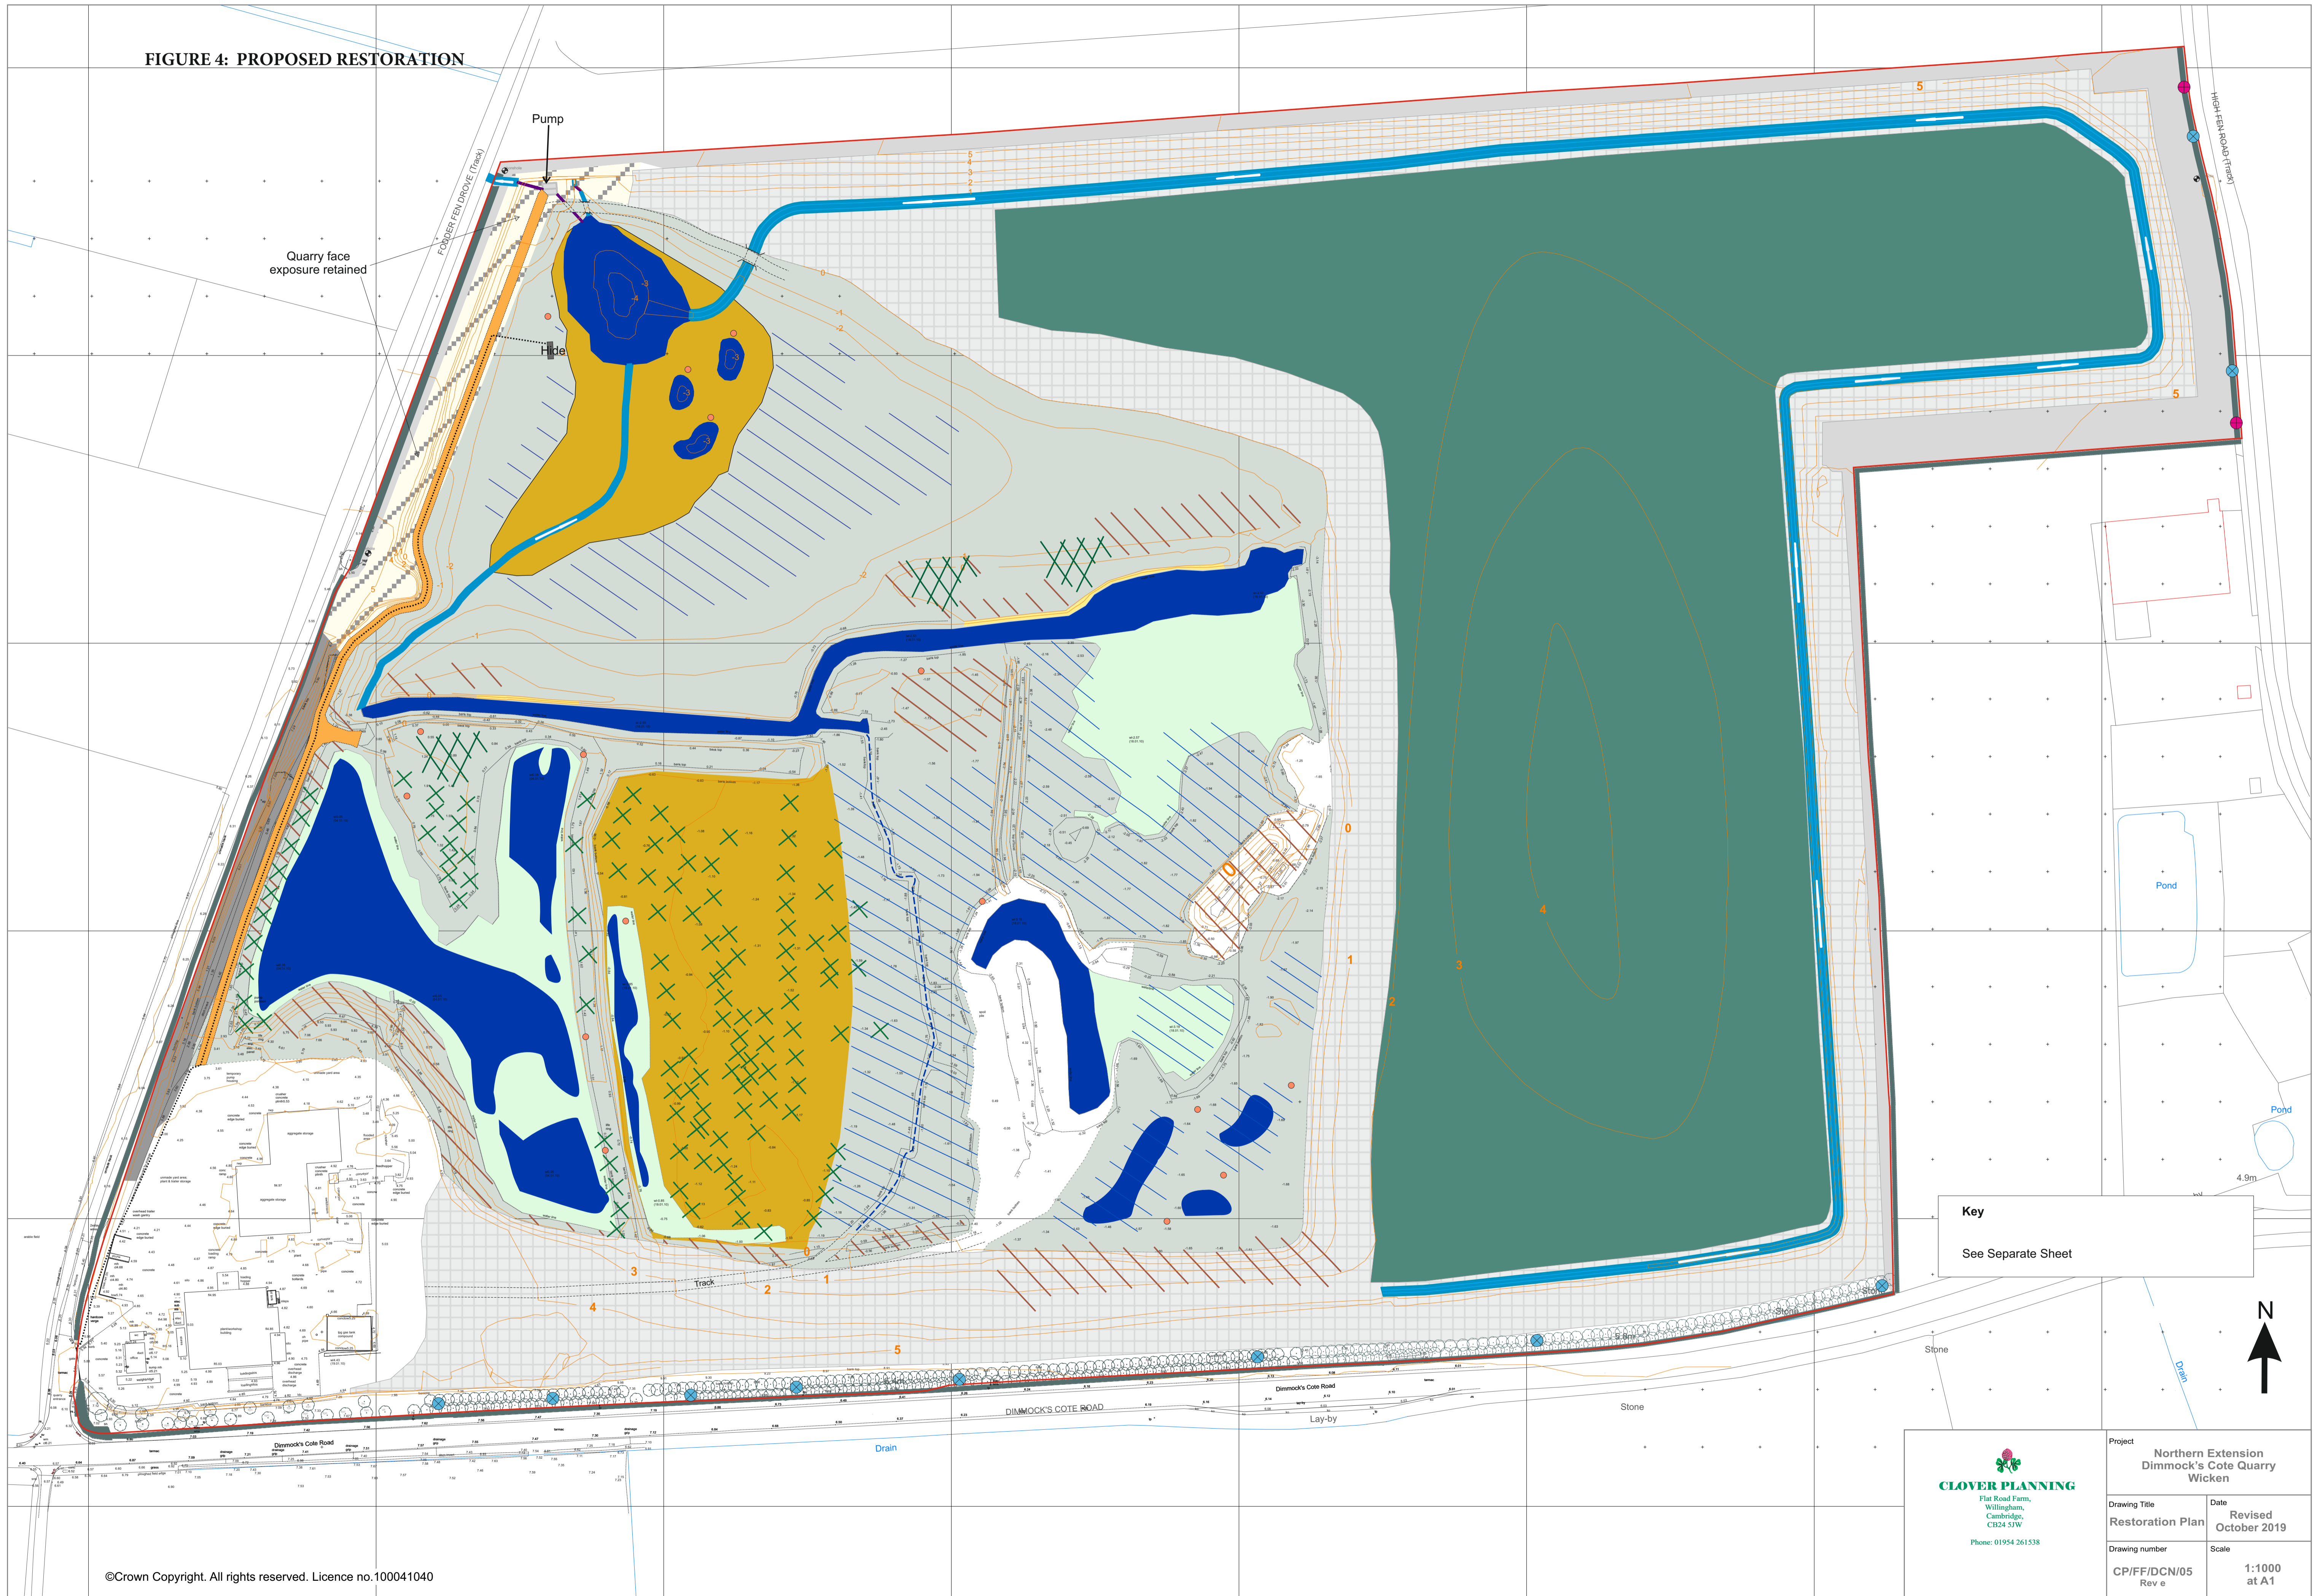
Quarry face exposure retained

Pump

FOLDER EN DROVE (Track)

Hide

Pond
