Phase 1 Environmental Site Assessment

Flax Farm, Stansfield Road, Poslingford, Sudbury, CO10 8RD

Survey and Report by: Simon Joynes, Consultant Reviewed by Tony Hargreaves, Director 29th September 2021 Project Ref: 17480

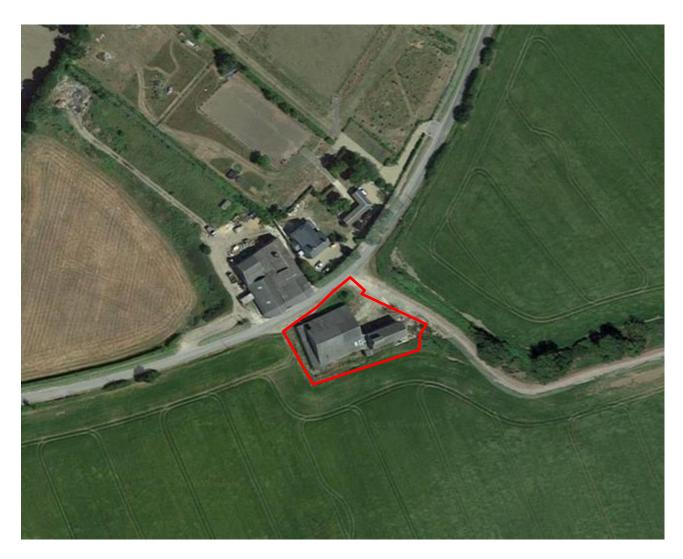
Aerial Photograph of Flax Farm, Stansfield Road, Poslingford, Sudbury

The site compromises part of a larger farm holding and consists of two main structures which are now unused and have fallen into significant disrepair. There are areas of hardstanding in front and around the sides of the building in various states of repair.

The structures themselves are of varying construction, predominantly of corrugated sheeting (possibility of asbestos bonded material) and steel profile sheets in varying states or repair. To the rear is a former plant room (milling or grain drying) adjacent to which can be seen the former plinths which supported a hydrocarbon tank. The tank is no longer present but there is an element of hydrocarbon staining beneath the tank (unbunded).
