# **Protected Species Survey of Buildings at Church Farm, Cotterstock, Northamptonshire**

**November 2022**

## **Buildings at Church Farm, Cotterstock Protected Species Survey**

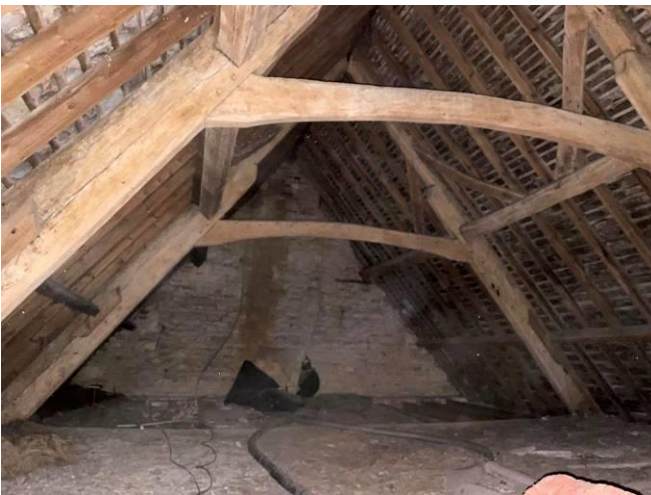
The farmhouse is of limestone construction with a pitched, slate roof, unlined internally, and containing three chimneys at the north and south ends and in the centre. It is a two storey building though attic bedrooms are present in the northern half of the farmhouse. The roof space is divided into two sections at the central chimney, the south section high, disused and sealed off from the adjacent attic rooms and containing frequent cobwebs, with a low roof space retained above the attic rooms of the north section.

*South section of roof space*

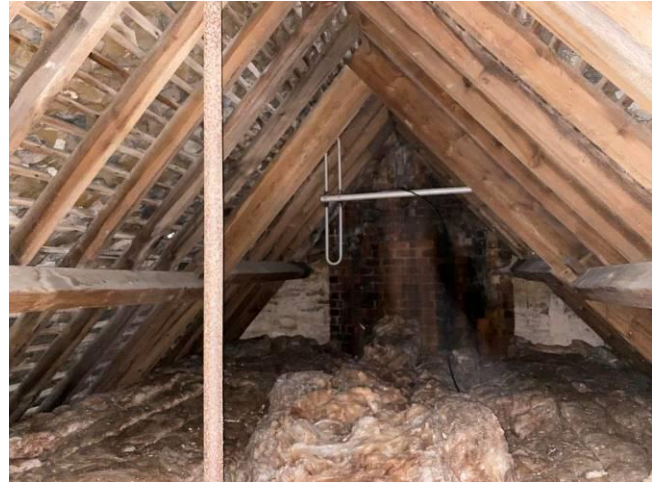
*North section of roof space*

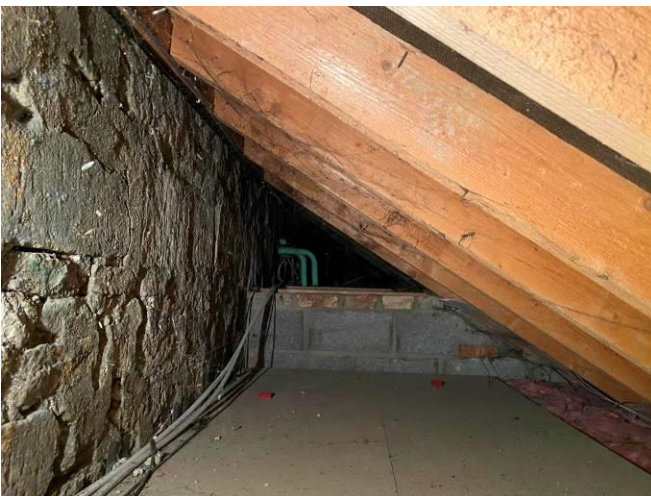
Attached to the north elevation of the farmhouse is a one storey extension of the same construction, the mono-pitched roof containing a single roof space above the plastered ceiling that contains frequent cobwebs. Attached to the east elevation is a one storey glazed, conservatory style extension (to be removed), the flat roof having narrow, sloping sections of slate around the edges with a single large skylight in the centre of the roof, this and the glazing creating high internal light levels.

*Roof space of northern extension*

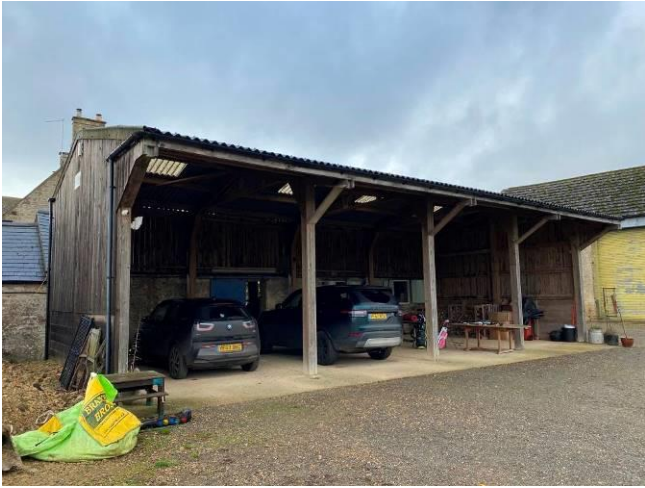
Attached to the north elevation of the western half of the outbuildings is a car port of modern timber framed construction, open-sided on the north elevation, and clad with Yorkshire and other timber boarding on the south, east and west elevations with the limestone wall of the adjacent outbuilding forming the lower half of the south elevation. The low-pitched corrugated sheeting roof is unlined internally and contains eight skylights, which with being open-sided makes the interior very light and draughty. Four woodcrete bat boxes have been attached to the west elevation.

*Car port attached to north elevation of outbuildings*

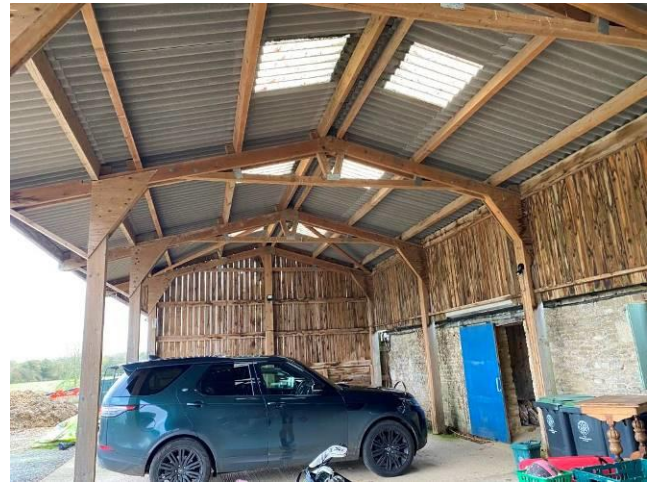
*Interior of car port*

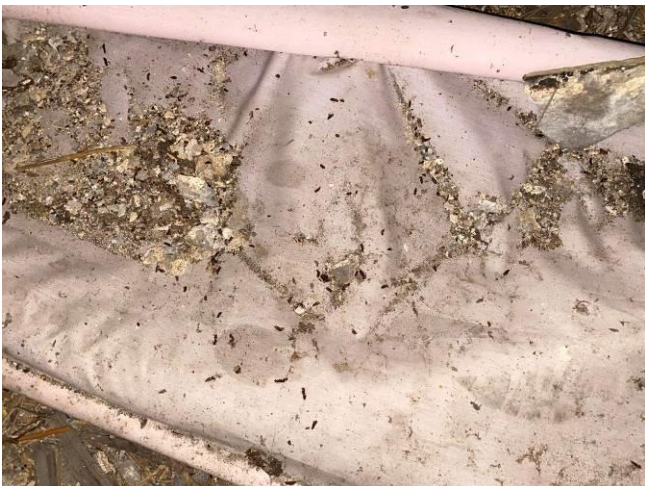
Frequent scattered old bat droppings, their appearance and location below the apex typical of those of brown long-eared bat, were present in the south section of the roof space of the farmhouse. Urine stains were also present on items within it, with a small number of similar droppings in the north section of the roof space. No evidence of bats was found in the extensions of the farmhouse or any of the outbuildings.

*Bat droppings in south section of farmhouse roof space*

As the work to the roof space of the farmhouse will result in the loss of a probable brown long-eared bat roost site, a licence from Natural England will need to be obtained. Bat activity surveys will be required during the May-August summer breeding period to confirm the species and level of use by bats and to inform the licence application once planning permission has been obtained. The following measures will be implemented to reduce the impact of disturbance to bats as a result of the proposed work and will form the basis of the bat licence application. As the presence of bats in the outbuildings can never be discounted entirely, these precautions should also be implemented during work on those buildings:

If the surveys confirm that the roof space supports only a low level brown long-eared bat day roost used by one or a small number of bats, artificial bat cavities such as Schwegler 2FR bat tubes or equivalents incorporated into the external south or west elevations of either the farmhouse, or one of the new extensions or converted outbuildings will provide an appropriate alternative roost site. If the surveys confirm it is used as a maternity roost, an appropriate sized roof space dedicated as a bat roost zone will need to be provided in the farmhouse (possibly the north section of roof space) or another suitable building at the property.

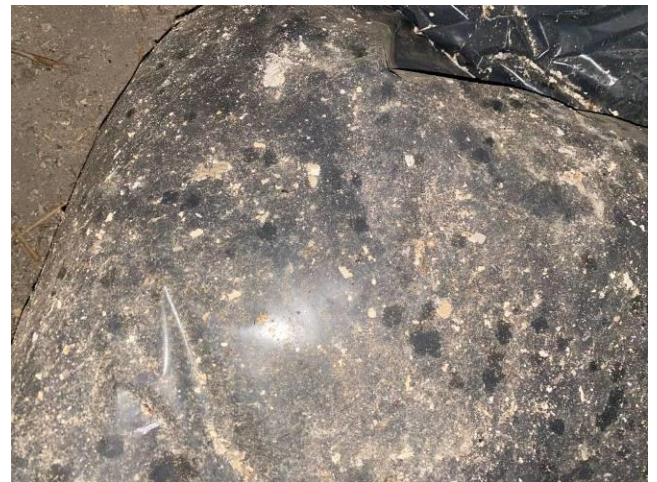
*Urine stains in south section of farmhouse roof space*

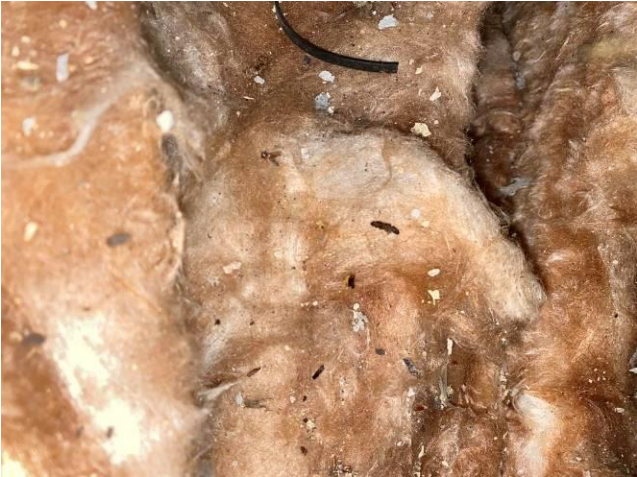
*Bat dropping in north section of farmhouse roof space*

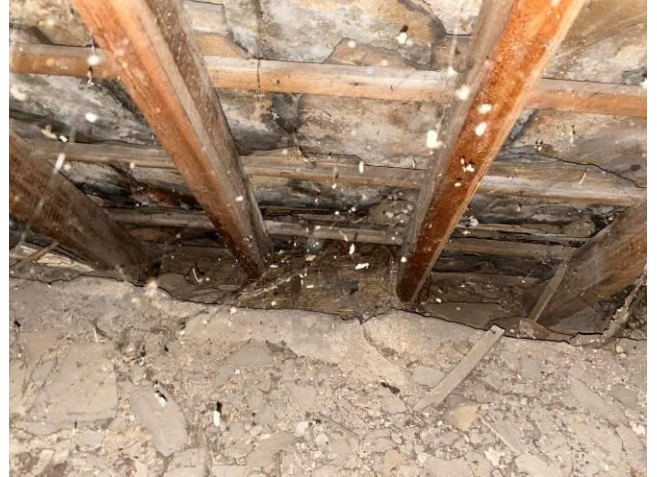
No evidence of barn owls was found in the buildings, with only an old bird nest present in the south section of the roof space of the farmhouse.

*Bird nest in south section of farmhouse roof space*

As nesting birds are protected by law under The Wildlife and Countryside Act 1981, a check for nesting birds should be undertaken prior to building work commencing. If an active nest is found, work must cease and an appropriate sized buffer established around the nest. The buffer must remain intact until it has been confirmed that the young have fledged and the nest is no longer in use.
