Initial Bat Scoping Report

6 Grange Terrace

Whorlton

December 2022

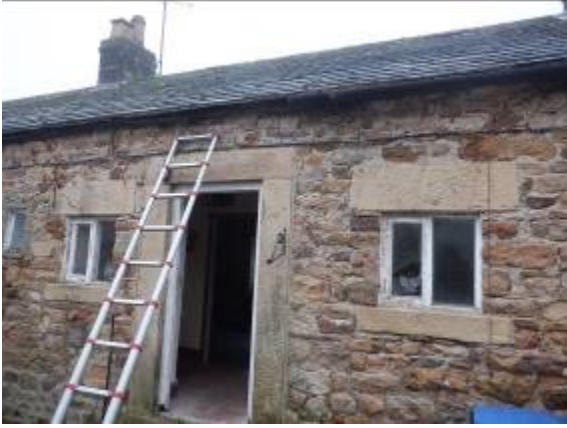
<p>House: East (rear) elevation. Pointing in good condition</p>	<p>House: East (rear) elevation. Roof tiles in good condition.</p>

- All brick work and pointing were in good condition with no gaps or holes suitable for bats observed as a result of displaced masonry or mortar.
- All roof and ridge tiles were in good condition with no missing or displaced tiles.

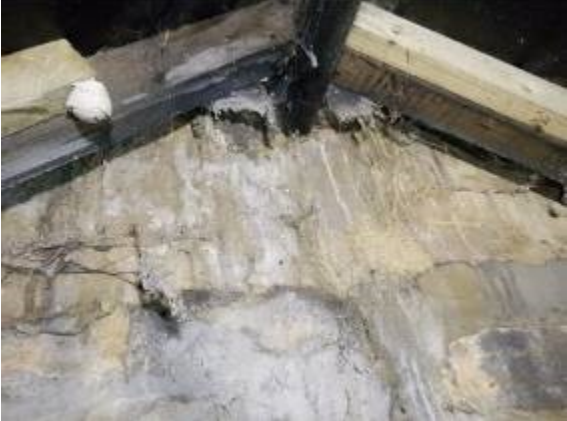
<p>Roof void. North internal wall with dense accumulations of webs and dust</p>	<p>Roof void. South internal wall with dense accumulations of webs and dust</p>

- The roof void was un-converted with a bitumen felt roof lining.
- The masonry, pointing and timber roof frame was in good condition with no gaps, holes or cracks suitable for bats observed.
- The ridge beams and gaps between the gable end rafters and internal walls were inspected and were clogged with dense accumulations of webs and dust and considered unsuitable for bats.
