PARSONAGE FARMHOUSE, CHRISHALL, ESSEX

Heritage Assessment & Conservation Plan

6 •XII • 22

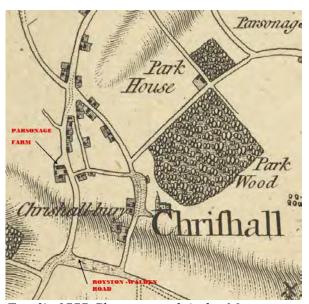
Fig. 3\; 1777 Chapman and Andre Map

The house is shown on Chapman and Andre's map with three outbuildings around a yard entered from the north. On the Verron survey for the OS, the northern barn appears as two structures but essentially confirms the 1777 layout. The extent of Broad Green to the north is evident on Verron and omitted on the Chapman and Andre map.

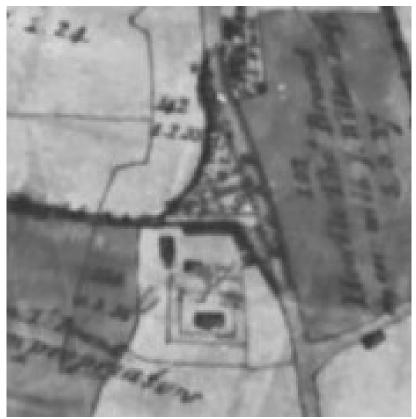
Fig 5 - 1808 Inclosure map

The 1808 map confirms the data on the C18 maps while the 1856 has almost no detail. The former shows the house with projecting bay and no eastern extension, and buildings to the north, west and east. A little square building is shown just north of the house too. The map is a photo so cannot be trusted for scale. The house appears much closer to the south side of the island than it is today but the moat and island are clearly drawn too large for the farmyard plot whose shape presumably has remained the same over the following 200 years.

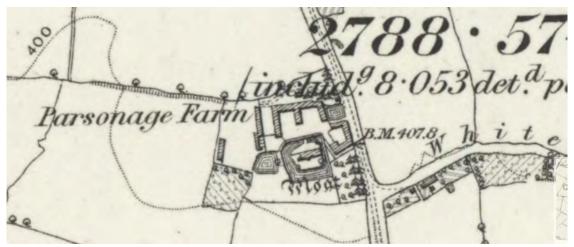
Fig. 7 -1876 six inch OS

The 1876 first edition 6" OS map shows the farm has been redeveloped. The eastern outbuilding is gone and the northern barn appears to have been rebuilt with three southern limbs which survive today without their parent structure. The NW building looks to have been rebuilt and extended too. The triangular entrance on the 1777 map is confirmed on the north side and Broad Green is absent. The farm is entered from the north *and* the east. A pond is shown to the west of the moat and another to the roadside to the east.

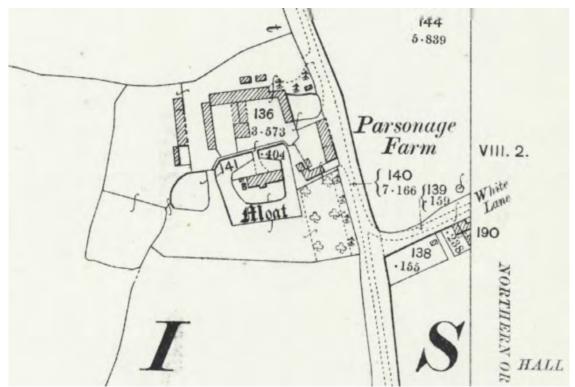
Fig. 8 - 1896 25inch OS

The house is about the same in 1896 with an orchard to the east of the moat and a couple of outbuildings to the west, one of which was demolished by 1919. The later map shows the orchard extended to the south of the moat. A small enclosure sits on the site of the current boiler house on the SE of the house. The narrow, south bridge has been built by 1919.

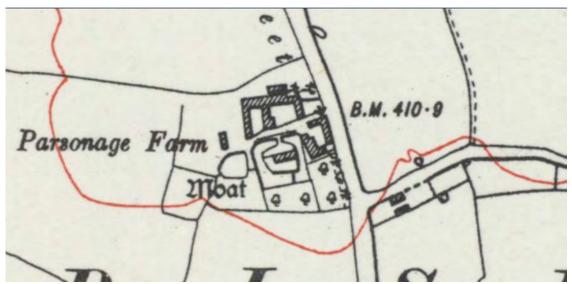
Fig. 10 - 1938 6 inch map

The projecting bay is not shown on the 1938 or 1946 maps but that does not necessarily mean that it was not there. No map records the fact that he east extension projects past the line of the north elevation. The bulk of the NW farm building was demolished by 1938 ad the southern orchard was gone by 1946.

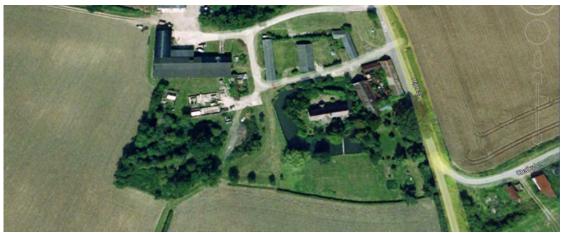
Fig. 12 – 2000 aerial photo

The house's west pond has become a hedge and copse by the time of the 2000 aerial photo.

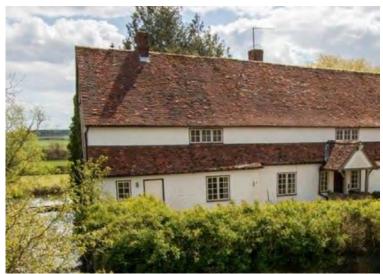
Fig. 13 - Front (north) Elevation and moat

The building is an unusual two-storey, three room, single pile, wood, plaster and tiled house with a full-length side lean-to on the long north (entry) front, brick gables and a motley collection of brick elevations on the south side which also has a full-height projecting brick bay. It sits on a once square island surrounded by a C15 moat, approached by a modest brick bridge to the north.

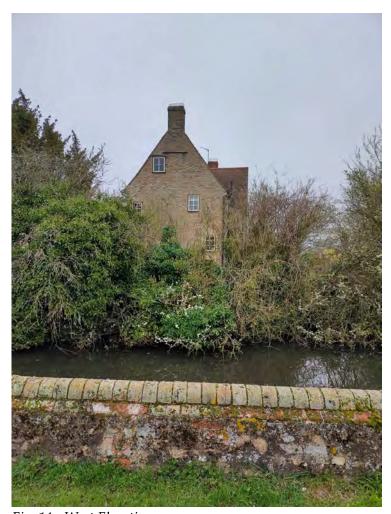
Fig. 14 - West Elevation

Eighteenth century in appearance, the house was extended to the west in the C19 as far as the revetment of the moat, single-storey at first and later raised to the full height of the C18 house to give the third room to the plan form. The list entry says that the building was originally a C15 manor house which may have been a two-room arrangement to which an eastern axial chimney was added in the C16. A large C16 inglenook certainly remains in the east gable even though it has been overclad in an C18 mottled Cambridge white brick.

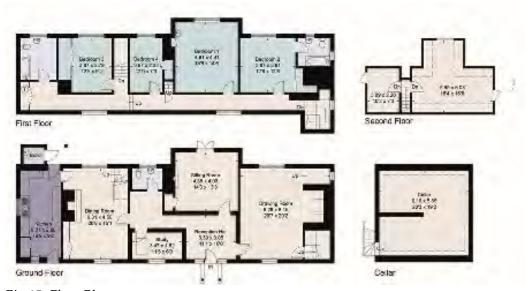
Fig 15: Floor Plans

Generally, the house has a 1950s air, overlaid onto an historic interior. A late C17/ early C18 newel stair remains next to the chimney and the C16 drawing room ceiling timbers add to the history despite alterations. Most walls sport exposed stud work, not all of which looks authentic.

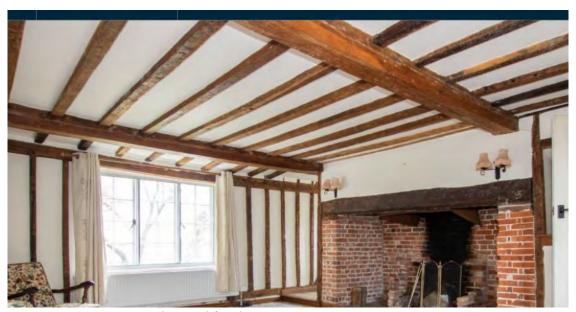
Fig 16: Drawing Room ceiling and fireplace

The interior retains some panelled doors of the early C19 and the Drawing Room beams and joists and part of its C16 inglenook.

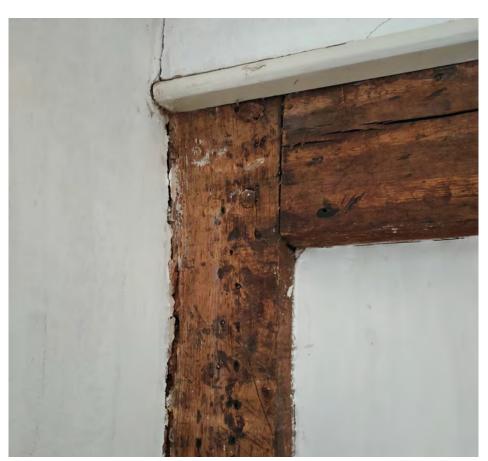
Fig 20 – Junction of principal corner post and FF beam in Dining Room

The principal form of the original house appears to be an oak box frame with a 'lid' of rafters, single pile and of two rooms (the current western 2/3 of the house). The brick plinth and wall plate of the west wall of the dining room supports the theory that this was the outside (east) wall of the house and the kitchen and dining room were added later. The mapping of 1808 confirms this. The two storey frame is visible in the two principal posts in this old east wall (the south one intact, the north one cut for later leanto) and in the west wall adjacent to the newel stair.

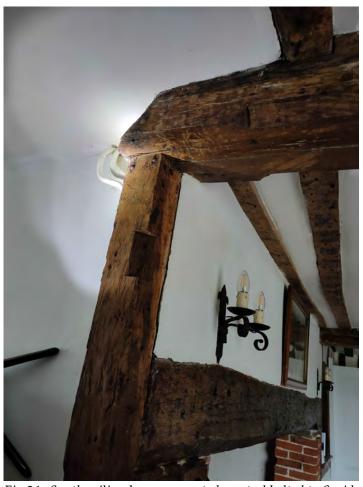
Fig 21 -South ceiling beam supported on stud bolted to S. side of inglenook- no hands tech!

The evidence of the structure suggests that the earliest parts of the building date to the late C16 and this is consistent with the general period of national rebuilding identified by Hoskins and others. The Drawing Room ceiling has a late C16 beam with ogee stop chamfer, and floor joists tenoned into its side. The inglenook fireplace also has C16 brickwork. Both are altered. The ceiling appears to have been relocated northward when the building was widened to the north and a further (reused) beam added on the south side. The fireplace has a later brick pier and a reused C17(?) beam as its bressummer. The joists are reused and were plastered; some are moulded. There is no indication of where the stair may have risen as the other floors are all C18 or later.

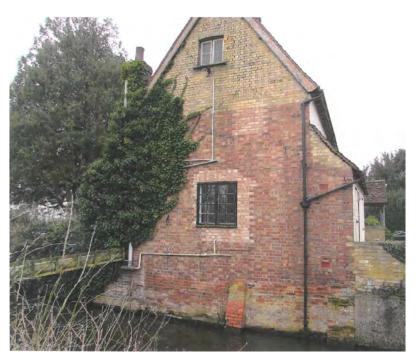
The east side of the house is of solid 9" brick construction raised on the moat revetment to a single storey and subsequently elevated to two storeys, possibly after WWII as much of the exposed structure is of flettons.

Fig. 22 East Elevation – C20 whites on Victorian reds on C18(?) revetment

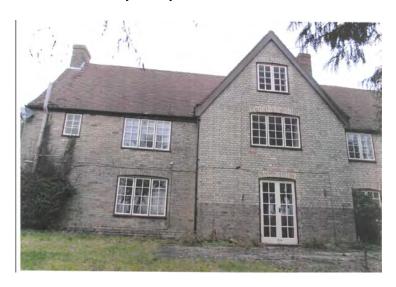
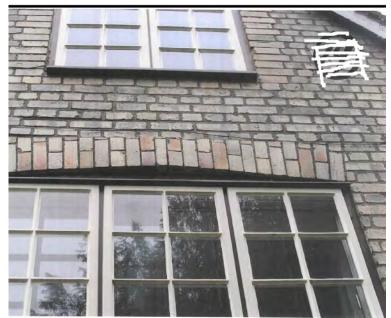
All the windows are 1980s style storm casements from John Carr or similar. Notably, all the window openings appear to be C20. Evidence of infilled windows even exists in the front FF timber wall. But the south bay is typical with the new fenestration crashed into older fabric, farmyard style.

Fig 23 a;b - South Elevation details showing new window openings
