## ***The Grange, West Pennard***

**Bat & Bird Scoping Report**

**Date: July 2022**

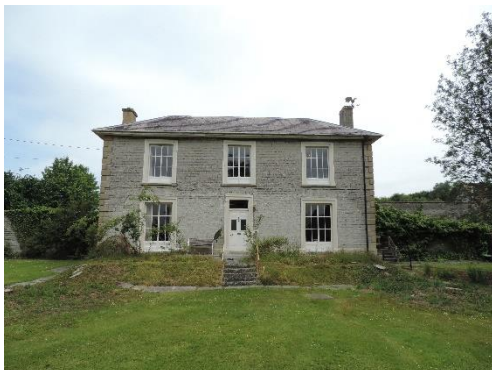
**Plate 1: The Grange (viewed from north)**

The Grange was a large, detached two-storey residential property (Plate 1); there was also a single-storey extension to the south (Plate 2) and a porch to the east. The walls were constructed from stone and were in good condition, lacking any cracks or crevices. Intact doors and windows were found throughout. The two-storey section included large wooden soffits, which were damaged in part and included gaps behind them (Plate 3). The roof over the two-storey section included pitched and hipped sections both of which were clad in slate. Several slipped slates were noted (Plate 4). The roof over single-storey extension was pitched and clad in double-roman tiles; two skylights were present. This roof was in good condition and lacked any slipped, raised or missing tiles. The roof over the porch was hipped and clad in slate; again, a skylight window was present.

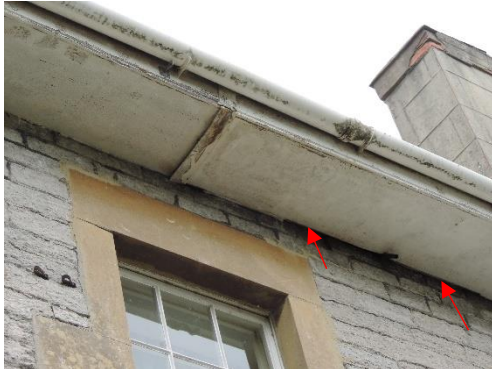
**Plate 3: Example of Gaps Behind Soffit Box**

Potential access points and external roost locations included behind the soffit boxes and beneath slipped tiles.

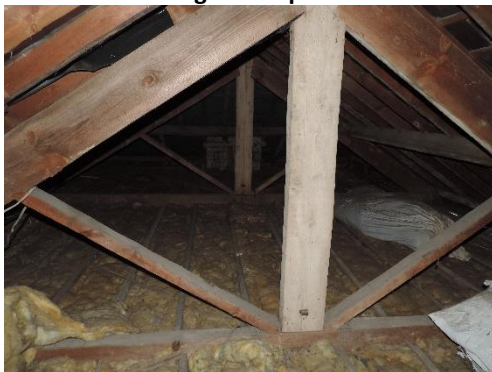
**Plate 5: The Grange Loft Space**

Internally, The Grange contained a single loft void, which measured c. 14 m (L) x 6.5 m (W) x 2 m (H) (Plate 5). Part of the roof was lined with bitumastic felt (northernmost pitch) and part unlined (southernmost pitch). The roof was supported by a sealed wooden frame. The floor was covered with fibreglass insulation. Daylight could be seen coming from gaps at the eaves.

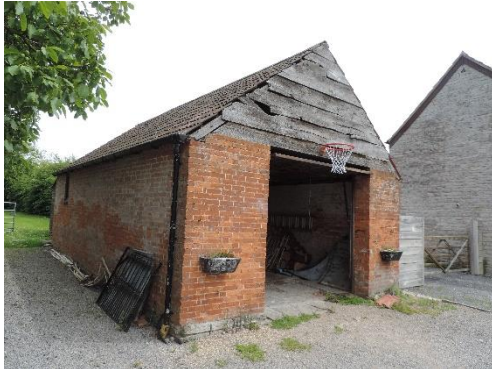
Plate 7: The Garage (western aspect)

The Garage was constructed from red brick with single-skin wooden weather boarding on its west-facing gable (Plates 7 & 8). Whilst the external walls were in a good condition, the weather boarding included large gaps. Further gaps were present at the wall tops throughout the Garage. The roof was pitched and clad in pan tiles; many of the ridge and roof tiles were raised, slipped or missing (Plates 9 & 10).

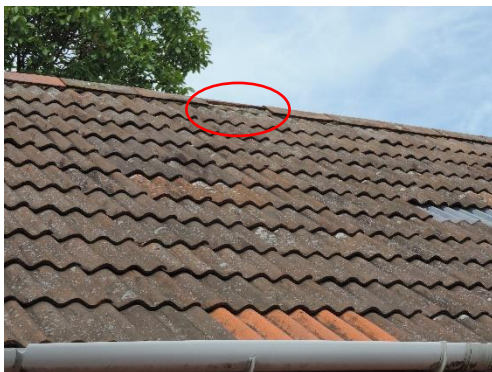
Plate 9: Example of Damaged Ridge Tile

Internally, the roof was lined with bitumen felt that was torn in places. An open chimney was located within the Garage; this was inspected and no signs of bats were recorded. No bat droppings were recorded; however, the Garage included features that could not be fully inspected (i.e. beneath ridge and roof tiles). Accordingly, the Garage was assessed as having Moderate Bat Roost Potential.

As all bat roosts are protected from damage by domestic law (see Section 1.2), it is important to establish presence / likely absence prior to submitting a planning application. To this end, further surveys will be required. For High potential buildings (i.e. The Grange), a minimum of three dusk emergence surveys will be required (Collins, 2016; BCT, 2022). Each survey should comprise a minimum of three surveyors to provide adequate coverage of the property. Moderate potential buildings (i.e. The Garage) will require two emergence surveys with a third only being required if bats are recorded emerging from the building. As the long-eared bats emerge later in the evening and do not always echolocate on emergence, the use of IR equipment is recommended. The surveys should be undertaken between May and August and ideally spaced apart by a minimum of two weeks.
