Ecological Impact Assessment and Bat Survey

THE DALE, ALLENDALE NORTHUMBERLAND

Summer 2022

Ecological Impact Assessment for The Dale, Allendale, Northumberland

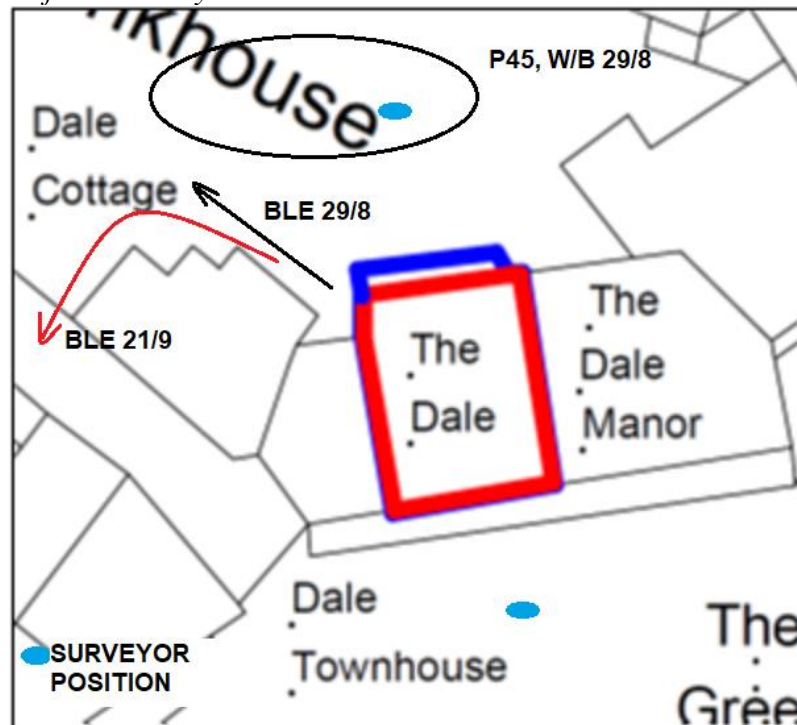
Figure 5. Plan of Bat activity

The emergence surveys confirmed bat emergence from the building gable wall with a single Brown long-eared seen emerging. Foraging or commuting Pipistrelle 45kHz bats, Noctule and a whiskered/Brandt's bat were heard or seen. No bats were heard or seen from the Market Place side, possibly due to the that area being well illuminated. The dawn survey did not identify any bats entering the building with Pipistrelle 45kHz bats heard social calling intermittently plus whiskered/Brandt's and a Daubenton's bat was also heard. Please see Appendix 2 for detail.

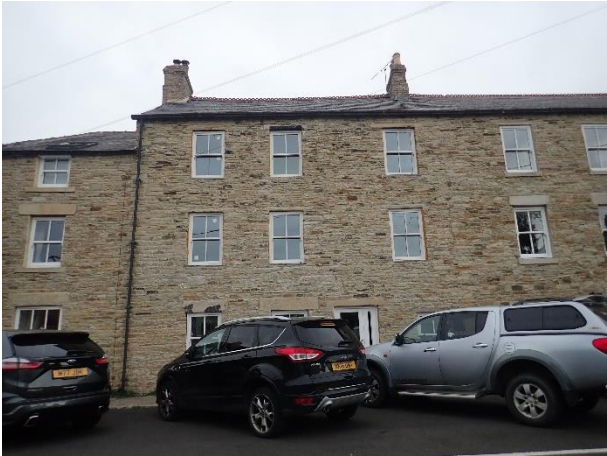
From the north, note open access windows

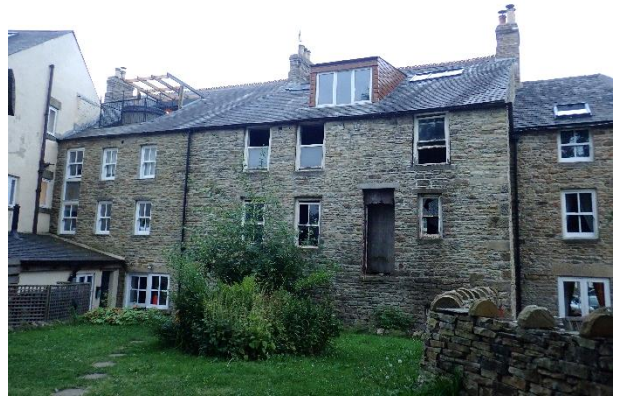
The former Dale Hotel from the south

Access to ground floor only

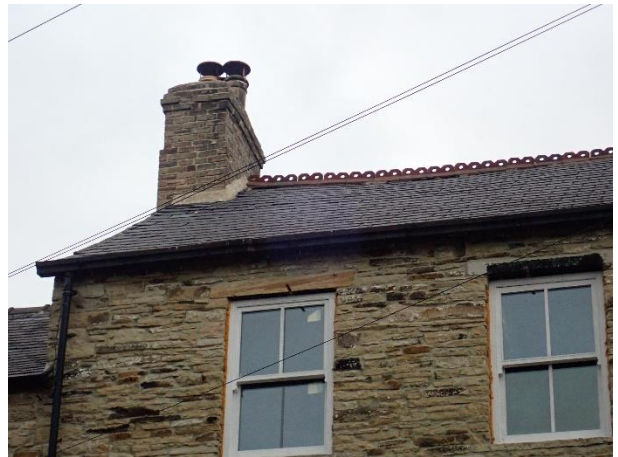
Roof of the north aspect

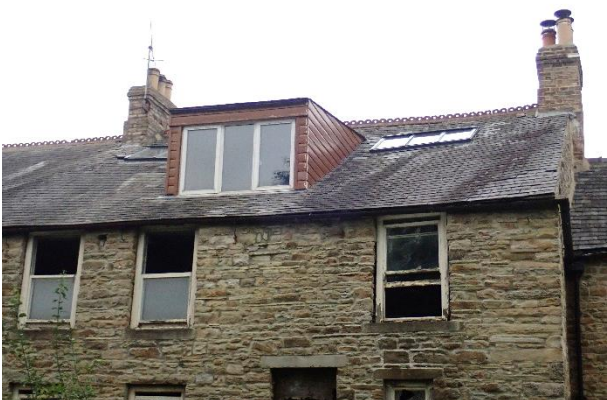
West gable showing raised slate – to be retained as at present

One day roost will be retained as at present on the west gable wall top as at present. This will be in the form of an external crevice which will be created to provide a roosting site for crevice-loving bats. This will be in the form of an access gap measuring 20mm by at least 20mm created between the slates and the gable wall top through the mortar fillet into a larger crevice on the wall top below the watertable, resembling a 'flattened bottle' measuring at least 100 x c.200 x 20mm. This provides a small space that acts as a suitable bat roost for the occasional bat. Please see Appendix 3 for detail and plan at Fig. 7 for location. No bat access to the breathable membrane to be allowed.

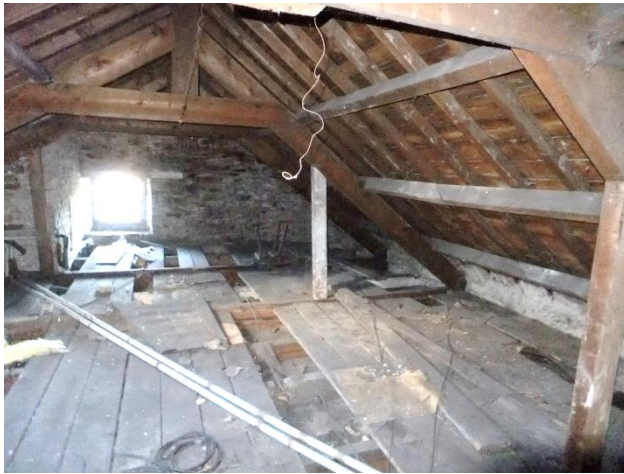
Photograph of the loft area showing wooden sarking (from 2011 report R Hadden)
