Our Ref: TH/B501/1222

**Re: Egremont Barns, Payhembury – Effect of Proposed Development on Trees**

This covering letter provides a full Arboricultural Impact Assessment in addition to a detailed Tree Protection Statement; the specific tree protection details are contained within the attached Tree Protection Plan, Arboricultural Method Statement and Arboricultural Guidance Sheets.

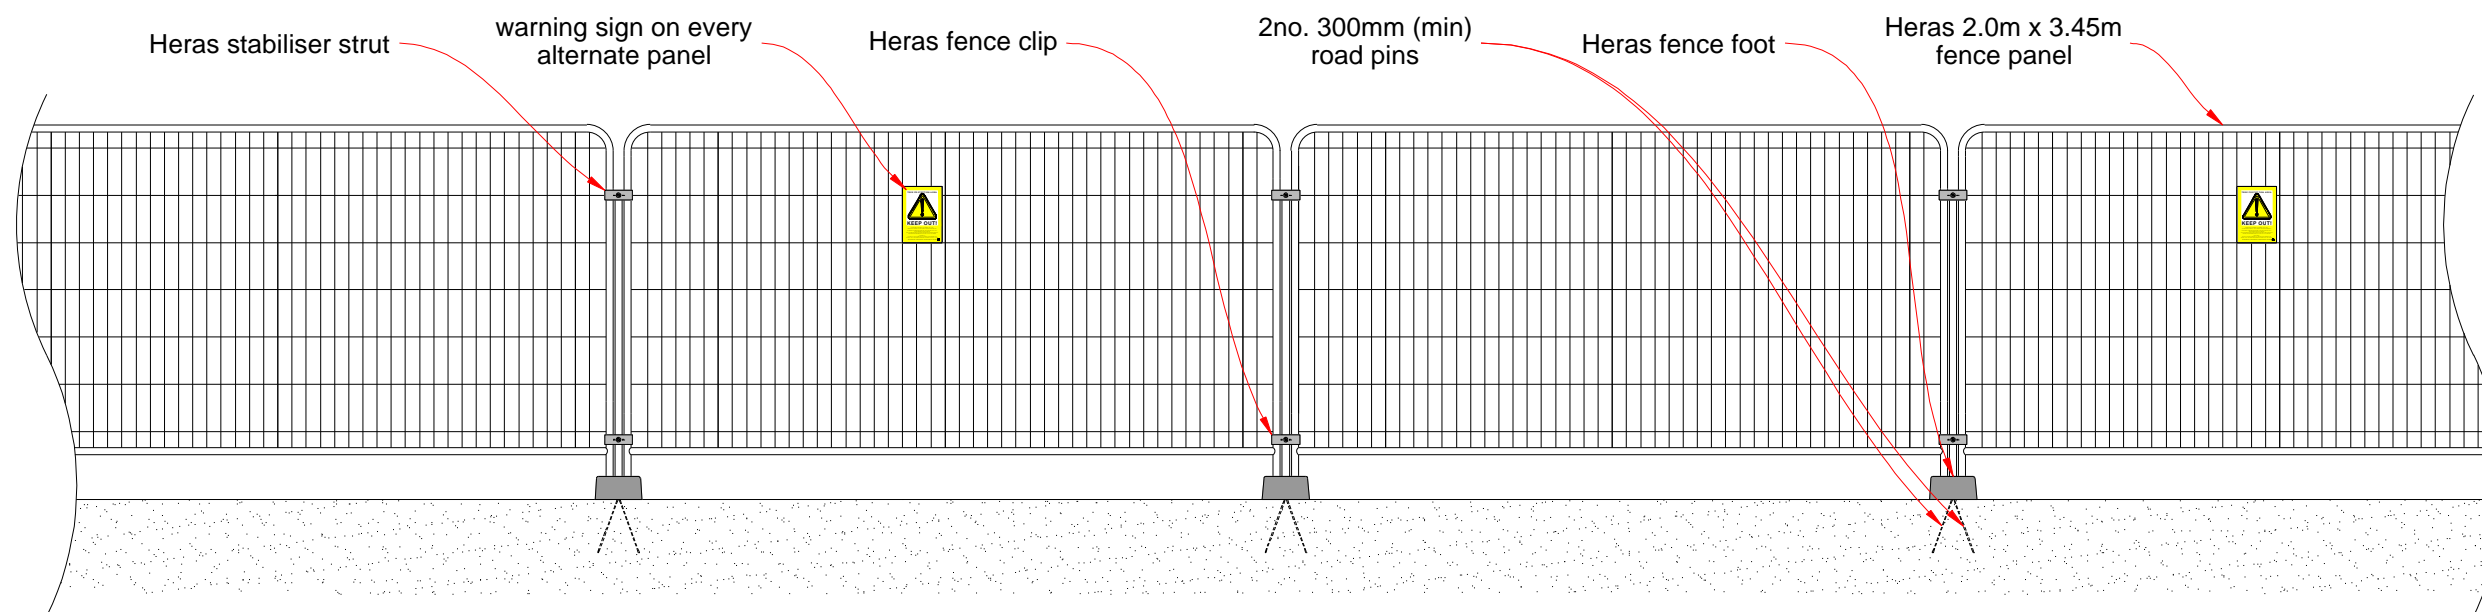
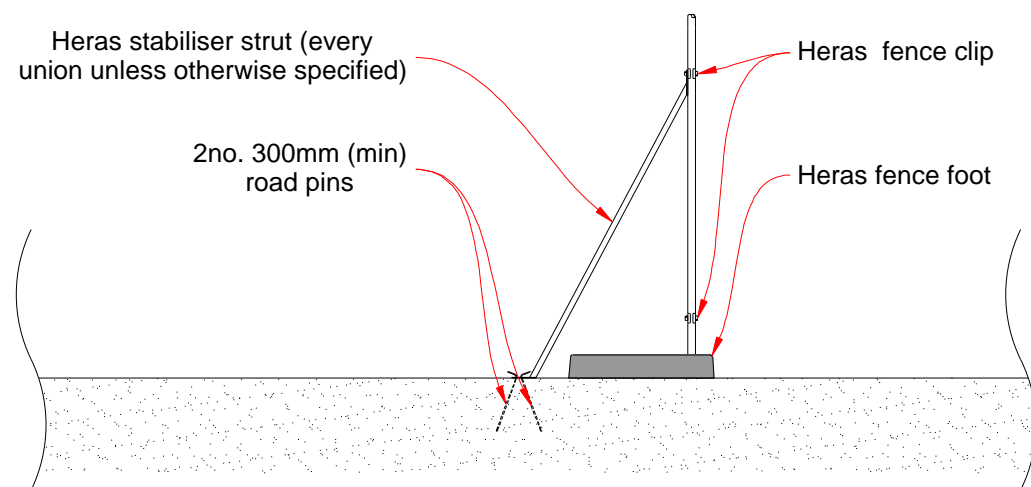
**Back Bracing Cross Section (for use where road pins may be driven into the ground)**

- Where it is not possible to use road pins due to hard surfacing or the presence of underground services, a Heras block tray may be used with a minimum of 10kg of ballast (concrete blocks, metal weights or sandbags).

Protective fencing is a key element of the tree protection measures for this project. This comprises 46 braced Heras panels (see Arboricultural Guidance Sheet AGS101 attached); the specification for these matches the specification detailed within British Standard 5837:2012. There may be instances on site where it is desirable to substitute braced Heras fencing with site hoarding; the specification for the hoarding and the method statement for its construction must be approved prior to installation by the arboricultural supervisor.
