Heritage Impact Assessment

MILL HOUSE  
BADLEY

Michael Collins  
December 2022

Listed Building Planning Consultant  
PO Box 383 Eye Suffolk IP23 9AN

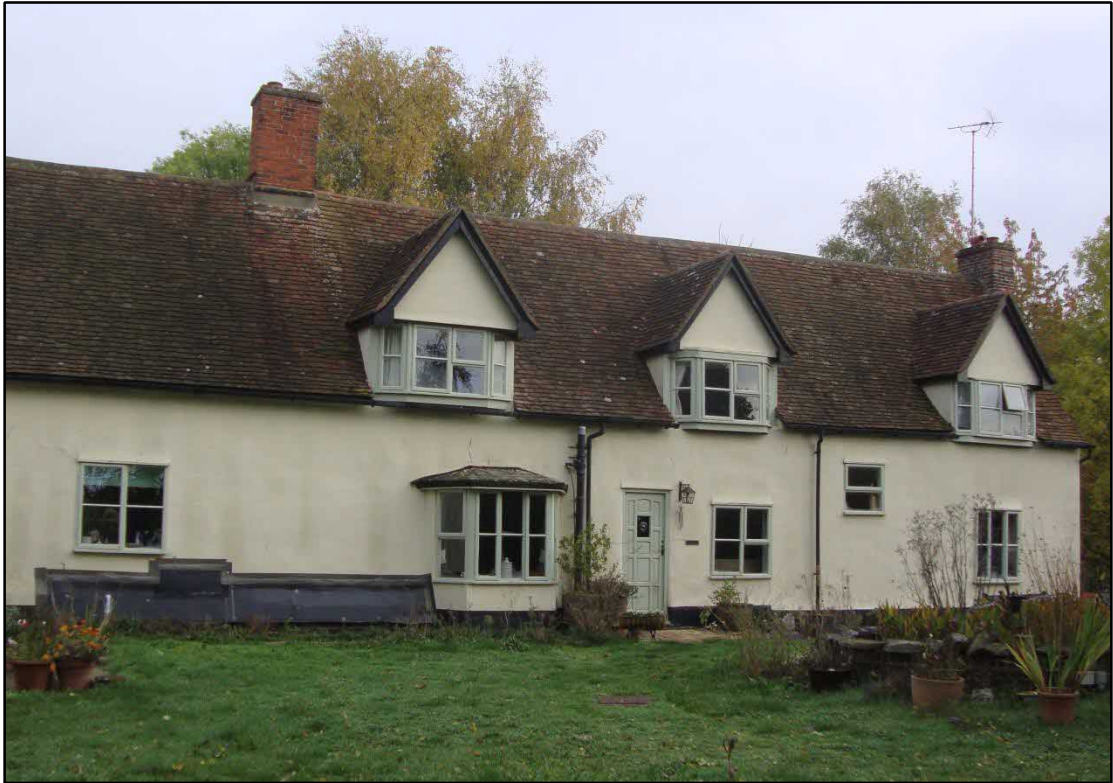
Fig.1 Mill House (south-west)

Mill House. 09.12.1955. II. House; former mill house. C17 with alterations of C18 and c.1980. One storey and attics. Three-cell plan; a further cell added to right in C18. Timber-framed and plastered, on a plinth of tarred red brick. Gabled plain-tiled casement dormers. Casements and panelled entrance door of c.1980. Typical unmoulded C17 framing with on-edge floor joists. An open fireplace in the hall has a large reused cambered lintel. An C18 extension to right has a cellar beneath it with fine deeply roll-moulded ceiling joists and beams of early C16. They correspond with similar beams above the cross passage at Badley Hall, whose open hall and parlour range was demolished and the components sold off in 1759 (NHLE ref. 1231092).

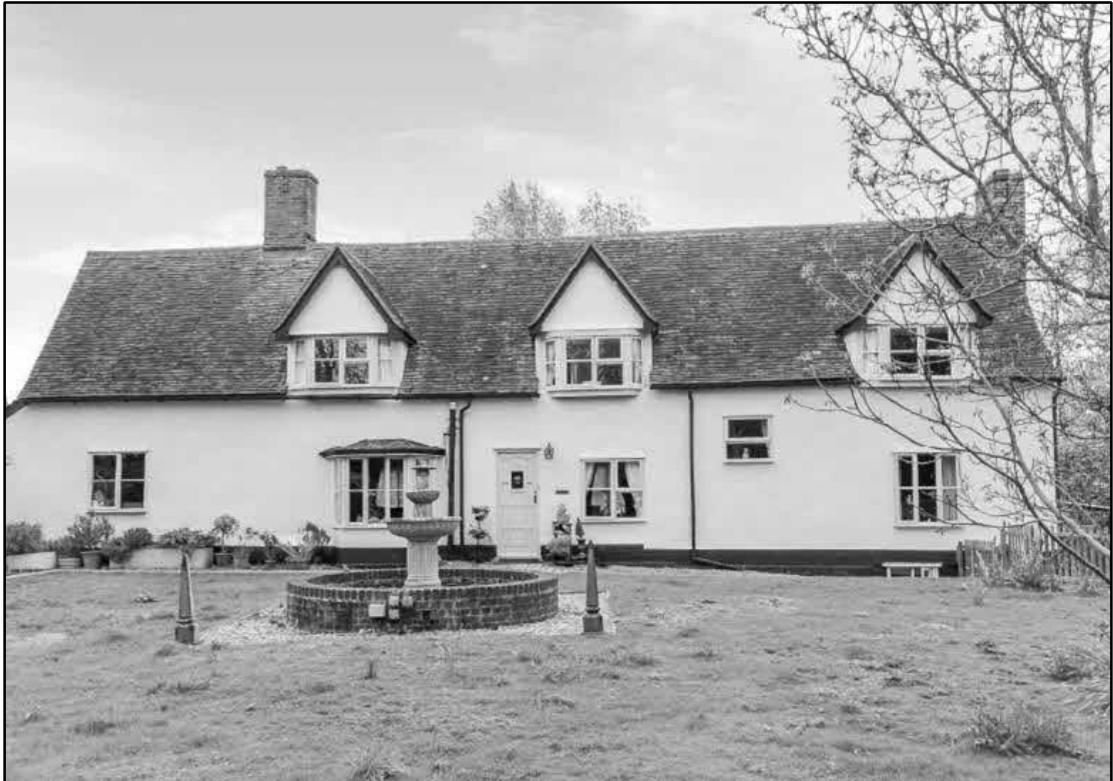
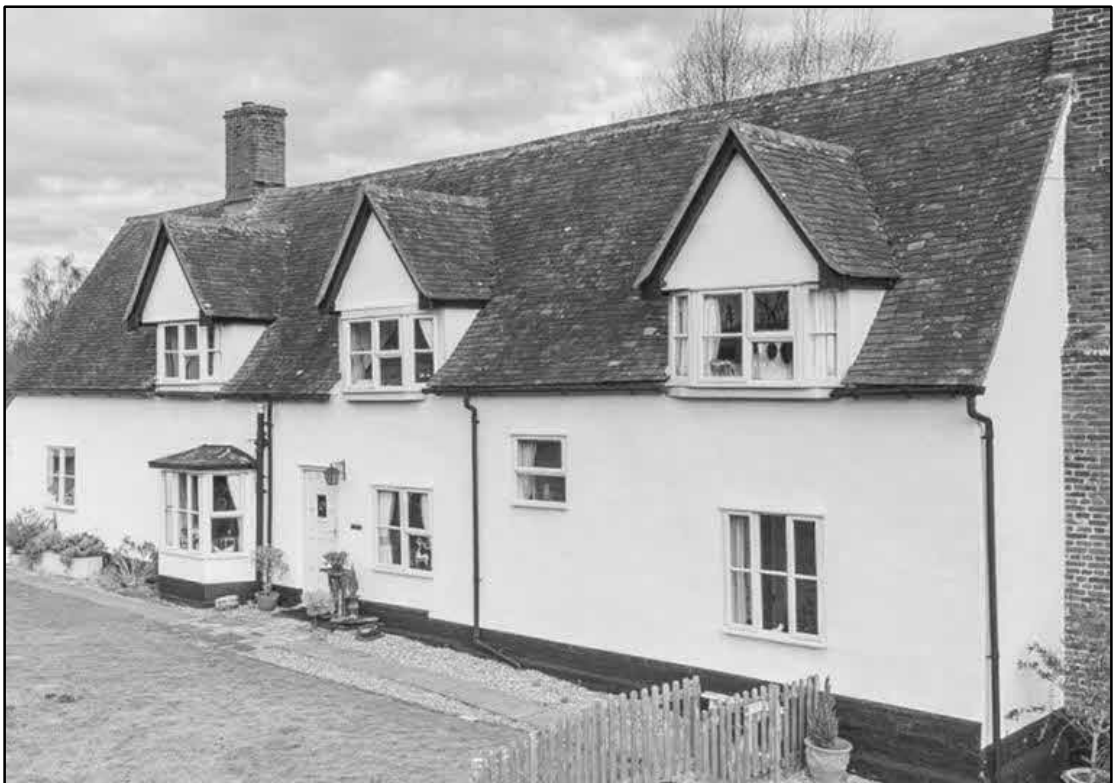
Fig .38 Mill House as *restored* in early 1980s

Fig.39 Mill House as *restored* in early 1980s

- 048 *Mill House was restored* in the early 1980s and in a manner which would be regarded today as having a negative impact on significance. The property has new owners and it is widely recognised that a change in ownership can often present an opportunity for significance to be enhanced. Listed building consent is sought for the replacement of the external cladding (render), together with repairs to the timber-frame and to the infill panels. Listed building consent is also sought for the replacement of external doors and windows within their existing openings, including the reconstruction of a pair of dormer windows. Planning permission is sought for the construction of a new outbuilding within the grounds of the house.

- 051 The *restoration* of *Mill House* in the early 1980s included the replacement of the external cladding of the timber-framed building with a cement-based render. It is proposed to replace this cladding with lime render on a backing of timber laths. The removal of the modern render will present an opportunity to assess the condition of the concealed structure of the timber-framed building and to undertake any necessary repairs.

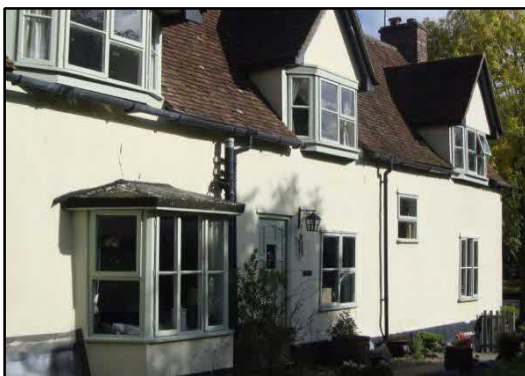
Fig.41 South-west elevation

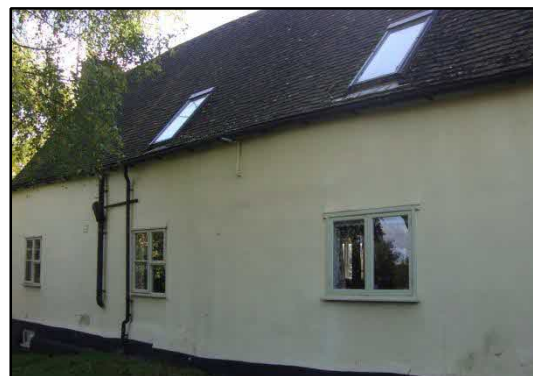
Fig.42 North-east elevation

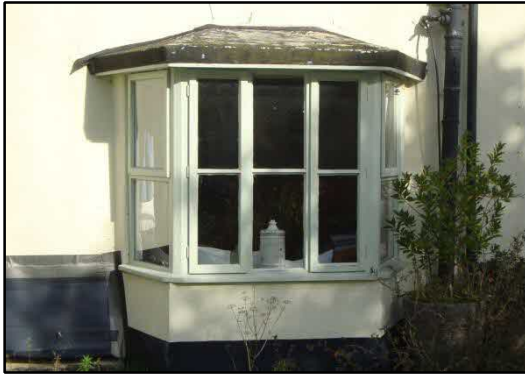
Fig.43 Window 03

- 058 The proposed work includes the provision of a tiled roof above the canted bay window and the reinstatement of a small-paned sash window to this addition. It is also proposed to remove a pair of roof-lights that were inserted in the rear roof-slope in the 1980s. The roof-lights replaced a pair of small flat-roofed dormers as is evident from a photograph taken in the early 1980s (fig.33). The roof-lights used the previous openings and it is similarly proposed to reconstruct the pair of dormer windows in their former position. The pair of windows in the cellar will be retained in their existing form.

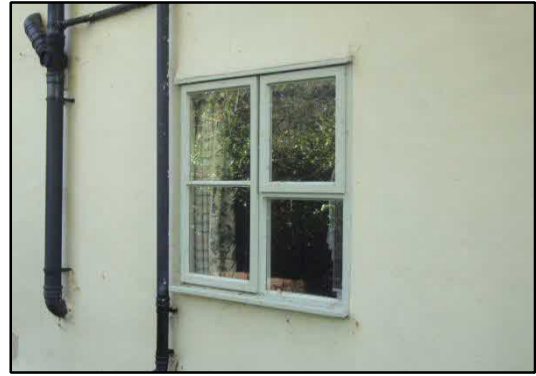
Fig.44 Window 13

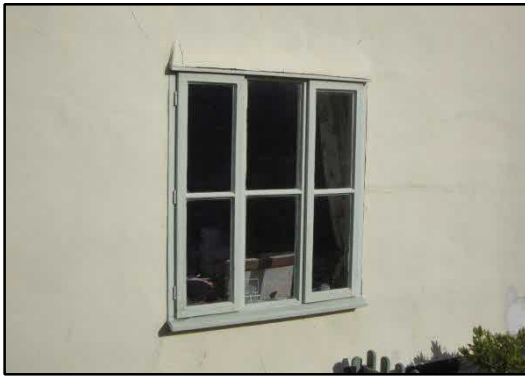
Fig.45 Window 07

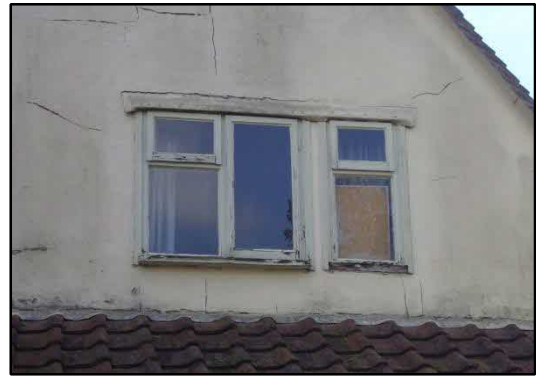
Fig.46 Windows 24 and 25

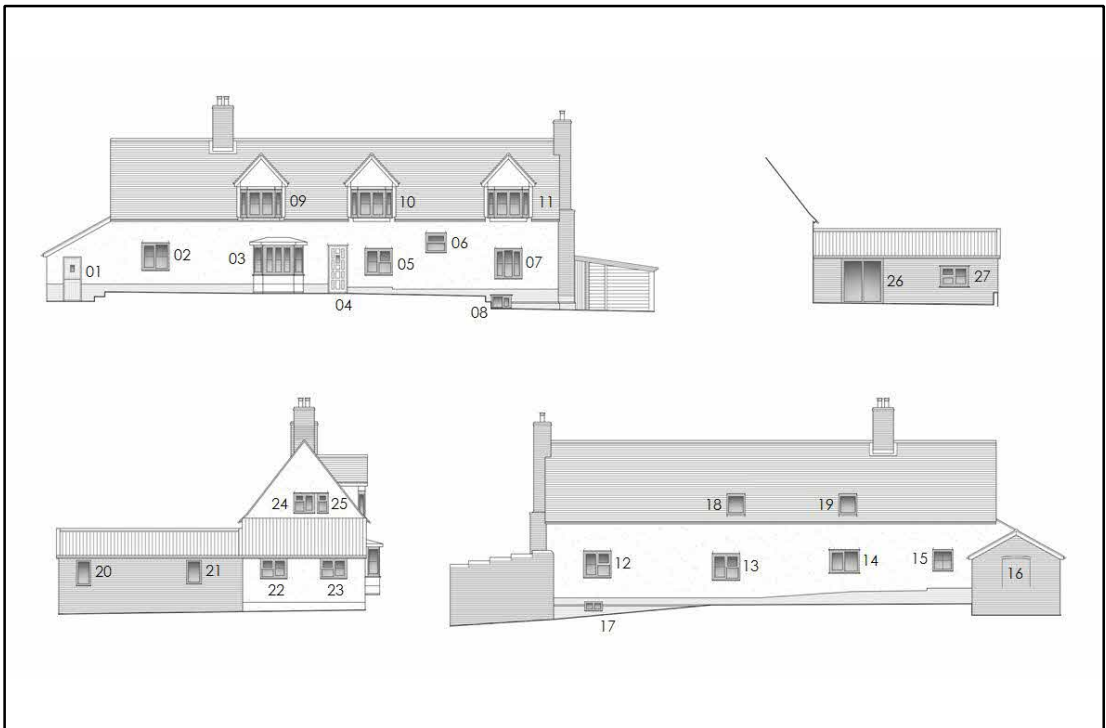
Fig.47 Existing openings (*Tim Moll Architecture*)

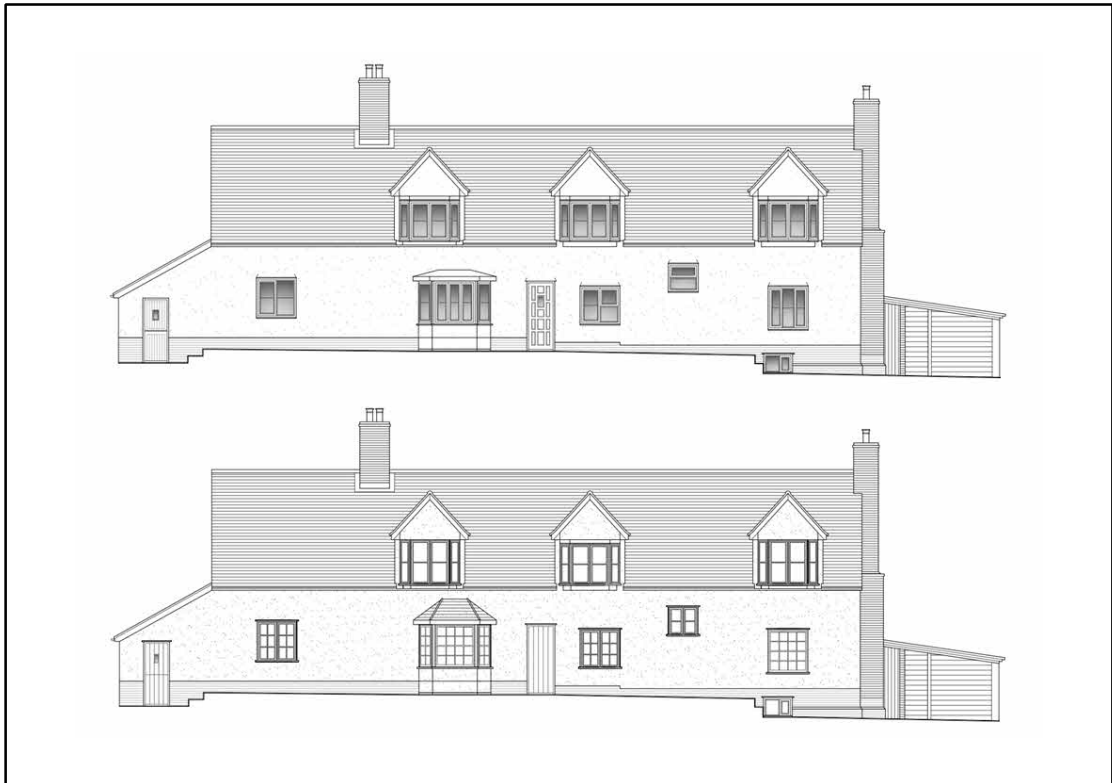
Fig .48 Proposed alterations to south-west elevation (*Tim Moll Architecture*)

- 057 It is therefore proposed to replace these windows with new windows of a sympathetic historic pattern. The proposed design of the replacement windows is based on the character of the building and on an understanding of the historic treatment of each opening. The windows will also incorporate slim-profile double-glazing.

- 059 The main entrance door to the house is located on the south-west front of the building. A second door is located in the lean-to at the north-west end of the building. It is proposed to replace both of these doors which are modern and of an inappropriate design. It is also proposed to replace a pair of modern sliding doors which have been inserted on the south-east elevation of the former back kitchen.

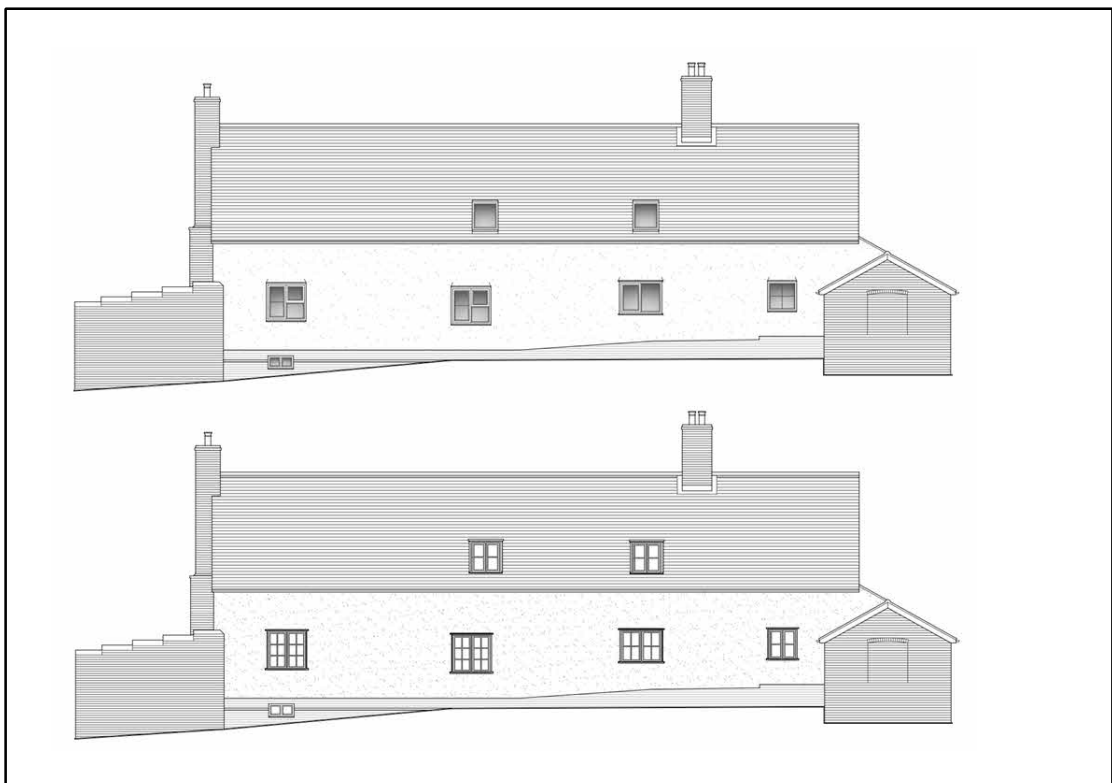
Fig.49 Proposed alterations to north-east elevation (*Tim Moll Architecture*)

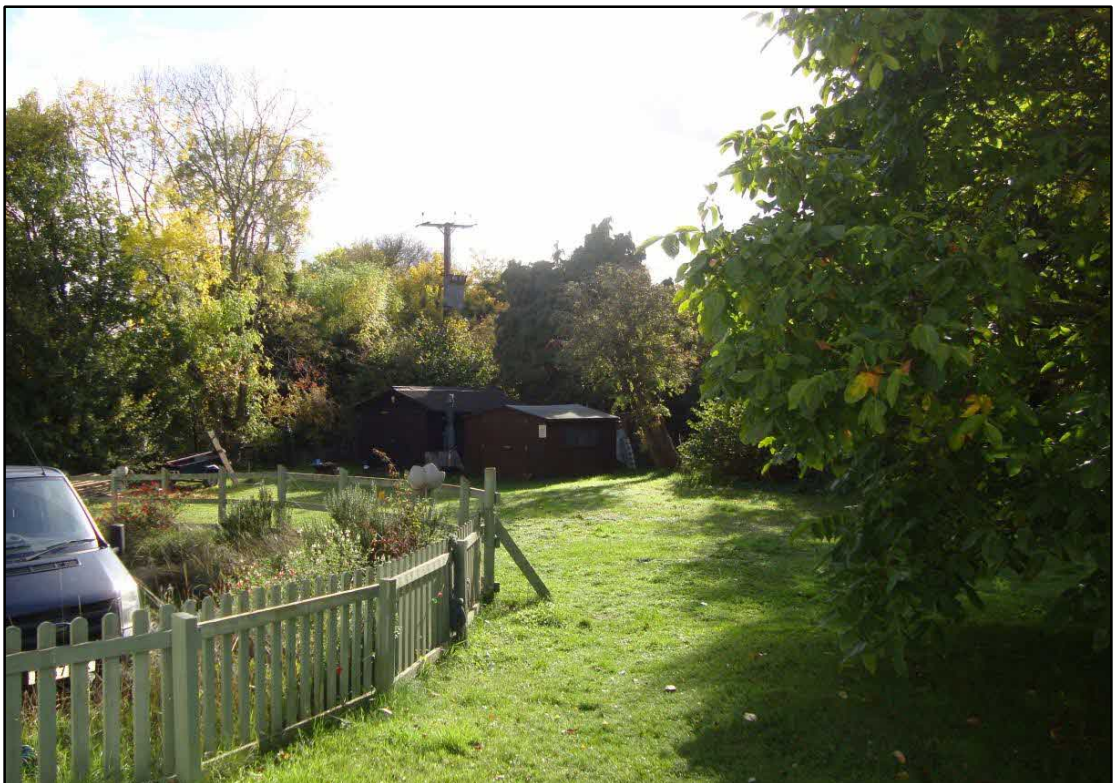
Fig .53 Proposed siting of outbuilding (replacing sheds)
