Outbuildings at
Home Farm House
Lower Street, Twywell
Northamptonshire NN14 3AH
(NGR 495274, 278233)

Historic Building Record

Listed Building Consent: NE/21/00814/LBC
HER No. ENN110642
Souterrain Project SOU22-811

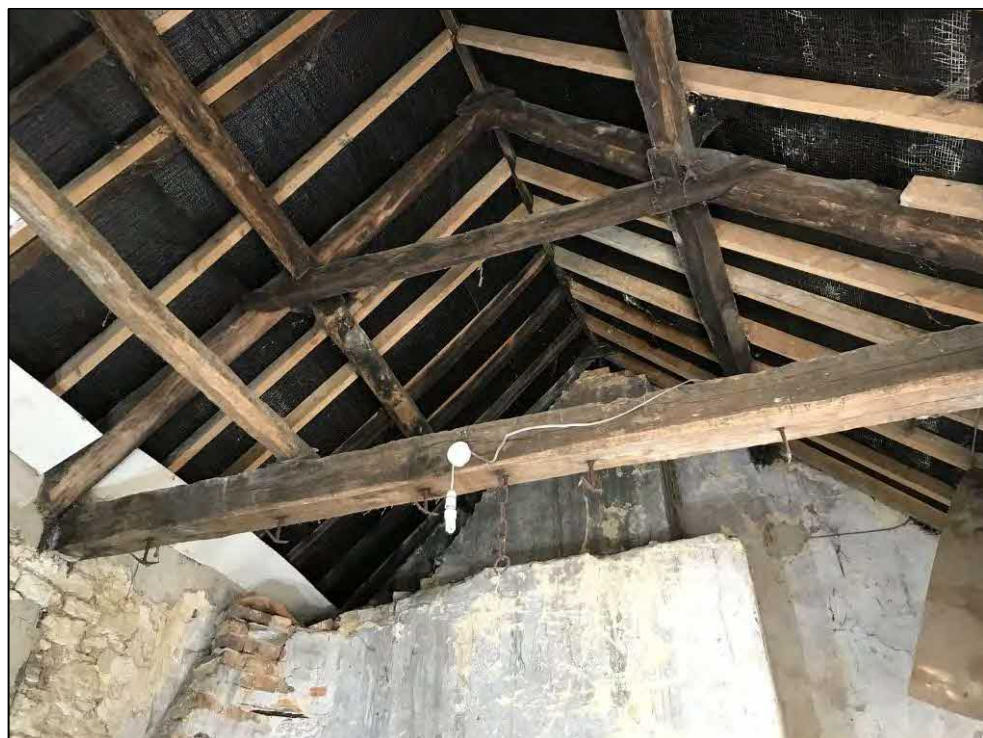
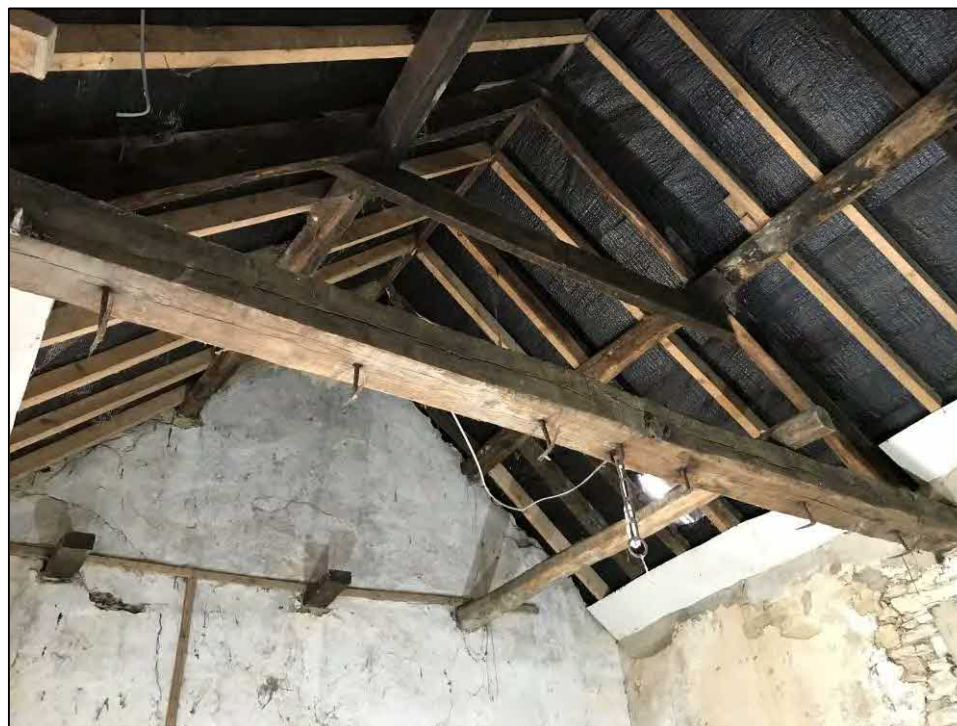
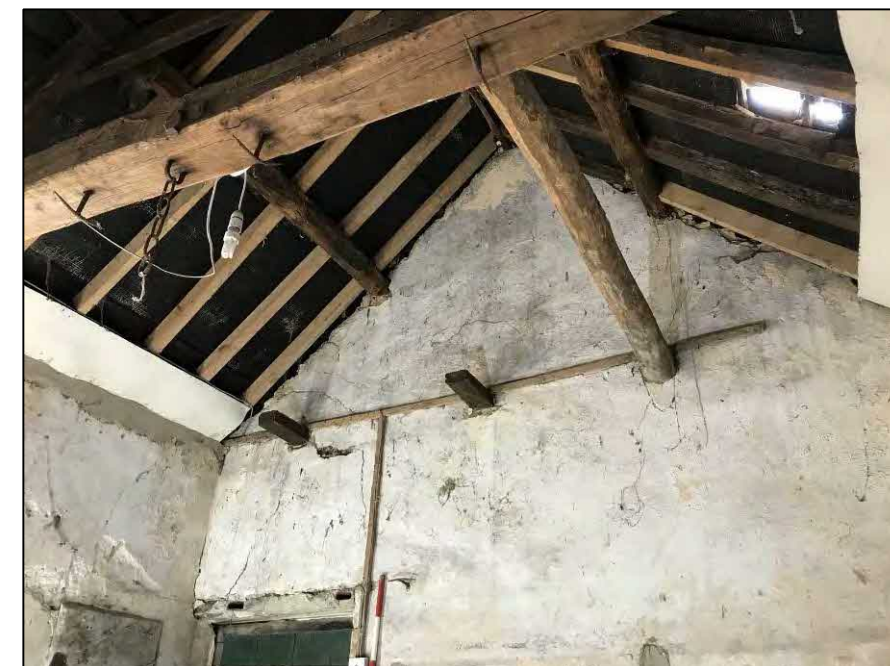
- 4.4 The building has a single-cell interior, open to the rafters [21-23], with a floor space 4.5 m x 3.91 m (c. 17.6 sq. m). The walls are rendered and lime-washed. Where the render has fallen from the west wall, two bond timbers have been exposed [25], each a piece of timber (oak) salvaged from an earlier building. Similarly, the lintel above the door is a salvaged timber with mortises [29]. The floor is constructed of irregular-shaped limestone flags, which are well-laid, tightly-fitted, and fairly level (around 52. 56 m OD) [55-60]. They were laid on directly above the geological stratum, at this point, a sandy ferruginous limestone [59-60].

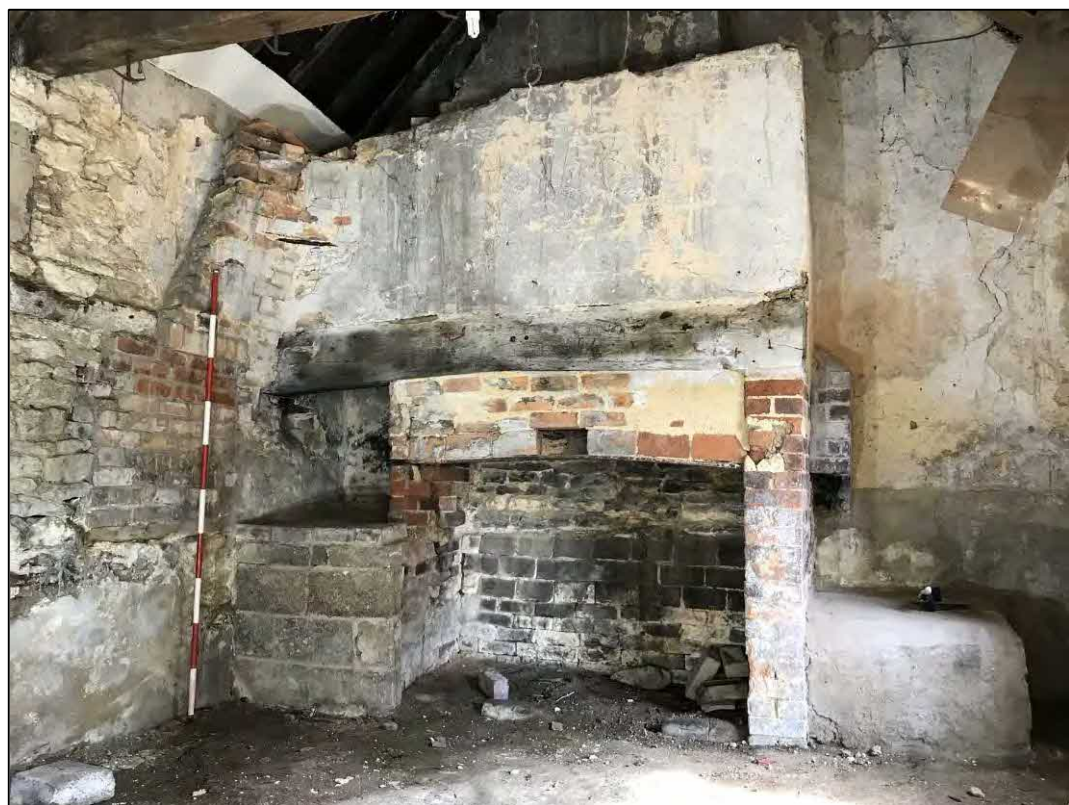
26. Outbuilding 1 interior: fireplace and chimney breast. Facing N

- 4.5 The main feature of the room is a large brick-backed fireplace / hearth [26], 2.72 m wide and 0.8 m deep, which occupies over two-thirds of the north wall. The fireplace has two identifiable phases, the first phase represented by a substantial oak lintel beam, chamfered with run-out stops [27, 31]. At its east end, the lintel rests on a 20-course-high brick wall, of double-thickness

[26], while its west end is set in the outer stone wall [31]. The chimney breast was vented on either side, one vent in the east alcove, the other through the west wall. The east alcove contains a low cement-rendered brick plinth of uncertain function. The hood and chimney breast are lime-mortar rendered and lime-washed.

- 4.6 The second phase was a fore-shortening of the fireplace. This comprised an infill of four brick courses just below the timber lintel [26]. These are supported on a cambered iron bar, the east end of which was inserted into the aforementioned brick wall, while the west end rested on a single-thickness brick wall of 14 courses. In the 20th century, the space between the latter brick wall and the west stone wall was part-in-filled with concrete blocks and slabs to create a shelf.

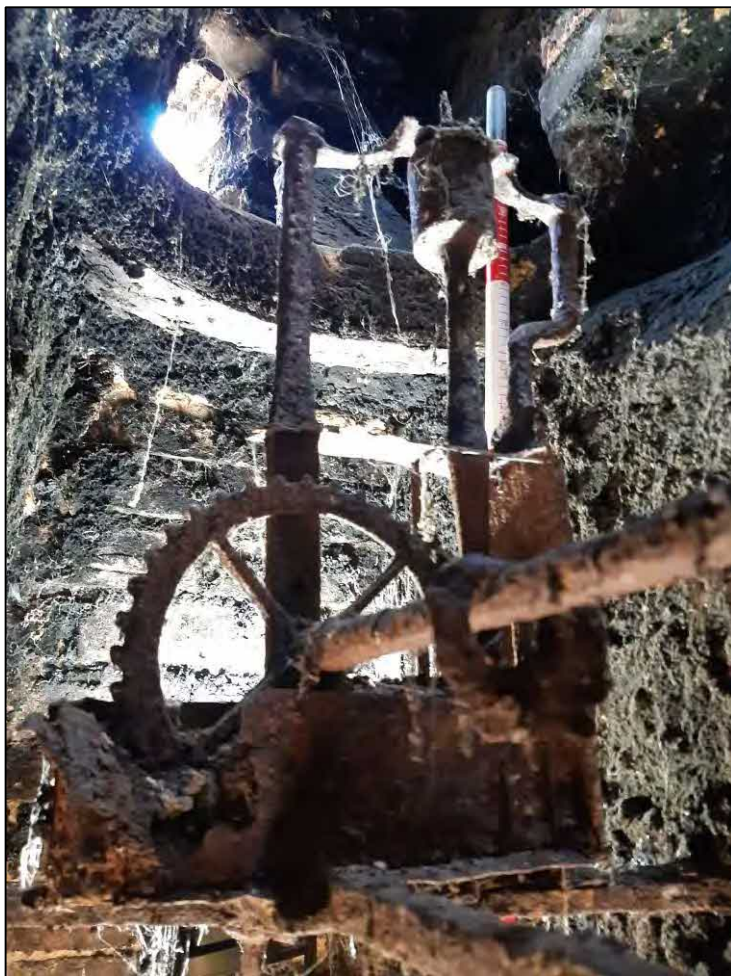
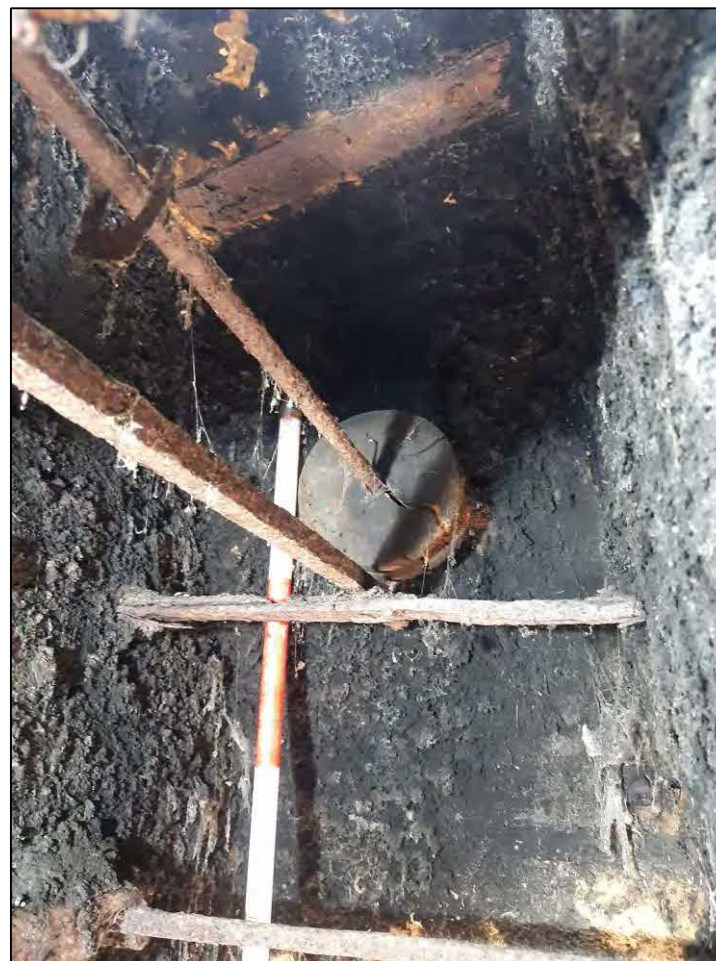
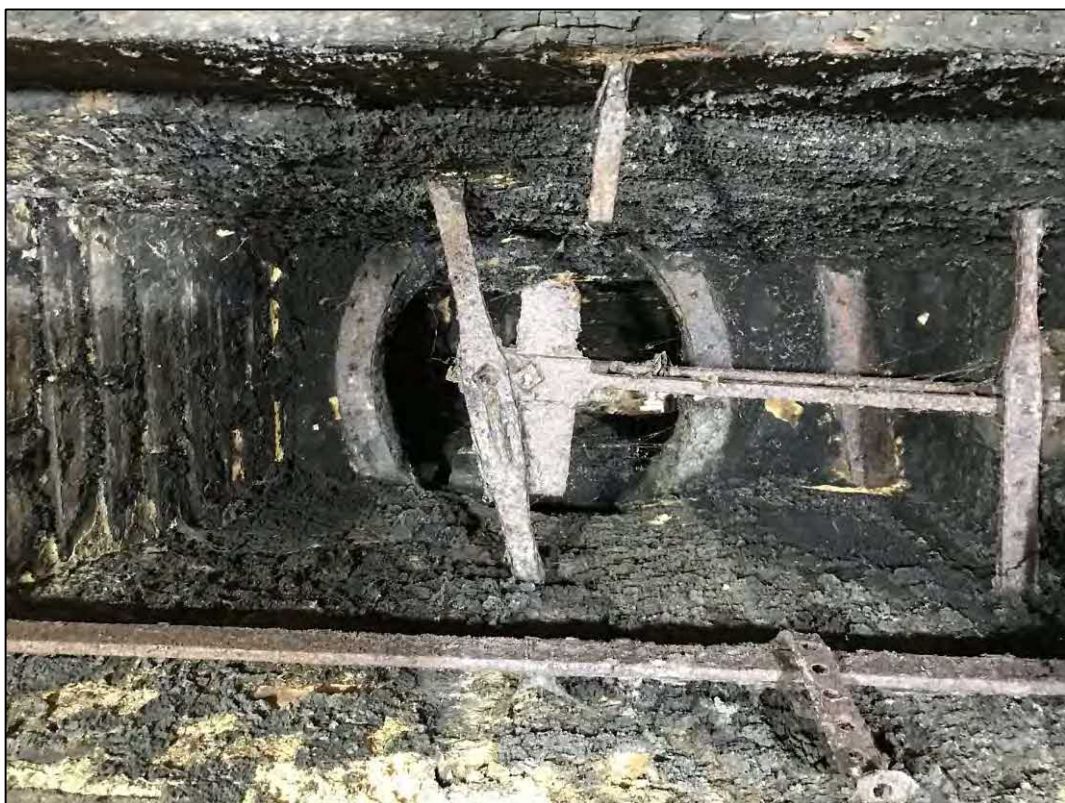
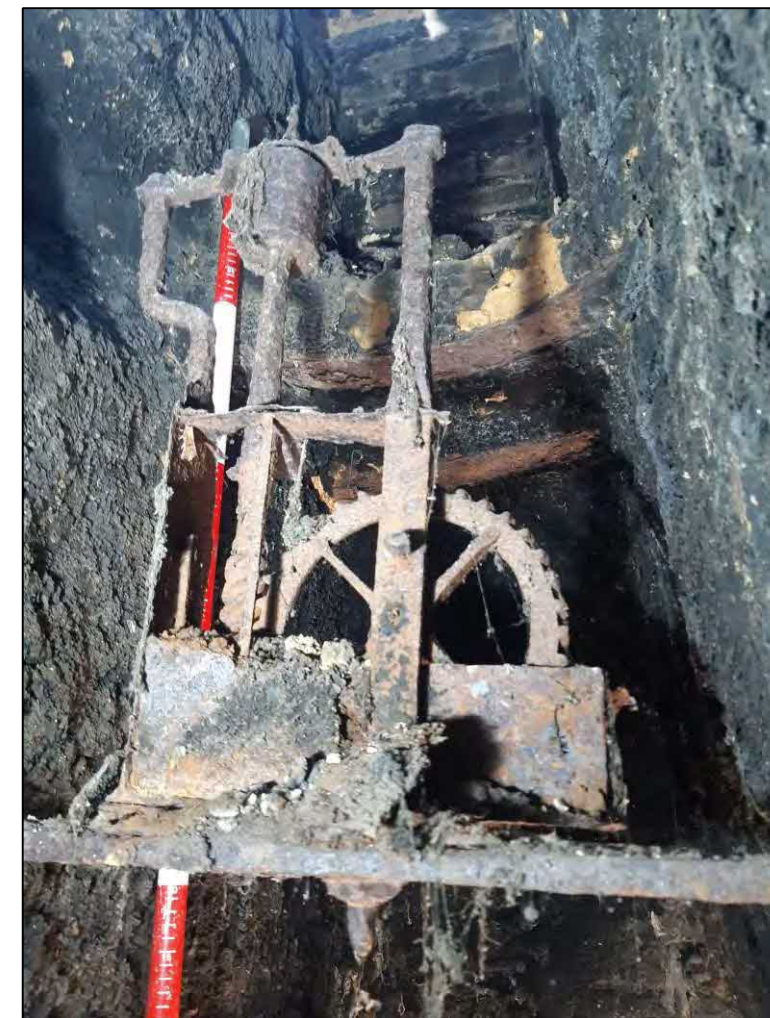
- 4.7 The reason for the fore-shortening of the fireplace was most likely to install a smoke jack mechanism [32-35], a device for turning joints of meat during roasting on a spit, which was driven by ascending smoke or rarified air. The iron mechanism, very corroded, was largely intact inside the chimney breast, comprised of, cogged face-wheel with screw spindle, wooden pulley wheel and iron vane wheel housing above. Comparable 18th century smoke jacks exist at the Castle Museum, York and the ruined kitchen of Kirby House, near Gretton, Northamptonshire. The means of operation is explained in the 1817 edition of *Encyclopaedia Britannica* (pp. 421-423) together with a diagram of a smoke jack in its simplest form. It is possible that meat preparation was a primary function of the building, since seven evenly-spaced iron meat hooks were arrayed on the underside of a main cross-beam [21-24], while another survived to right of the doorway [29]. Investigative cleaning of the hearth area revealed only a layer of wood-ash directly above heat-reddened geological stratum and a back draft beneath the brick-lining of the hearth [56].

32. Outbuilding 1: chimney breast interior. Smoke jack mechanism (c. 18th century)

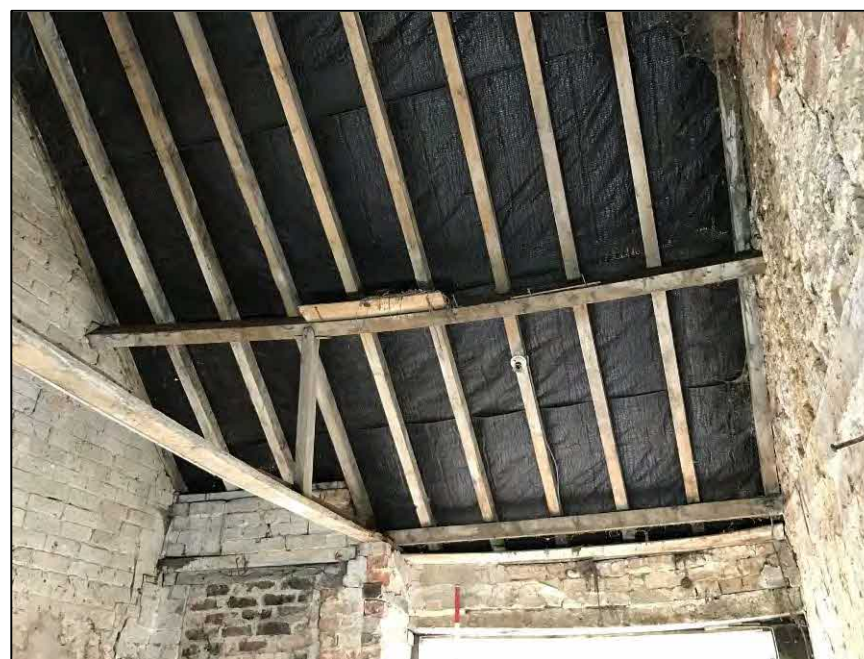
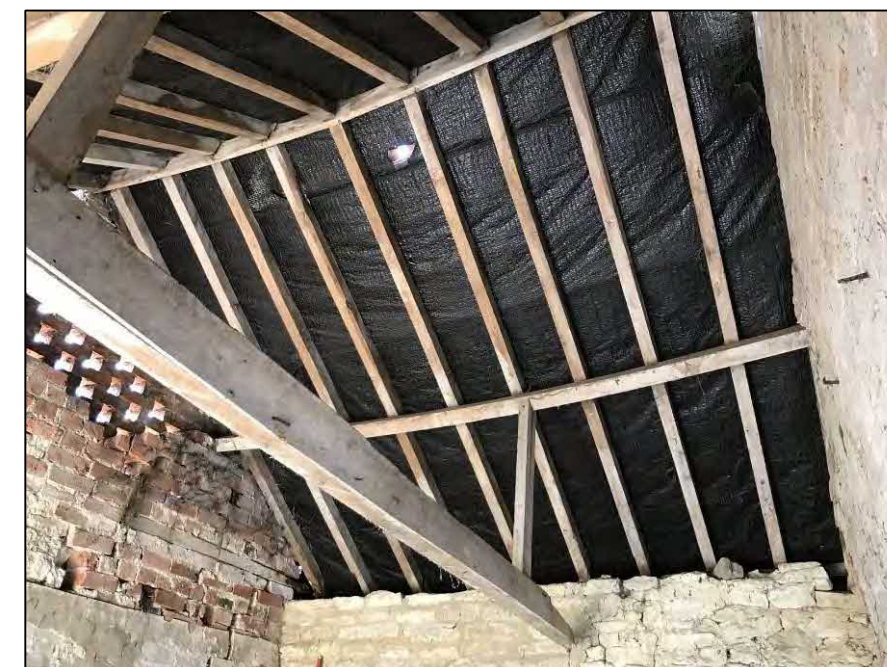
- 4.11 The roof is covered in pantiles. Replaced rafters and installation [40-41] suggested that it had been re-roofed at the same time as Outbuilding 1, in the late 20th century,

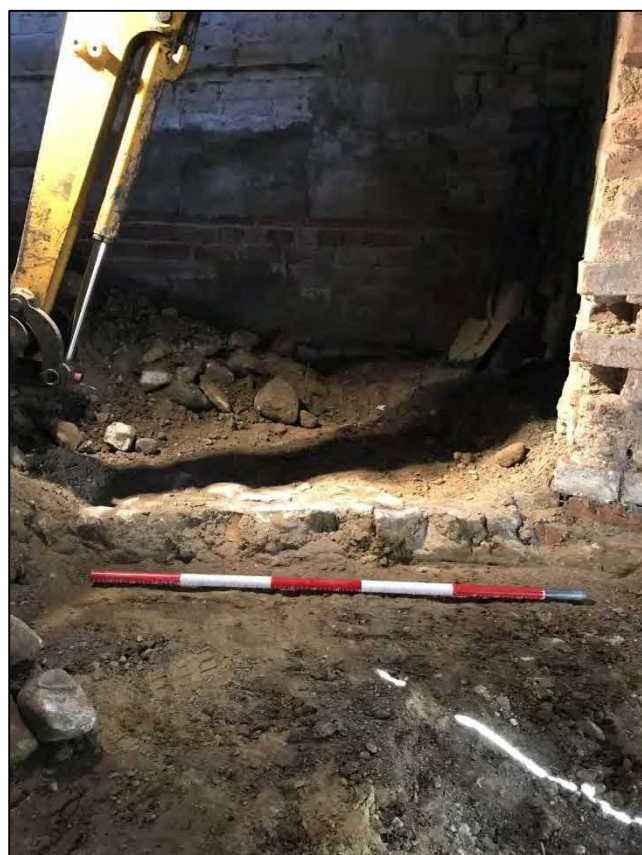
52. Outbuilding 2: section through cobbled floor. Facing NE

- 4.13 Oral tradition suggests that the building was once used as a pig pen⁹, hence the floor was concealed by c. 0.1 m of dried muck [36-39]. Machine excavation revealed remnants of a cobbled floor [52] with a possible drain along its south side [50]. A clay floor tile and fragments of a similar type were recovered from the foundation of the rear wall. The tiles are stamped 'W. BLUNDELL MAKER TWYWELL NR, THRAPSTON' [54].

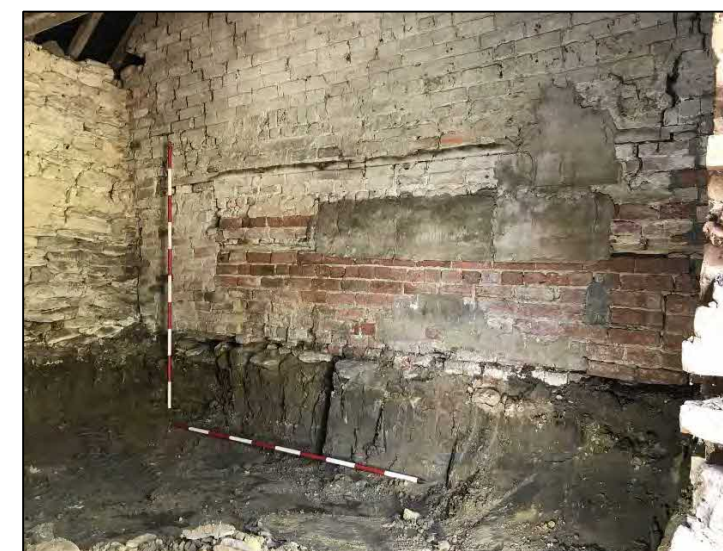
51. Outbuilding 2: excavated floor. Facing N

- 4.15 The floor was laid directly above the geological stratum, which at this point was comprised of blue-grey mudstone [51]. Four sherds of pottery were recovered. They comprised two very abraded pieces of possible late medieval Glapthorn ware (14th / 15th century), and two 17th / 18th century sherds, one a pale green vitrified ware with slip decoration, the other, a piece of brown glazed earthenware.

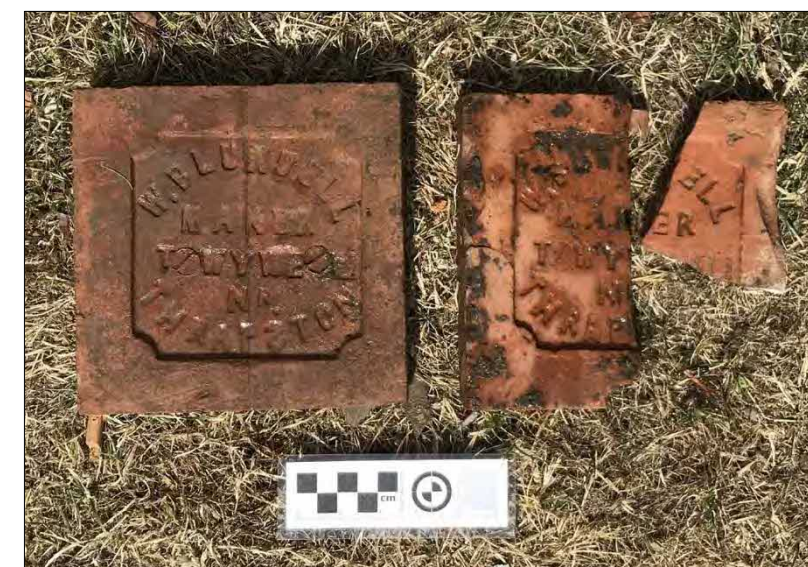
54. Outbuilding 2: locally made tiles recovered from excavated floor

- 4.14 The tiles were made at the Twywell Brick and Tile Works where Mr Blundell was the manager in 1884-86¹⁰. The brickyard was located to the east of Twywell Railway Station, about 700 m to the southeast of the village. The company was owned by Mr P Phipps MP (the Northampton Brewer) and it is curious that it was Blundell and not Phipps stamped on the tiles. The product range advertised in 1887 included pantiles¹¹. Formerly known as the Newbridge Brick Works the manufactory was started up c. 1867 by Thomas Walters, an iron ore businessman (O' Rourke 1970, 25). The brickworks were put up for auction in 1870¹² and were subsequently acquired by Phipps. It is thought to have been shut down in the mid-1890s (Rourke 1970, op. cit.). It is not known whether Mr Blundell had also been manager of the Newbridge Brick Works, and therefore the construction date for Outbuilding 2 is somewhere between c. 1867 and 1884.
