BAT SURVEY REPORT

OLD MILL, DOWNHEAD, SOMERSET

DECEMBER 2022

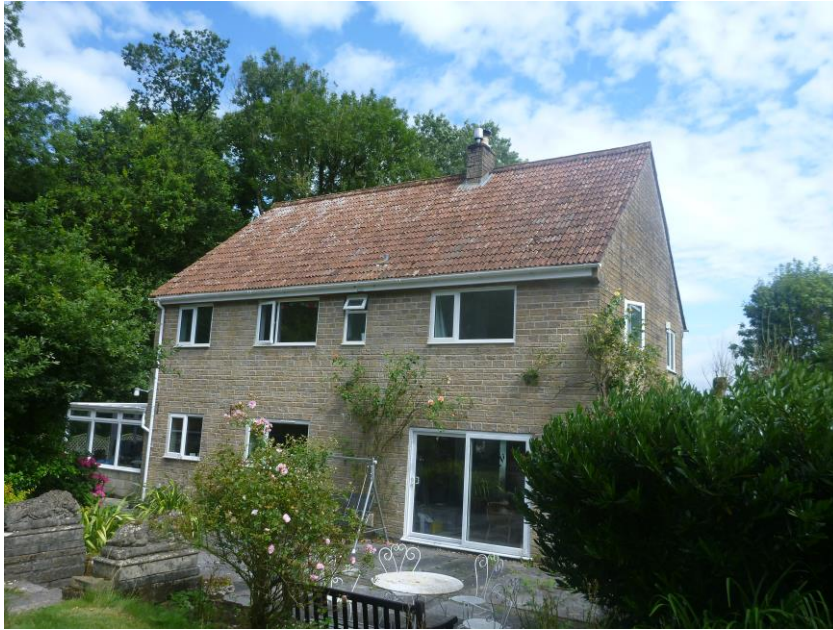
Old Mill is a two-storey brick house with pointing which is generally in good condition. The roof is clay tiles which are an unusual “M” shape. None of the roof tiles were noted to be missing, damaged, lifted or slipped and they sit quite tightly across all aspects of the roof.

Fig 2: Old Mill.

This photo taken from the south-west on 17th August 2021.

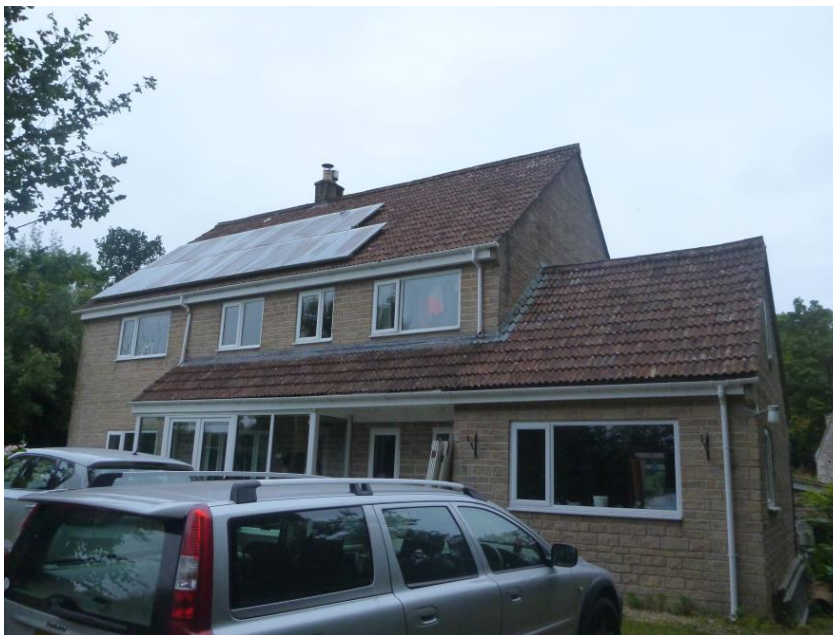
At the northern end of the property is a single storey extension, which is of the same construction.

Fig 3: The single storey extension to the north of Old Mill.

This photo taken 17th August 2021, from the north-east.

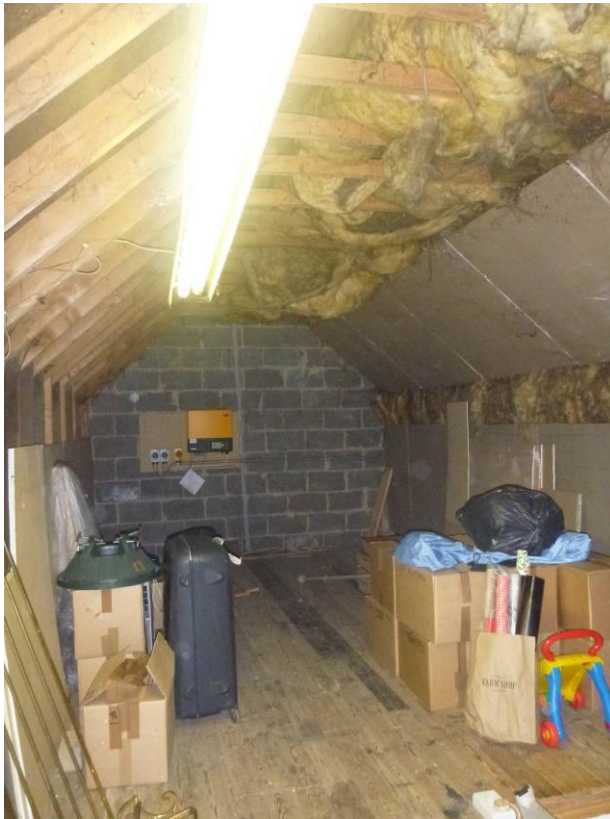
There is a single loft space above the two-storey part of the house which is c.3.5m high to the ridge. The loft space is boarded throughout and is used for storage.

The roof is lined with bitumen roofing felt and along the length of the ridge there is a large bundle of fibreglass insulation.

Fig 4: The loft space at Old Mill.

This photo taken facing north within the loft space on 17th August 2021.

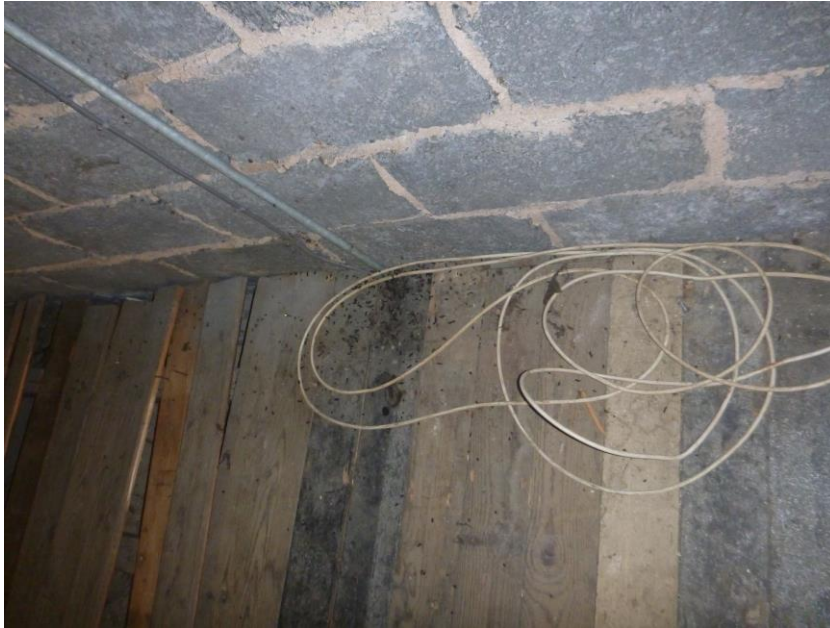
At the northern end of the loft space, against the gable end wall, an accumulation of approximately 50 bat droppings was noted. A sample of the droppings was collected and sent for DNA analysis, which confirmed they were from serotine bats.

Fig 5: An accumulation of serotine droppings against the northern gable end wall of the loft space.

This photo taken 17th August 2021.

The serotine day roost at the northern end of the property will be disturbed and modified by work to convert the loft space to habitable accommodation.

Work to create habitable accommodation in the loft space of the property will result in modifications to the serotine bat roost at the northern gable end. Leaving a void at the ridge in this area of the property will allow serotine bats to continue to use the roof of the property as they do currently and will result in minimal disturbance. Unless the property is to be re-roofed, no change to the roost access point would be anticipated and no new access points will need to be provided.

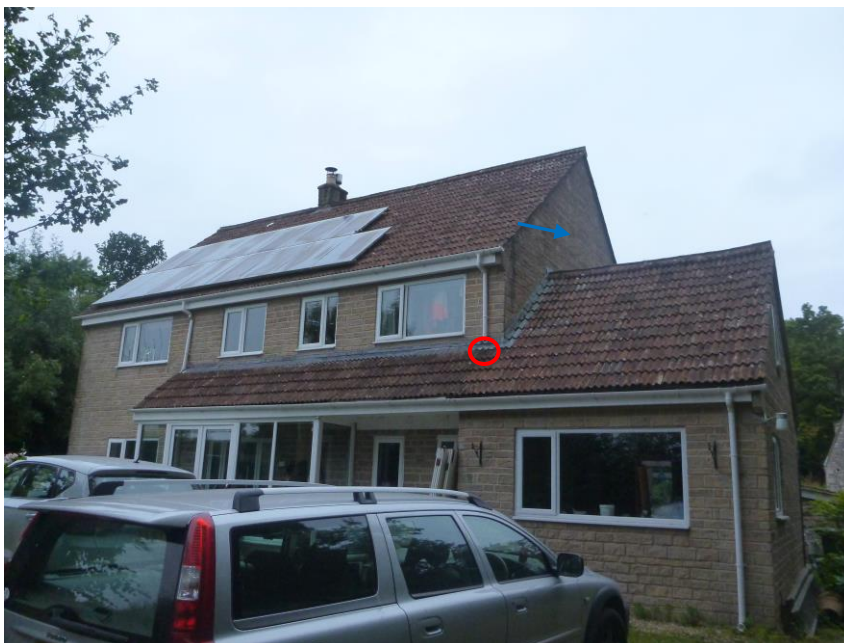
During this survey two soprano pipistrelle bats emerged from the property. One from the verge of the southern gable end of the house, between the wall and roof tile, the other from below the lead flashing at the north-eastern corner of the house.

One serotine bat emerged from the verge of the northern gable end of the house, between the wall and roof tile.

Fig 6: Emergences by one soprano pipistrelle and one serotine bat during an emergence survey on 19th August 2021.

This photo taken from the north-east.

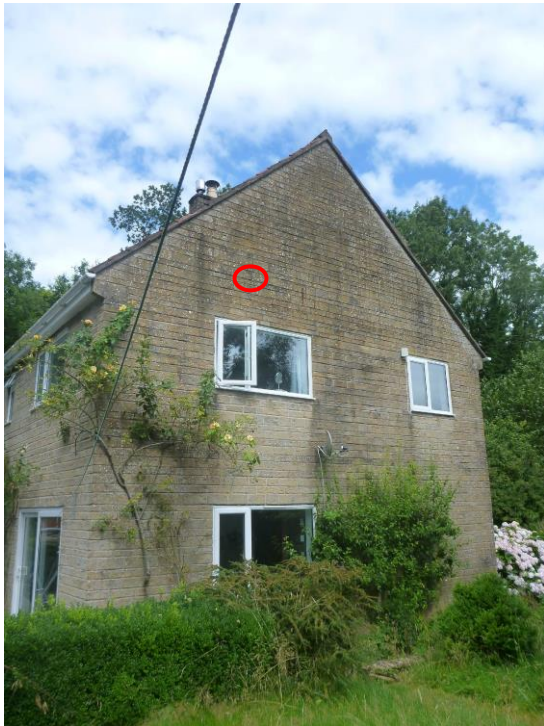
Five soprano pipistrelle bats were recorded returning to roost in a crevice in the brick work on the southern aspect of the property, seven brick courses above a large window.

Fig 7: Five soprano pipistrelle bats were recorded roosting in this crevice feature in the southern aspect of the property on 30th August 2021.

Where timber cladding is to be added to the southern face of the property, where soprano pipistrelle bats are roosting in a cavity in the wall, a gap will be created in the timber cladding which will allow bats to continue to access their roost and this work will be supervised by a suitably licensed ecologist to ensure the roost remains viable. Although this work could be carried out at any time of the year, in order to minimise disturbance to bats the timber cladding should be added outside the peak of the summer maternity period, between September and April (inclusive).

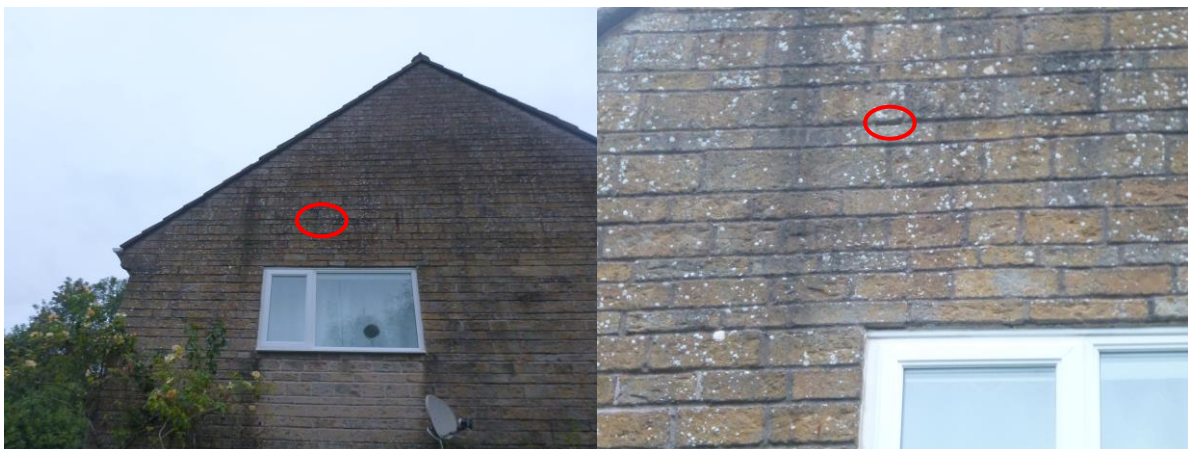
Fig 8: Crevice in the brickwork on the southern aspect of Old Mill where five soprano pipistrelle bats were recorded roosting during a re-entry survey carried out on 30th August 2021.

the brickwork on the southern aspect of the building, which likely leads to a cavity in the wall.

The cavity in the brickwork on the southern aspect of the property is to be retained but will be disturbed when timber cladding is added to this face of the building.

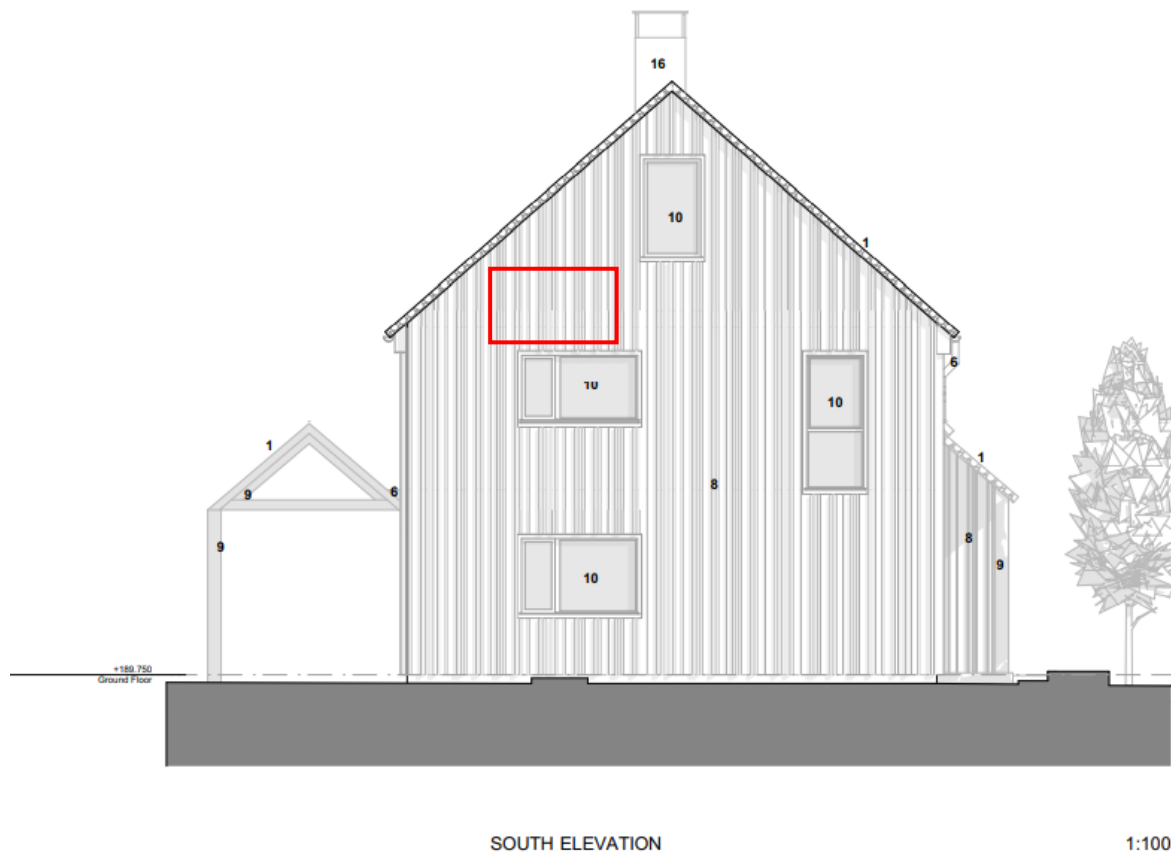
Fig 9: The timber cladding in this area of the property should be added between September and April (inclusive) under the supervision of a suitably licensed ecologist. A gap will be left around the roost access.

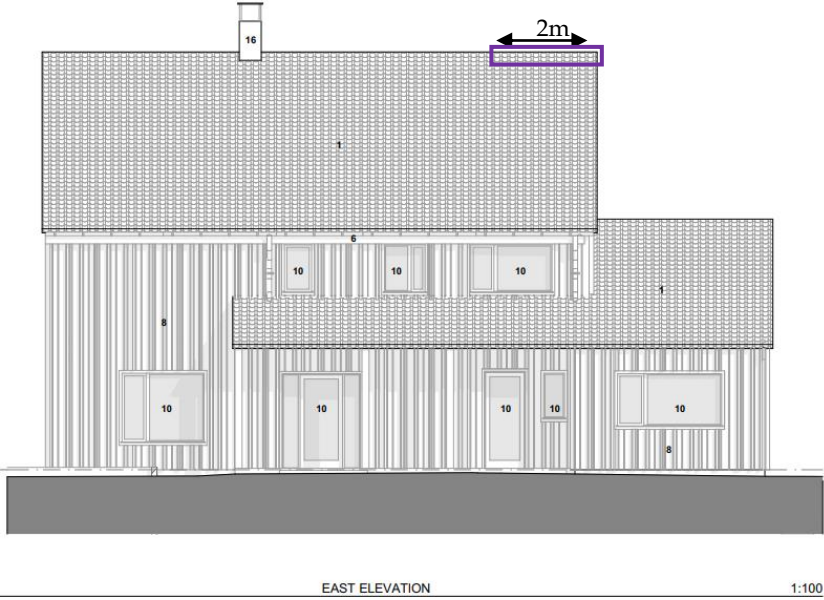
Fig 11: A crevice feature will be created around the ridge at the northern end of the property for the benefit of serotine bats.

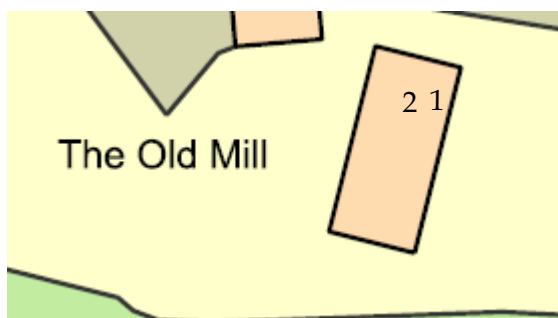
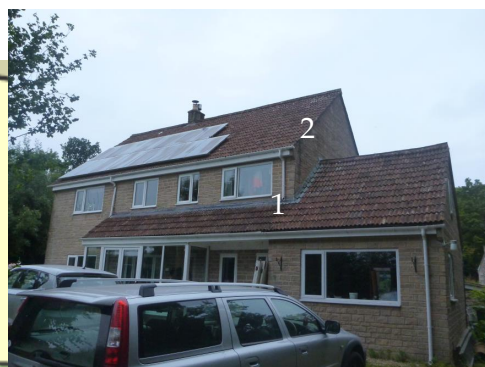
Time	Map Ref	Species	Activity
2018	1	55 pip	1 bat emerged from gap between tiles below lead
2030		45 pip	Brief HnS below trees to N
2031		55 pip	1 bat foraging over driveway
2032		45 pip	Foraging HnS
2034		45 pip	Flew from back of house then foraged over driveway
2036		45 pip	Foraging around trees on driveway
2039		55 pip	Foraging over driveway
2042		55 pip	HnS
2051		Serotine	Flew from back garden around house
2052		Serotine	Foraging around mature trees to N of house

Time	Map Ref	Species	Activity
2053		Serotine	Foraging over driveway
2056	2	Serotine	1 bat emerged
2059		Serotine	1 bat foraging over driveway
2101		Serotine	Foraging up and down tree line to N of house
2018		Serotine	HnS
2110		Serotine	HnS
2118		45 pip	HnS
2122		Serotine + 45 pip	HnS foraging over driveway
2125		45 pip	Foraging over drive
2127		45 pip	HnS
2128		Noctule	HnS
2128		45 pip	2 bats foraging over driveway
2132		Serotine	Foraging HnS
2133		Serotine	Foraging ongoing HnS
2134		45 pip	HnS
2136		Noctule	HnS
2141		55 pip	HnS until 2143

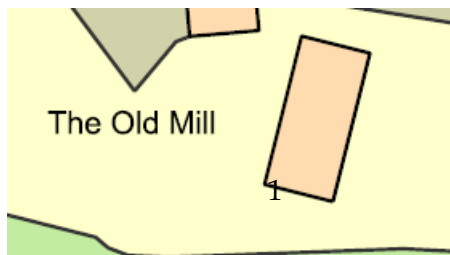
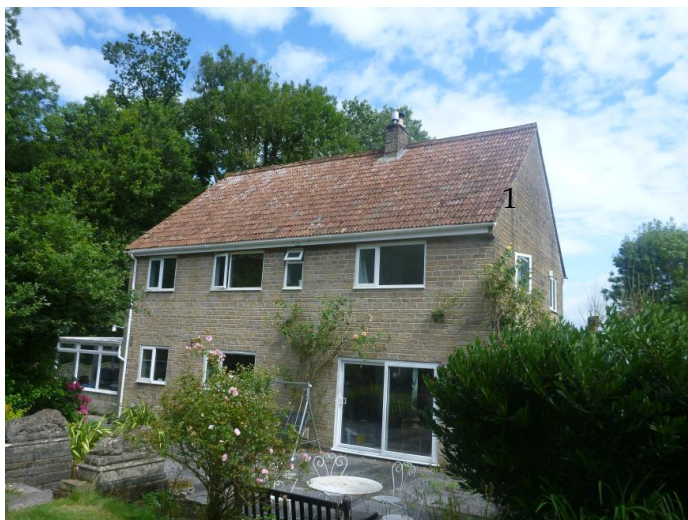
Time	Map Ref	Species	Activity
2039		45 pip	HnS
2040	1	55 pip	1 bat emerged
2048		55 pip	HnS
2050		55 pip	2 bats HnS
2051		LE	Foraging overhead
2052-55		LE + Noctule	Continuous calls HnS
2056		Serotine	Flew towards house from hedgerow to S
2101		Serotine	Foraging over garden to S of house
2108		Noctule	HnS
2109		Serotine	Foraging high over the garden
2112		45 pip	HnS
2122		Serotine	HnS
2123		55 pip	HnS
2125		55 pip	HnS
2128		45 pip	HnS

Time	Map Ref	Species	Activity
2129		45 pip	HnS
2131		Serotine	HnS
2132		Serotine	HnS
2133		Serotine	HnS
2136		45 pip	HnS
2137-39		55 pip	Foraging HnS
2139		Serotine	HnS
2141		55 pip	HnS
2142		55 pip	HnS
2144		Noctule	HnS
2145		55 pip	HnS

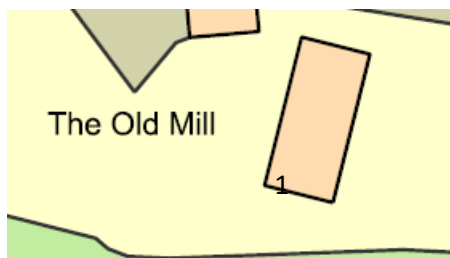
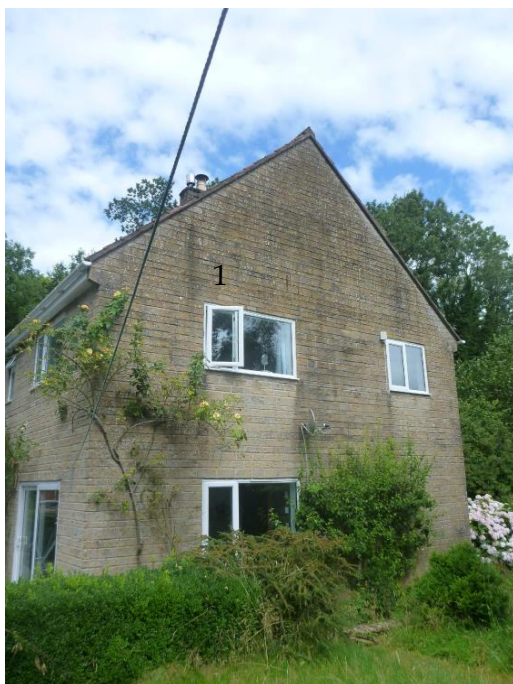
Time	Map Ref	Species	Activity
0454		45 pip	HnS
0455		55 pip	HnS
0457		55 pip	HnS
0500		LE	Commuting over garden
0505		55 pip	HnS
0506		LE + Noctule	HnS
0516		55 pip	HnS
0517		Noctule	HnS
0518		Noctule	HnS
0520		55 pip	HnS
0521		55 pip	HnS
0525		45 pip	HnS
0527		LE	Commuting over garden
0534		Serotine	Flying NW to SE over garden
0536		55 pip	HnS

Time	Map Ref	Species	Activity
0539		55 pip	HnS
0542		45 pip	Flew N to S over roofline
0551		55 pip	Foraging over garden
0600	1	55 pip	3 bats entered into crevice in brick work
0605		LE	1 bat circling over roof
0606	1	55 pip	1 bat entered into crevice in brick work
0614	1	55 pip	1 bat circled house then entered into crevice in brick work
0620		45 pip	1 bat continuing to forage over the garden

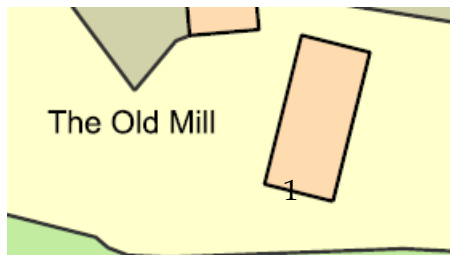
Time	Map Ref	Species	Activity
1921	1	55 pip	1 bat emerged from apex of southern gable end
1933		55 pip	1 bat foraging over driveway
1934		55 pip	1 bat foraging over driveway
1939		45 pip	1 bat foraging over driveway
1943		LE	HnS
1945		45 pip	1 bat foraging over driveway
1946		45 pip	1 bat foraging over driveway
1947		LE	Brief call HnS
1950		45 pip	Foraging HnS
1955		45 pip	1 bat foraging along tree line to N

Time	Map Ref	Species	Activity
1958		45 pip + Serotine	HnS
2003		55 pip	Foraging HnS
2010		LE	HnS
2020		45 pip	HnS over driveway
2039		45 pip	HnS
2042		Serotine	HnS
2043		Serotine	Foraging HnS
