# **Ecological Survey and Assessment for Duck End Farm Barn Lindsell**

**October 2022**

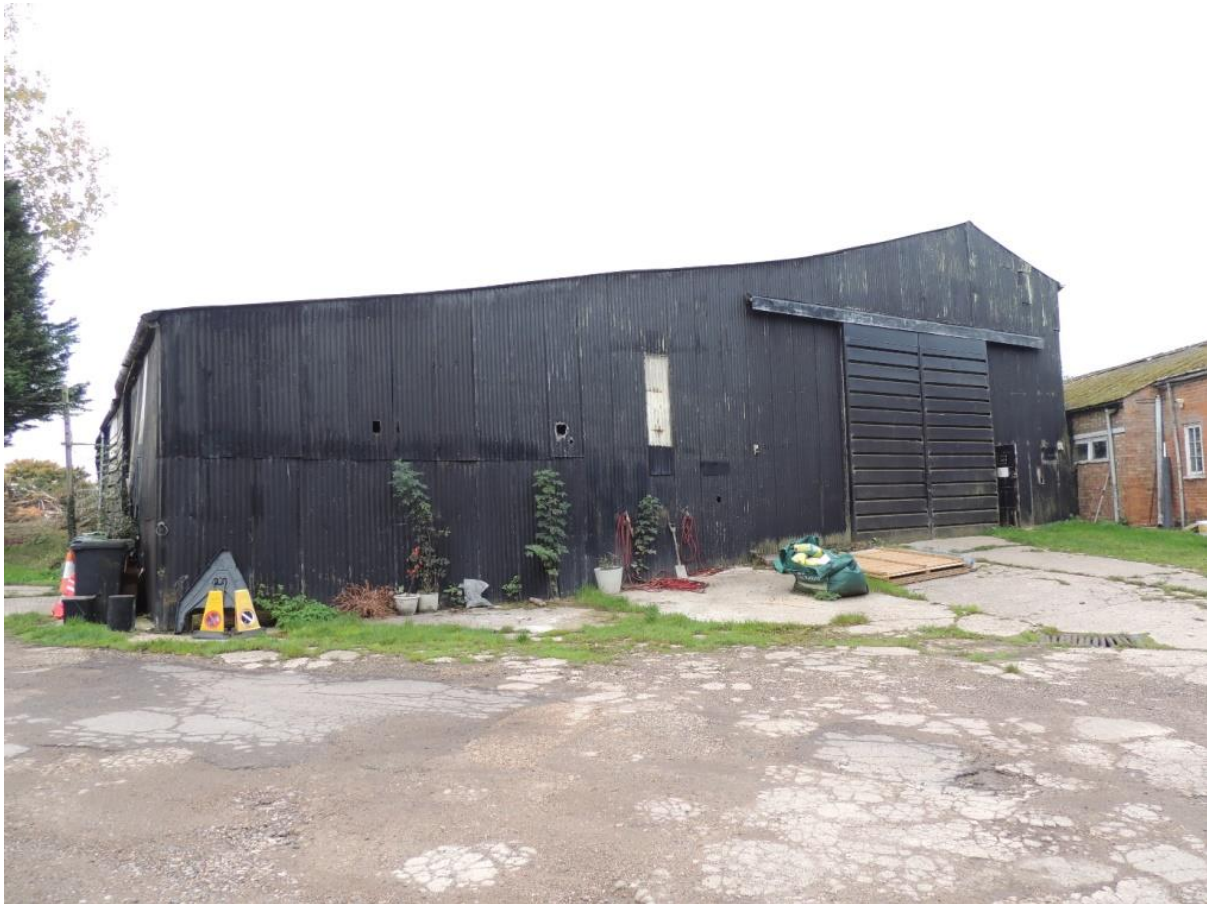
**Photo 1:** Front (northern) elevation. Note hardstanding. The proposal involves replacement with a residential dwelling

The survey building is a detached pole barn with an unlined roof and walls of corrugated tin. The building is aligned approximately N-S. A single-storey brick building is unaffected by the project. The survey found that the interior was used for storage and received daylight illumination from numerous transparent panels in the walls and roof. In such conditions, bats seek out dark areas or cavities in which to roost and the lack of such features in the machine cut beams and vertical poles made the building less suitable as a roosting place for bats. No evidence of their presence was found on the walls and floor of the building or on items stored within it. Externally, there were no cavities in the tin walls that might offer potential roosting places for bats. The barn was considered to have **negligible potential** as a roosting place for bats.

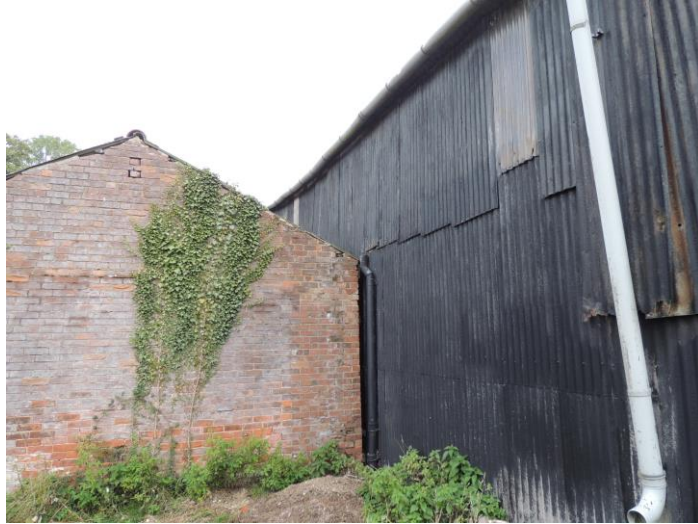
**Photo 8:** NW corner. The brick building is to be retained

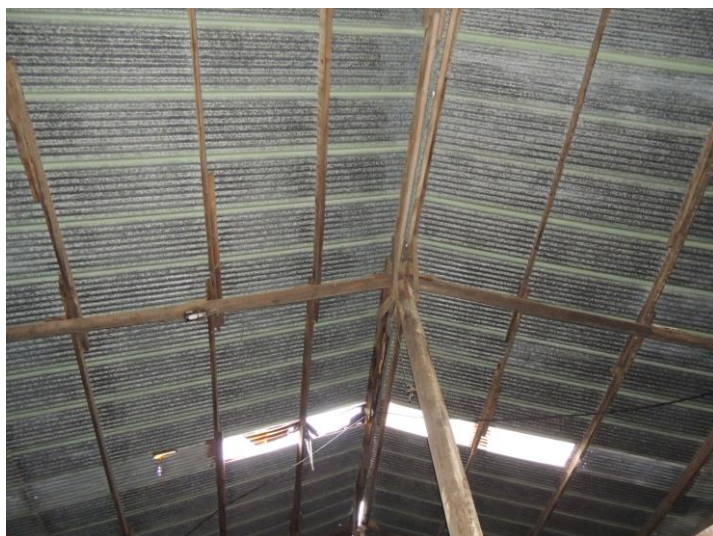
**Photo 15:** The roof had no features that might be occupied by bats

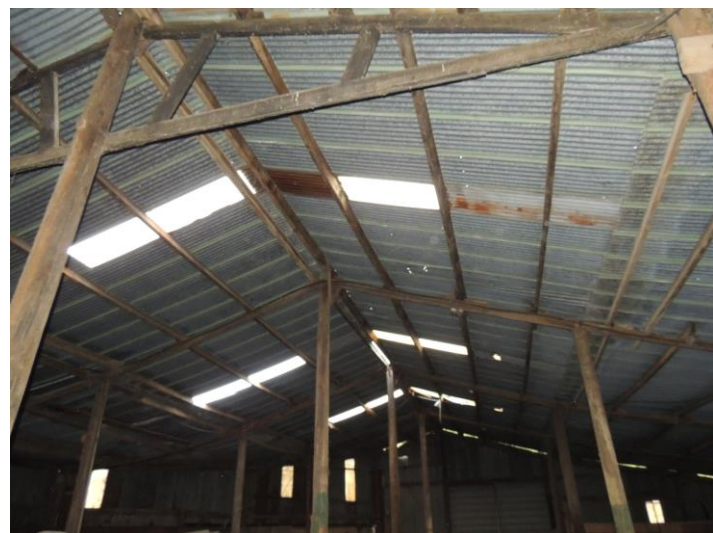
**Photo 16:** The roof had no features that might be occupied by bats

The lack of potential roosting places and absence of any evidence of the presence of bats means that **no** further surveys are required for this building.

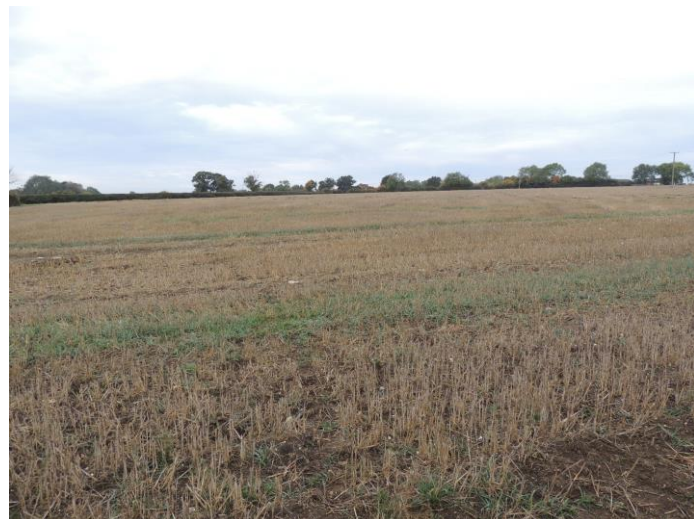
**Photo 21:** Looking westwards. The mammal path is used by fallow deer (droppings were present)

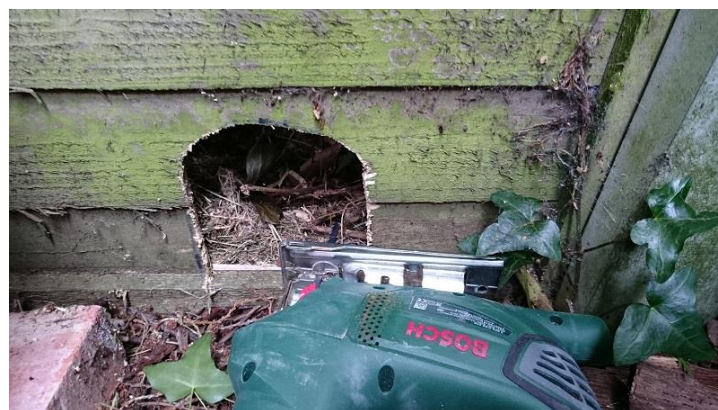
**Photo 22:** Hedgehog pathway at base of fence

**A gap 13cm by 13cm is sufficient for any hedgehog to pass through. This will be too small for nearly all pets.**

It is recommended that the existing gaps along the site boundaries are retained to allow hedgehogs and common toads to forage across the site as, potentially, at present. However if boundary fences are to be introduced, see below:

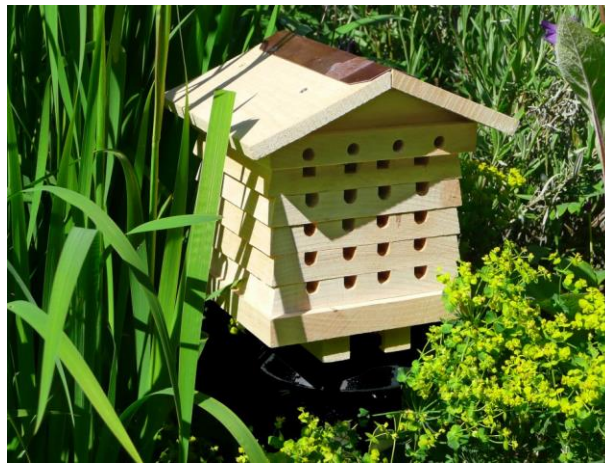
**Photo 23:** Solitary beehive

A solitary beehive may be made from durable FSC timber (several designs are available) and provides valuable habitat for bees in modern gardens. It is designed specifically to attract non-swarming bees like the Red Mason Bee, Leafcutter Bee and other solitary bees which are naturally attracted to holes in wood.

**Siting:** Site in a visible warm place ideally oriented to face between southeast and south and to catch some sun. It is helpful to have soil nearby, and food sources such as flowers, orchards and fruit.
